# Huntly Bauxite Mine – WQMS Data Review

August 2025

**Revision:** Rev 02

# Willowdale – Water Quality Monitoring System Data Review

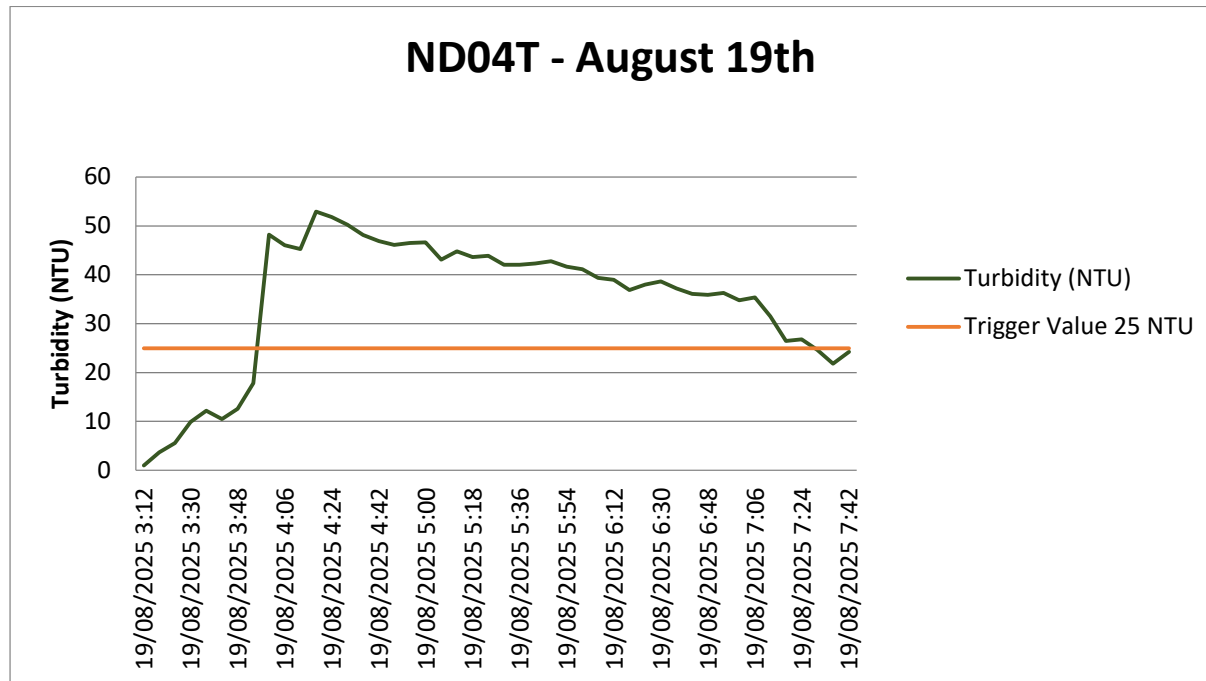
Figure 3 HUN-2508-028

The event, occurring between 4:00 and 7:24 on the 19<sup>th</sup> of August at ND04T exhibits a sharp, incline in turbidity levels followed by a gradual return to baseline levels in a pattern resembling a normal (Gaussian) distribution as shown in Figure 3 below. This criteria is in line with a typical true event as per the 'Turbidity Event Classification Guidelines'.

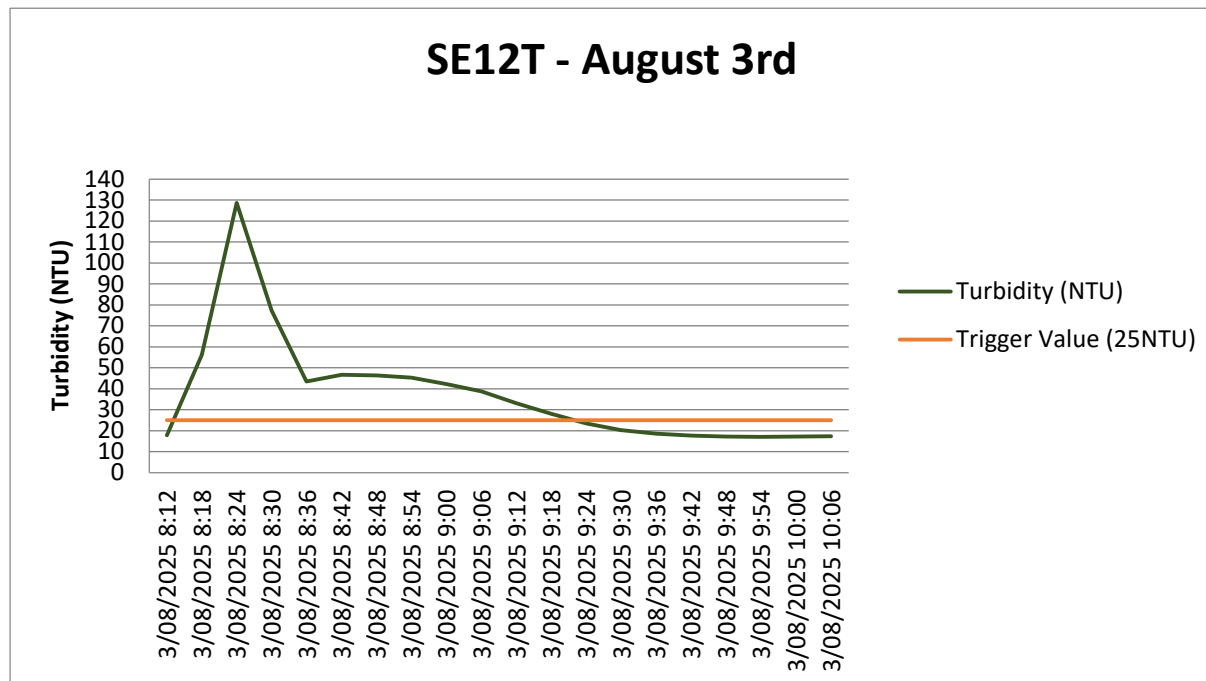
Figure 4 - HUN-2508-036

The event, occurring between 8:18 and 9:18 on the 3<sup>rd</sup> of August at SE12T exhibits a sharp, incline in turbidity levels followed by a gradual return to baseline levels in a pattern resembling a normal (Gaussian) distribution as shown in Figure 4 below. This criteria is in line with a typical true event as per the ‘Turbidity Event Classification Guidelines’.

*Data analysis indicates a true rise in stream turbidity, as well as sensor interference caused by organic debris.*

*On 2 August 2025, site SE12T was inspected and found to have very low stream depth, with water just covering the sensor lens which was positioned close to the stream bed. Organic*

*debris was observed in the stream bed and around the sensor, along with mild stream turbidity. On the same day, upstream monitor SE12INV was also inspected and found buried in sediment caused by runoff from the adjacent forest track. The sensor was cleaned and repositioned. On 3 August 2025, SE12T was revisited. Stream depth had increased, and the sensor was adjusted to sit horizontally and higher in the water profile to reduce interference from stream bed sediment/debris. SE12INV was again found nearly buried by sediment and was cleaned and repositioned. Both sites were again inspected on 4 August 2025, the stream was clear at both SE12T and SE12INV, with no new sediment accumulation observed at SE12INV.*

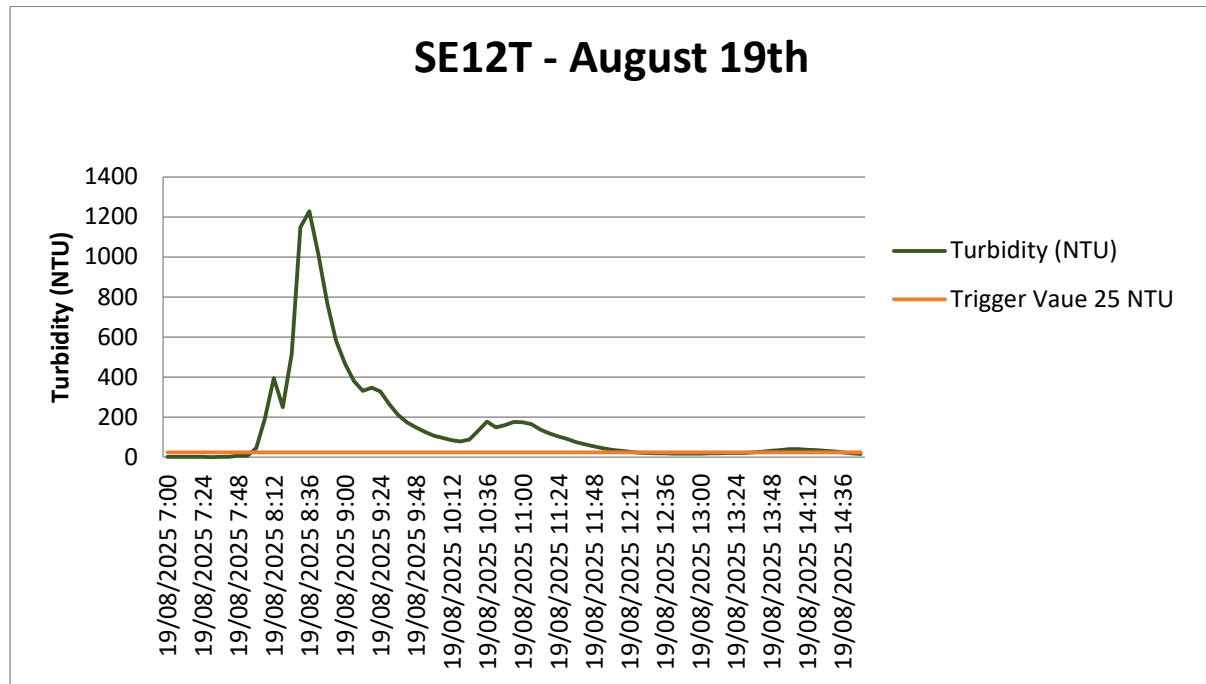
Figure 5 - HUN-2508-040

The event, occurring between 8:00 and 12:12 on the 19<sup>th</sup> of August at SE12T exhibits a sharp, incline in turbidity levels followed by a gradual return to baseline levels in a pattern resembling a normal (Gaussian) distribution as shown in Figure 5 below. This criteria is in line with a typical true event as per the ‘Turbidity Event Classification Guidelines’.

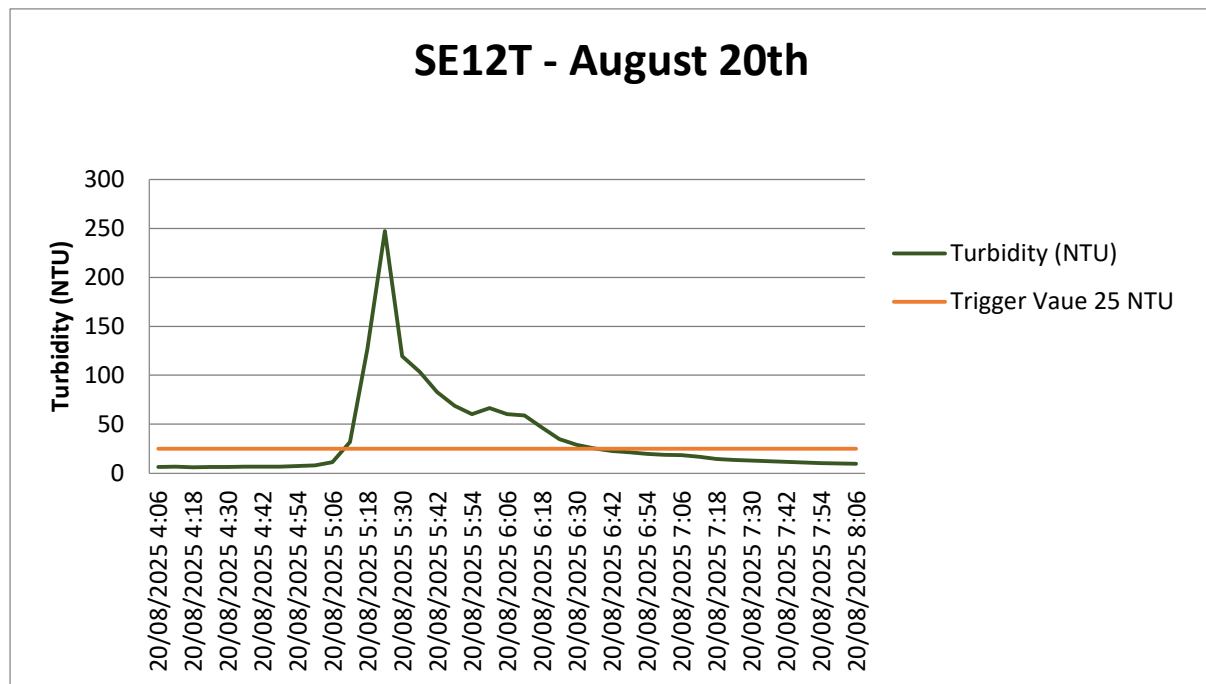
Figure 6 - HUN-2508-041

The event, occurring between 5:12 and 6:36 on the 20th of August at SE12T exhibits a sharp, incline in turbidity levels followed by a gradual return to baseline levels in a pattern resembling a normal (Gaussian) distribution as shown in Figure 6 below. This criteria is in line with a typical true event as per the 'Turbidity Event Classification Guidelines'.

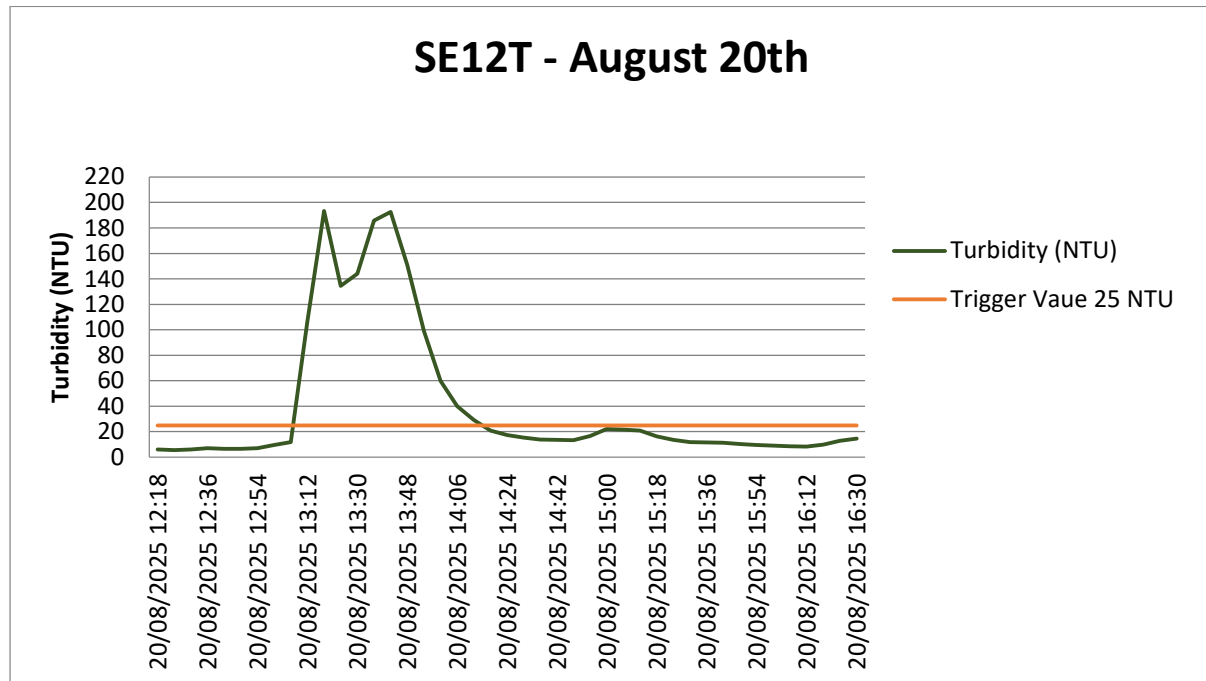
Figure 7 - HUN-2508-042

The event, occurring between 13:12 and 14:12 on the 20<sup>th</sup> of August at SE12T exhibits a sharp, incline in turbidity levels followed by a gradual return to baseline levels in a pattern resembling a normal (Gaussian) distribution as shown in Figure 7 below. This criteria is in line with a typical true event as per the 'Turbidity Event Classification Guidelines'.

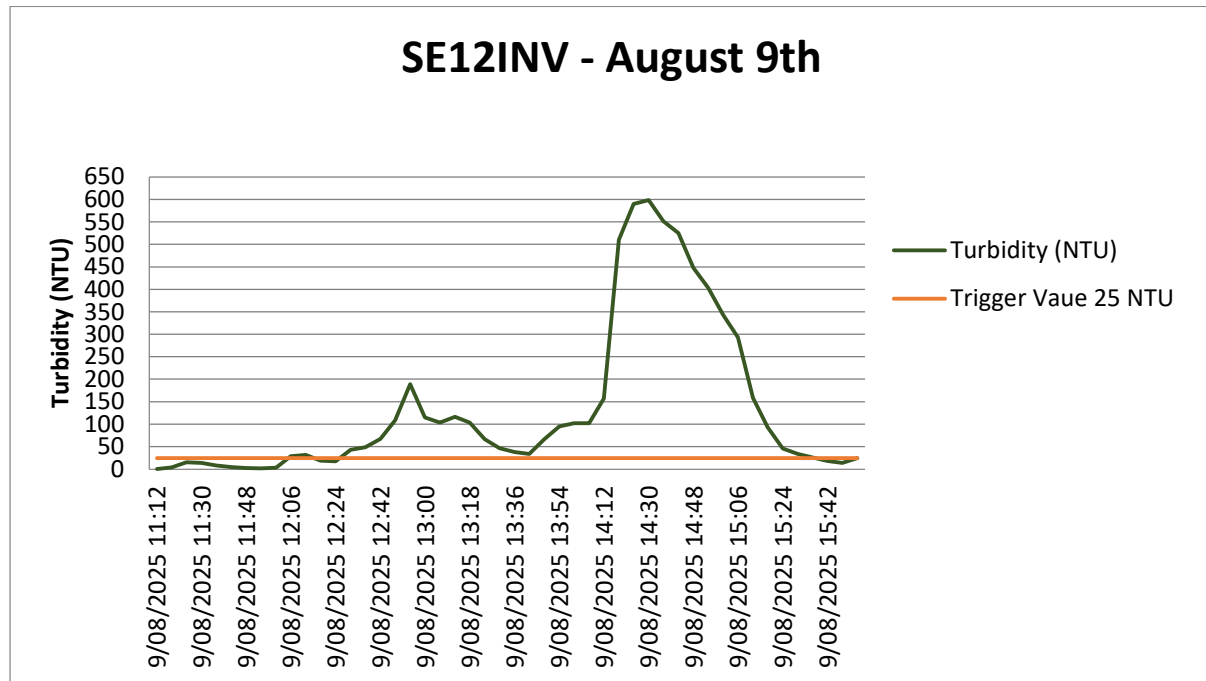
Figure 8 - HUN-2508-046

The event, occurring between 12:30 and 15:36 on the 9<sup>th</sup> of August at SE12INV exhibits a sharp, incline in turbidity levels followed by a gradual return to baseline levels in a pattern resembling a normal (Gaussian) distribution as shown in Figure 8 below. This criteria is in line with a typical true event as per the ‘Turbidity Event Classification Guidelines’.

*Data analysis indicates a true rise in stream turbidity, as well as sensor interference caused by organic debris.*

*On 10 August 2025, site SE12INV was inspected and found to have buried in sediment. Organic debris was observed in the stream bed and around the sensor, along with mild stream turbidity. The sensor was cleaned and repositioned in the stream, only partially submerged due to shallow stream. The sediment is believed to be derived from the DBCA forest track which has been eroded. On the same day, upstream monitor SE12T was also inspected and found to be impacted by sediment.*

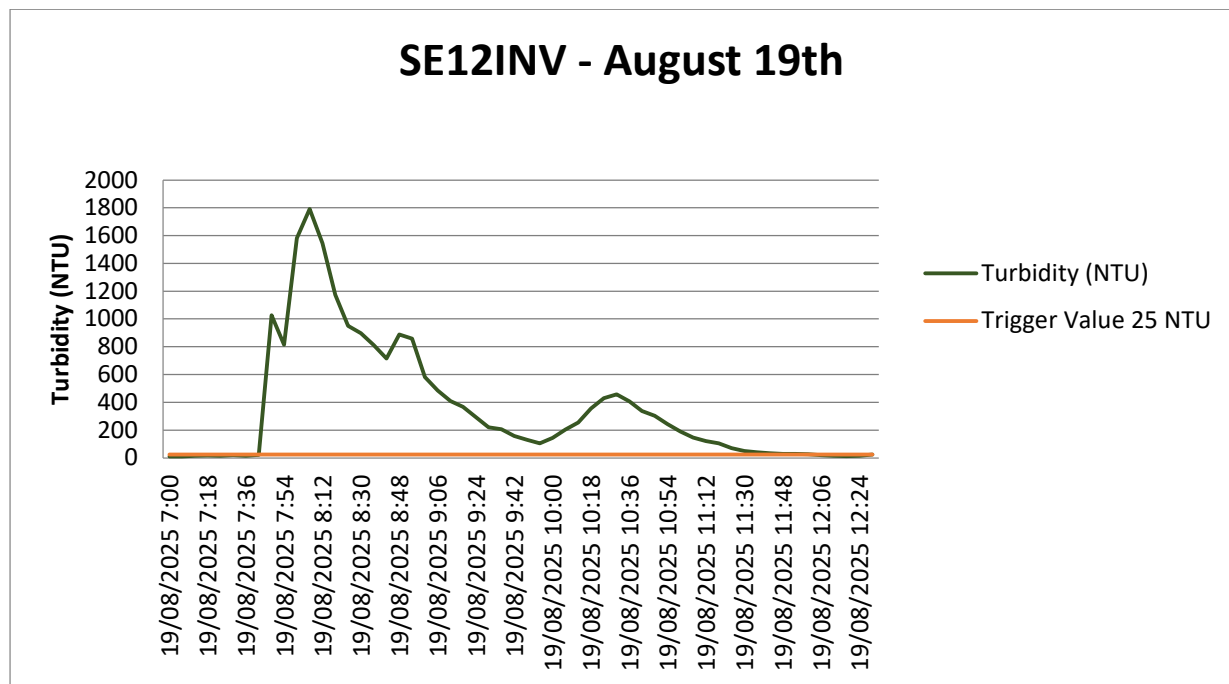
Figure 9 - HUN-2508-048

The event, occurring between 7:48 and 12:00 on the 19<sup>th</sup> of August at SE12INV exhibits a sharp, incline in turbidity levels followed by a gradual return to baseline levels in a pattern resembling a normal (Gaussian) distribution as shown in Figure 9 below. This criteria is in line with a typical true event as per the ‘Turbidity Event Classification Guidelines’.

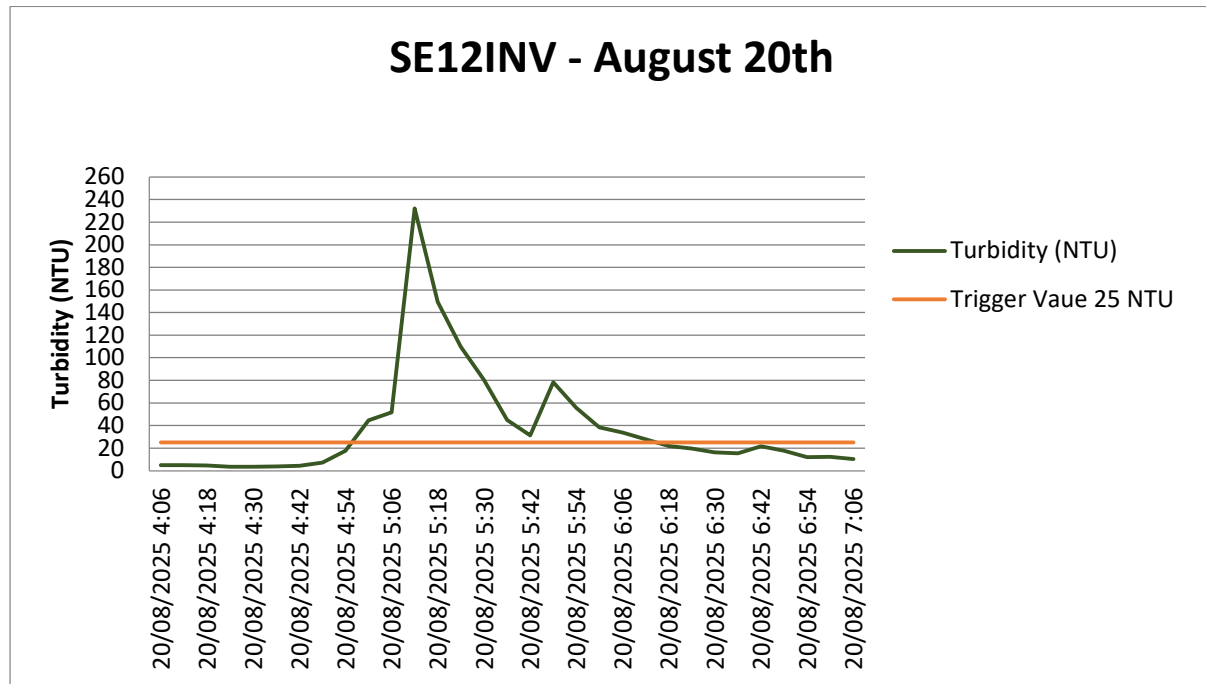
Figure 10 - HUN-2508-052

The event, occurring between 5:00 and 6:12 on the 20<sup>th</sup> of August at SE12INV exhibits a sharp, incline in turbidity levels followed by a gradual return to baseline levels in a pattern resembling a normal (Gaussian) distribution as shown in Figure 10 below. This criteria is in line with a typical true event as per the ‘Turbidity Event Classification Guidelines’.

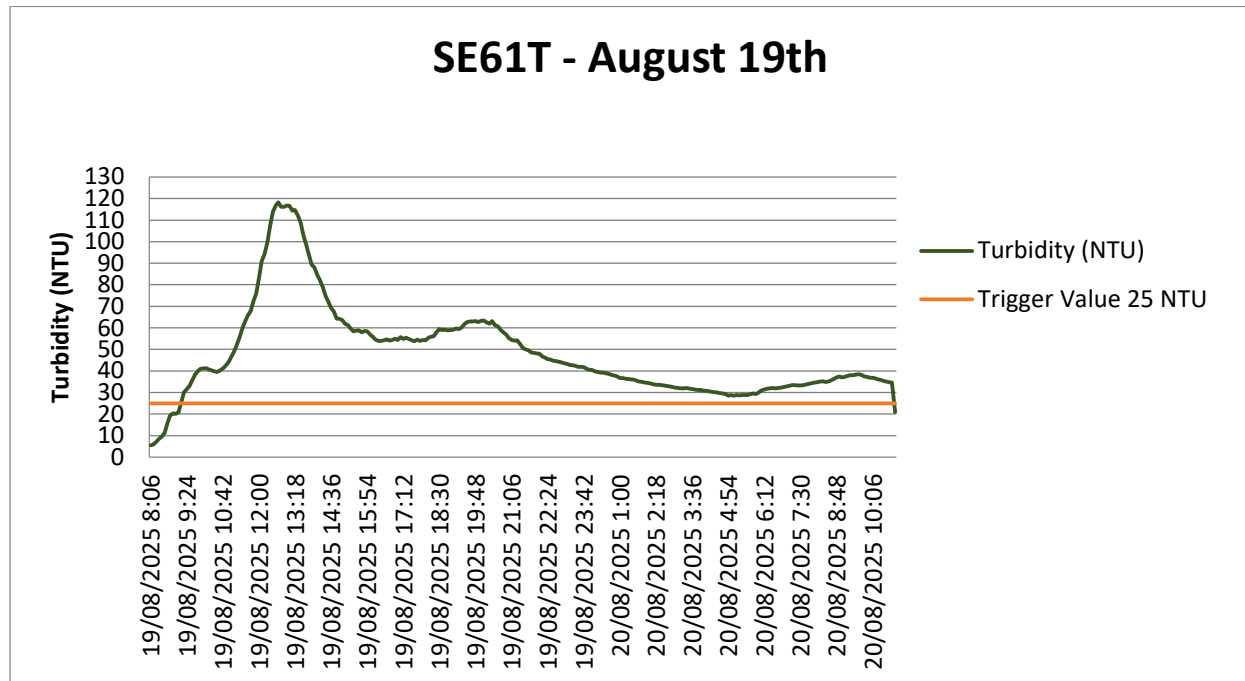
Figure 11 - HUN-2508-084

The event, occurring between 9:12 on the 19<sup>th</sup> of August and 10:48 on the 20<sup>th</sup> of August at SE61T exhibits a sharp, incline in turbidity levels followed by a gradual return to baseline levels in a pattern resembling a normal (Gaussian) distribution as shown in Figure 11 below. This criteria is in line with a typical true event as per the ‘Turbidity Event Classification Guidelines’.

*An inspection of the SE61T catchment including mining pits, rehabilitation pits, tracks and sumps was completed, no evidence on mining contribution was found.”*

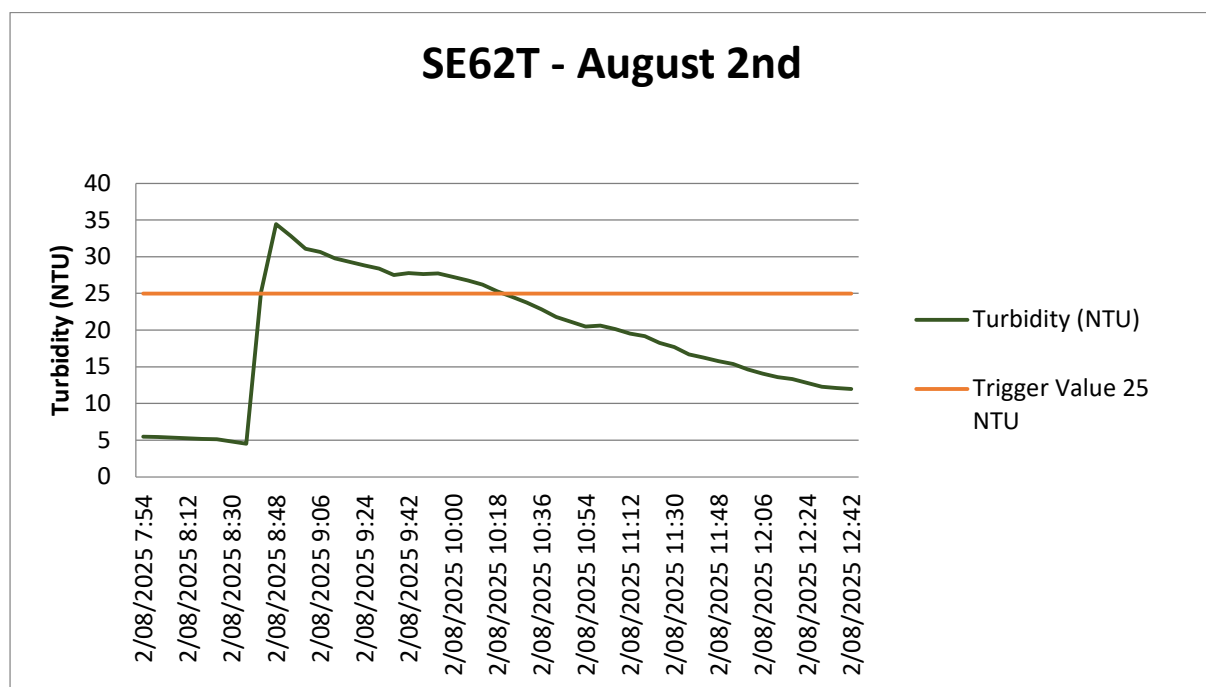
Figure 102 - HUN-2508-086

The event, occurring between 8:42 and 10:18 on the 2<sup>nd</sup> of August at SE62T exhibits a sharp, incline in turbidity levels followed by a gradual return to baseline levels in a pattern resembling a normal (Gaussian) distribution as shown in Figure 12 below. This criteria is in line with a typical true event as per the ‘Turbidity Event Classification Guidelines’.

Based on the inspections on the days before and after, the event is likely to have been caused by a first flush with debris impacting the sensor. The event is considered false, no further investigation is required.

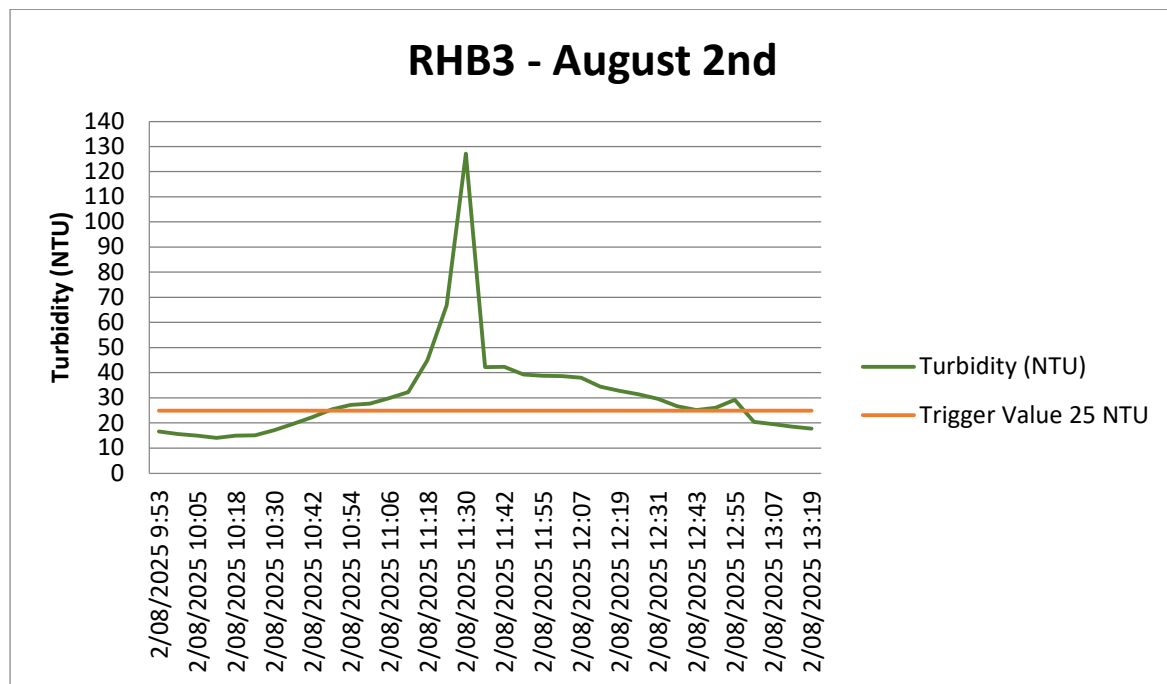
Figure 3 WDL-2587-001

The event, occurring between 10:48 and 13:01 on the 2<sup>nd</sup> of August at RHB3 does not exhibit the typical sharp, incline in turbidity levels however the initial spike and gradual return to baseline levels in a pattern resembling a normal (Gaussian) distribution as shown in Figure 3 below indicates a potential drainage event.
