Huntly Bauxite Mine – WQMS Data Review

February 2026

Revision: Rev 02

Client: SciDev Pty Ltd

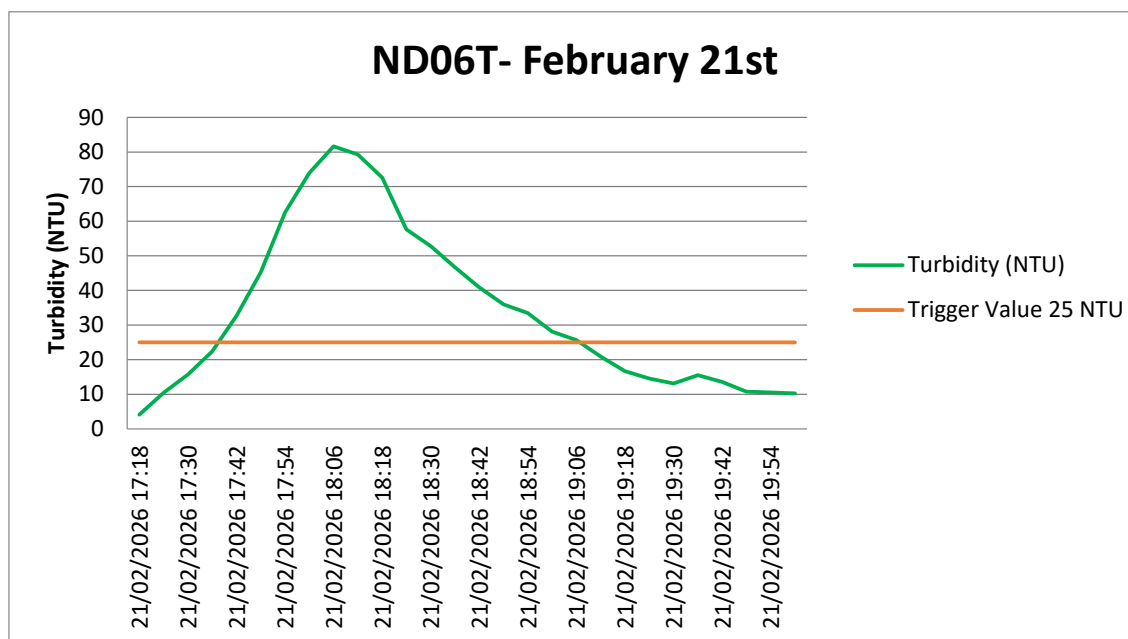
Figure 3 - HUN-2602-008

The event, occurring between 17:42 and 19:06 on 21 February at ND06T, is characterised by a rise in turbidity to a peak of 81.6 NTU, followed by a gradual recession back toward baseline. Although the event is not fully consistent with the Alcoa true turbidity event guidelines, the Gaussian style response profile suggests a pattern that may be consistent with a runoff-driven turbidity event.

Site observations recorded on 23/02/2026 noted that the stream level was low, with visible sediment present on the stream bed, and that the sensor was positioned on the stream bed due to the low water level. Review of the broader turbidity record indicates the sensor may have been temporarily impacted by localised sediment disturbance under these shallow flow conditions. In addition, no rainfall was recorded in the preceding 24 hours. While the event exhibits a clear rise and fall profile, the available field evidence indicates that localised sediment interference at the sensor is the likely cause. Accordingly, the event has been considered as 'False'.

“Site inspected on 23/02/2026. The stream level is low with visible sediment on the stream bed. The sensor is positioned on the stream bed due to low water level. Review of the turbidity trend indicates the sensor was likely temporarily impacted by sediment on the stream bed. No rainfall was received in the proceeding 24 hours.”

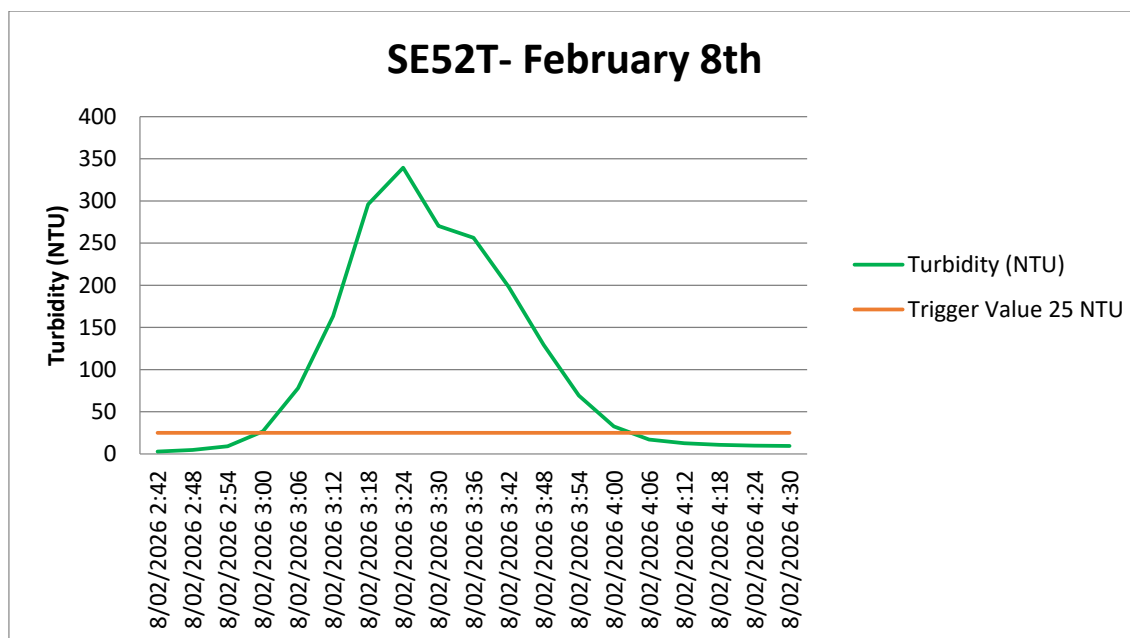
Figure 4 - HUN-2602-035

The event, occurring between 03:00 and 04:00 on 8 February at SE52T is characterised by a rise in turbidity to a peak of 339.4 NTU followed by a recession back toward baseline. Although the event is not fully consistent with the Alcoa true turbidity event guidelines, the broadly Gaussian response profile suggests a pattern that may be consistent with a runoff-driven turbidity event.

Site observations indicate that the stream level was very low and that water depth was insufficient to submerge the sensor, resulting in unreliable readings. The site notes also record that the stream bed was heavily impacted by organic debris and algae, and that water levels had been fluctuating between flow and dry conditions during the preceding weeks. These observations indicate the sensor was operating under unstable local conditions. The event has therefore been reclassified as False.

“The stream level is very low and depth is insufficient to submerge the sensor, causing false readings. The level float has been fluctuating between 1(flow) and 0(dry) during the preceding weeks. The stream bed is heavily impacted by organic debris and algae.”
