Huntly Bauxite Mine – WQMS Data Review

July 2025

Date: 07 September 2025

Client: SciDev Pty Ltd

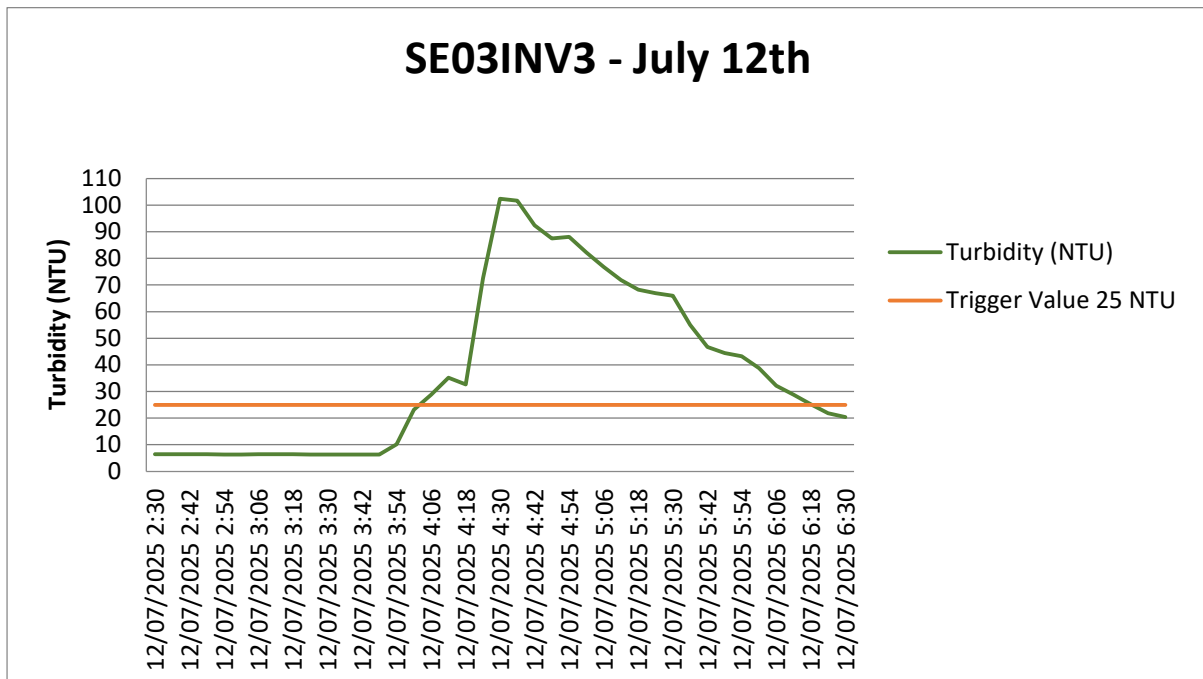
Figure 3 HUN-2507-028

The event, occurring between 4:06 and 6:18 on the 12th of July at SE03INV3 exhibits a sharp, incline in turbidity levels followed by a gradual return to baseline levels in a pattern resembling a normal (Gaussian) distribution as shown in Figure 3 below. This criteria is in line with a typical true event as per the 'Turbidity Event Classification Guidelines'.

- Rainfall occurred in the 12 hours prior to the event, a further 6.5mm of rain was recorded in the hours following the event during which time the turbidity levels returned to background levels.
- A large volume of leaf litter was observed in the stream bed with minimal signs of high flow events.

“Data trend indicates false event likely caused by debris impacting the Lense. Relatively sharp incline and decline in turbidity values, followed by 2 sharp spikes immediately following the event. There was a further 6.5mm of rainfall recorded in the 3 hours following the event, during which time turbidity levels had returned to <1 NTU, indicating debris was flushed clear of the sensor. The site was inspected on 09/07/2025. Stream flow had commenced; however, water depth was insufficient to fully submerge the sensor. A substantial accumulation of leaf litter was observed in the stream bed.”

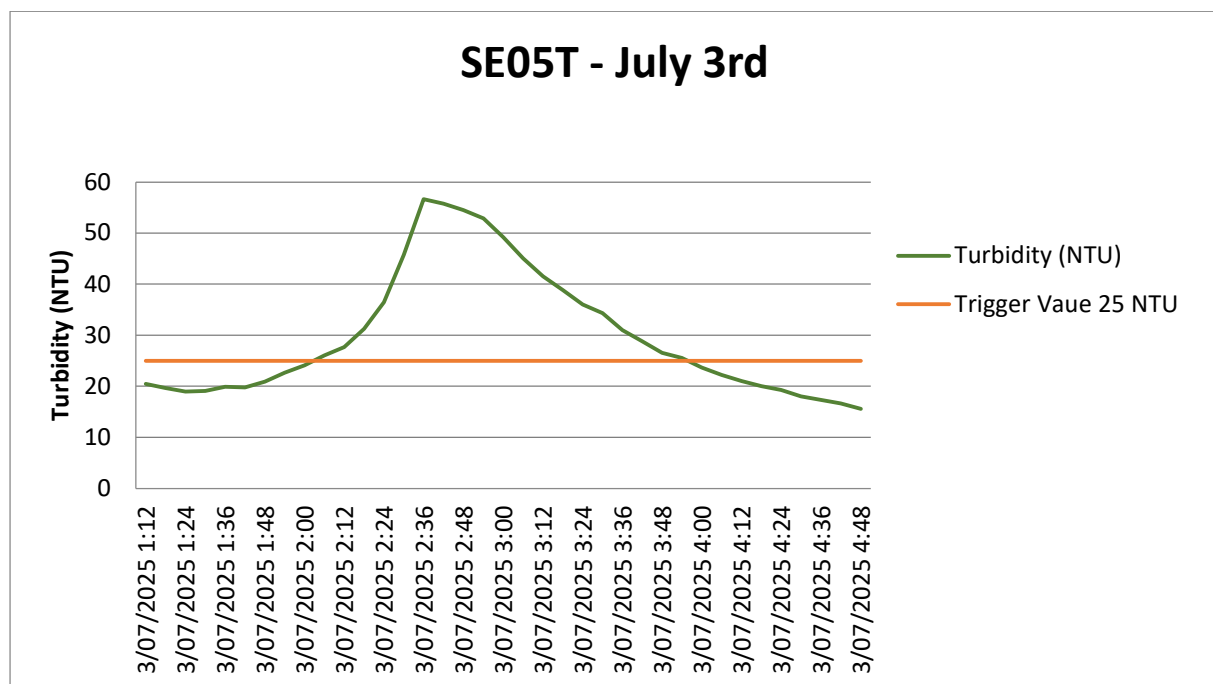
Figure 4 HUN-25-07-030

The event, occurring between 2:06 and 3:54 on the 3rd of July at SE05T exhibits a sharp, incline in turbidity levels followed by a gradual return to baseline levels in a pattern resembling a normal (Gaussian) distribution as shown in Figure 4 below. This criteria is in line with a typical true event as per the ‘Turbidity Event Classification Guidelines’.

The SE05T catchment inspection was completed in rehabilitation areas at Hill 1, 2, and 3. No drainage events were identified. Further inspection also included an inspection of the historical Doherty 3 drainage concern, which occurred on 22 June 2025, all temporary controls observed to be holding well, with no further evidence of sediment mobilisation visible.”

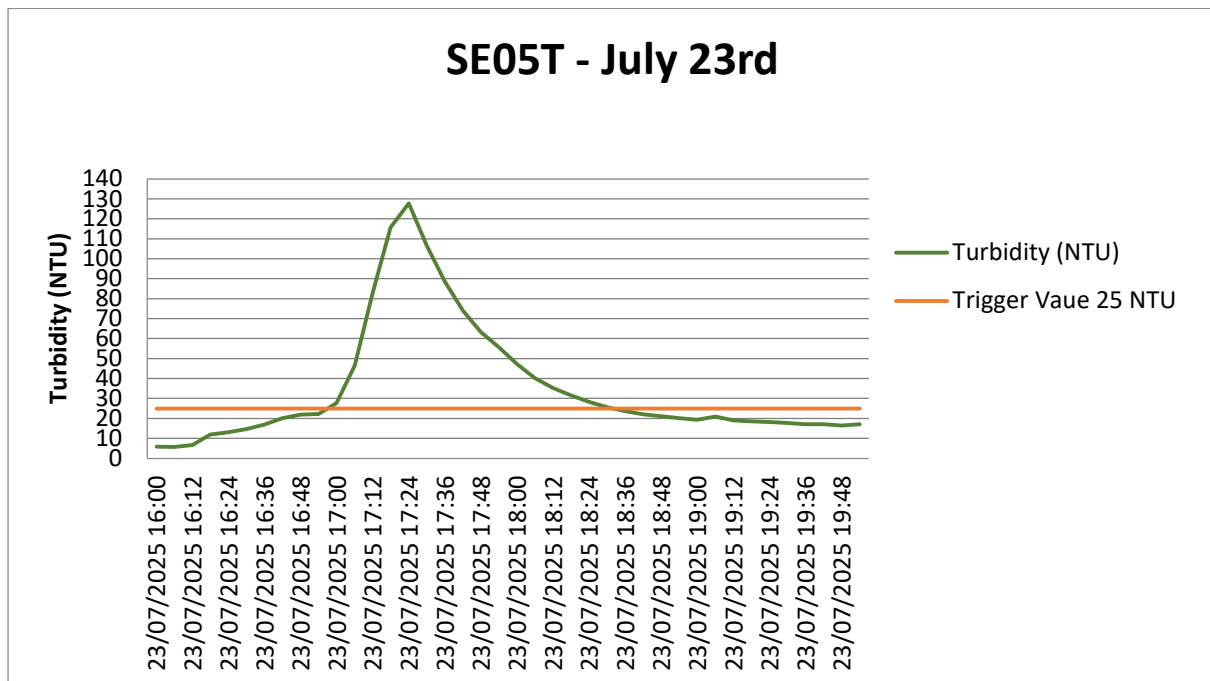
Figure 5 HUN-2507-032

The event, occurring between 17:00 and 18:30 on the 23rd of July at SE05T exhibits a sharp, incline in turbidity levels followed by a gradual return to baseline levels in a pattern resembling a normal (Gaussian) distribution as shown in Figure 5 below. This criteria is in line with a typical true event as per the ‘Turbidity Event Classification Guidelines’.

increases and high peak values suggest temporary interference, likely caused by organic debris.

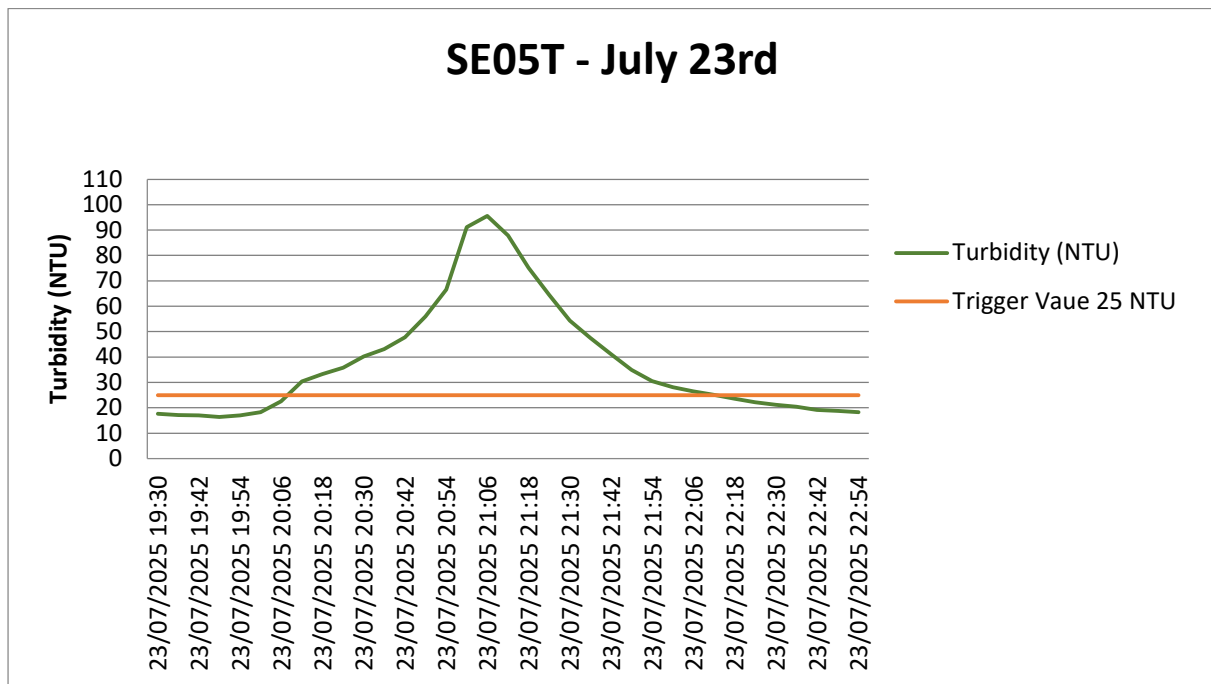
Figure 6 HUN25-07-033

The event, occurring between 21:12 and 22:12 on the 23rd of July at SE05T exhibits a sharp, incline in turbidity levels followed by a gradual return to baseline levels in a pattern resembling a normal (Gaussian) distribution as shown in Figure 6 below. This criteria is in line with a typical true event as per the ‘Turbidity Event Classification Guidelines’.

increases and high peak values suggest temporary interference, likely caused by organic debris.

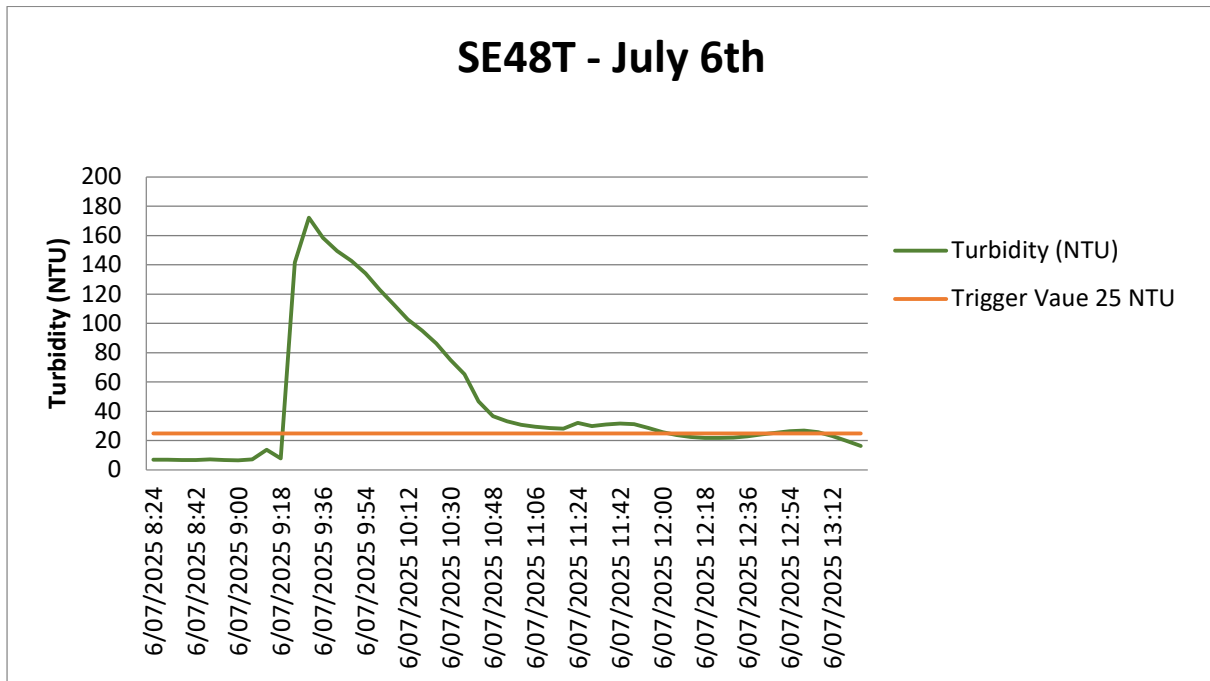
Figure 7 HUN-2507-047

The event, occurring between 09:24 and 12:00 on the 6th of July at SE48T exhibits a sharp, incline in turbidity levels followed by a gradual return to baseline levels in a pattern resembling a normal (Gaussian) distribution as shown in Figure 7 below. This criteria is in line with a typical true event as per the ‘Turbidity Event Classification Guidelines’.

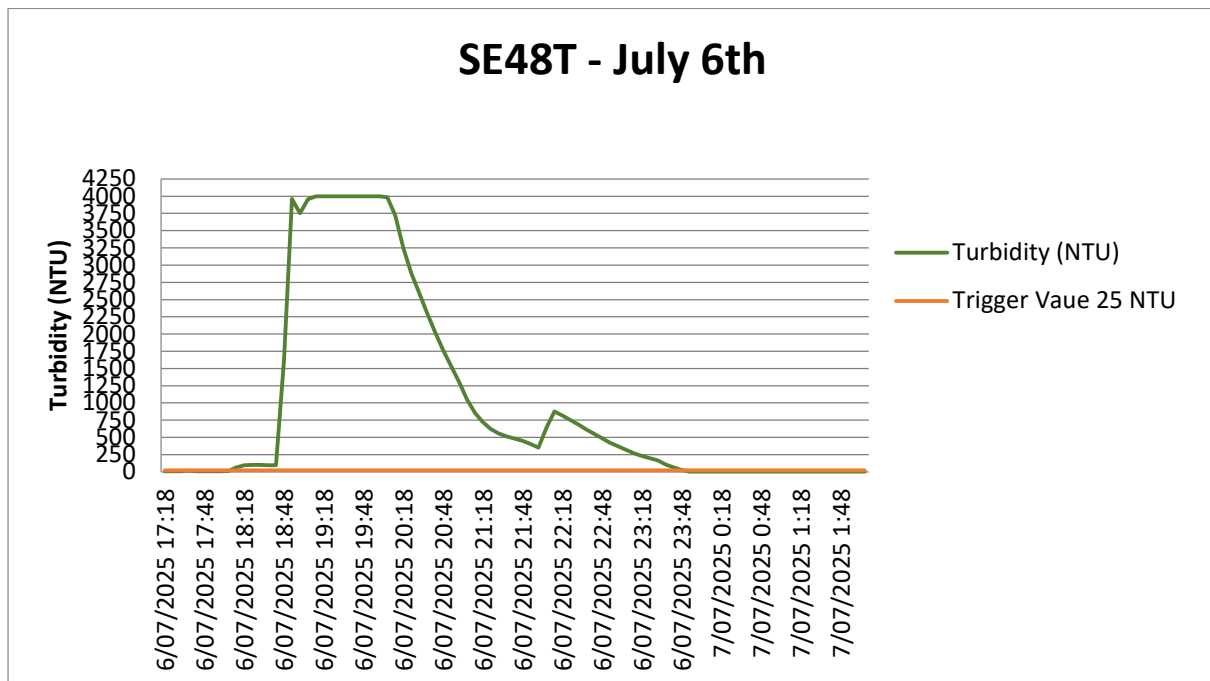
Figure 8 HUN-2507-048

The event, occurring between 18:12 and 23:42 on the 6th of July at SE48T exhibits a sharp, incline in turbidity levels followed by a gradual return to baseline levels in a pattern resembling a normal (Gaussian) distribution as shown in Figure 8 below. This criteria is in line with a typical true event as per the ‘Turbidity Event Classification Guidelines’.

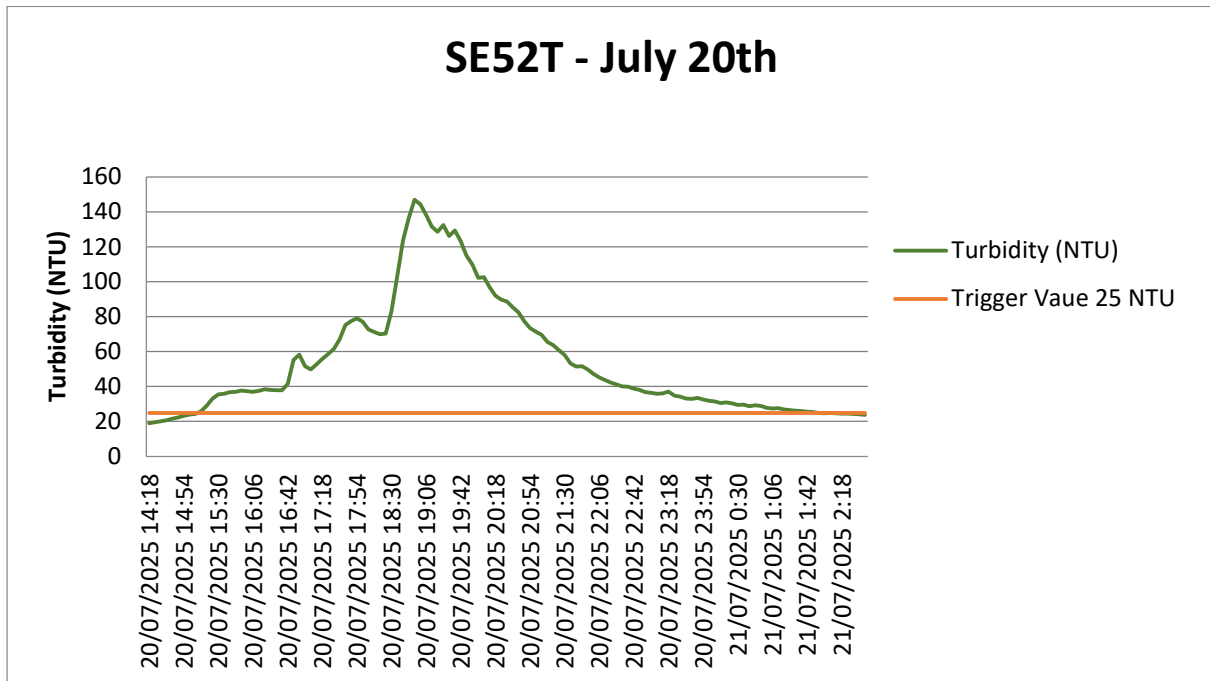
Figure 9 HUN-2507-053

The event, occurring between 15:12 on the 20th of July and finishing at 1:48 on the 21st of July at SE52T exhibits a sharp, incline in turbidity levels followed by a gradual return to baseline levels in a pattern resembling a normal (Gaussian) distribution as shown in Figure 9 below. This criteria is in line with a typical true event as per the ‘Turbidity Event Classification Guidelines’.

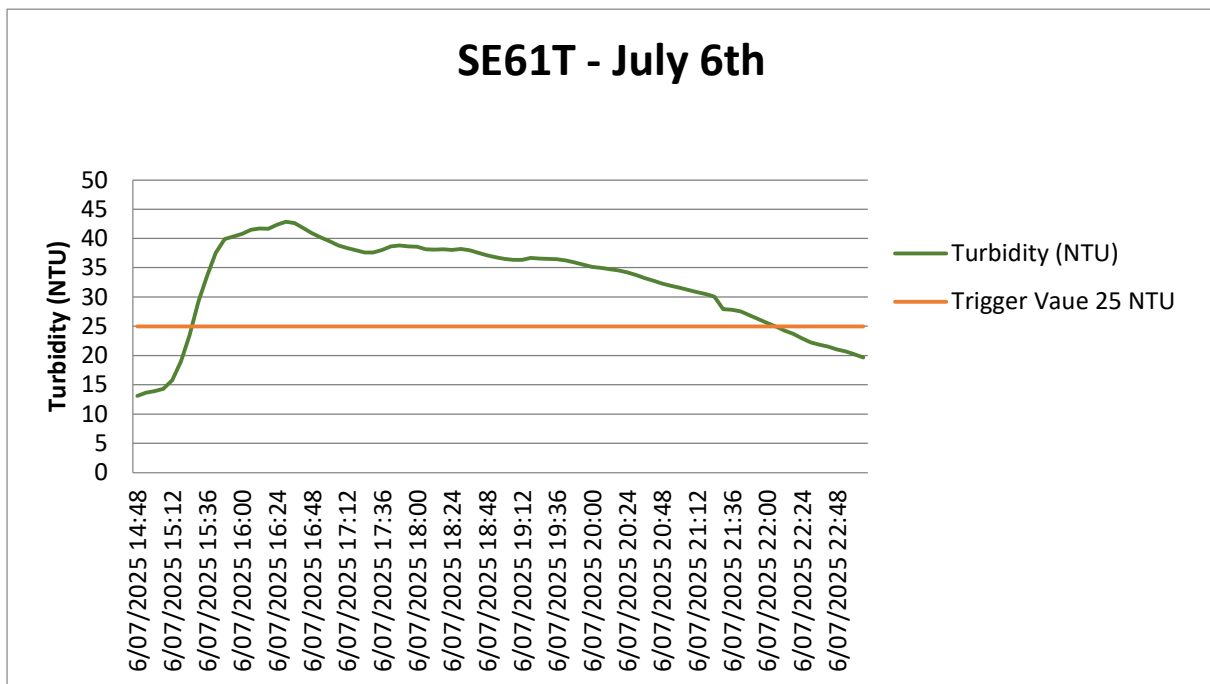
Figure 10 HUN2507-065

The event, occurring between 15:30 and 22:00 on the 6th of July at SE61T exhibits a sharp, incline in turbidity levels followed by a gradual return to baseline levels in a pattern resembling a normal (Gaussian) distribution as shown in Figure 10 below. This criteria is in line with a typical true event as per the ‘Turbidity Event Classification Guidelines’.

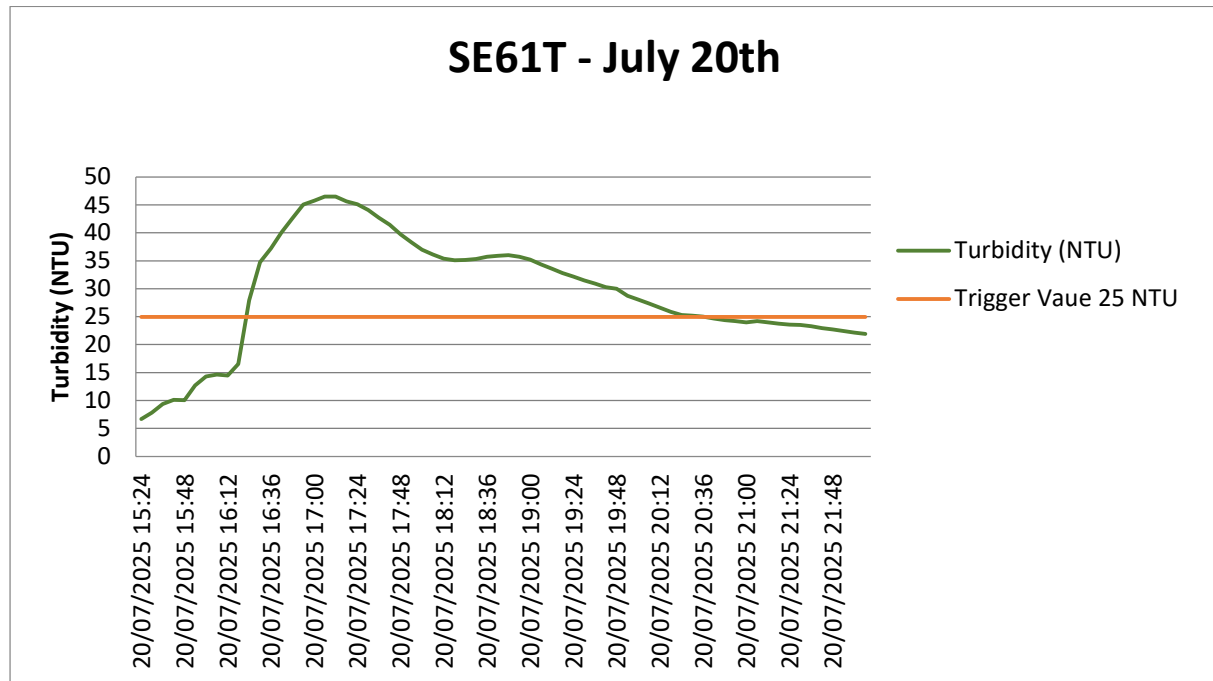
Figure 11 HUN-2507-066

The event, occurring between 16:24 and 20:36 on the 20th of July at SE61T exhibits a sharp, incline in turbidity levels followed by a gradual return to baseline levels in a pattern resembling a normal (Gaussian) distribution as shown in Figure 11 below. This criteria is in line with a typical true event as per the ‘Turbidity Event Classification Guidelines’.

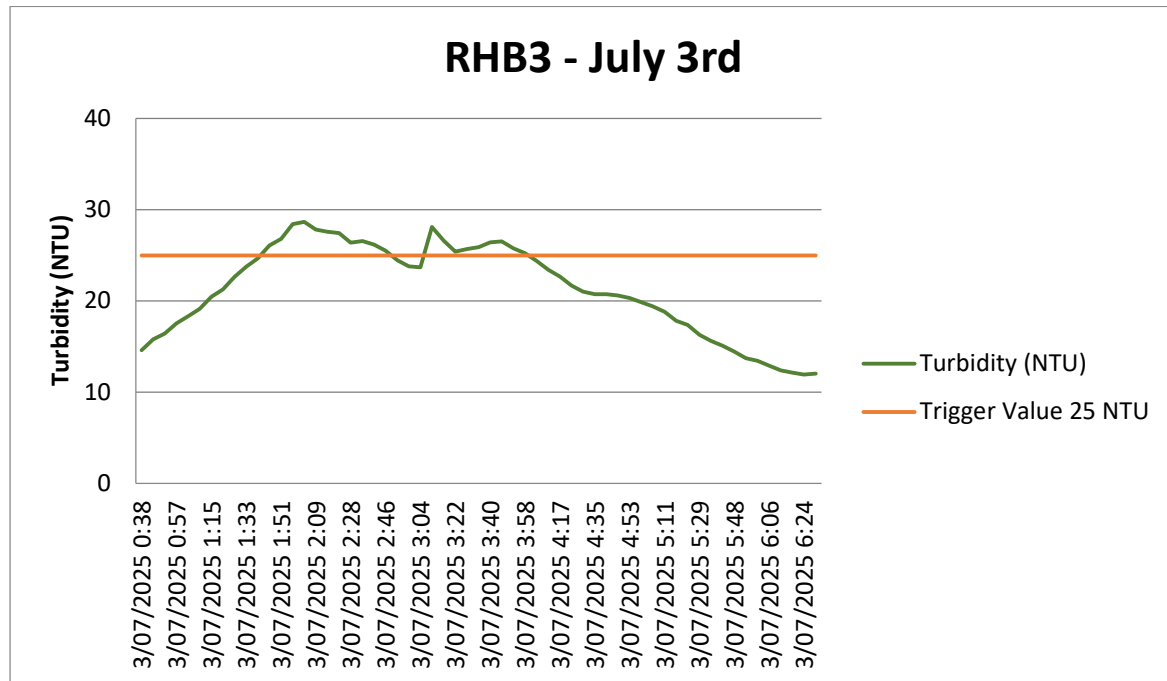
Figure 3 WDL-2507-002

The event, occurring between 1:45 and 2:46 on the 3rd of July at RHB3 does not exhibit the typical sharp, incline in turbidity levels however the initial spike and gradual return to baseline levels in a pattern resembling a normal (Gaussian) distribution as shown in Figure 3 below indicates a potential drainage event.

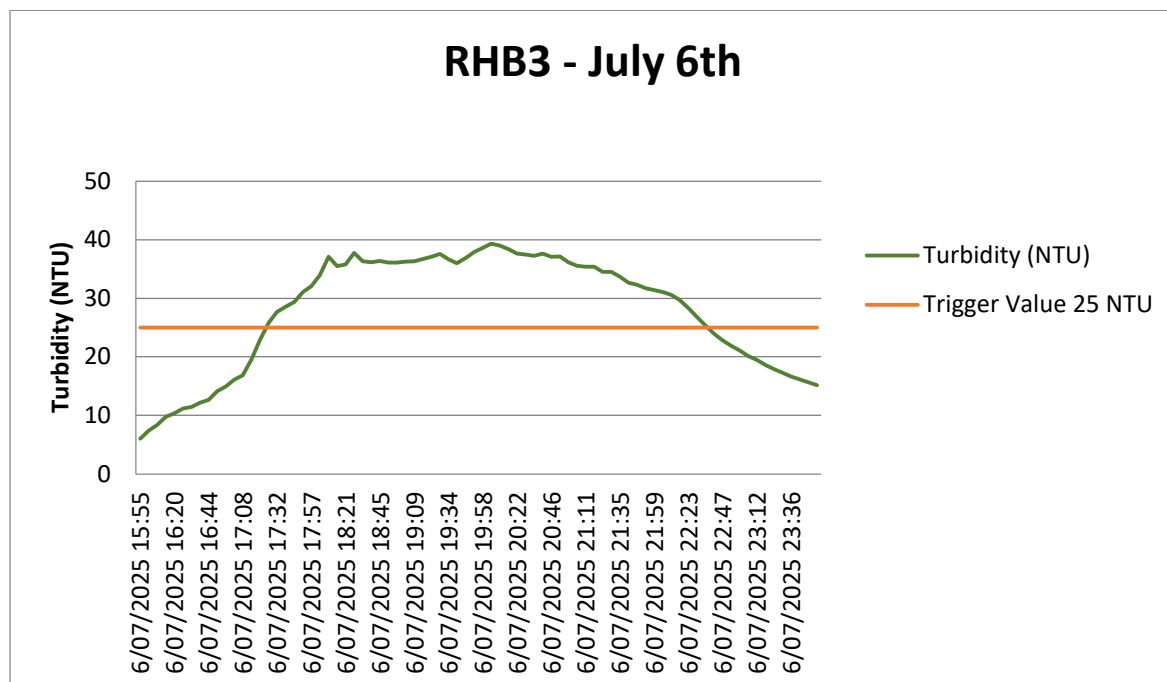
Figure 4 WDL-2507-003

The event, occurring between 17:26 and 22:35 on the 6th of July at RHB3 does not exhibit the typical sharp, incline in turbidity levels however the initial spike and gradual return to baseline levels in a pattern resembling a normal (Gaussian) distribution as shown in Figure 4 below indicates a potential drainage event.
