# Huntly Bauxite Mine – WQMS Data Review

November 2025

**Revision:** Rev 02

**Client:** SciDev Pty Ltd

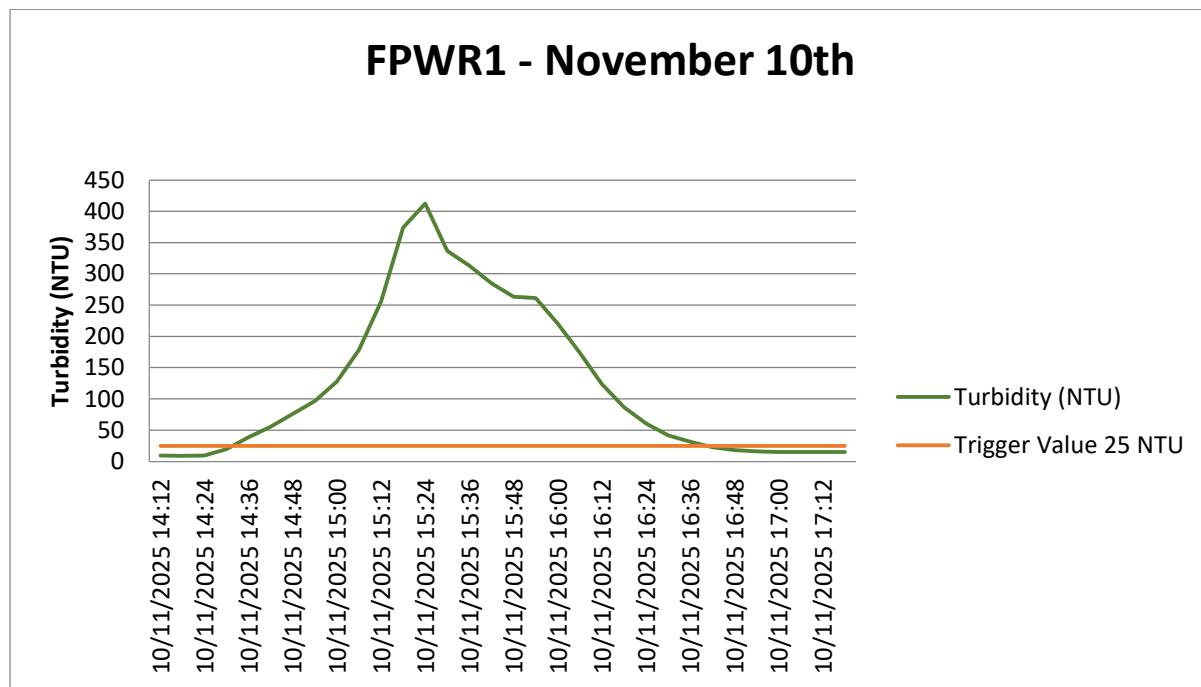
Figure 3 - HUN-2511-004

The event, occurring between 14:36 and 16:36 on the 10<sup>th</sup> of November at FPWR1 exhibits a sharp, incline in turbidity levels followed by a gradual return to baseline levels in a pattern resembling a normal (Gaussian) distribution as shown in Figure 3 below. This criteria is in line with a typical true event as per the ‘Turbidity Event Classification Guidelines’.

The FPWR1 turbidity exceedance on 10/11/2025 shows a sharp increase to elevated turbidity followed by a return toward baseline without any supporting rainfall. The follow-up inspection confirmed ponded conditions with the probe positioned on the stream bed. The low turbidity recorded at the inspection and the absence of rainfall support an equipment/setting-related event rather than a catchment-driven discharge. On this basis, the FPWR1 event is interpreted as a ‘False’ event, no additional investigation is required.

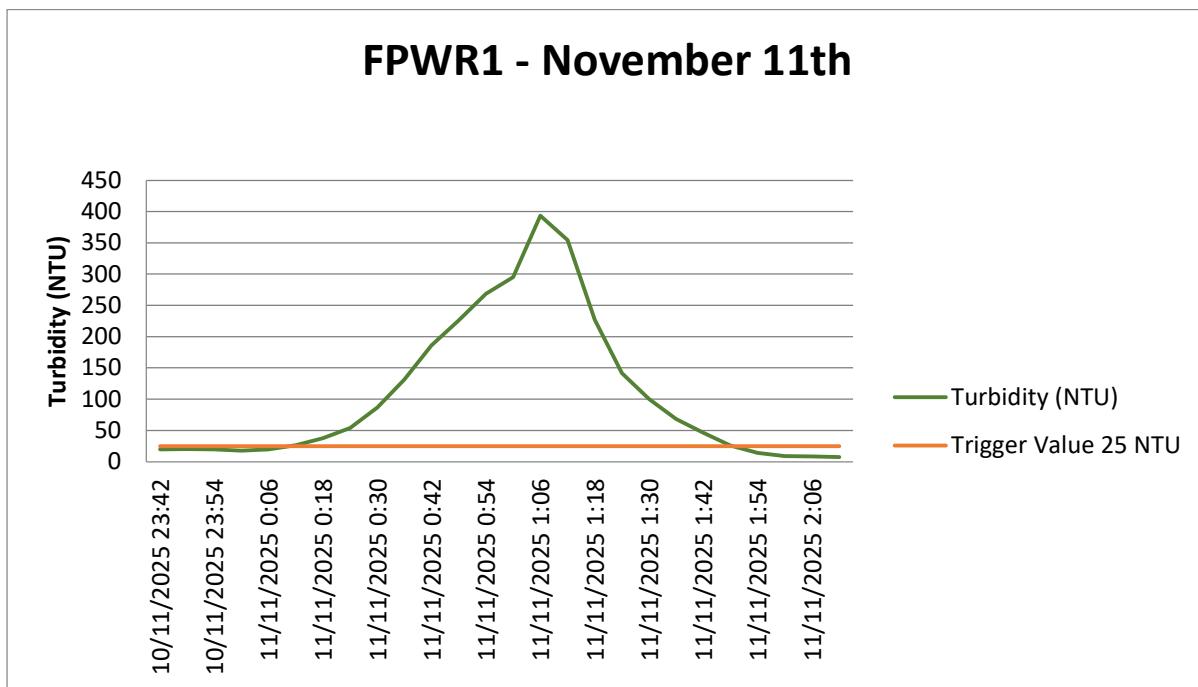
Figure 4 - HUN-2511-005

The event, occurring between 00:12 and 01:48 on the 11<sup>th</sup> of November at FPWR1 does not exhibit the typical sharp, incline in turbidity levels however the initial spike and gradual return to baseline levels in pattern resembling a normal (Gaussian) distribution as shown Figure 4 below indicates a potential drainage event.

The FPWR1 turbidity exceedance on 10/11/2025 shows a sharp increase to elevated turbidity followed by a return toward baseline without any supporting rainfall. The inspection confirmed ponded conditions with the probe positioned on the stream bed. The low turbidity recorded at the inspection and the absence of rainfall support an equipment/setting-related event rather than a catchment-driven discharge. On this basis, the FPWR1 event is interpreted as a ‘False’ event, no additional investigation is required.

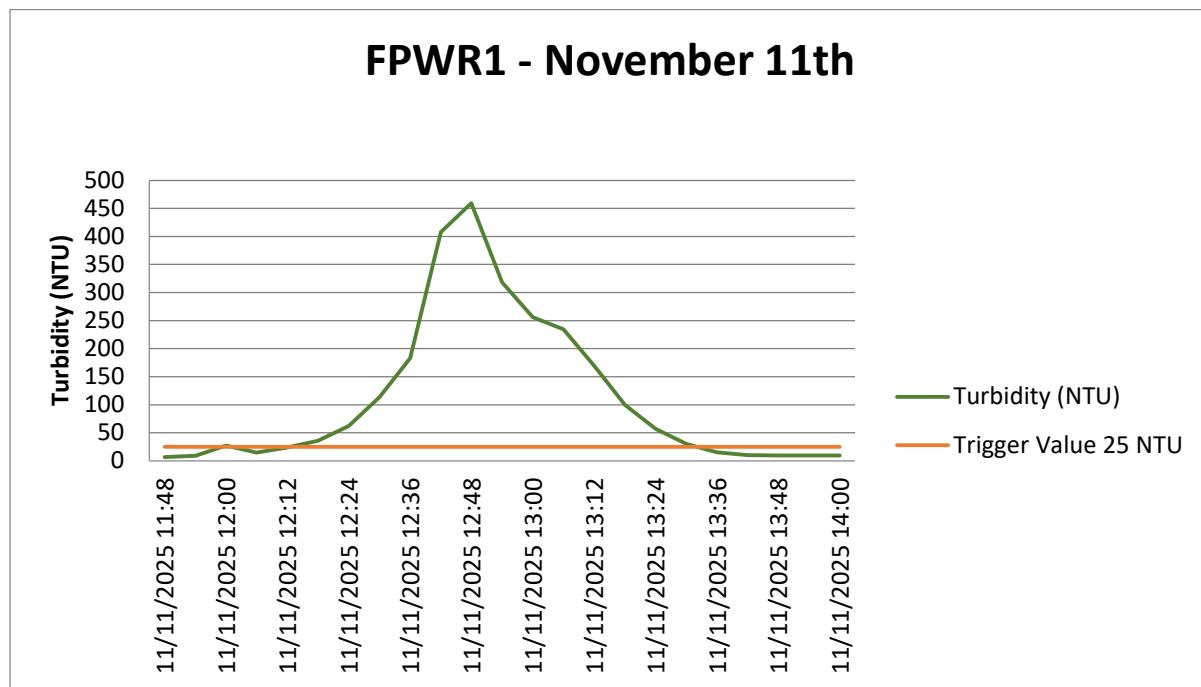
Figure 5 - HUN-2511-006

The event, occurring between 12:18 and 13:30 on the 11<sup>th</sup> of November at FPWR1 exhibits a sharp, incline in turbidity levels followed by a gradual return to baseline levels in a pattern resembling a normal (Gaussian) distribution as shown in Figure 5 below. This criteria is in line with a typical true event as per the ‘Turbidity Event Classification Guidelines’.

The FPWR1 turbidity exceedance on 11/11/2025 shows a sharp increase to elevated turbidity followed by a return toward baseline without any supporting rainfall. The inspection on the 10/11/2025 confirmed ponded conditions with the probe positioned on the stream bed. The low turbidity recorded at the inspection and the absence of rainfall support an equipment/setting-related event rather than a catchment-driven discharge. On this basis, the FPWR1 event is interpreted as a 'False' event, no additional investigation is required.

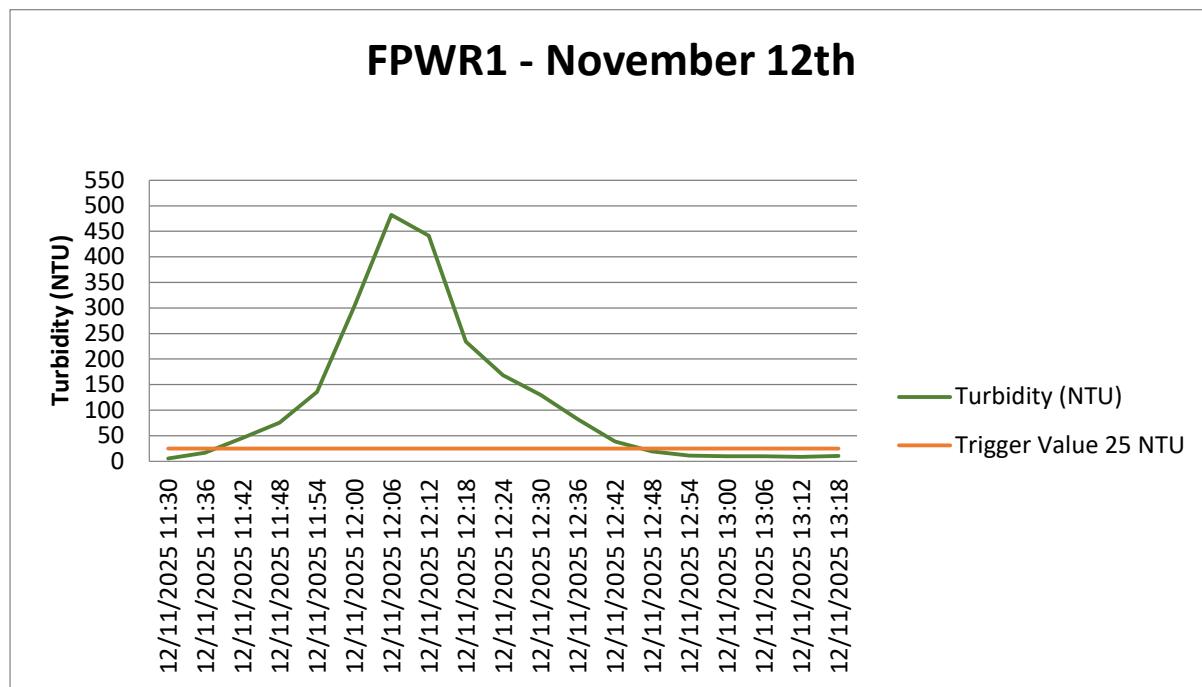
Figure 6 - HUN-2511-008

The event, occurring between 11:42 and 12:42 on the 12<sup>th</sup> of November at FPWR1 does not exhibit the typical sharp, incline in turbidity levels however the initial spike and gradual return to baseline levels in pattern resembling a normal (Gaussian) distribution as shown Figure 6 below indicates a potential drainage event.

The FPWR1 turbidity exceedance on 12/11/2025 shows a sharp increase to elevated turbidity followed by a return toward baseline without any supporting rainfall. The inspection on the 10/11/2025 confirmed ponded conditions with the probe positioned on the stream bed. The low turbidity recorded at the inspection and the absence of rainfall support an equipment/setting-related event rather than a catchment-driven discharge. On this basis, the FPWR1 event is interpreted as a 'False' event, no additional investigation is required.

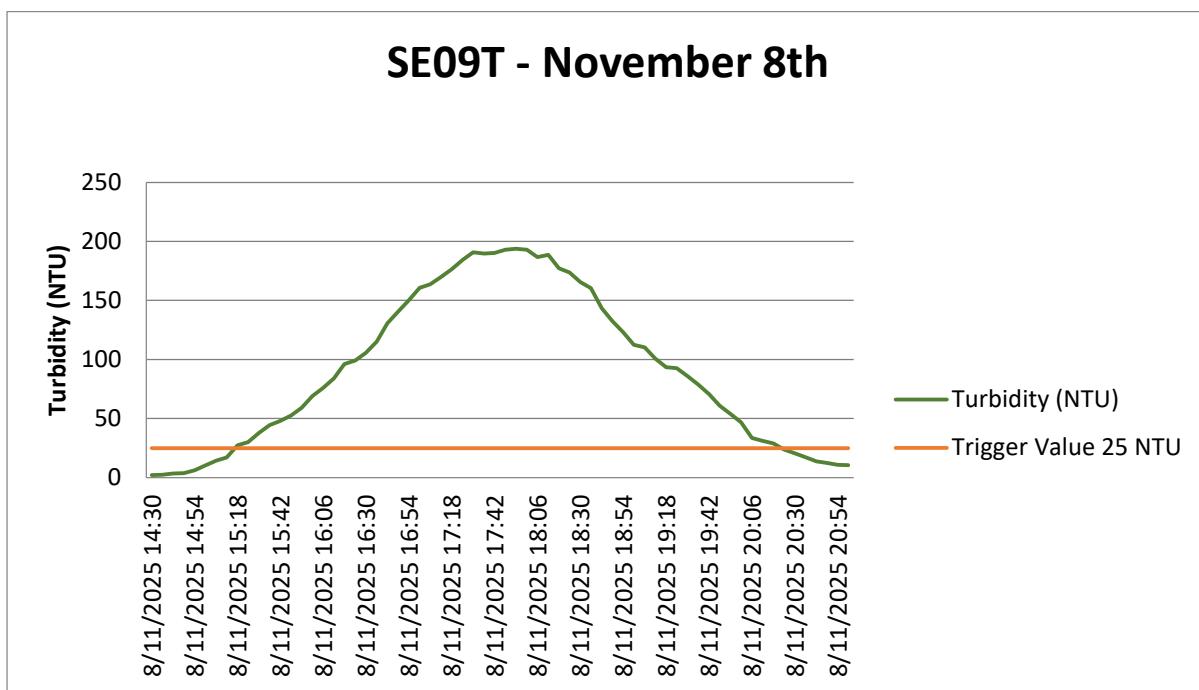
Figure 7 - HUN-2511-048

The event, occurring between 15:18 and 20:18 on the 8<sup>th</sup> of November at SE09T does not exhibit the typical sharp, incline in turbidity levels however the initial spike and gradual return to baseline levels in pattern resembling a normal (Gaussian) distribution as shown Figure 7 below indicates a potential drainage event.

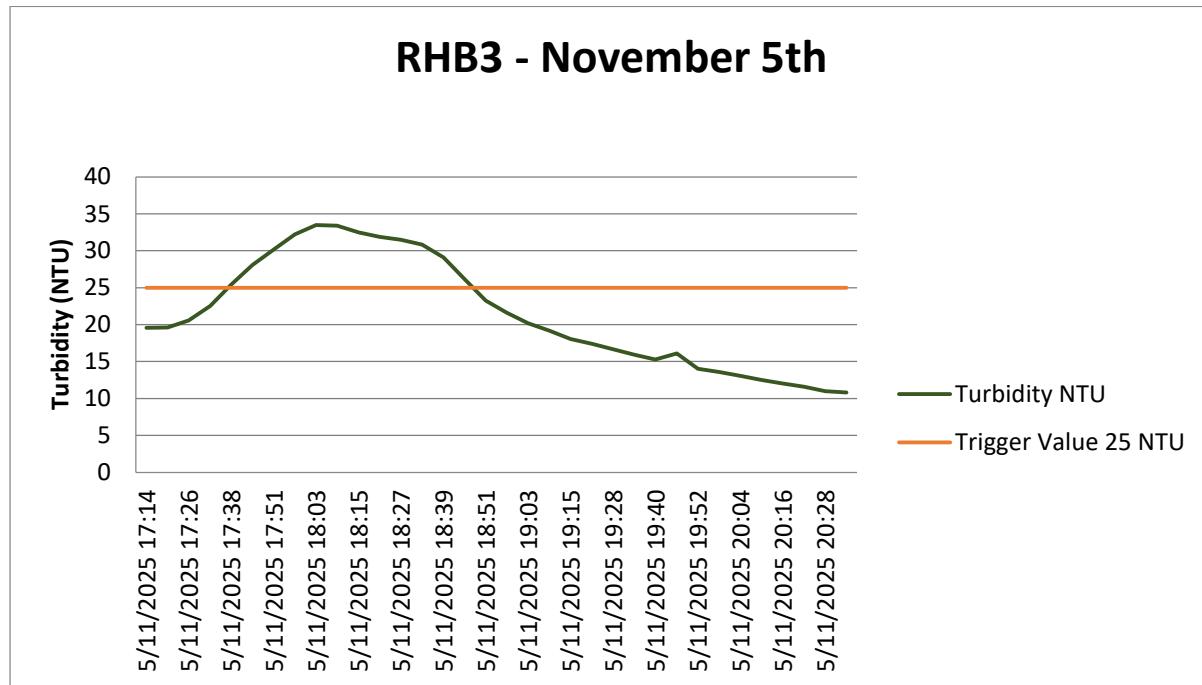
Figure 3 - WDL-2511-001

The event, occurring between 17:38 and 18:45 on the 5<sup>th</sup> of November at RHB3 does not exhibit the typical sharp, incline in turbidity levels however the initial spike and gradual return to baseline levels in pattern resembling a normal (Gaussian) distribution as shown in Figure 3 below indicates a potential drainage event.

- The stream was inspected on 07/11/2025 at 11:30 AM and was flowing and clear, with no signs of turbid water or sediment deposition at the monitor location.
- A catchment investigation did not identify any mining-related potential sources of turbidity.
- A recently reopened forest track running alongside the stream upstream of the monitor was observed to have multiple locations where runoff discharges into the stream, representing a plausible non-mining source of sediment mobilisation during rainfall/runoff conditions.

*"Stream inspected on 07/11/2025 at 11:30am. Stream flowing and clear at the time of the inspection with no signs of turbid water or sediment deposition at the monitor location. A catchment investigation was undertaken which did not identify any mining related potential sources of turbidity. As previously identified, a recently reopened forest tracks was found to have multiple locations of water runoff into the stream. The forest track runs alongside the stream and upstream from the monitor. No other potential sources of turbidity were identified within the catchment. Event classified as a true, non-mining related event."*
