Huntly Bauxite Mine – WQMS Data Review

October 2025

Revision: Rev 02

Client: SciDev Pty Ltd

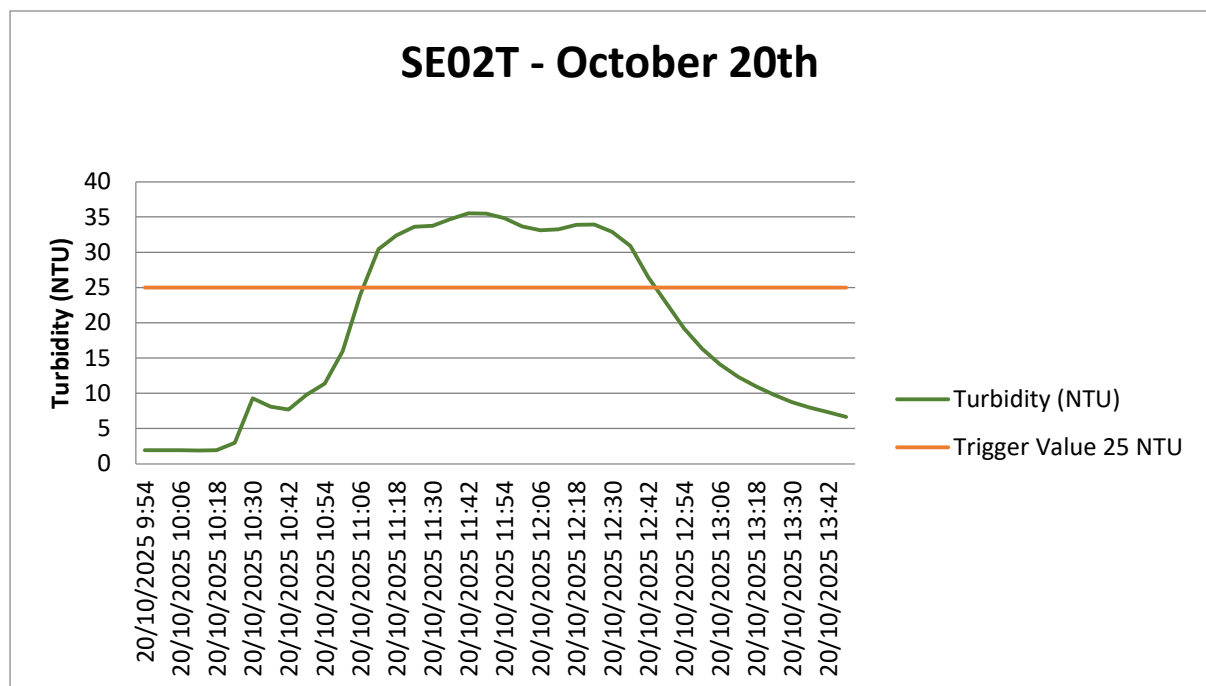
Figure 3 - HUN-2510-004

The event, occurring between 11:12 and 12:42 on the 20th of October at SE02T does not exhibit the typical sharp, incline in turbidity levels however the initial spike and gradual return to baseline levels in pattern resembling a normal (Gaussian) distribution as shown in Figure 3 below indicates a potential drainage event.

- The event occurred during a rainfall period.
- The monitoring site and catchment were inspected within 24 hours; the stream was clear and flowing at low turbidity.

- No evidence of mining-related disturbance or discharge was observed in the upstream catchment.

The SE02T turbidity exceedance on 20/10/2025 shows a short-lived rise and fall in turbidity that closely follows the rainfall event, with values returning to background soon after the event and no evidence of an ongoing discharge. The clear, low-turbidity conditions observed at the follow-up inspection and the absence of any mining-related disturbance in the catchment support rainfall-runoff mechanisms rather than a mining source event. On this basis, the SE02T event is interpreted as a rainfall-driven turbidity response from non-mining areas upstream of the monitor and is classified as a True, non-mining-related event.

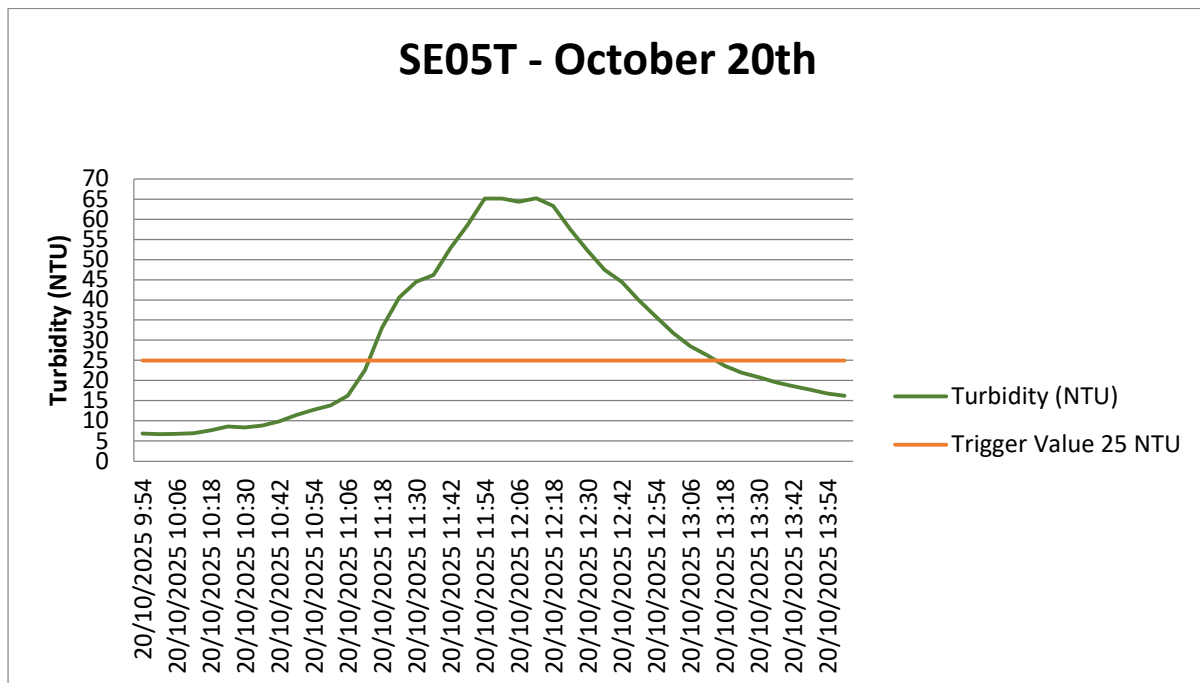
Figure 4 - HUN-2510-008

The event, occurring between 11:18 and 13:12 on the 20th of October at SE05T does not exhibit the typical sharp, incline in turbidity levels however the initial spike and gradual return to baseline levels in pattern resembling a normal (Gaussian) distribution as shown Figure 4 below indicates a potential drainage event.

- The event occurred during a rainfall period
- The monitoring site and catchment were inspected following the event; the stream showed slightly elevated turbidity associated with organic debris and bed sediment.
- No evidence of mining-related disturbance or discharge was observed in the upstream catchment.

The SE05T turbidity exceedance on 20/10/2025 shows a rainfall-driven rise and fall in turbidity, with values returning to relatively low levels despite further rainfall and no indication of an ongoing source. The follow-up inspection recorded only slightly elevated turbidity (7.7 NTU), attributed to organic debris and bed sediment, and catchment inspections did not

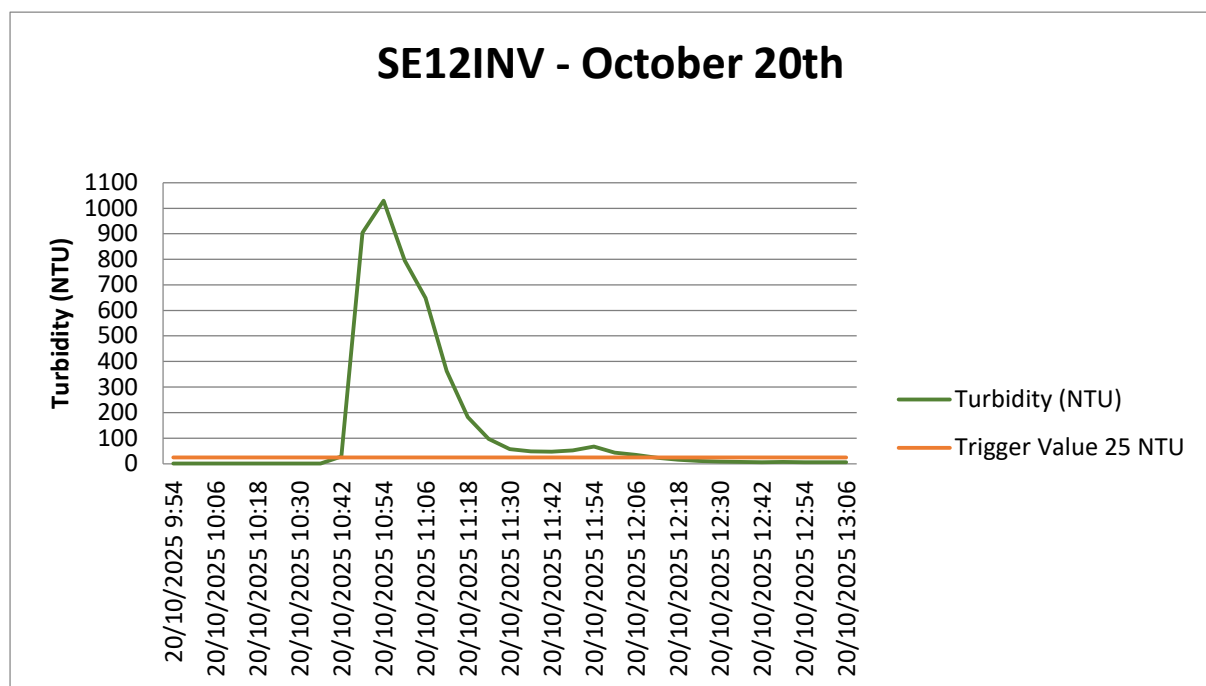
Figure 5 - HUN-2510-019

The event, occurring between 10:42 and 12:06 on the 20th of October at SE12INV exhibits a sharp, incline in turbidity levels followed by a gradual return to baseline levels in a pattern resembling a normal (Gaussian) distribution as shown in Figure 5 below. This criteria is in line with a typical true event as per the ‘Turbidity Event Classification Guidelines’.

The SE12INV event on 20/10/2025 is characterised by a sharp, short-lived spike in turbidity that closely aligns with rainfall, followed by a rapid return to clear, shallow flow conditions at the time of inspection. Erosion controls adjacent to the Wittwer haul embankment were found to be functioning as intended, and the catchment has a known history of rainfall-driven turbidity linked to runoff from the adjacent forest track rather than from mining activities. No mining-related disturbance or discharge was identified during catchment inspections. On this basis, the SE12INV event is interpreted as a brief, rainfall-runoff response mobilising sediment from non-mining areas (as per previous months events) and is classified as a True, non-mining-related turbidity event.

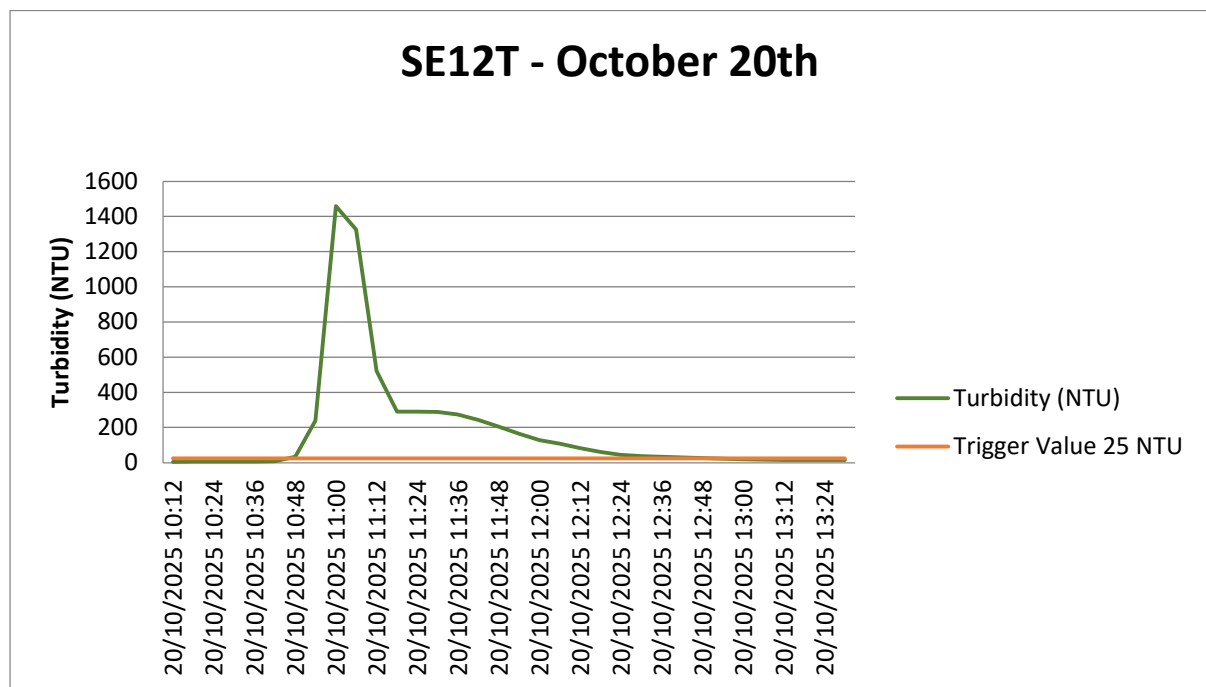
Figure 6 - HUN-2510-023

The event, occurring between 10:48 and 12:48 on the 20th of October at SE12T exhibits a sharp, incline in turbidity levels followed by a gradual return to baseline levels in a pattern resembling a normal (Gaussian) distribution as shown in Figure 6 below. This criteria is in line with a typical true event as per the ‘Turbidity Event Classification Guidelines’.

The SE12T event on 20/10/2025 shows a short-lived turbidity exceedance with a sharp rise and gradual decline that aligns with a 22.2 mm rainfall event, consistent with a rainfall-runoff response rather than a sustained discharge. At the time of inspection on 21/10/2025, the stream was clear, shallow and flowing at low turbidity, and erosion controls adjacent to the Wittwer haul road were found to be operating effectively. Catchment inspections, including the SE12T investigation sites, did not identify any mining-related disturbance or discharge that could account for the exceedance. On this basis, the SE12T event is interpreted as a transient, rainfall-driven turbidity response from non-mining areas within the SE12 catchment as per previous reports, and is classified as a True, non-mining-related event.

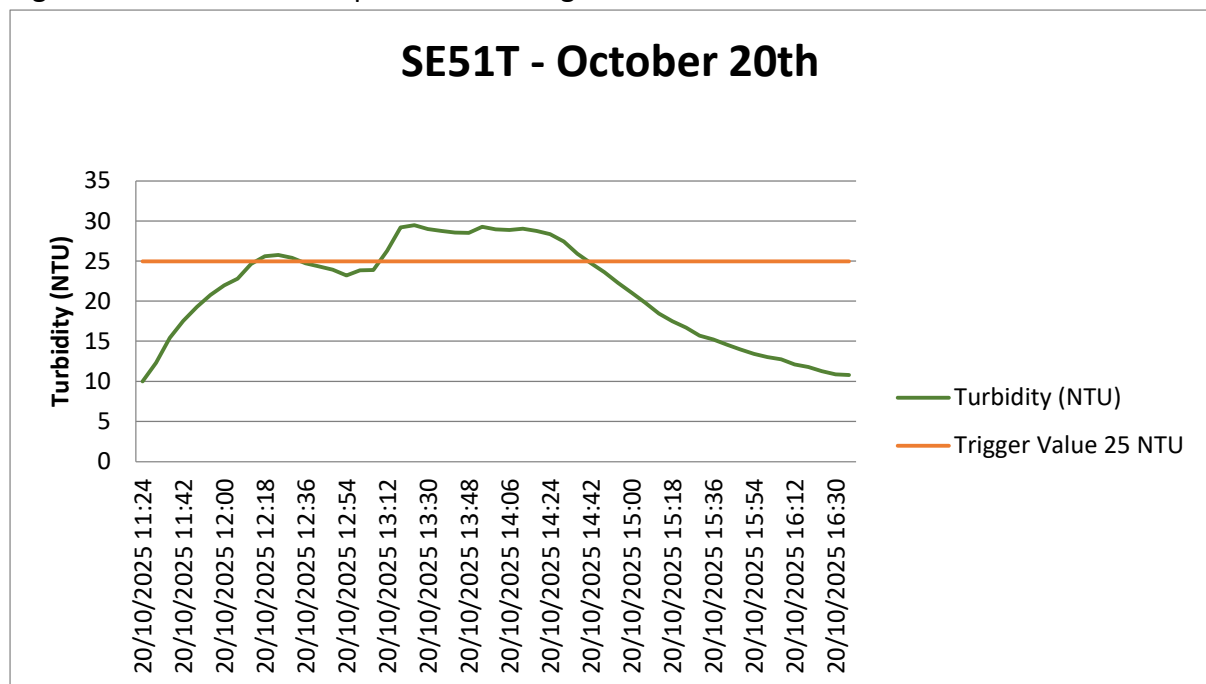
Figure 7 – HUN-2510-029

The event, occurring between 13:12 and 14:36 on the 20th of October at SE51T does not exhibit the typical sharp, incline in turbidity levels however the initial spike and gradual return to baseline levels in pattern resembling a normal (Gaussian) distribution as shown Figure 7 below indicates a potential drainage event.

The SE51T event on 20/10/2025 shows a turbidity exceedance that rises and falls in step with a 16.4 mm rainfall period, which is consistent with a rainfall-runoff response rather than a sustained discharge. The manual data download and subsequent inspection confirmed a clear stream and clean sensor, ruling out logger malfunction or probe fouling as the cause. Catchment inspections considered the reinstated DBCA forest track at Ingpen 5 (rehabilitated by Alcoa); however, investigation of the drainage incident found no evidence of water flowing from that area to the stream, and Alcoa does not consider it to have contributed to the event. Overall, the temporal alignment between rainfall intensity and indicates the exceedance was driven by rainfall-related catchment runoff rather than mining activities. The SE51T exceedance is therefore classified as a True, non-mining-related turbidity event.

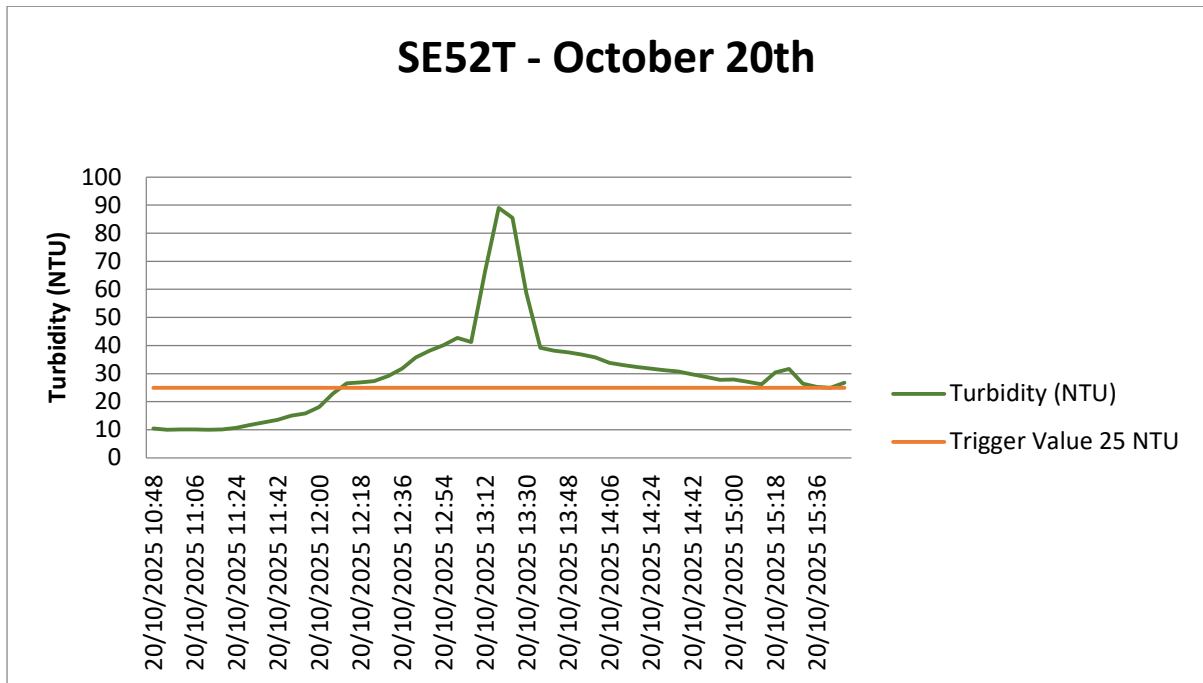
Figure 8 – HUN-2510-031

On 20 October 2025, compliance turbidity monitoring site SE52T recorded two turbidity events during a rainfall event. The first event (12:12–15:36) and the second event (15:48–16:54) both show a rise in turbidity followed by a gradual return towards baseline in a bell-shaped pattern (Figures 8 and 9), consistent with the characteristics of a True event under the *Turbidity Event Classification Guidelines*.

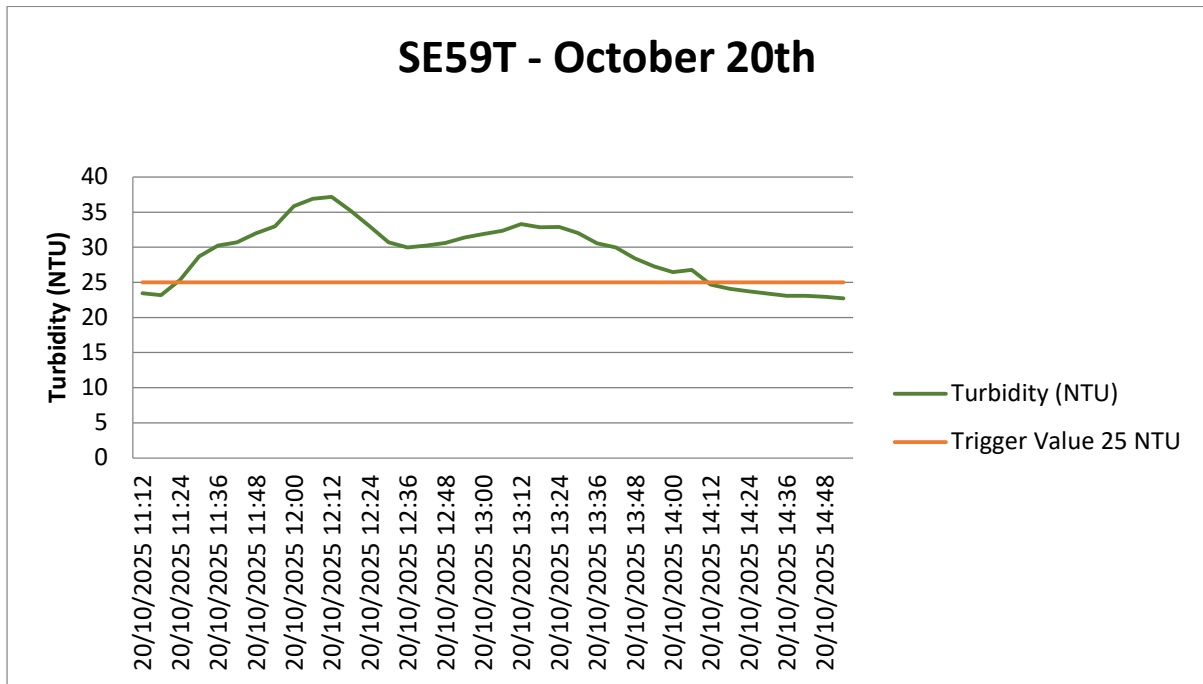
Figure 10 - HUN-2510-034

The event, occurring between 11:24 and 14:06 on the 20th of October at SE59T does not exhibit the typical sharp, incline in turbidity levels however the initial spike and gradual return to baseline levels in pattern resembling a normal (Gaussian) distribution as shown Figure 10 below indicates a potential drainage event.

The SE59T exceedance on 20/10/2025 occurred under high-flow conditions following 15.6 mm of rainfall, with the turbidity record showing an initial sharp spike and then a more gradual pattern as flows stabilised. The high-velocity, cascading flow observed during inspection is consistent with turbulence and short-term debris interference around the sensor, rather than a sustained source of sediment or discharge. No mining-related
