Document type
Compliance Assessment Report (CAR)

Alcoa of Australia Limited – WA Operations

2024 – 2028 Mining and Management Program - Compliance Assessment Report 2025

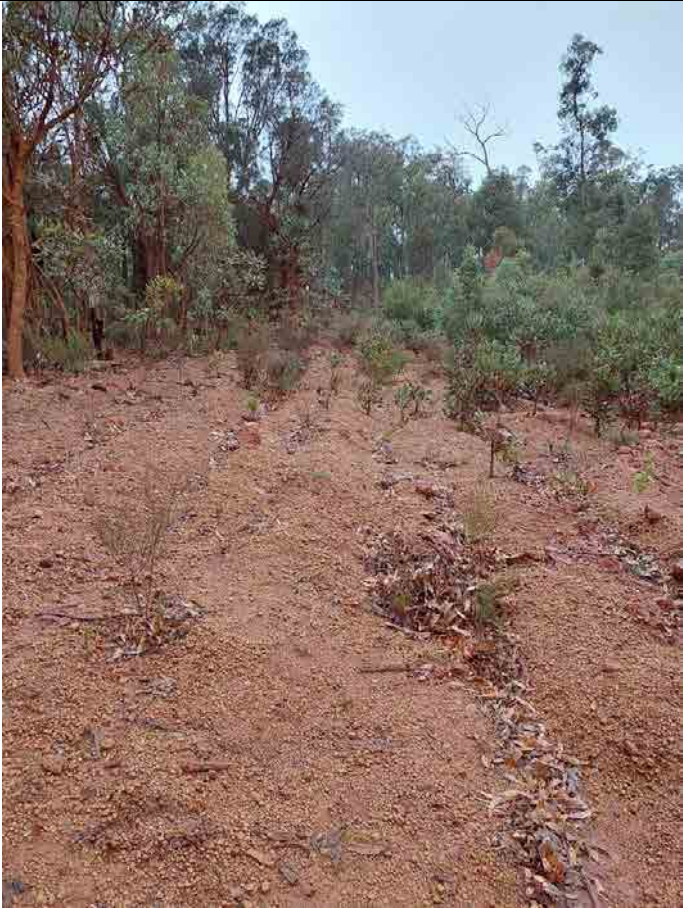
<p>Inspected rehabilitated area in <25% drainage capacity area at Downes 9. Pit has been rehabbed.</p>

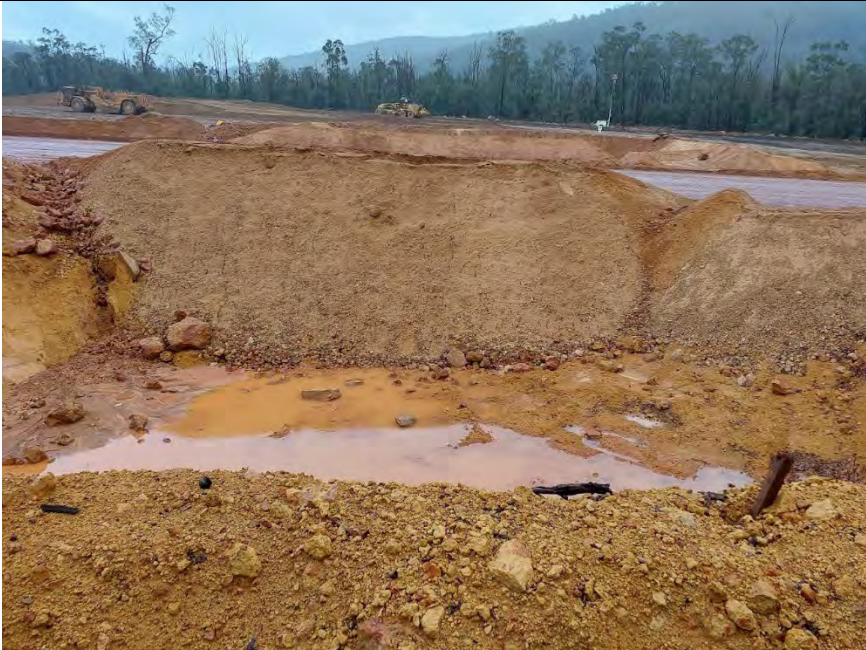
<p>Sighted large bund at pit edge to contain runoff.</p> <p>Wittwer 10- exp drill holes</p> <ul style="list-style-type: none"> Sighted 5 drill holes. All holes filled in and no disturbance within area

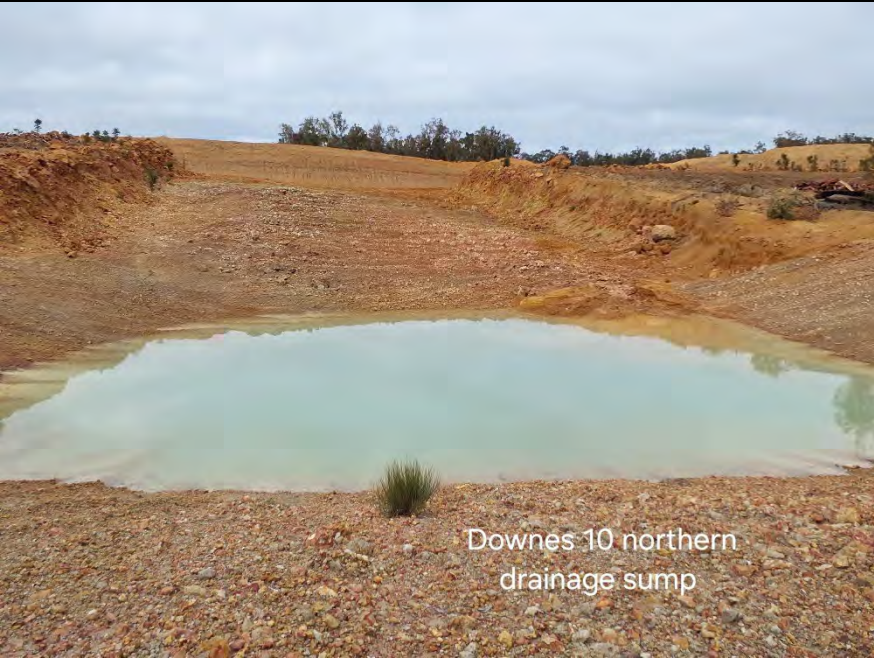
<p>Downes 10 northern drainage sump</p>

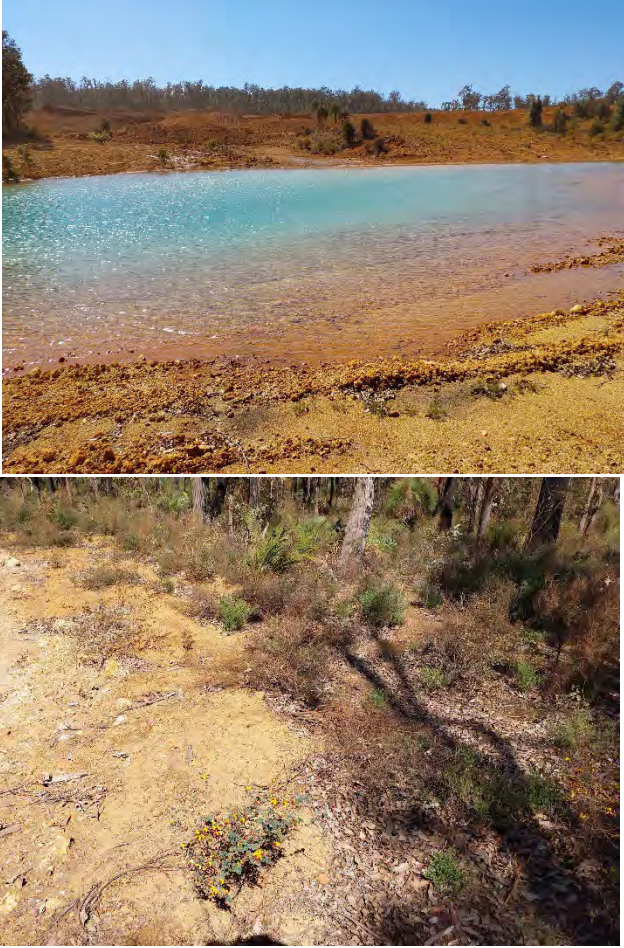
4 (d)	<p>Gibber 8 (F5320, F5324 G5317, G5321)</p> <ul style="list-style-type: none"> From previous inspection notes - Water ponding at the bottom of the old rehabilitated area. Run off from rehabbed area in the east and water not captured in the trenches in the north runs into the bowl. About 1 m free board to the forest edge level. Recommend monitoring and revisit after heavy rain. Check DC in pit is adequate 		<p>Sumps observed to have adequate freeboard remaining.</p> <p>Drainage Control within pit is adequate to manage runoff from the pit.</p> <p>Groundwater observed flowing down watershed in western side of the pit into low lying area where it has pooled within the pit boundary.</p> <p>Stream flowing through culvert under haul road had brown and orange sediment on stream floor.</p>

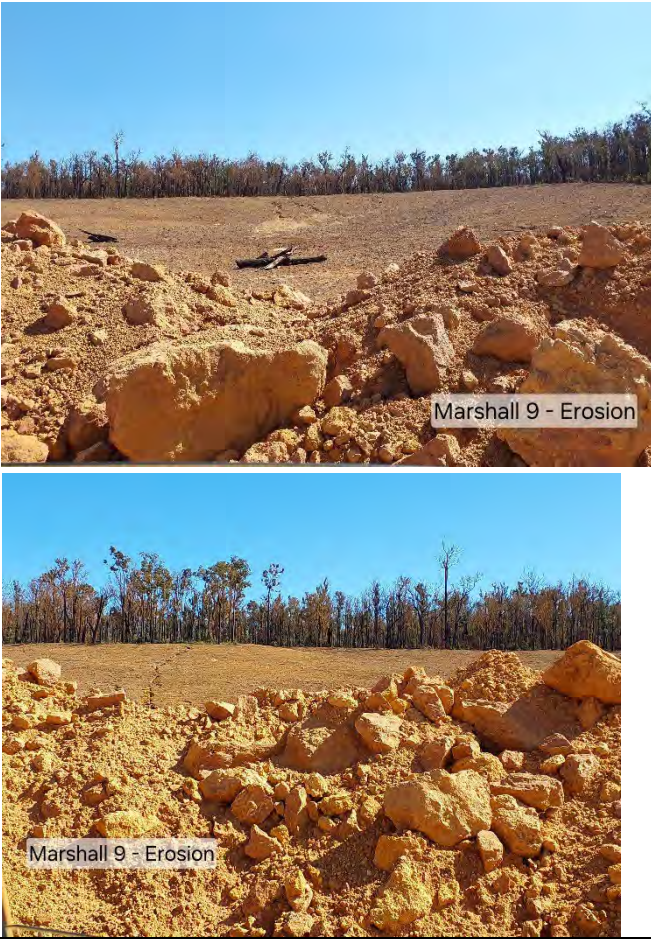
Condition number(s)	Task and Purpose	PNC Issues	Notes	Photo taken
			<p>Erosion on the eastern side of the rehabilitated area. Photos and coordinates taken. Alcoa is aware of these erosions. All erosion is contained within the oit.</p>

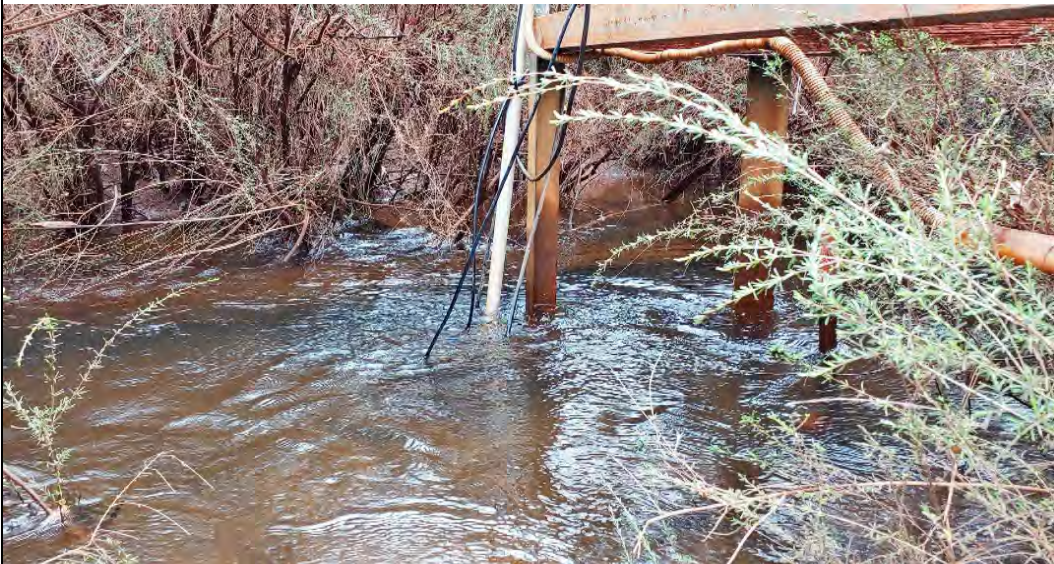
4(d)	SE48T (H4220) <ul style="list-style-type: none"> Turbidity event recorded 17/09/24. Site inspection showed stream level drop and sensor out of water 	None Identified	<p>Good flow with visibly clear water is noted in the stream during inspection at 11:20 am. No disturbance or runoff noted around the monitor. .</p>

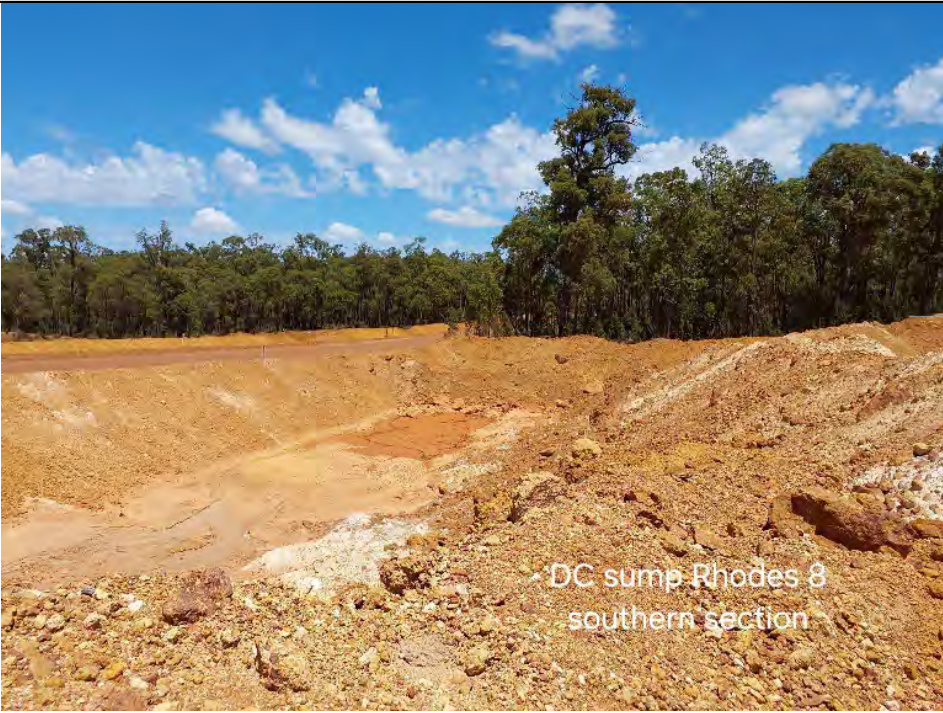
<p>DC sump Rhodes 8 southern section</p>

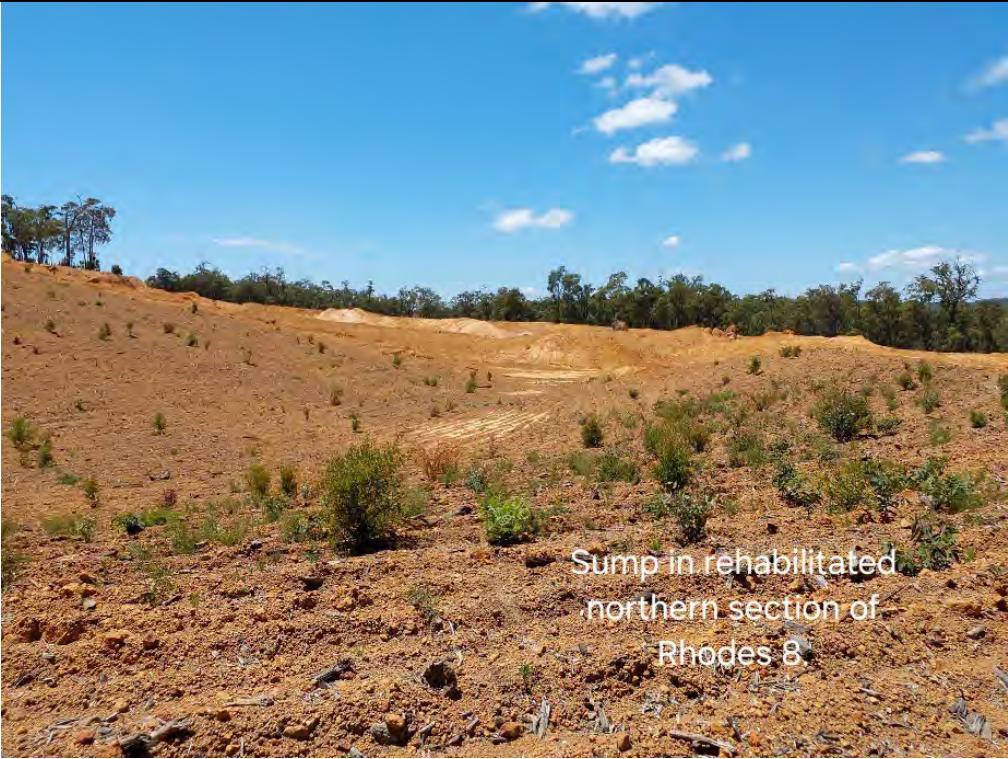
<p>Sump in rehabilitated northern section of Rhodes 8.</p>

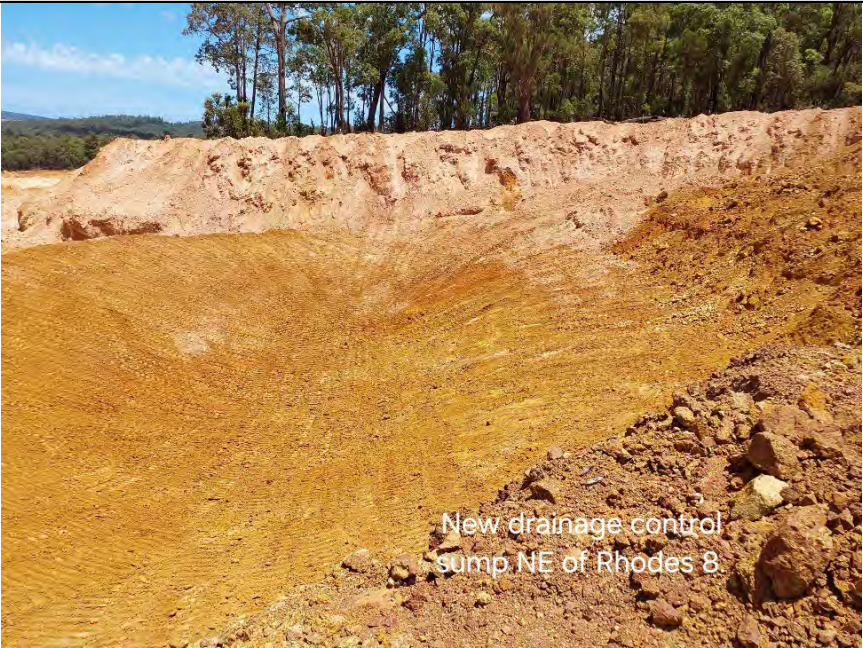
<p>New drainage control sump NE of Rhodes 8.</p>

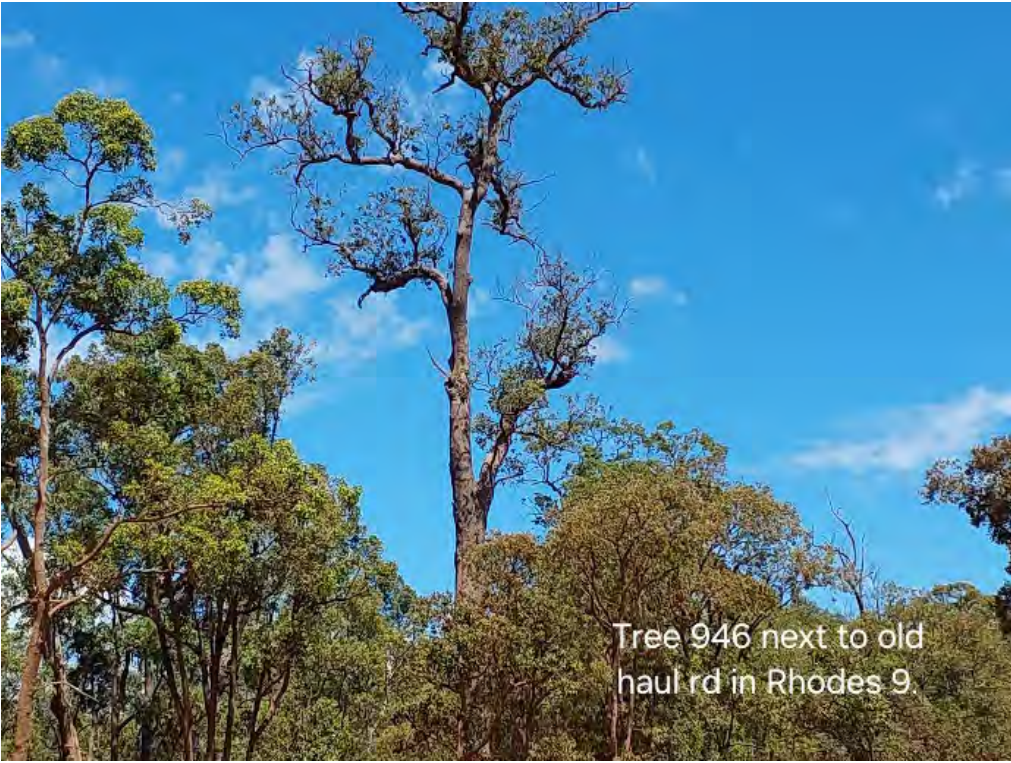
<p>Tree 946 next to old haul rd in Rhodes 9.</p>

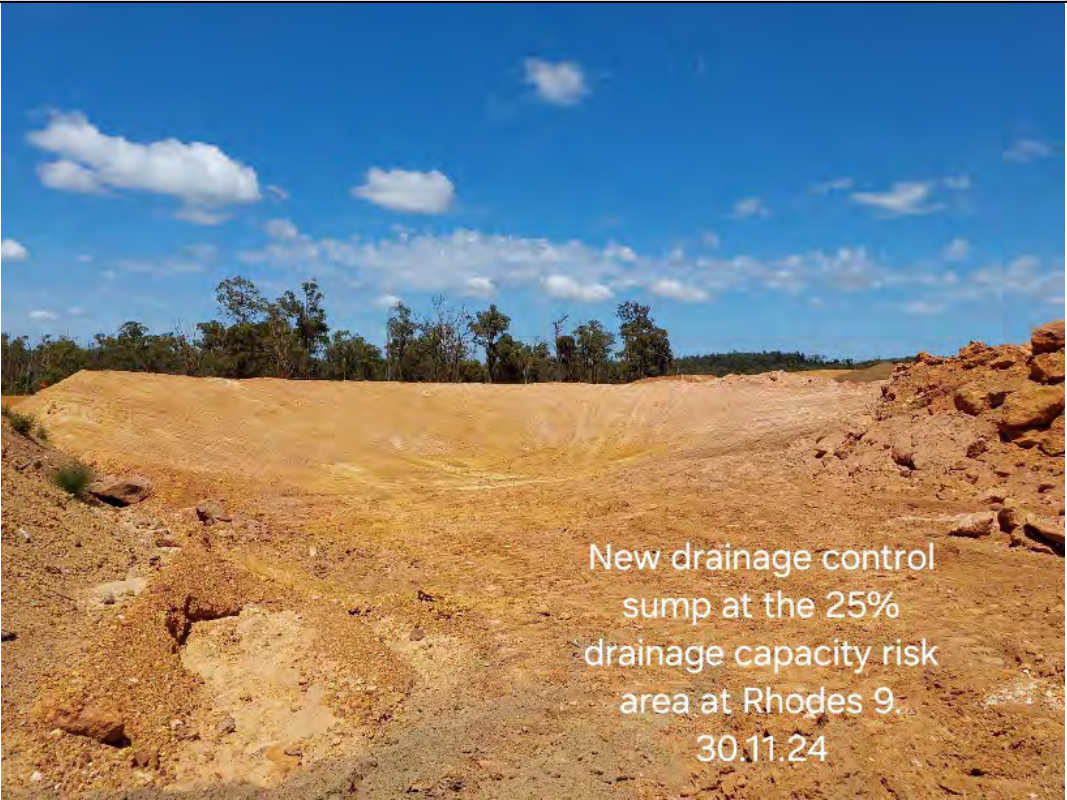
<p>New drainage control sump at the 25% drainage capacity risk area at Rhodes 9. 30.11.24</p>

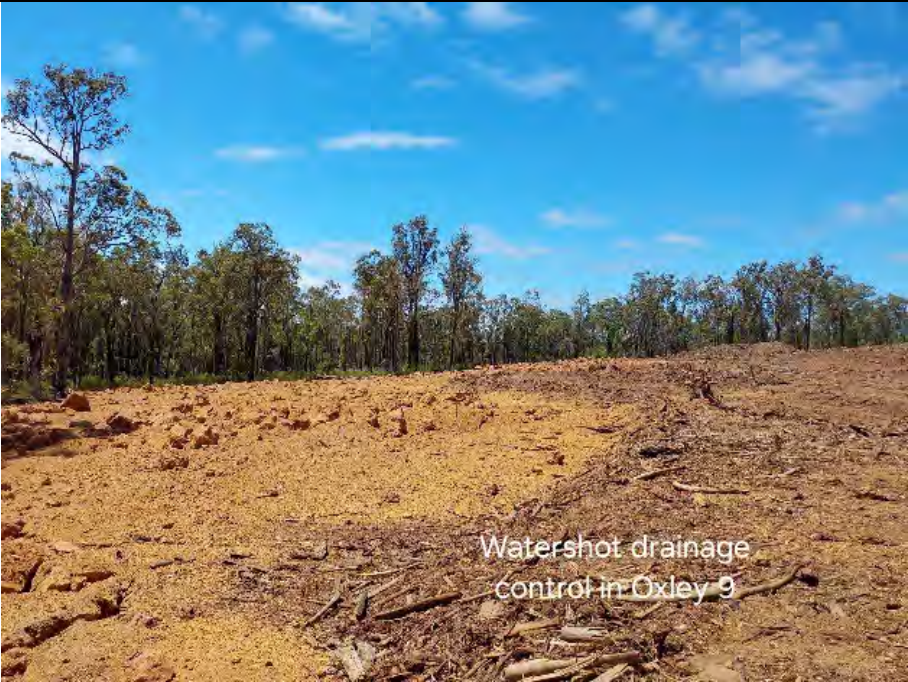
<div>Watershot drainage control in Oxley 9</div> </div>

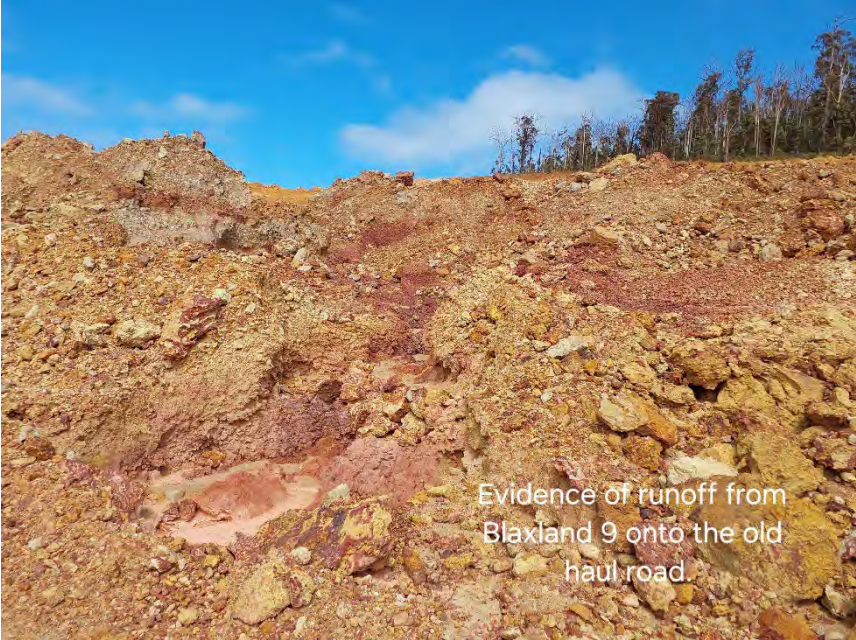
<p>Evidence of runoff from Blaxland 9 onto the old haul road.</p>	
--	--	--	--	--

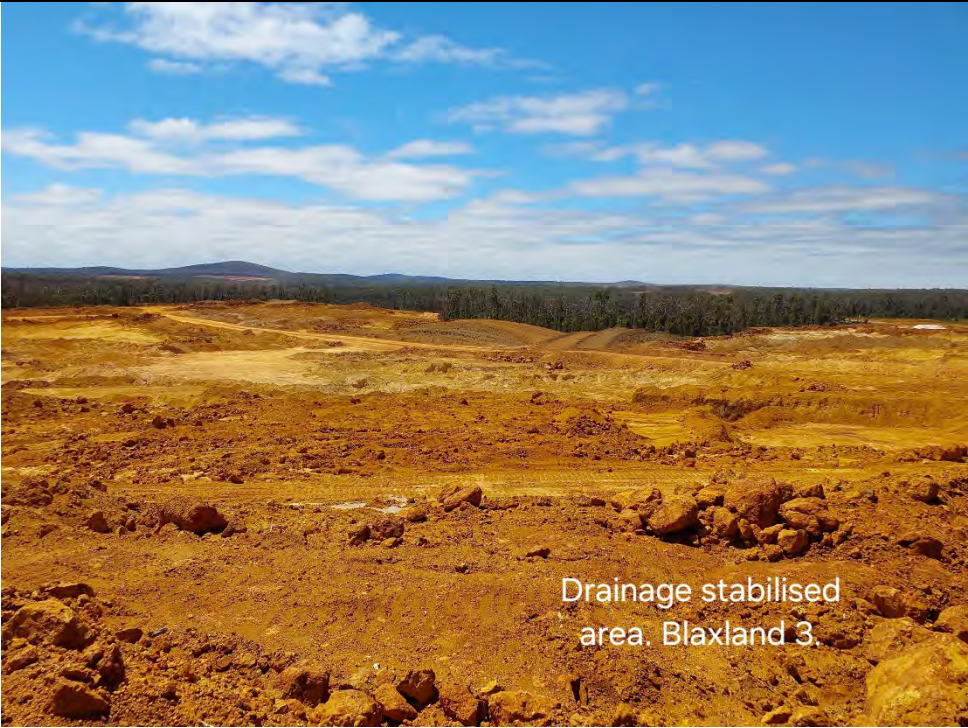
<div>Drainage stabilised area. Blaxland 3.</div> </div>

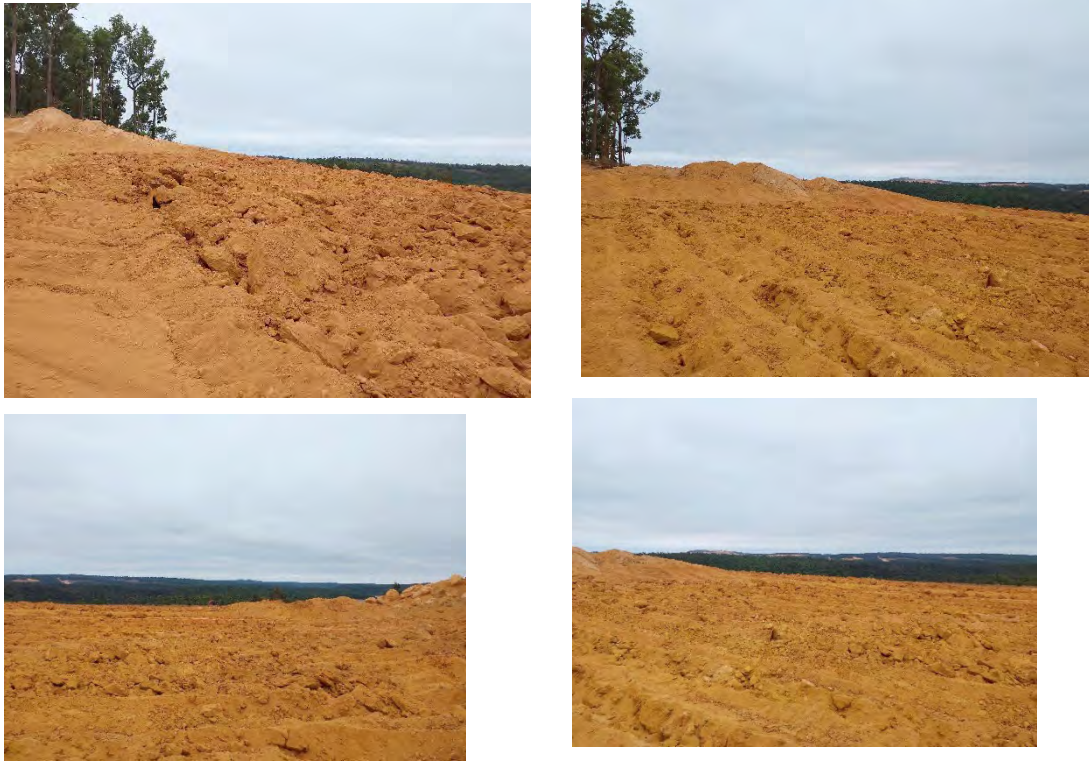
<p>- Evidence of ripping at stone 12 for drainage control.</p>

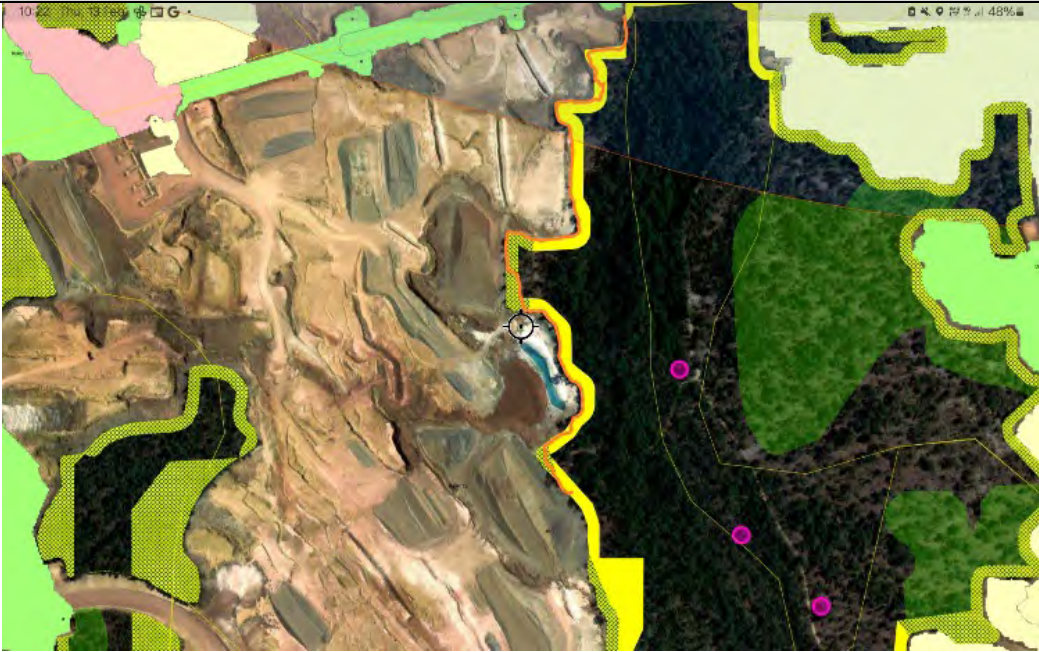
</div> <div>Disturbance is within the native vegetation disturbance boundary.</div>

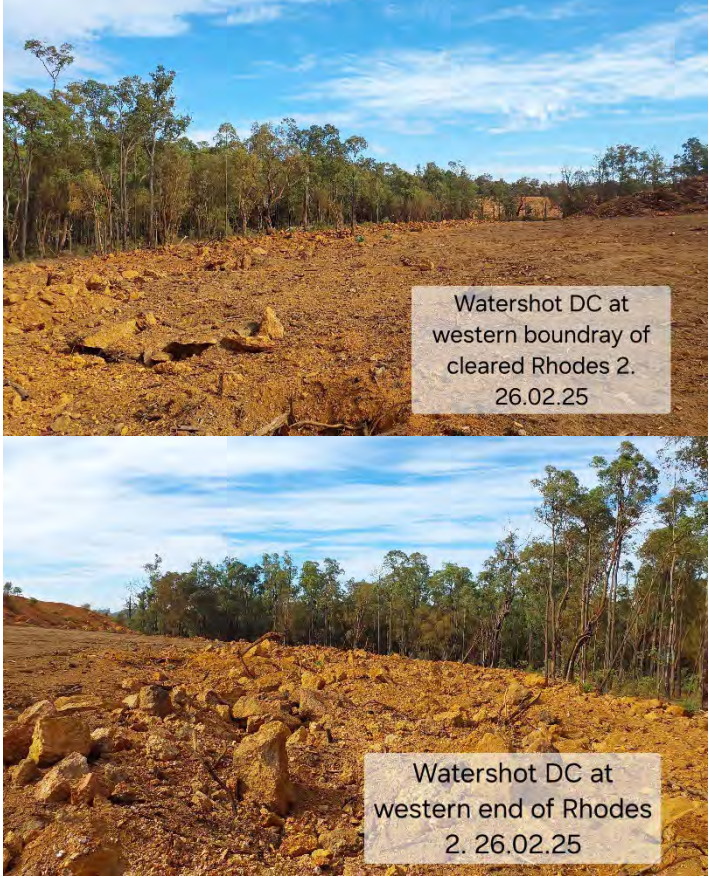
<p>Watershot DC at western boundray of cleared Rhodes 2. 26.02.25</p> <p>Watershot DC at western end of Rhodes 2. 26.02.25</p>

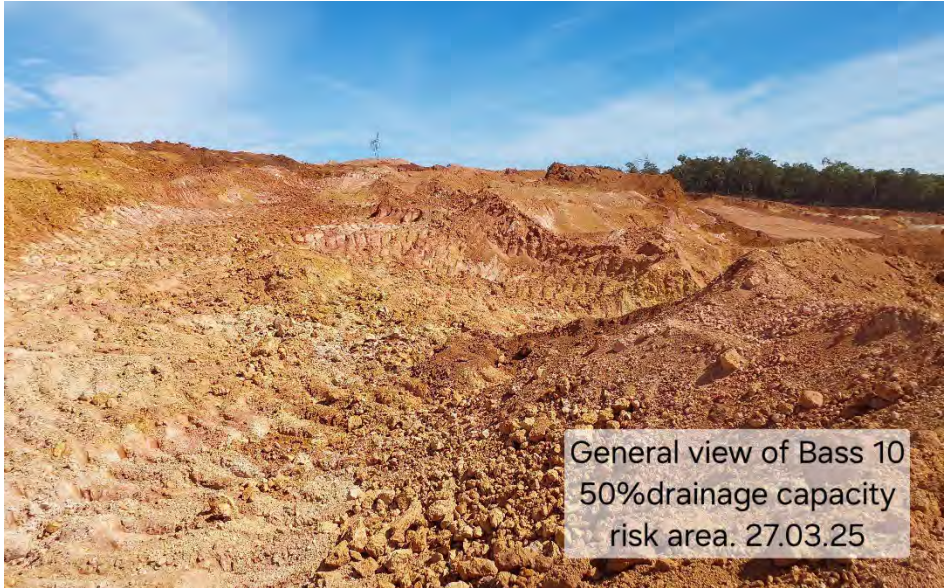
<p>General view of Bass 10 50% drainage capacity risk area. 27.03.25</p>

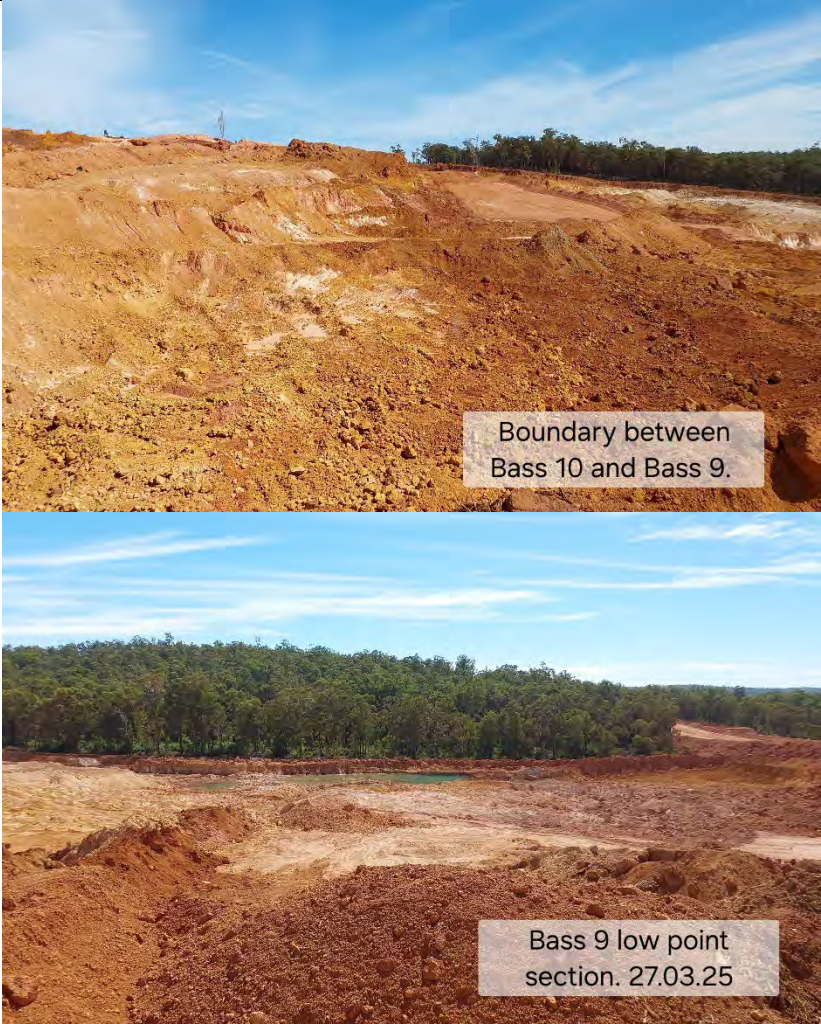
<p>Boundary between Bass 10 and Bass 9.</p> <p>Bass 9 low point section. 27.03.25</p>

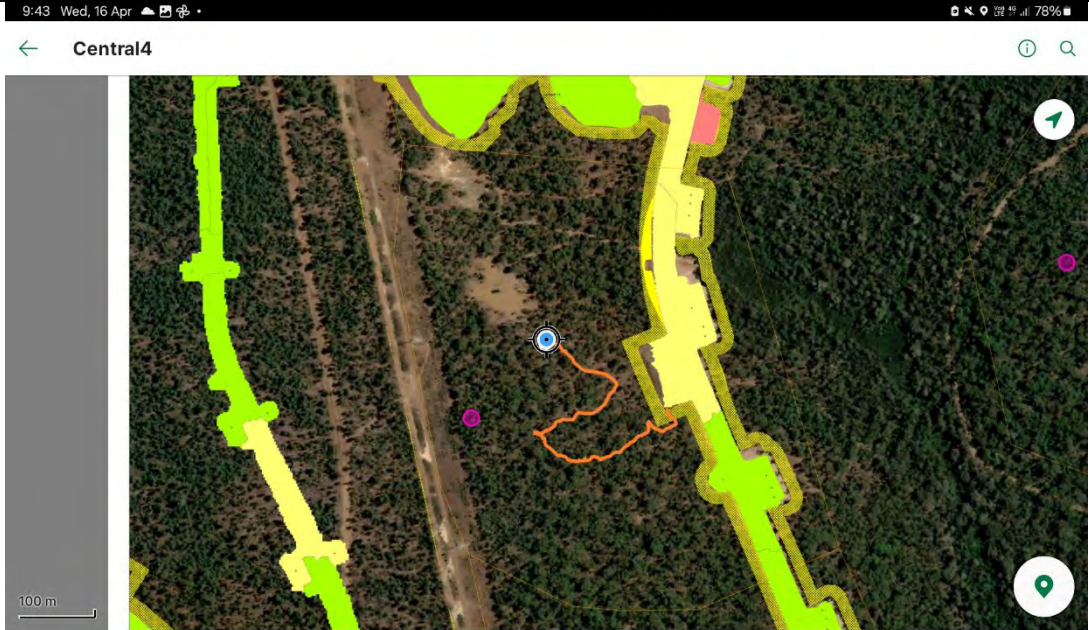
4(d)	Turbidity Monitor HV08 (G5509) <ul style="list-style-type: none"> Check that turbidity monitors are in place and no observed disturbance or sediment/ debris has built up around the sensor. <i>Travel north on LV bypass road, turn right and follow track to bottom. Turn left</i>		<p>Clear water flowing through the stream, no observed sediment in the water.</p> <p>Could not access NTU readings, box is locked.</p>

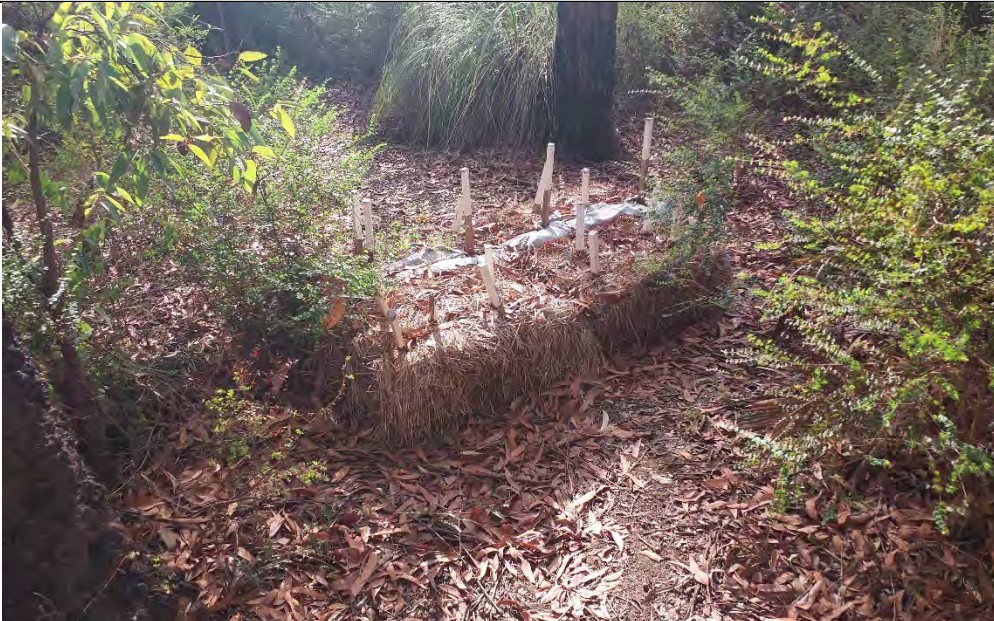
4(d)	<p>Turbidity Monitor PTM02 (G5521)</p> <ul style="list-style-type: none"> Check that turbidity monitors are in place and no observed disturbance or sediment/ debris has built up around the sensor. <p><i>Travel north on LV bypass road, turn right and follow track to bottom. Turn right and follow track for</i></p>	None Identified	Monitor is in place, small amount of ponded water where monitor is placed. No flow to creek some debris around the monitor is present, water is clear of sediment and limited fauna disturbance.

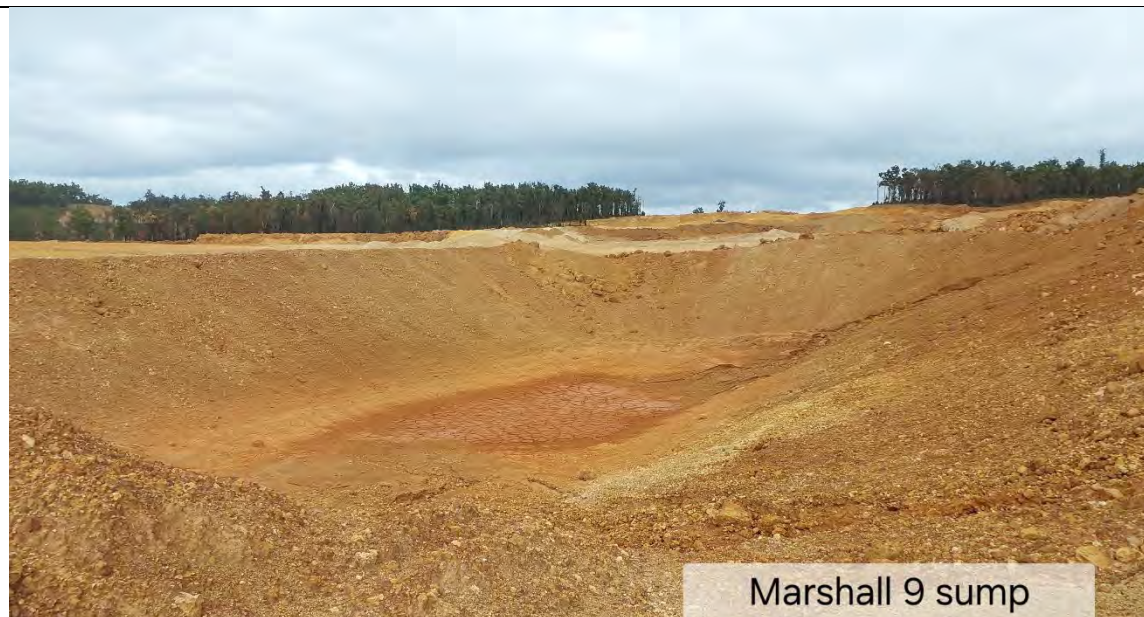
Marshall 9 sump

Condition number(s)	Task and Purpose	PNC Issues	Notes	Photo taken
5	Marshall 9 (G4117) <ul style="list-style-type: none"> Recent drainage works have occurred in the pit, check the condition and capacity of the sumps within the pit. Check areas of 50% drainage capacity for controls preventing runoff into eh surrounding forest. Pit is beside the Serpentine Pipehead catchment area. 	<i>None identified</i>	<p>Sumps in good condition with full capacity.</p> <p><50% DC area north of Marshall 9 road is used as stockpile. Lower end of pit drains towards haul road.</p> <p><50% DC area south of Marshall 9 road is used as stockpile with some mining activity. Lower end of pit drains towards Sump.</p> <p>No drainage issues</p>
