# WQMS Data Review

## Huntly Bauxite Mine

APRIL 2026

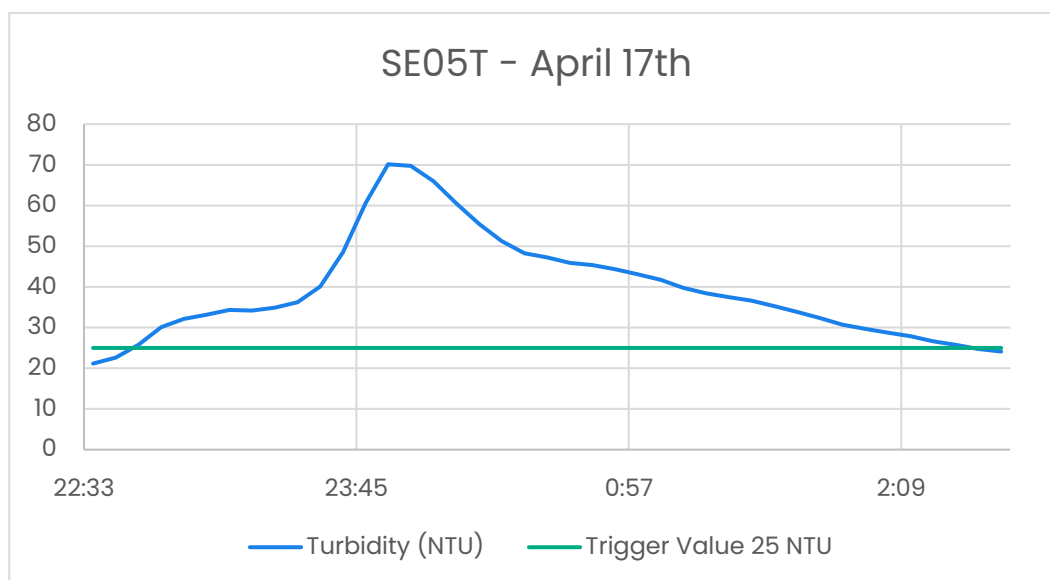
Figure 3 SE05T - April 17<sup>th</sup>

The turbidity exceedance event occurred between 10:48 PM on 17 April 2026 and 02:24 AM on 18 April 2026 at monitoring location SE05T. Trend analysis of the monitoring data (Figure 3) indicates a response pattern consistent with a genuine turbidity exceedance event, characterised by progressively increasing turbidity levels followed by a gradual return toward baseline conditions.

Trend analysis indicates a correlation between turbidity response and preceding rainfall conditions. A total of 8.2 mm of rainfall was recorded in the 24 hours preceding the event. While this rainfall amount is relatively low, it is considered sufficient to have generated localized surface runoff, particularly in areas with antecedent moisture conditions.

*Compliance turbidity monitoring site SE05T recorded a turbidity event exceeding 25 NTU for >1 hour on 17 April 2026. The event was recorded from 10:48 PM 27 to 2:24 AM, with a duration of 3 hours and 36 minutes. The average turbidity value during the event was 41.15 NTU, with a peak of 70.15 NTU. There was 8.2mm of rainfall recorded in the 24 hours preceding the event.*

*The data trend indicates a steady rise in turbidity coinciding with a period of sustained rainfall, with approximately 12 mm recorded over a two-hour period. Turbidity values gradually declined in the hours following the rainfall event, returning to background levels.*

*The SE05T monitoring site was inspected on 19 April 2026, during which significant algae and natural stream sediments were observed settled on organic debris within the stream bed, as well as on the equipment. The turbidity value recorded during the inspection was 12.9 NTU and remained consistent following lens cleaning.*

*The SE05T catchment area was inspected, no evidence of mining related contribution to the turbidity exceedance was found.”*

Based on the comments provided by Alcoa this event is considered ‘True’, but not mining related.

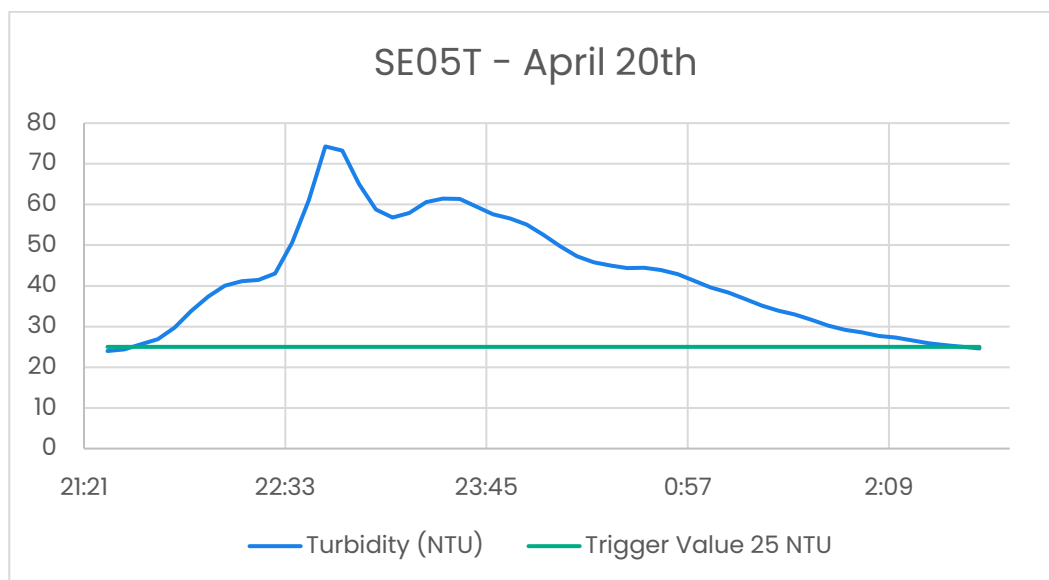
Figure 4 SE05T - April 20th

The turbidity exceedance event occurred between approximately 9:42PM on 20 April 2026 and 2:30AM on 21 April 2026 at monitoring location SE05T. Trend analysis of the monitoring data (Figure 4) indicates a response pattern consistent with a genuine turbidity exceedance event.

The turbidity profile shows a progressive initial increase, followed by a more rapid increase to a primary peak. After this peak, turbidity levels decrease slightly before exhibiting a secondary elevated plateau/peak. Following this secondary peak, turbidity levels show a consistent and gradual decline over several hours, returning to below the trigger threshold of 25 NTU.

Trend analysis indicates a clear correlation between turbidity response and preceding rainfall conditions. A total of 4.2 mm of rainfall was recorded in the 24 hours prior to the event. While relatively moderate, this rainfall is considered sufficient to have generated surface runoff, particularly under potentially wet antecedent conditions.

*“Compliance turbidity monitoring site SE05T recorded a turbidity event exceeding 25 NTU for >1 hour on 20 April 2026. The event was recorded from 20/04/2026 9:42 PM to 21/04/2026 2:30 AM, with a duration of 4 hours and 48 minutes. The average turbidity value during the event was 43.98 NTU, with a peak of 74.27 NTU. There was 4.2mm of rainfall in the 24 hours preceding the event. Data analysis shows an increase in turbidity coinciding with rainfall and a subsequent rise in stream flow. As rainfall eased (total rainfall of approximately 10 mm), turbidity values gradually declined and returned to the pre-rainfall baseline of approximately 13 NTU. The monitoring site was inspected on 21 April 2026. Stream observations indicated slightly elevated background turbidity of approximately 13 NTU, which did not change following lens cleaning. These observations are consistent with previous inspections and are attributed to algal influence within the stream.*

*The SE05T catchment area was inspected, no evidence of mining related contribution to the turbidity event was found.”*

Based on the comments provided by Alcoa this event is considered ‘True’, but not mining related.

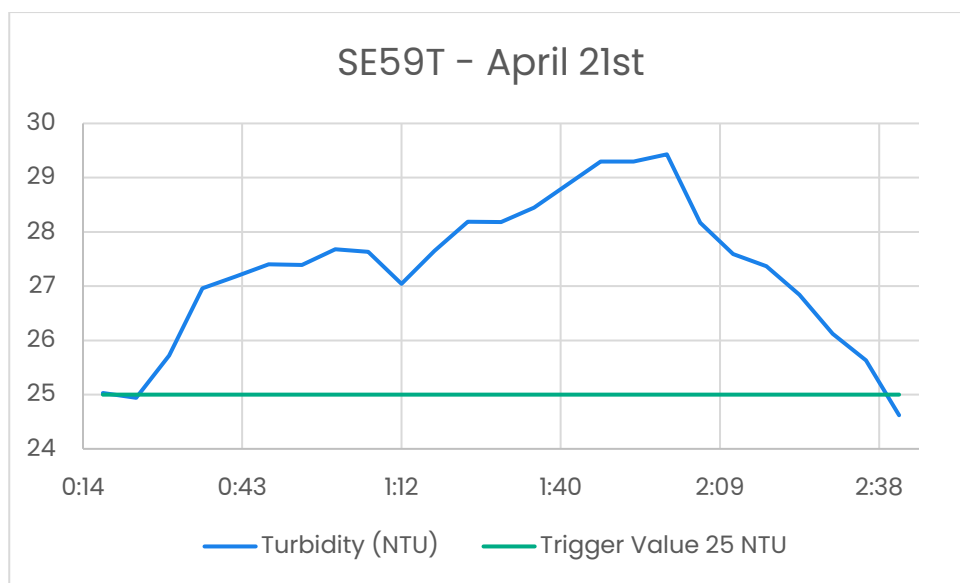
Figure 5 SE59T - April 21st

The turbidity exceedance event occurred between approximately 12:30 AM and 2:36 AM on 21 April 2026 at monitoring location SE59T. Trend analysis of the monitoring data (Figure 5) indicates a response pattern consistent with a genuine turbidity exceedance event.

The turbidity profile shows a gradual rise, increasing steadily to a moderate peak. Following this peak, turbidity levels exhibit a consistent and gradual decline.

Trend analysis indicates a clear correlation between turbidity response and preceding rainfall conditions. A total of 10.2 mm of rainfall was recorded in the 24 hours prior to the event. While relatively modest, this rainfall is considered sufficient to have generated localized surface runoff, particularly under antecedent wet conditions.

*values gradually declined to stable levels of 8-10 NTU. The SE59T monitoring site was inspected on 21 April 2026, during which elevated stream flow conditions were observed. Lens inspection during sensor cleaning identified slight biofilm accumulation, with turbidity readings decreasing from 8.3 to 2.7 NTU following cleaning. The SE59T catchment area was inspected, no evidence of mining related contribution was found.”*

Based on the comments provided by Alcoa this event is considered ‘True’, but not mining related.

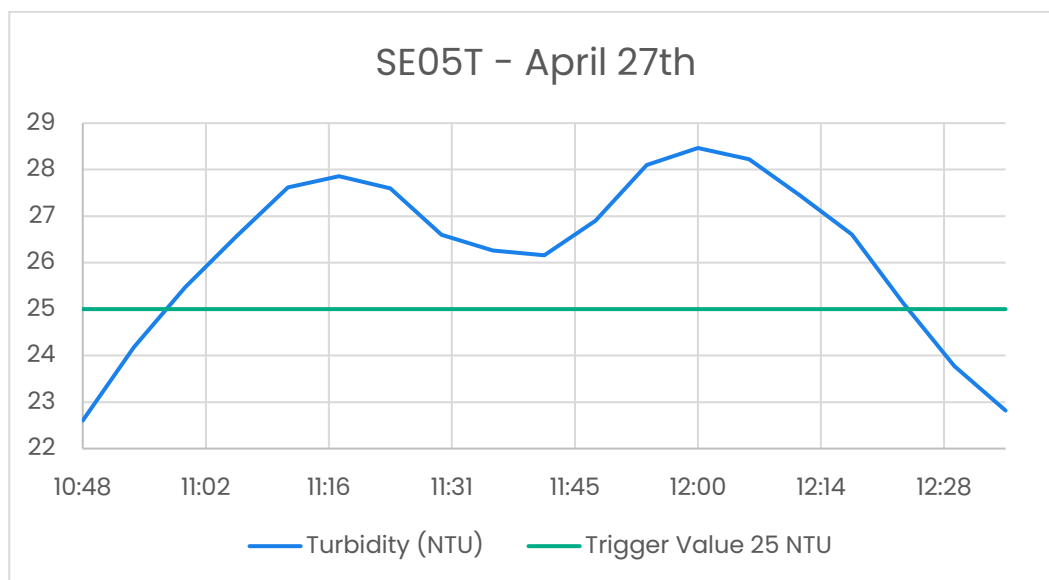
Figure 6 SE05T - April 27th

The turbidity profile shows an initial rise followed by a minor decline and fluctuation, before a secondary peak. After this point, turbidity levels steadily decline, falling below the trigger threshold.

Trend analysis indicates a clear correlation between turbidity response and preceding rainfall conditions. A total of 7.7 mm of rainfall was recorded in the 24 hours prior to the event. While relatively low, this rainfall is considered sufficient to have generated localized surface runoff, particularly under potentially wet antecedent conditions.

*The data trend indicates a gradual increase in turbidity following an approximately six-hour period of sustained rainfall. In the hours following the rainfall event turbidity values gradually declined to stable average levels of 12-13 NTU. The SE59T monitoring site was inspected on 28 April 2026. The stream was clear and flowing, with no visible debris impacting the turbidity sensor. Turbidity readings remained consistent at 13 NTU both before and after cleaning the sensor. The SE05T catchment area was inspected, no evidence of mining related contribution was found.”*
