# WQMS Data Review

## Huntly Bauxite Mine

JUNE 2026

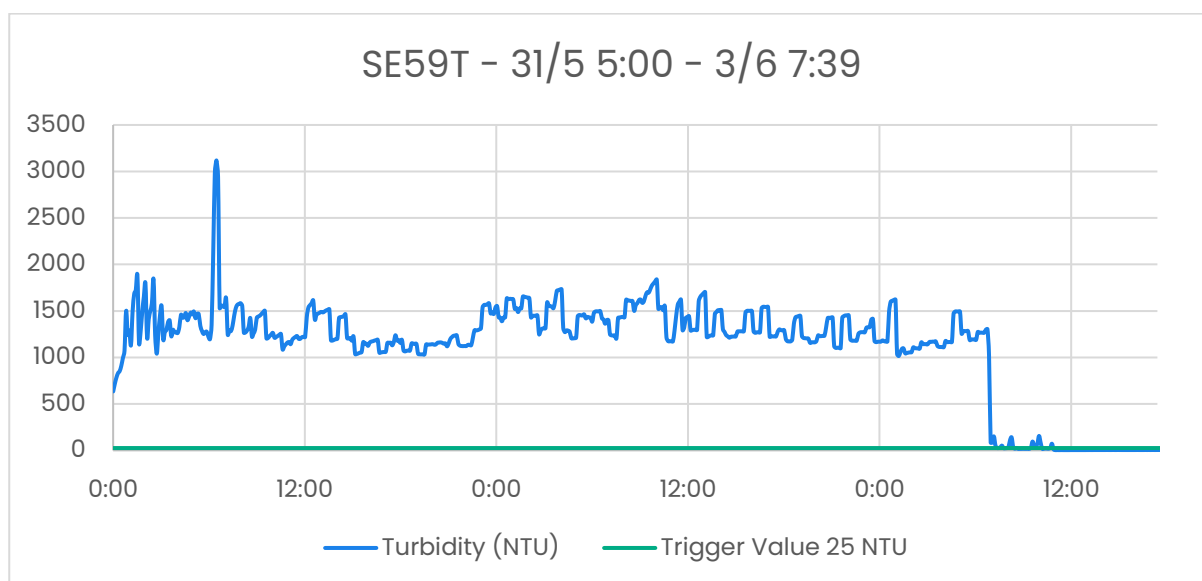
Figure 3 – SE59T May 31<sup>st</sup> – June 3<sup>rd</sup>

The turbidity exceedance event occurred at monitoring location SE59T between 5:00 AM on 31 May 2026 and 7:39 AM on 3 June 2026. During the first 24hrs of this period, 10.6 mm of rainfall was recorded, providing a plausible mechanism for increased sediment mobilisation and transport within the monitored waterbody. The turbidity graph (Figure 3) displays a response pattern consistent with a genuine turbidity event. Following the initial rise in turbidity, sediment accumulation on the sensor likely contributed to persistently elevated readings, prolonging the apparent duration of the exceedance.

*The SE59T catchment area has been inspected and no evidence of mining related drainage concerns observed.'*

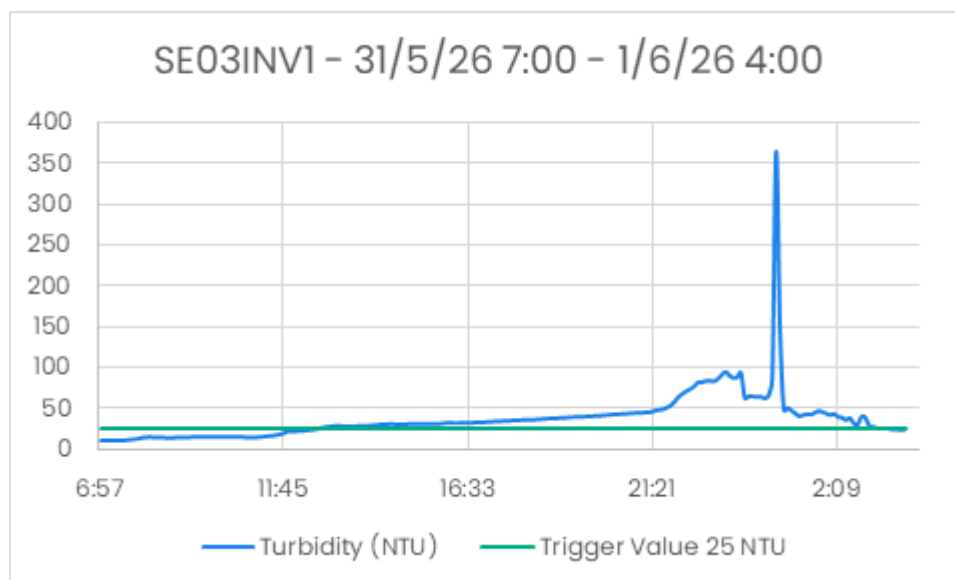
Figure 4 – SE03INV1 31<sup>st</sup> May – 1<sup>st</sup> June

The observed turbidity response is consistent with rainfall-driven runoff processes. A total of 17.6 mm of rainfall was recorded in the 24 hours preceding the event, which is sufficient to generate sustained runoff and sediment mobilisation. However, the magnitude and abrupt nature of the peak suggest a localised or discrete input of highly turbid water, such as a concentrated inflow, resuspension event, or disturbance within the channel. This indicates a complex response involving both gradual catchment runoff and a short-duration, high-intensity turbidity pulse.

*SE03INV1 catchment area was inspected and no evidence of mining related drainage concerns were observed.’*

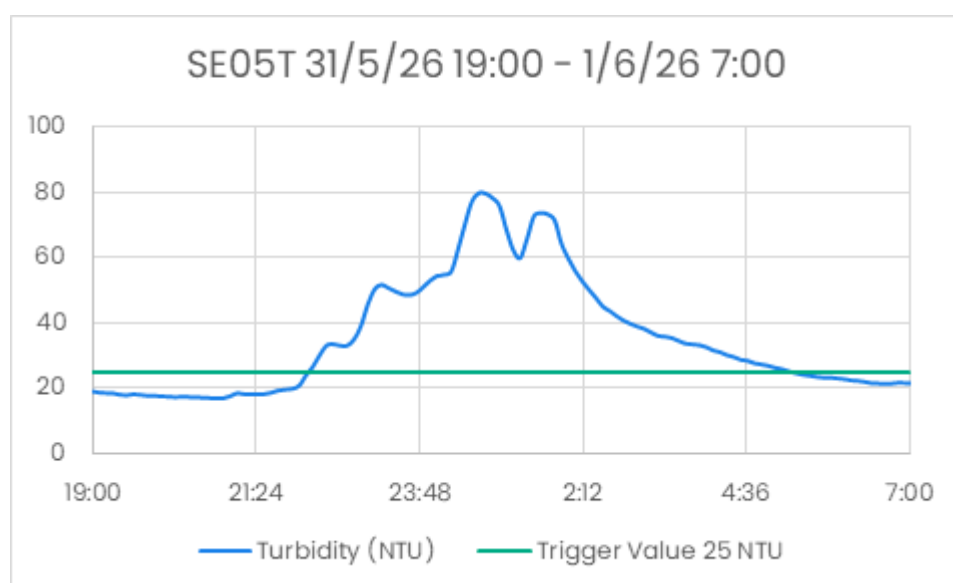
Figure 5 – SE05T 31<sup>st</sup> May – 1<sup>st</sup> June

The observed turbidity response is consistent with rainfall-driven runoff processes. A total of 20.6 mm of rainfall was recorded in the 24 hours preceding the event. This rainfall is sufficient to generate localised surface runoff, particularly under potentially wet antecedent conditions. The presence of multiple peaks suggests staggered runoff inputs and/or delayed mobilisation of sediments within the catchment.

*The SE05T catchment area was inspected, no evidence of mining related contribution was found.’*

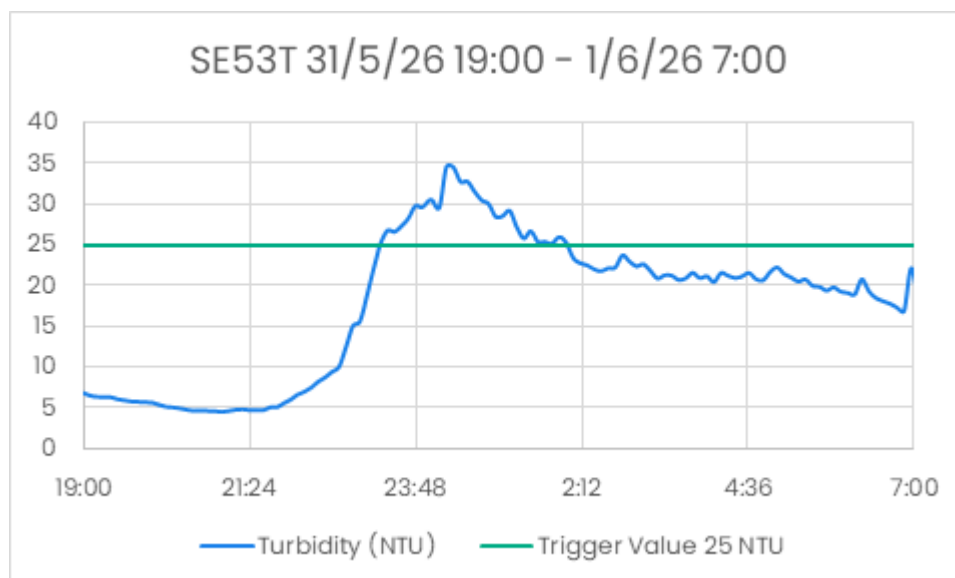
Figure 6 – SE53T 31<sup>st</sup> May – 1<sup>st</sup> June

The observed turbidity response is consistent with rainfall-driven runoff processes. A total of 29.3 mm of rainfall was recorded in the 24 hours preceding the event. This relatively high rainfall volume is sufficient to generate sustained surface runoff and sediment mobilisation across the catchment.

*The data trend indicates a gradual incline in turbidity NTU commencing midway through the rain event and a gradual decline post rainfall. SE53T monitoring site was inspected on 03 June 2026, stream was clear and flowing with vegetation surrounding the sensor location. On arrival, the sensor pole was observed to have vertically dropped and therefore the sensor appeared to be sitting close to the stream bed. The sensor face was covered in a light film of algae.*

*The SE53T catchment area was inspected, no evidence of mining related contribution was found.'*

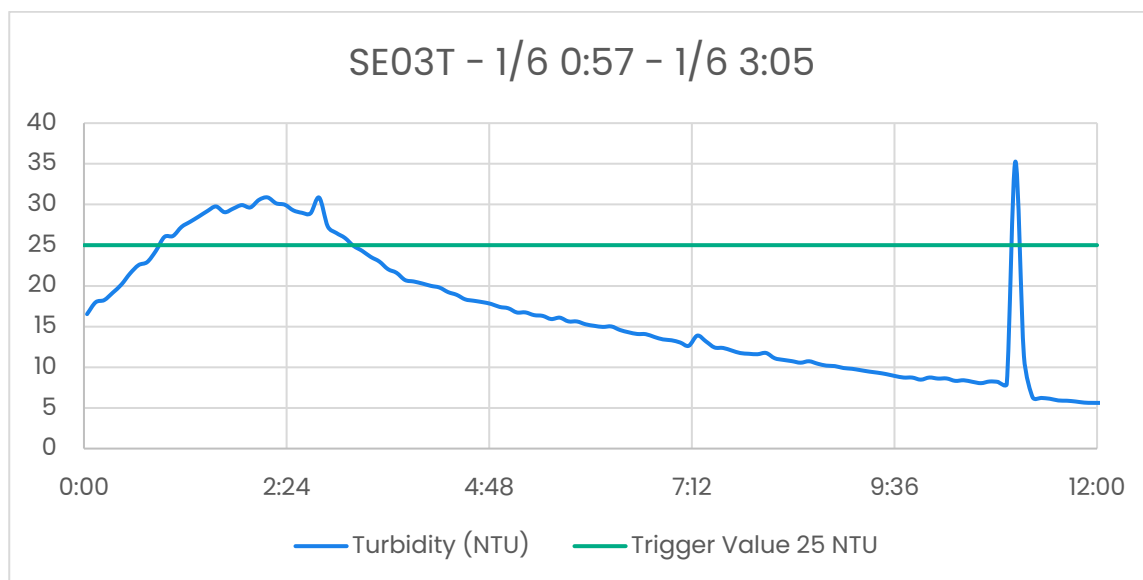
Figure 7 – SE03T 1<sup>st</sup> June

The turbidity exceedance event occurred at monitoring location SE03T between 12:57 AM and 3:05 AM on 1 June 2026. A total of 28.77 mm of rainfall was recorded during the 24 hours preceding the event, providing a plausible mechanism for increased sediment mobilisation and transport within the monitored waterbody. The turbidity graph (Figure 7) displays a response pattern consistent with a genuine turbidity event, with turbidity rising above the 25 NTU trigger value and reaching a peak of approximately 31 NTU before gradually declining towards baseline levels. The substantial rainfall recorded prior to the event is considered the most likely cause of the observed increase in turbidity

*‘Local turbidity monitor SE03T recorded a turbidity event exceeding 25NTU for >1 hour on 01/06/2026 at 12:57 AM for a duration of 2 hours and 8 minutes. The duration of the event was 2 hours and 8 minutes, following a 28.74mm rainfall event. The monitor site was inspected on 3/06/2026. The stream was clear and flowing, however on removal from flow cell, sensor was observed to be impacted with silt, resulting in a higher turbidity reading of 30.8 NTU. Data trend indicates a gradual incline with the rain event followed by a gradual decline once the rain event ceased.’*

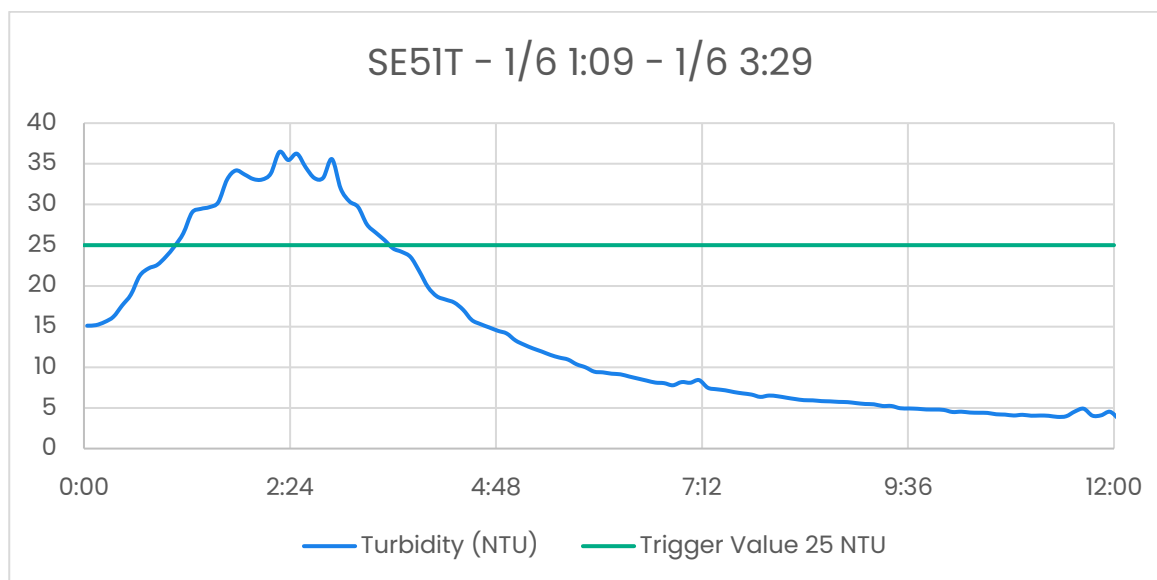
Figure 8 – SE51T 1<sup>st</sup> June

The turbidity exceedance event occurred at monitoring location SE51T between 1:09 AM and 3:29 AM on 1 June 2026. A total of 28 mm of rainfall was recorded during the 24 hours preceding the event, providing a plausible mechanism for increased sediment mobilisation and transport within the monitored waterbody. The turbidity graph (Figure 8) displays a response pattern consistent with a genuine turbidity event, with turbidity rising above the 25 NTU trigger value and reaching a peak of approximately 36 NTU before gradually declining towards baseline levels. The substantial rainfall recorded prior to the event is considered the most likely cause of the observed increase in turbidity. The smooth rise and gradual recession of turbidity readings are characteristic of a rainfall-driven runoff response.

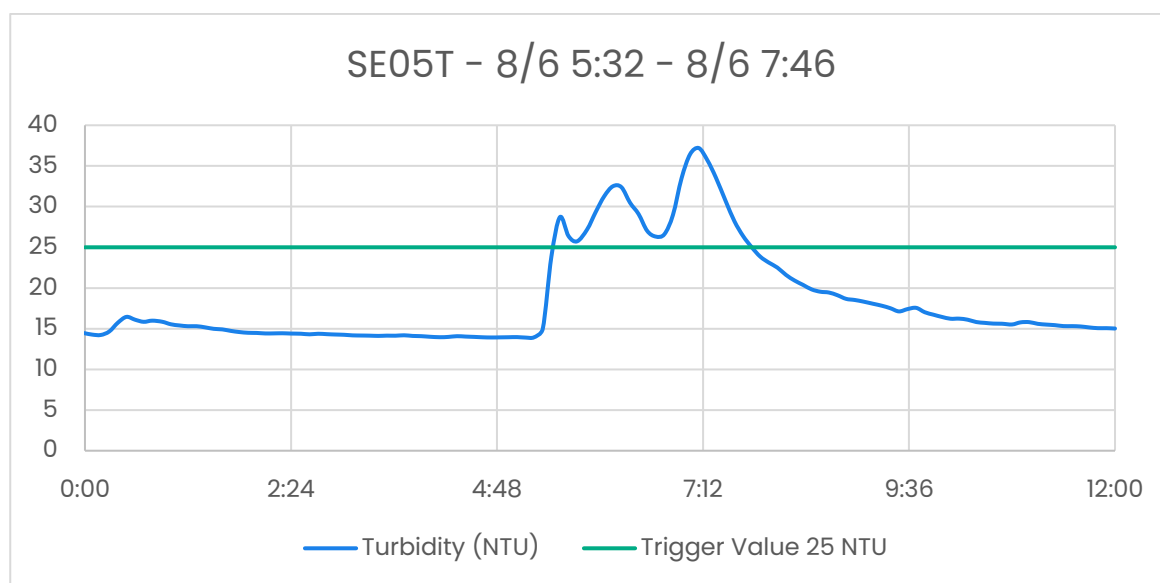
Figure 9 - SE05T 8<sup>th</sup> June

and transport within the monitored waterbody. The turbidity graph (Figure 9) displays a response pattern consistent with a genuine turbidity event, with turbidity rising rapidly above the 25 NTU trigger value and reaching a peak of approximately 37 NTU before gradually declining towards baseline levels. The substantial rainfall recorded prior to the event is considered the most likely cause of the observed increase in turbidity. The distinct rise and subsequent recession in turbidity readings are characteristic of a rainfall-driven runoff response and do not indicate sensor malfunction.

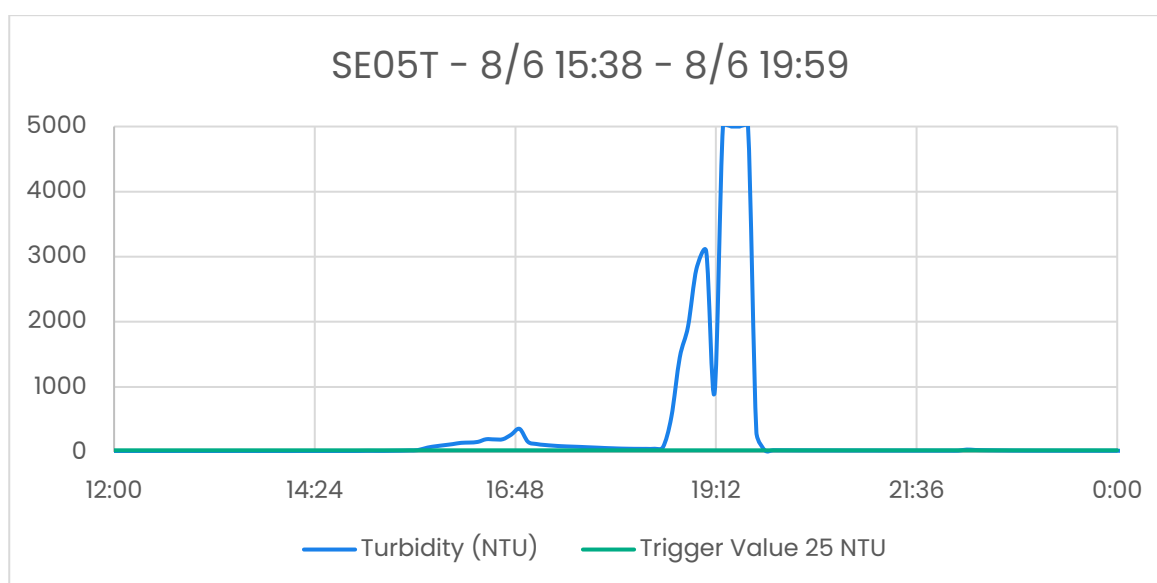
Figure 10 – SE05T 8<sup>th</sup> June

The turbidity exceedance event occurred at monitoring location SE05T between 3:38 PM and 7:59 PM on 8 June 2026. A total of 32.7 mm of rainfall was recorded during the 24 hours preceding the event, providing a plausible mechanism for increased sediment mobilisation and transport within the monitored waterbody. The turbidity graph (Figure 10) displays a response pattern consistent with a genuine turbidity event, with turbidity rapidly increasing above the 25 NTU trigger value and reaching a peak of approximately 5,000 NTU. The substantial rainfall recorded prior to the event is considered the most likely cause of the observed increase in turbidity. The sharp rise in turbidity followed by a rapid return to baseline levels is indicative of a significant sediment pulse associated with rainfall-driven runoff rather than sensor malfunction. The exceptionally high turbidity values recorded during the event suggest a substantial influx of suspended sediments within the catchment.

*interference, while also suggesting an increase in background turbidity levels. The SE05T catchment area was inspected, no evidence of mining contribution was found."*

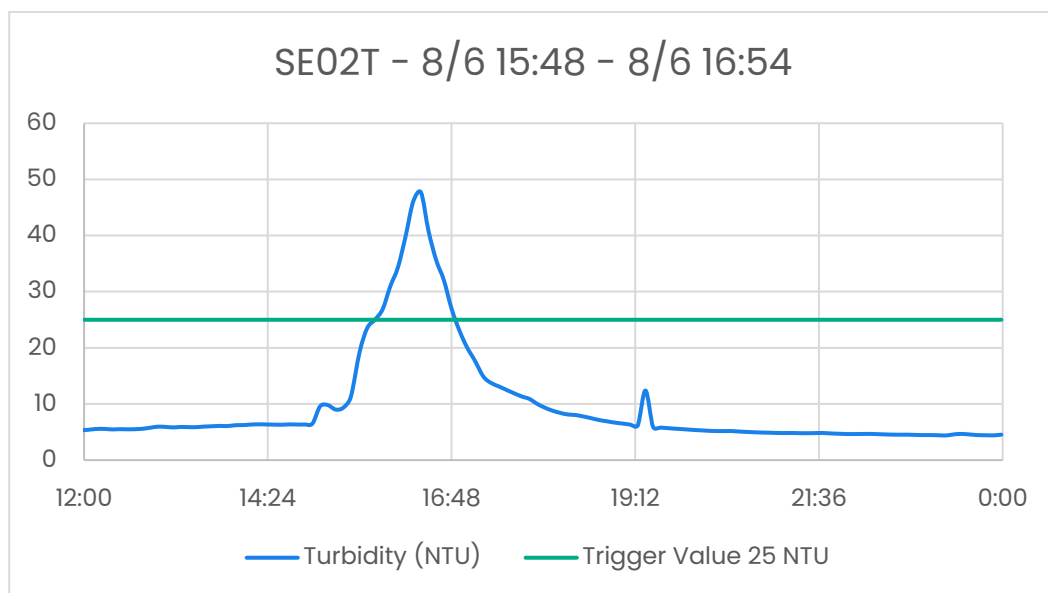
Figure 11 - SE02T 8<sup>th</sup> June

The turbidity exceedance event occurred at monitoring location SE02T between 3:48 PM and 4:54 PM on 8 June 2026. A total of 32.1 mm of rainfall was recorded during the 24 hours preceding the event, providing a plausible mechanism for increased sediment mobilisation and transport within the monitored waterbody. The turbidity graph (Figure 11) displays a response pattern consistent with a genuine turbidity event, with turbidity rising rapidly above the 25 NTU trigger value and reaching a peak of approximately 48 NTU before gradually declining towards baseline levels. The substantial rainfall recorded prior to the event is considered the most likely cause of the observed increase in turbidity. The well-defined rise and recession of turbidity readings are characteristic of a rainfall-driven runoff response and support the interpretation of the exceedance as a genuine environmental event rather than an instrument anomaly.

*A monitor and catchment inspection was completed on the 10/06. it was noted moderate levels of algae present on the sensor.*

*A catchment inspection was undertaken, where no evidence of mining drainage discharge was found."*

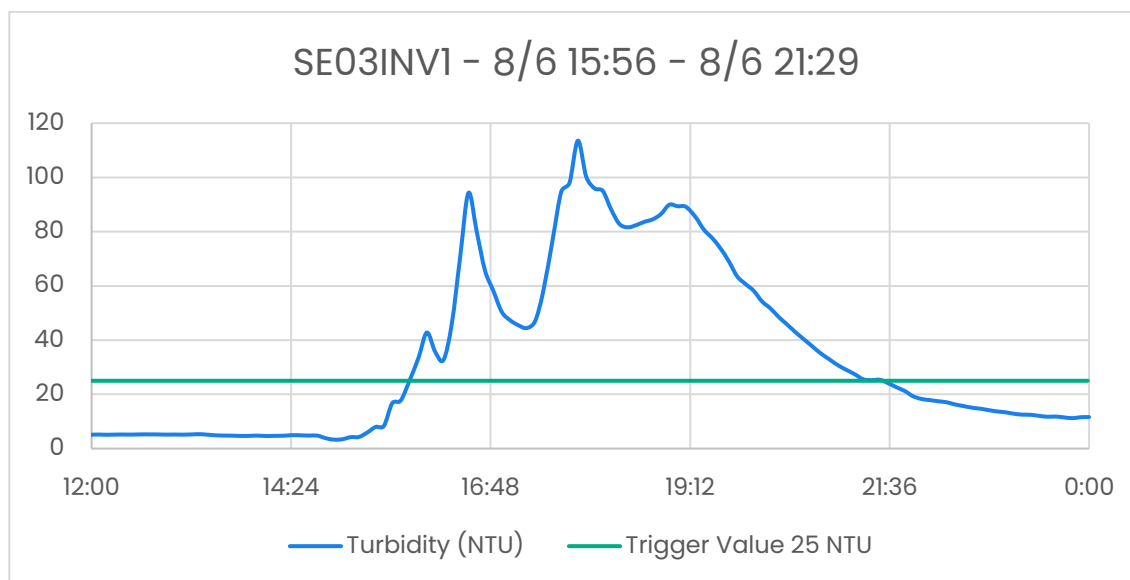
Figure 12 – SE03INV1 8<sup>th</sup> June

The turbidity exceedance event occurred at monitoring location SE03INV1 between 3:56 PM and 9:29 PM on 8 June 2026. A total of 34.9 mm of rainfall was recorded during the 24 hours preceding the event, providing a plausible mechanism for increased sediment mobilisation and transport within the monitored waterbody. The turbidity graph (Figure 12) displays a response pattern consistent with a genuine turbidity event, with turbidity rising rapidly above the 25 NTU trigger value and reaching a peak of approximately 113 NTU before gradually declining towards baseline levels. The substantial rainfall recorded prior to the event is considered the most likely cause of the observed increase in turbidity. The multiple peaks observed during the event are indicative of successive pulses of sediment-laden runoff entering the waterbody, while the gradual recession of turbidity levels is characteristic of a natural rainfall-driven response rather than an instrument anomaly.

*A monitor and catchment inspection was completed over the 12th and 13th June. A drainage event was identified, but through investigation, found no impact the SE03INV1 stream. No other mining drainage was identified"*

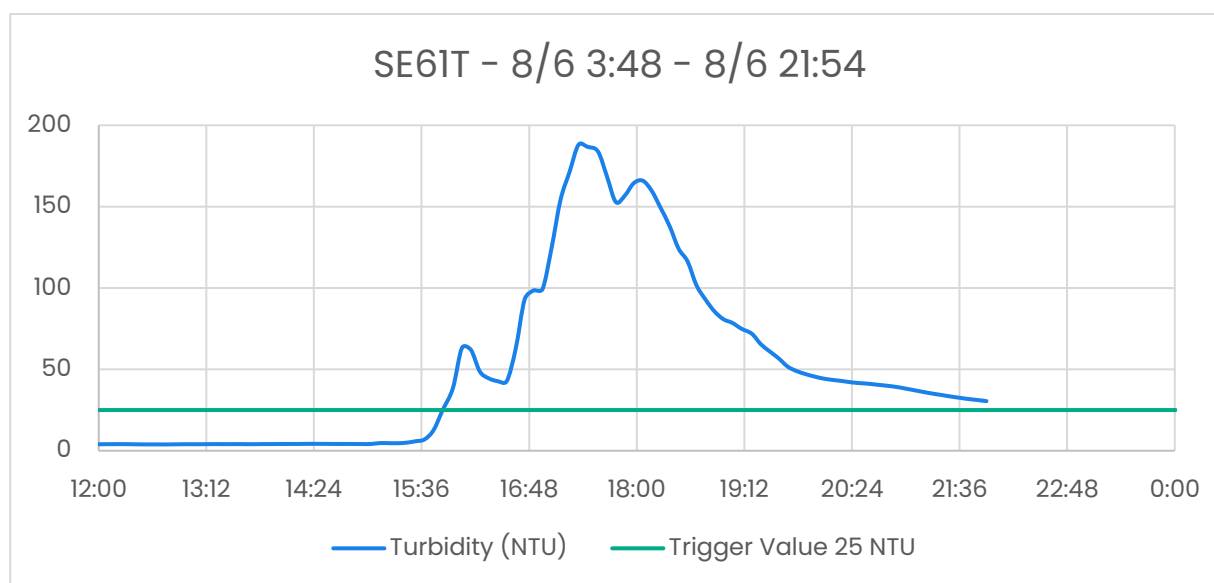
Figure 13 – SE061T 8<sup>th</sup> June

response pattern consistent with a genuine turbidity event, with turbidity rising rapidly above the 25 NTU trigger value and reaching a recorded peak of approximately 188 NTU before gradually declining towards baseline levels. The substantial rainfall recorded prior to the event is considered the most likely cause of the observed increase in turbidity. The pronounced rise, multiple peaks, and gradual recession of turbidity levels are characteristic of a rainfall-driven runoff response and indicate successive inflows of sediment-laden water rather than an instrument anomaly. However, due to battery-related issues during the monitoring period, the complete event was not captured.

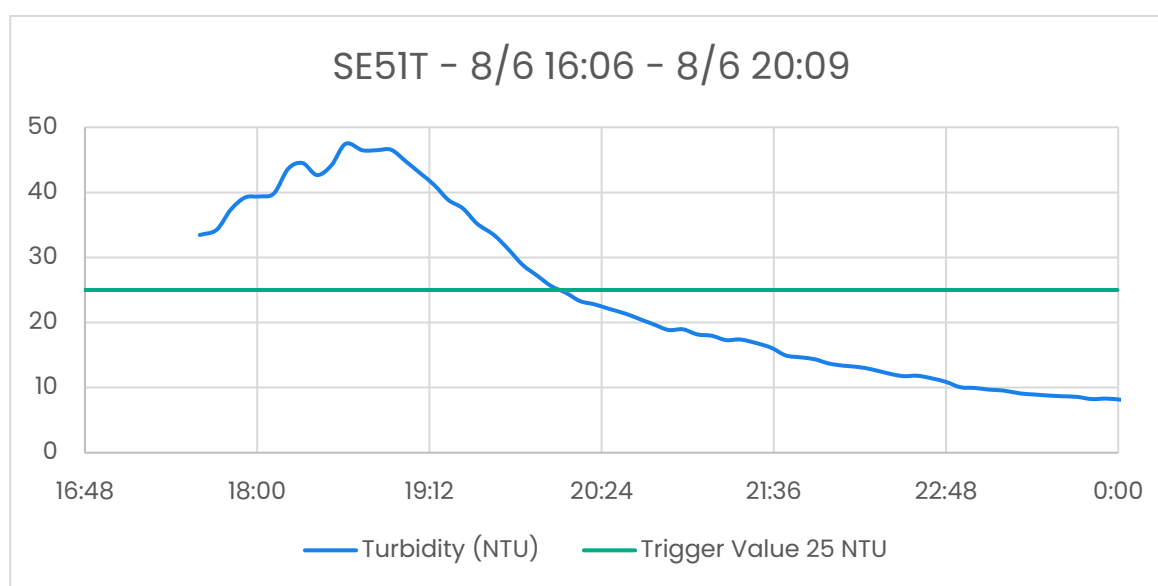
Figure 14 – SE51T 8<sup>th</sup> June

and transport within the monitored waterbody. The turbidity graph (Figure 14) displays a response pattern consistent with a genuine turbidity event, with turbidity remaining above the 25 NTU trigger value and reaching a recorded peak of approximately 48 NTU before gradually declining towards baseline levels. The substantial rainfall recorded prior to the event is considered the most likely cause of the observed increase in turbidity. The gradual recession in turbidity levels is characteristic of a rainfall-driven runoff response rather than an instrument anomaly. However, a data gap was present at the commencement of the event, and as a result, the onset of the exceedance was not have been fully captured.

*A monitor and catchment inspection was completed on the 12/06 A catchment inspection was undertaken, where no evidence of mining drainage discharge was found."*

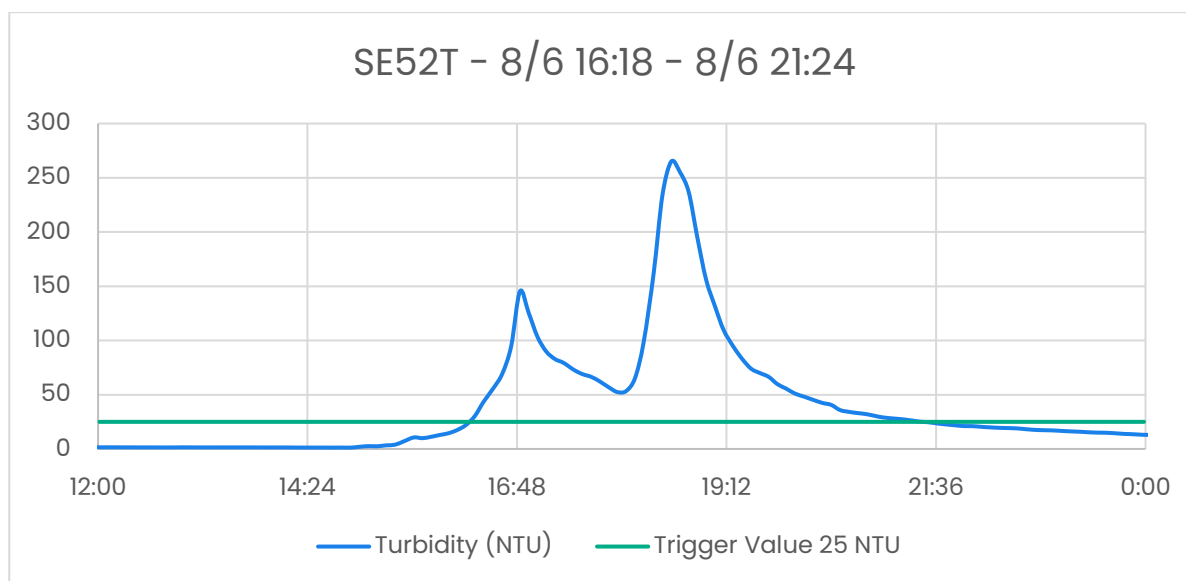
Figure 15 – SE52T 8<sup>th</sup> June

The turbidity exceedance event occurred at monitoring location SE52T between 4:18 PM and 9:24 PM on 8 June 2026. A total of 37.4 mm of rainfall was recorded during the 24 hours preceding the event, providing a plausible mechanism for increased sediment mobilisation and transport within the monitored waterbody. The turbidity graph (Figure 15) displays a response pattern consistent with a genuine turbidity event, with turbidity rising rapidly above the 25 NTU trigger value and reaching a peak of approximately 265 NTU before gradually declining towards baseline levels. The substantial rainfall recorded prior to the event is considered the most likely cause of the observed increase in turbidity. The event is characterised by multiple turbidity peaks, indicating successive pulses of sediment-laden runoff entering the waterbody. The subsequent gradual recession in turbidity levels is characteristic of a rainfall-driven response and supports the interpretation of the exceedance as a genuine environmental event rather than an instrument anomaly.

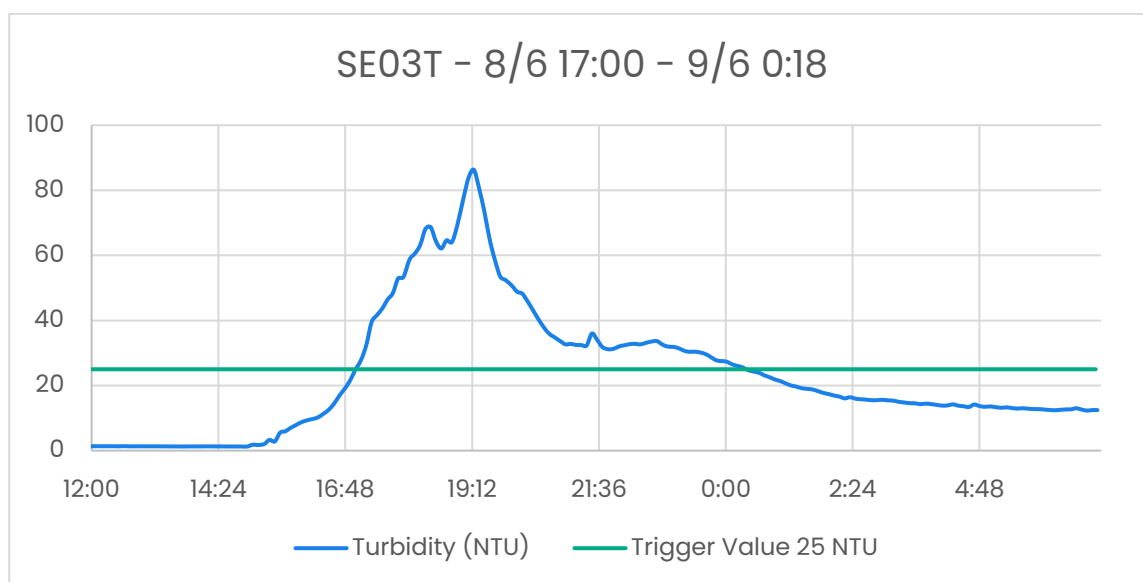
Figure 16 – SE03T 8<sup>th</sup> June

The turbidity exceedance event occurred at monitoring location SE03T between 5:00 PM on 8 June 2026 and 12:18 AM on 9 June 2026. A total of 38.0 mm of rainfall was recorded during the 24 hours preceding the event, providing a plausible mechanism for increased sediment mobilisation and transport within the monitored waterbody. The turbidity graph (Figure 16) displays a response pattern consistent with a genuine turbidity event, with turbidity rising above the 25 NTU trigger value and reaching a peak of approximately 86 NTU before gradually declining towards baseline levels. The substantial rainfall recorded prior to the event is considered the most likely cause of the observed increase in turbidity. The event is characterised by a progressive rise in turbidity, multiple peaks during the rising limb, and a prolonged recession period, indicating successive inputs of sediment-laden runoff to the waterbody. This response is characteristic of a rainfall-driven turbidity event and does not indicate sensor malfunction.

*A monitor and catchment inspection was completed over the 12th and 13th June. A drainage event was identified, but through investigation, found no impact the SE03T stream. No other mining drainage was identified"*

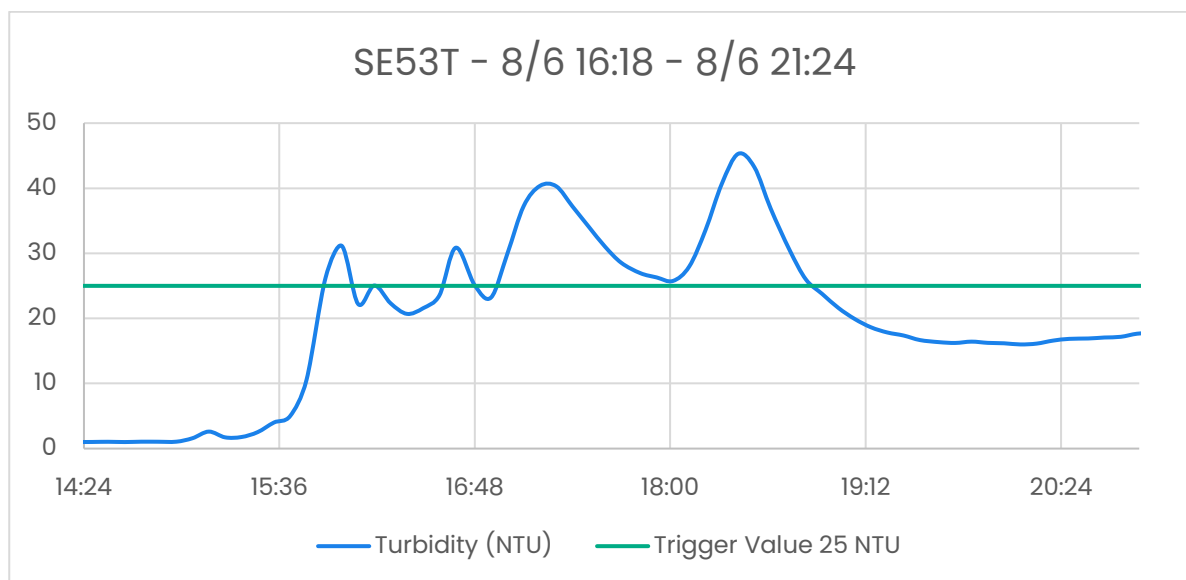
Figure 17 – SE53T 8<sup>th</sup> June

The turbidity exceedance event occurred at monitoring location SE53T between 4:18 PM and 9:24 PM on 8 June 2026. A total of 34.7 mm of rainfall was recorded during the 24 hours preceding the event, providing a plausible mechanism for increased sediment mobilisation and transport within the monitored waterbody. The turbidity graph (Figure 17) displays a response pattern consistent with a genuine turbidity event, with turbidity rising above the 25 NTU trigger value and reaching a peak of approximately 45 NTU before gradually declining towards baseline levels. The substantial rainfall recorded prior to the event is considered the most likely cause of the observed increase in turbidity. The event is characterised by multiple peaks and fluctuations in turbidity, indicating successive pulses of sediment-laden runoff entering the waterbody. The subsequent decline in turbidity levels is consistent with a natural rainfall-driven runoff response and supports the interpretation of the exceedance as a genuine environmental event rather than an instrument anomaly.

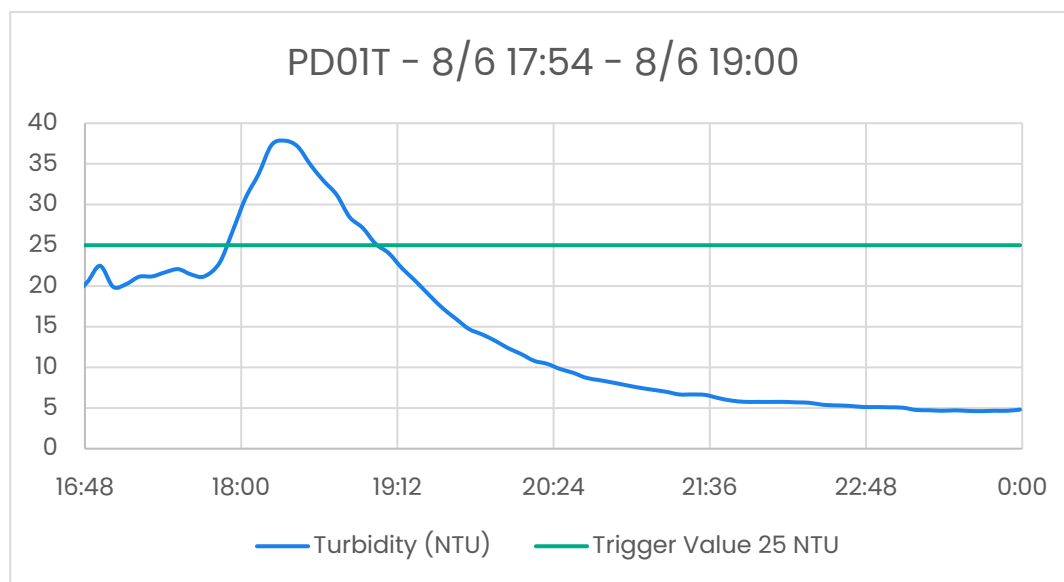
Figure 18 – PD01T 8<sup>th</sup> June

of turbidity levels are characteristic of a rainfall-driven runoff response and support the interpretation of the exceedance as a genuine environmental event rather than an instrument anomaly. The sustained decline in turbidity following the peak indicates the progressive settling and dispersal of suspended sediments within the waterbody

*A monitor and catchment inspection was completed on the 11/06 A catchment inspection was undertaken, where no evidence of mining drainage discharge was found."*

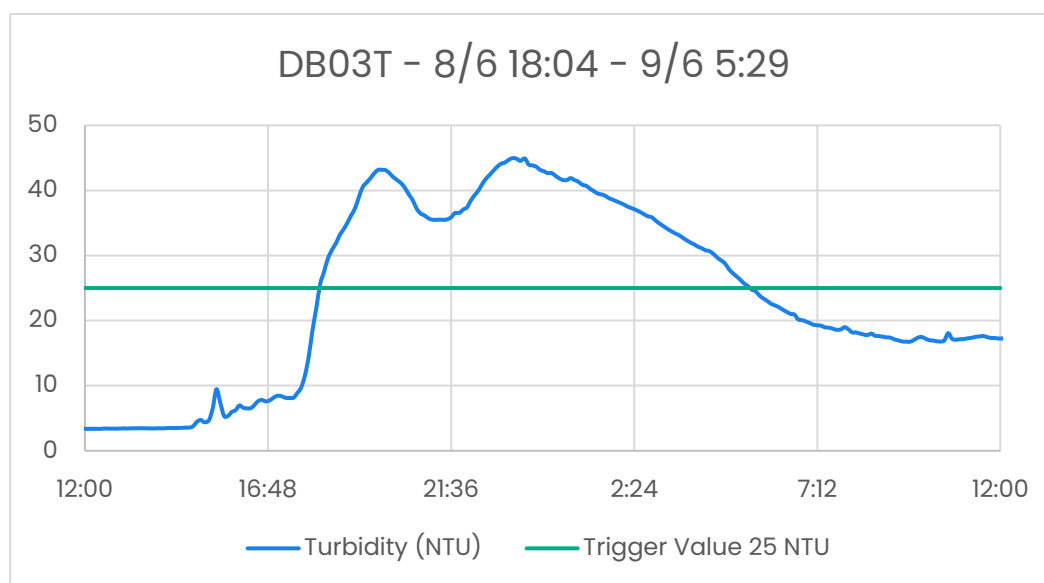
Figure 19 – DB03T 8<sup>th</sup> – 9<sup>th</sup> June

24 hours preceding the event, providing a plausible mechanism for increased sediment mobilisation and transport within the monitored waterbody. The turbidity graph (Figure 19) displays a response pattern consistent with a genuine turbidity event, with turbidity rising above the 25 NTU trigger value and reaching a peak of approximately 45 NTU before gradually declining towards baseline levels. The substantial rainfall recorded prior to the event is considered the most likely cause of the observed increase in turbidity. The event is characterised by multiple peaks during the elevated turbidity period, indicating successive pulses of sediment-laden runoff entering the waterbody. The prolonged recession and gradual return towards ambient conditions are consistent with a natural rainfall-driven response and support the interpretation of the exceedance as a genuine environmental event rather than an instrument anomaly.

*The data trend of the event displays a rapid increase of NTU within 2 hours of 27mm rainfall within 1 hour and 30 minutes. The NTU gradually declined as rainfall slowed. DB03T monitoring site was inspected on the 10/06/2026, and it was noted that the stream was slightly turbid with dark material (~5-10NTU).*

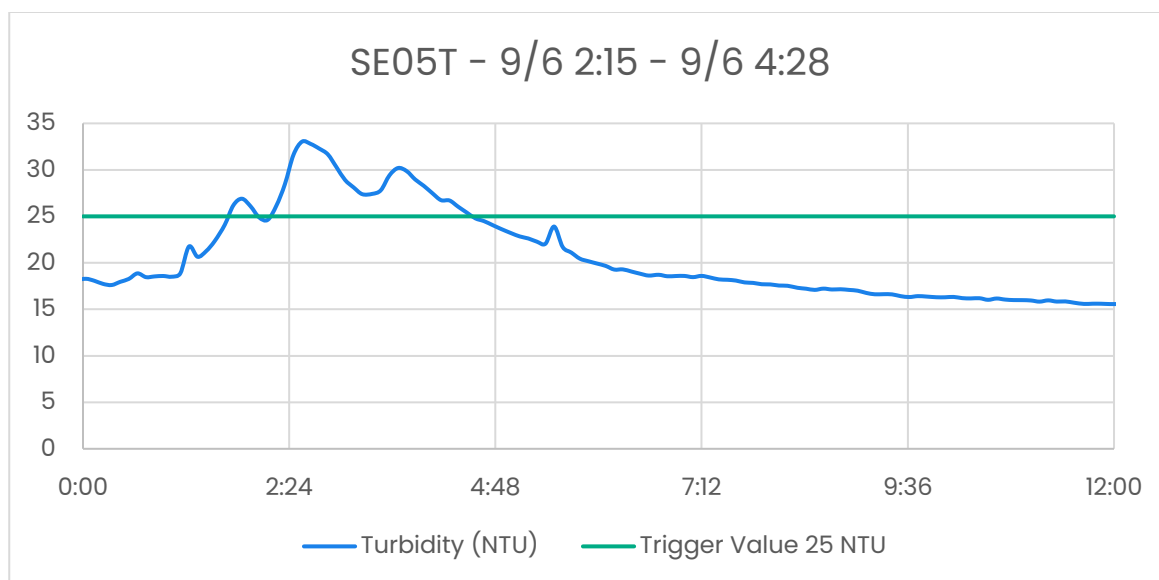
Figure 20 – SE05T 9<sup>th</sup> June

The turbidity exceedance event occurred at monitoring location SE05T between 2:15 AM and 4:28 AM on 9 June 2026. A total of 52.2 mm of rainfall was recorded during the 24 hours preceding the event, providing a plausible mechanism for increased sediment mobilisation and transport within the monitored waterbody. The turbidity graph (Figure 20) displays a response pattern consistent with a genuine turbidity event, with turbidity rising above the 25 NTU trigger value and reaching a peak of approximately 33 NTU before gradually declining towards baseline levels. The significant rainfall recorded prior to the event is considered the most likely cause of the observed increase in turbidity. The event is characterised by a gradual rise in turbidity followed by a sustained recession, consistent with the mobilisation and subsequent settling of suspended sediments associated with rainfall-driven runoff. This response is indicative of a genuine environmental event and does not suggest instrument malfunction.

*event with a gradual increase then decrease of NTU during rain fall. The SE05T catchment was inspected and there was no evidence of mining contribution found.*

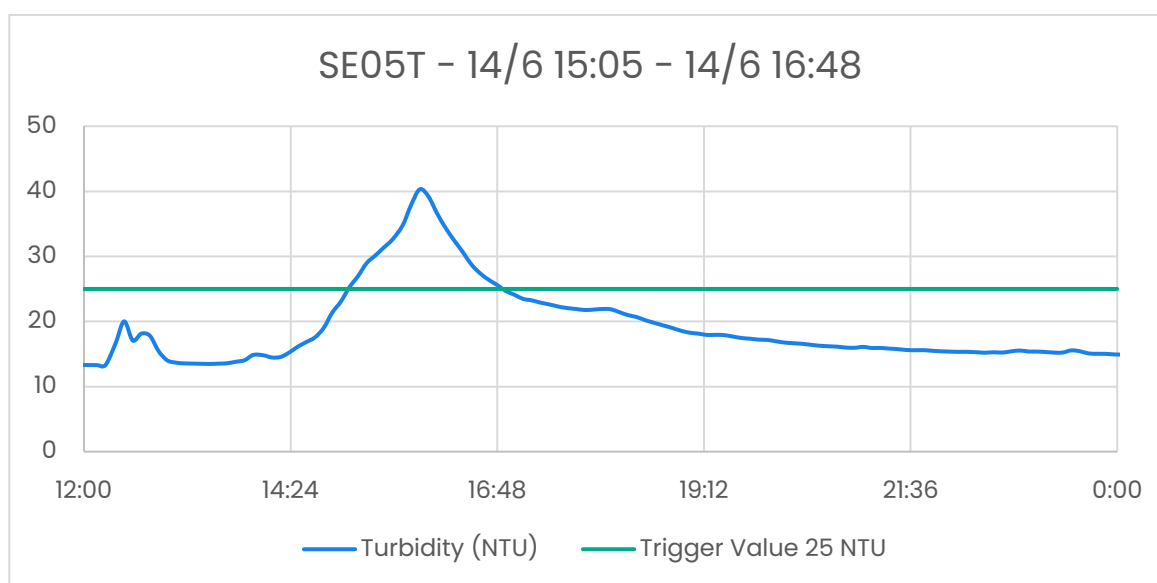
Figure 21 – SE05T 14<sup>th</sup> June

The turbidity exceedance event occurred at monitoring location SE05T between 3:05 PM and 4:48 PM on 14 June 2026. A total of 21.2 mm of rainfall was recorded during the 24 hours preceding the event, providing a plausible mechanism for increased sediment mobilisation and transport within the monitored waterbody. The turbidity graph (Figure 21) displays a response pattern consistent with a genuine turbidity event, with turbidity rising above the 25 NTU trigger value and reaching a peak of approximately 40 NTU before gradually declining towards baseline levels. The rainfall recorded prior to the event is considered the most likely cause of the observed increase in turbidity. The event is characterised by a distinct rise in turbidity followed by a gradual recession, consistent with the mobilisation and subsequent settling of suspended sediments associated with rainfall-driven runoff. This response is indicative of a genuine environmental event and does not suggest instrument malfunction.

*rainfall in the proceeding 24hrs. Analysis of data trend indicates true event as NTU gradually increases with rain fall, then gradually declines with bell curve to below 25NTU. The SE05T catchment was inspected and there was no evidence of mining related contribution found.*

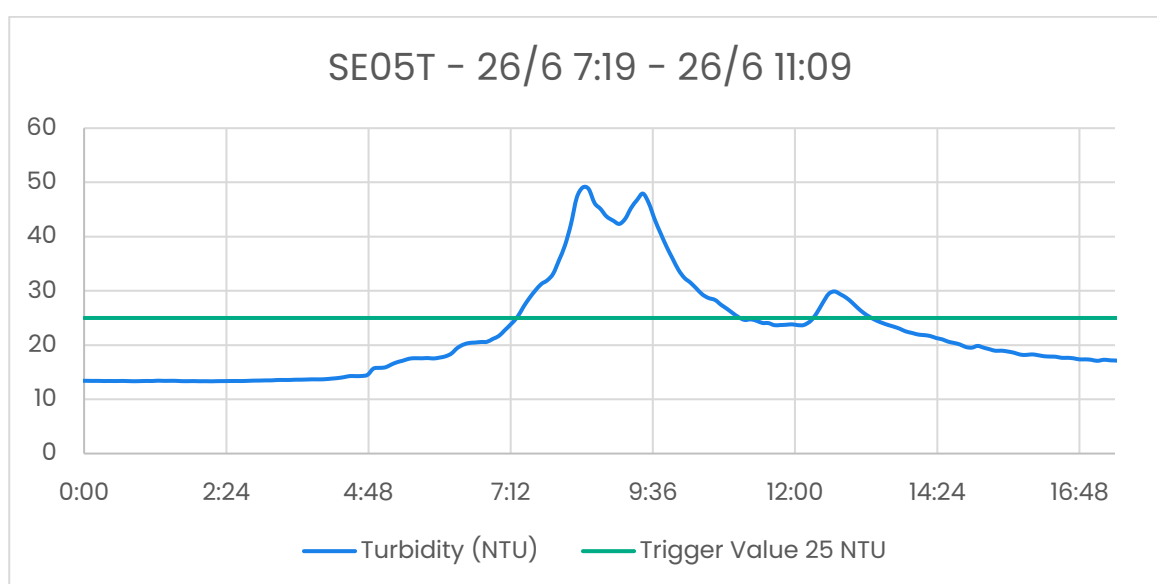
Figure 22 - SE05T 26<sup>th</sup> June

The turbidity exceedance event occurred at monitoring location SE05T between 7:19 AM and 11:09 AM on 26 June 2026. A total of 10.4 mm of rainfall was recorded during the 24 hours preceding the event, providing a plausible mechanism for increased sediment mobilisation and transport within the monitored waterbody. The turbidity graph (Figure 22) displays a response pattern consistent with a genuine turbidity event, with turbidity rising above the 25 NTU trigger value and reaching a peak of approximately 49 NTU before gradually declining towards baseline levels. The rainfall recorded prior to the event is considered the most likely cause of the observed increase in turbidity. The event is characterised by multiple turbidity peaks, indicating successive pulses of sediment-laden runoff entering the waterbody. The subsequent gradual recession in turbidity levels is consistent with the settling and dispersal of suspended sediments following a rainfall-driven runoff event and supports the interpretation of the exceedance as a genuine environmental event rather than an instrument anomaly.

*The SE05T catchment area was inspected, no evidence of mining related contribution was found."*

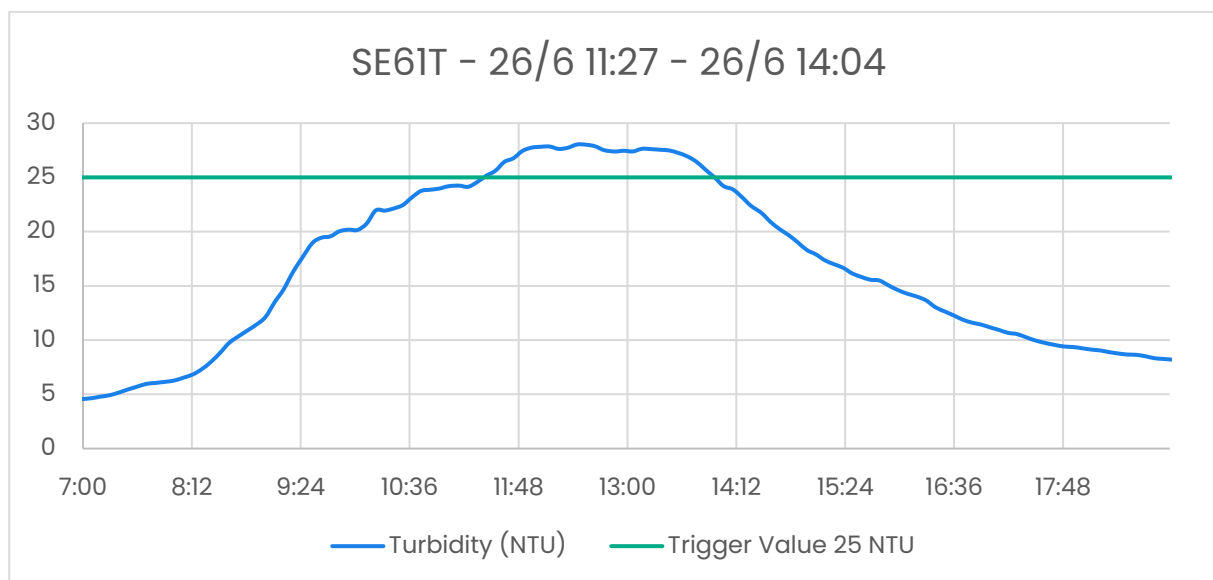
Figure 23 – SE61T 26<sup>th</sup> June

The turbidity exceedance event occurred at monitoring location SE61T between 11:27 AM and 2:04 PM on 26 June 2026. A total of 19.4 mm of rainfall was recorded during the 24 hours preceding the event, providing a plausible mechanism for increased sediment mobilisation and transport within the monitored waterbody. The turbidity graph (Figure 23) displays a response pattern consistent with a genuine turbidity event, with turbidity gradually rising above the 25 NTU trigger value and reaching a peak of approximately 28 NTU before declining towards baseline levels. The rainfall recorded prior to the event is considered the most likely cause of the observed increase in turbidity. The gradual increase and subsequent recession in turbidity are characteristic of a rainfall-driven runoff response, reflecting the mobilisation and settling of suspended sediments within the waterbody. This response is consistent with a genuine environmental event and does not indicate sensor malfunction.

*‘Local turbidity monitor SE61T recorded a turbidity event exceeding 25 NTU for more than 1 hour on 26th June 2026. The event was recorded on 26 June 2026 from 11:27 AM to 2:04 PM, with a duration of 2 hours and 37 minutes. The average turbidity value during the event was 27.11 NTU, with a peak of 28.03 NTU. There was 19.4mm of rainfall recorded in the 24 hours preceding the event. The SE61T monitoring site and associated catchment area was inspected, no evidence of erosion, sediment mobilisation, drainage control failure, or other mining-related contributions to stream turbidity was identified.*

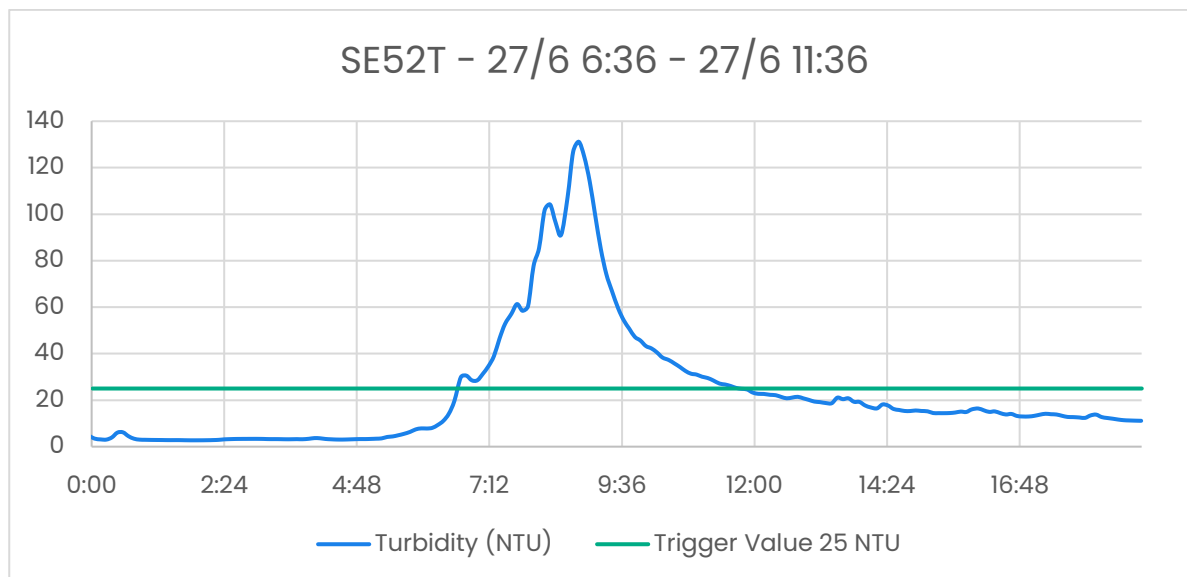
Figure 24 – SE52T 27<sup>th</sup> June

consistent with the settling and dispersal of suspended sediments following a rainfall-driven runoff event and support the interpretation of the exceedance as a genuine environmental event rather than an instrument anomaly.

*The SE52T monitoring site and associated catchment were inspected following the exceedance. No evidence of erosion, sediment mobilisation, drainage control failure, or other mining-related sources of turbidity was identified during the inspection. Based on the site observations and catchment assessment, no evidence of mining-related contributions to the turbidity exceedance was found.*

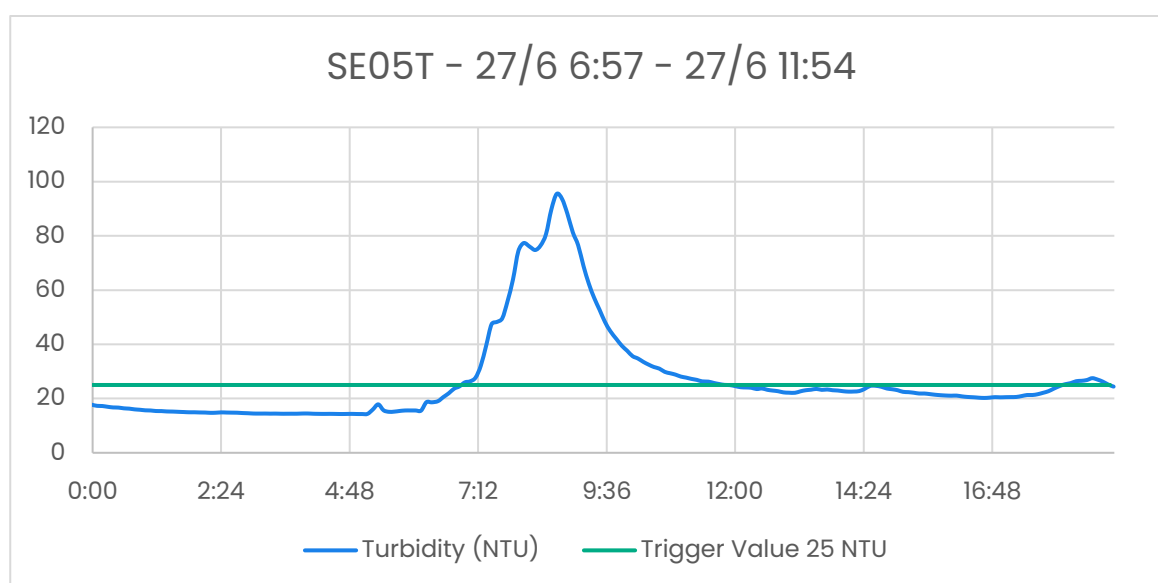
Figure 25 – SE05T 27<sup>th</sup> June

The turbidity exceedance event occurred at monitoring location SE05T between 6:57 AM and 11:54 AM on 27 June 2026. A total of 10.9 mm of rainfall was recorded during the 24 hours preceding the event, providing a plausible mechanism for increased sediment mobilisation and transport within the monitored waterbody. The turbidity graph (Figure 25) displays a response pattern consistent with a genuine turbidity event, with turbidity rising rapidly above the 25 NTU trigger value and reaching a peak of approximately 96 NTU before gradually declining towards baseline levels. The rainfall recorded prior to the event is considered the most likely cause of the observed increase in turbidity. The event is characterised by a sharp increase in turbidity followed by a prolonged recession, indicating the mobilisation and subsequent settling of suspended sediments within the waterbody. This response is consistent with a rainfall-driven runoff event and supports the interpretation of the exceedance as a genuine environmental event rather than an instrument anomaly.

*The SE05T catchment area was inspected, no evidence of mining related contribution was found."*
