# WQMS Data Review

## Huntly Bauxite Mine

JUNE 2026

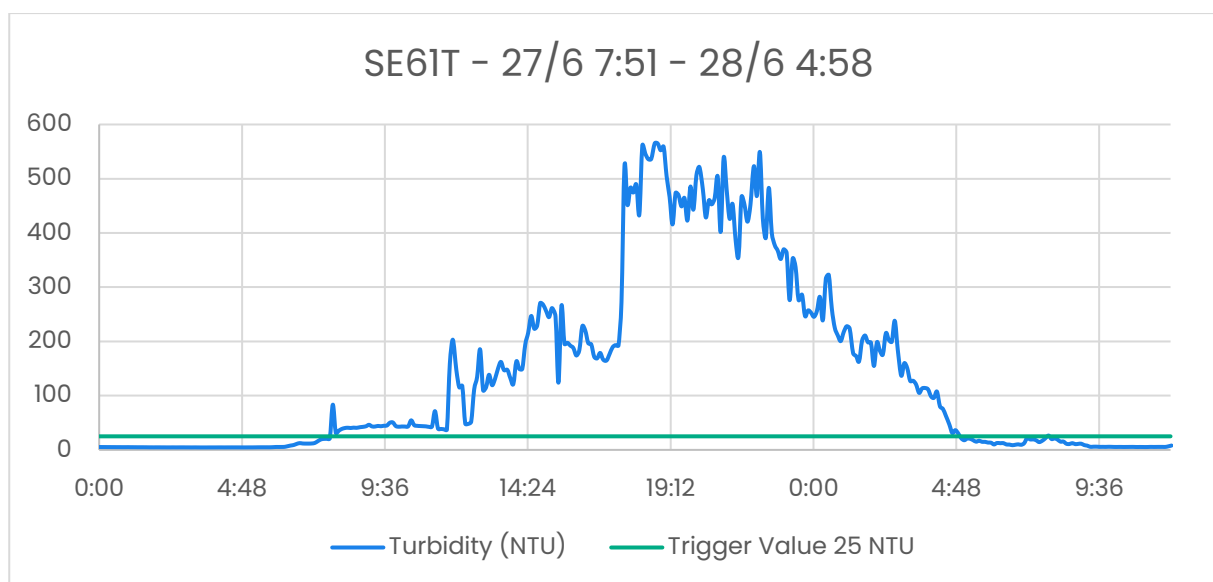
Figure 26 – SE61T 27<sup>th</sup> June

The turbidity exceedance event occurred at monitoring location SE61T between 7:51 AM on 27 June 2026 and 4:58 AM on 28 June 2026. A total of 24.5 mm of rainfall was recorded during the 24 hours preceding the event, providing a plausible mechanism for increased sediment mobilisation and transport within the monitored waterbody. The turbidity graph (Figure 26) displays a response pattern consistent with a genuine turbidity event, with turbidity rising significantly above the 25 NTU trigger value and reaching a peak of approximately 570 NTU before gradually declining towards baseline levels. The rainfall recorded prior to the event is considered the most likely cause of the observed increase in turbidity. The event is characterised by multiple elevated peaks and sustained periods of high turbidity, indicating successive pulses of sediment-laden runoff entering the waterbody. The prolonged recession and gradual return to ambient conditions are consistent with the settling and dispersal of suspended sediments following a substantial rainfall-driven runoff event and support the interpretation of the exceedance as a genuine environmental event rather than an instrument anomaly.

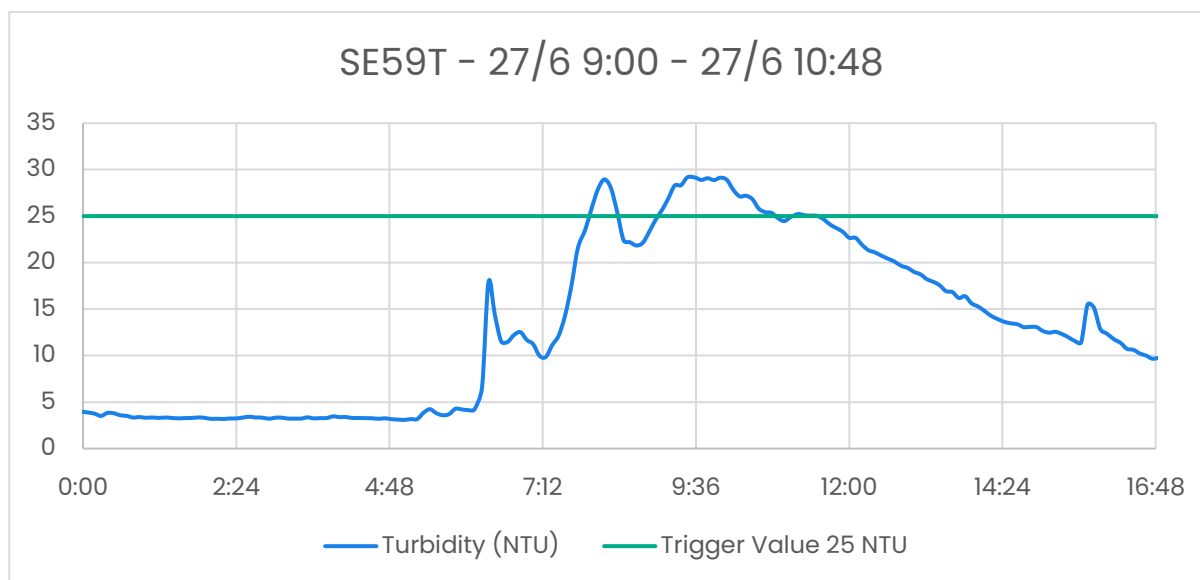
Figure 27 – SE59T 27<sup>th</sup> June

The turbidity exceedance event occurred at monitoring location SE59T between 9:00 AM and 10:48 AM on 27 June 2026. A total of 24.7 mm of rainfall was recorded during the 24 hours preceding the event, providing a plausible mechanism for increased sediment mobilisation and transport within the monitored waterbody. The turbidity graph (Figure 27) displays a response pattern consistent with a genuine turbidity event, with turbidity rising above the 25 NTU trigger value and reaching a peak of approximately 29 NTU before gradually declining towards baseline levels. The rainfall recorded prior to the event is considered the most likely cause of the observed increase in turbidity. The event is characterised by multiple peaks and a sustained period of elevated turbidity, indicating successive inputs of sediment-laden runoff into the waterbody. The gradual recession following the peak is consistent with the settling and dispersal of suspended sediments and supports the interpretation of the exceedance as a genuine environmental event rather than an instrument anomaly.

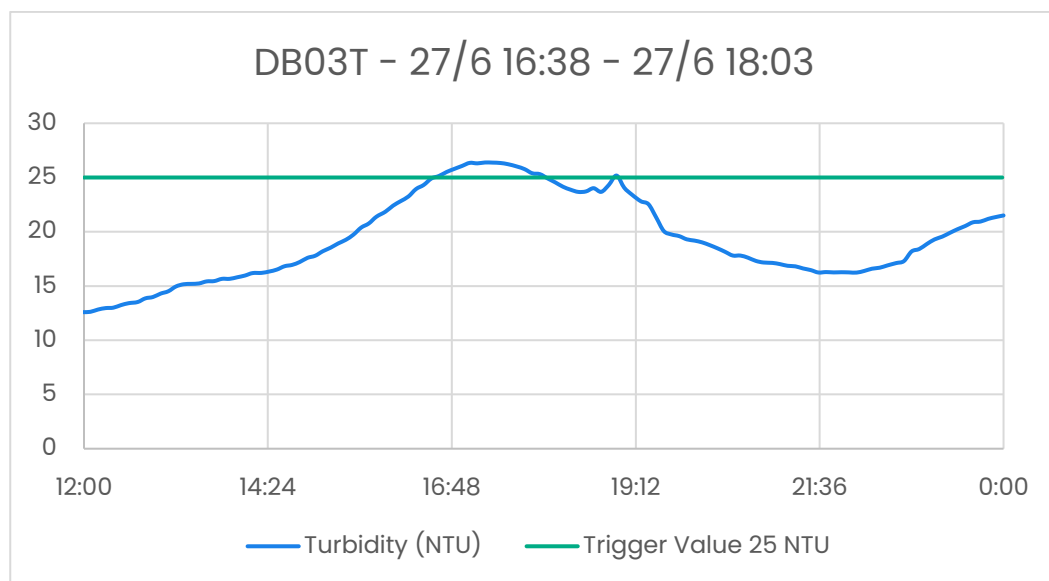
Figure 28 – DB03T 27<sup>th</sup> June

towards baseline levels. The substantial rainfall recorded prior to the event is considered the most likely cause of the observed increase in turbidity. The smooth rise and subsequent recession in turbidity are characteristic of a rainfall-driven runoff response, indicating the mobilisation and subsequent settling of suspended sediments within the waterbody. This response is consistent with a genuine environmental event and does not suggest instrument malfunction.

*The data trend indicates a gradual increase and decrease in turbidity aligned with a rainfall event. DB03T monitoring site was inspected on 29 June 2026. The stream was observed to be slightly turbid and rapidly flowing.*

*The DB03T catchment was inspected, and no evidence of mining related contribution or drainage control failure was identified. "*

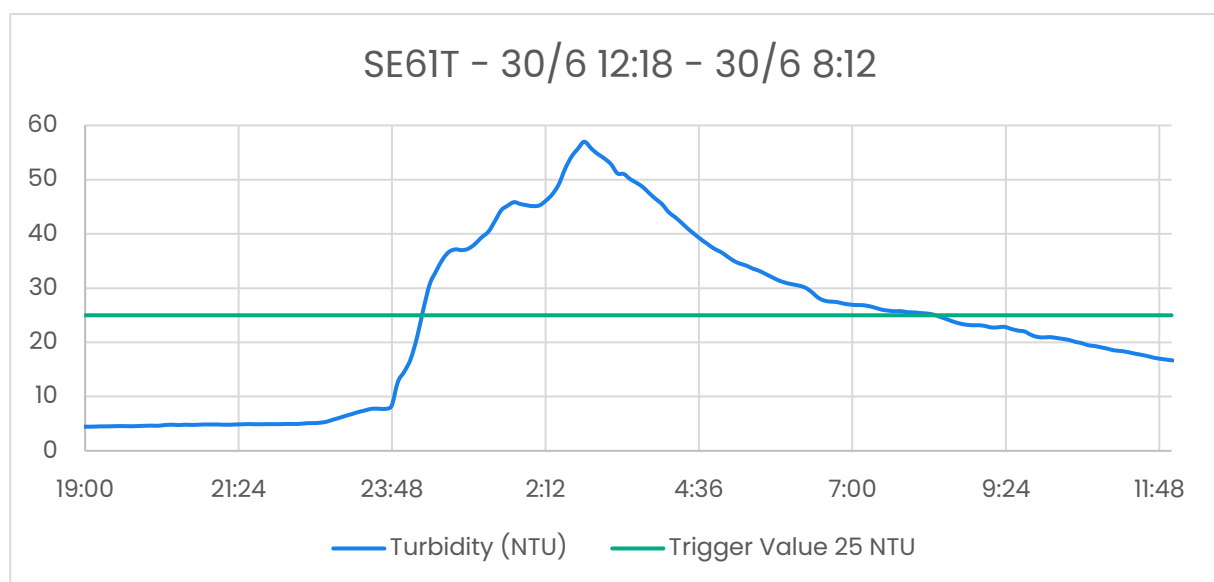
Figure 29 – SE61T 30<sup>th</sup> June

The turbidity exceedance event occurred at monitoring location SE61T between 12:18 AM and 8:12 AM on 30 June 2026. A total of 19.2 mm of rainfall was recorded during the 24 hours preceding the event, providing a plausible mechanism for increased sediment mobilisation and transport within the monitored waterbody. The turbidity graph (Figure 29) displays a response pattern consistent with a genuine turbidity event, with turbidity rising rapidly above the 25 NTU trigger value shortly after midnight and reaching a peak of approximately 57 NTU before gradually declining towards baseline levels. The rainfall recorded prior to the event is considered the most likely cause of the observed increase in turbidity. The event is characterised by a distinct rise in turbidity followed by a prolonged recession, reflecting the mobilisation and subsequent settling of suspended sediments within the waterbody. This response is consistent with a rainfall-driven runoff event and supports the interpretation of the exceedance as a genuine environmental event rather than an instrument anomaly.

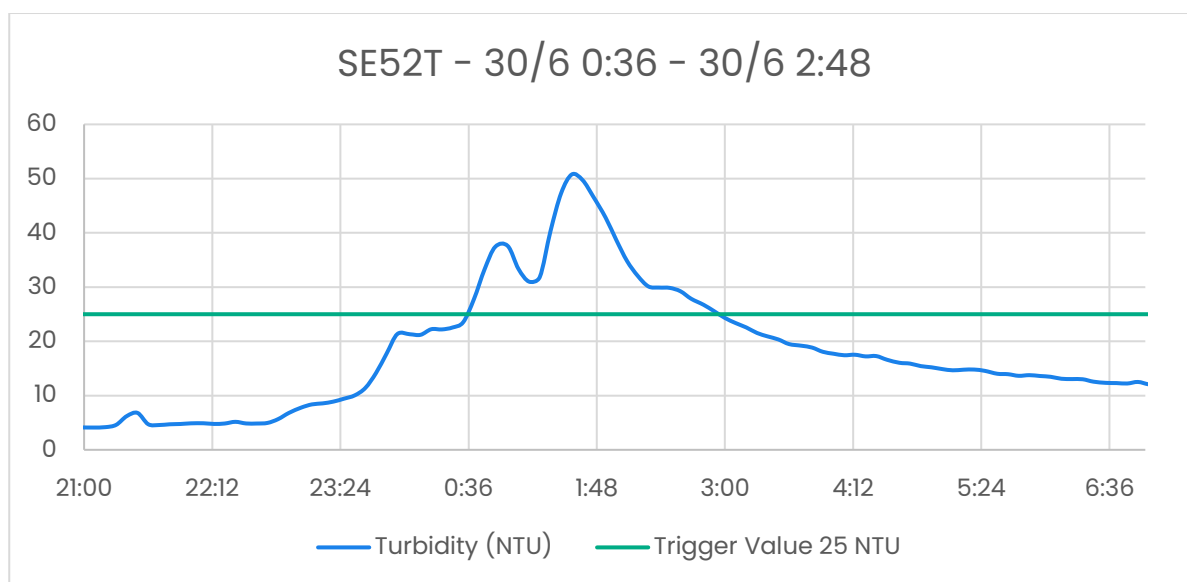
Figure 30 – SE52T 30<sup>th</sup> June

The turbidity exceedance event occurred at monitoring location SE52T between 12:36 AM and 2:48 AM on 30 June 2026. A total of 19.2 mm of rainfall was recorded during the 24 hours preceding the event, providing a plausible mechanism for increased sediment mobilisation and transport within the monitored waterbody. The turbidity graph (Figure 30) displays a response pattern consistent with a genuine turbidity event, with turbidity rising above the 25 NTU trigger value and reaching a peak of approximately 51 NTU before gradually declining towards baseline levels. The rainfall recorded prior to the event is considered the most likely cause of the observed increase in turbidity. The event is characterised by multiple peaks during the rising limb, indicating successive pulses of sediment-laden runoff entering the waterbody. The subsequent gradual recession in turbidity levels is consistent with the settling and dispersal of suspended sediments following a rainfall-driven runoff event and supports the interpretation of the exceedance as a genuine environmental event rather than an instrument anomaly.

*The SE52T monitoring site was inspected on 3 July 2026. Strong stream flow was observed, with organic debris caught around the monitoring equipment; however, the debris was not impacting sensor at the time of inspection.*

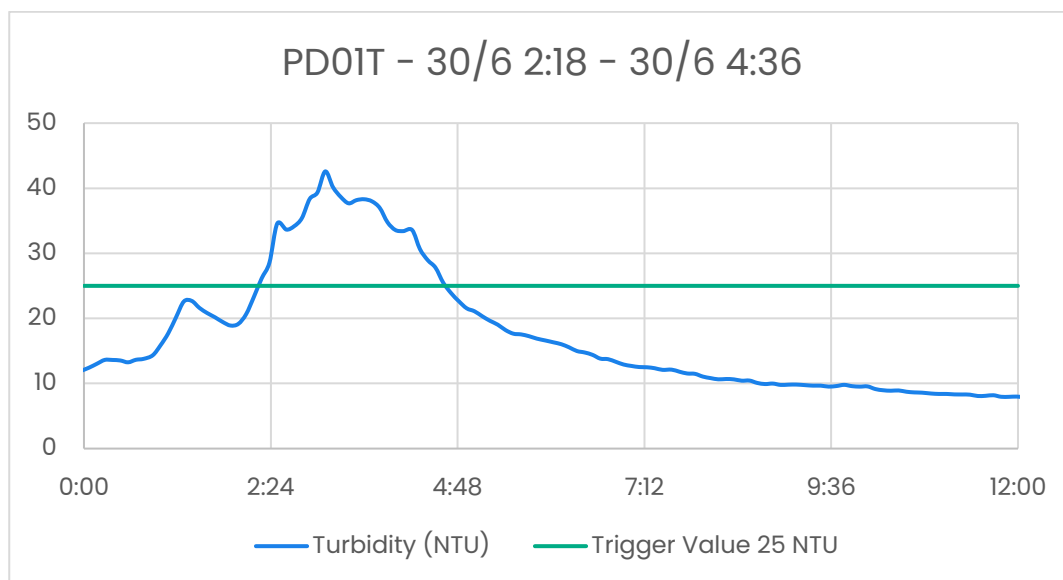
Figure 31 – PD01T 30<sup>th</sup> June

The turbidity exceedance event occurred at monitoring location PD01T between 2:18 AM and 4:36 AM on 30 June 2026. A total of 20.8 mm of rainfall was recorded during the 24 hours preceding the event, providing a plausible mechanism for increased sediment mobilisation and transport within the monitored waterbody. The turbidity graph (Figure 31) displays a response pattern consistent with a genuine turbidity event, with turbidity rising above the 25 NTU trigger value and reaching a peak of approximately 43 NTU before gradually declining towards baseline levels. The rainfall recorded prior to the event is considered the most likely cause of the observed increase in turbidity. The event is characterised by a sustained increase in turbidity, with several minor fluctuations occurring during the rising limb before peak turbidity was reached. The subsequent gradual recession in turbidity levels is consistent with the settling and dispersal of suspended sediments following a rainfall-driven runoff event and supports the interpretation of the exceedance as a genuine environmental event rather than an instrument anomaly.

*The data trend indicates a gradual incline in turbidity values which coincides with increasing rainfall. Turbidity values then gradually decline following cessation of rainfall. The PD01T turbidity monitoring site and associated catchment area were inspected, no evidence of mining related contribution was found.*

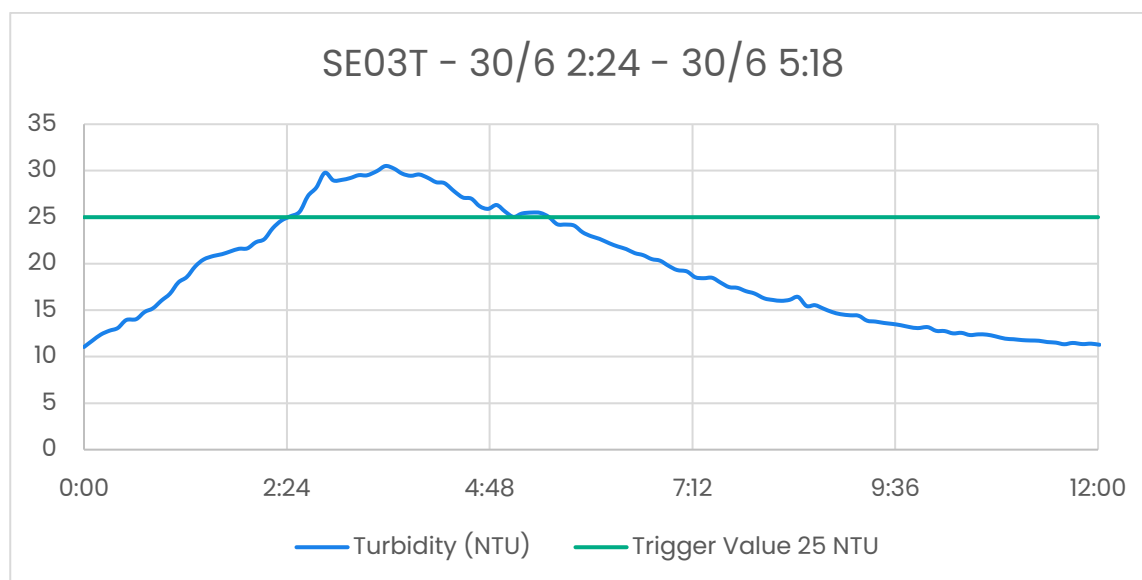
Figure 32 – SE03T 30<sup>th</sup> June

turbidity followed by a gradual recession, indicative of the mobilisation and subsequent settling of suspended sediments associated with rainfall-driven runoff. This response is consistent with a genuine environmental event and does not indicate sensor malfunction.

*Local turbidity monitoring site SE03T recorded a turbidity event exceeding 25 NTU for more than 1 hour on 30 June 2026, from 2:24 AM to 5:18 AM (duration 2 hours 53 minutes). The average turbidity value during the event was 27.85 NTU, with a peak of 30.5 NTU. There was 20.6mm of rainfall recorded in the 24 hours preceding the event. The data trend shows a gradual incline and decline coinciding with rainfall. The SE03T monitoring site and associated catchment area were inspected, no evidence of mining related contribution was found.*

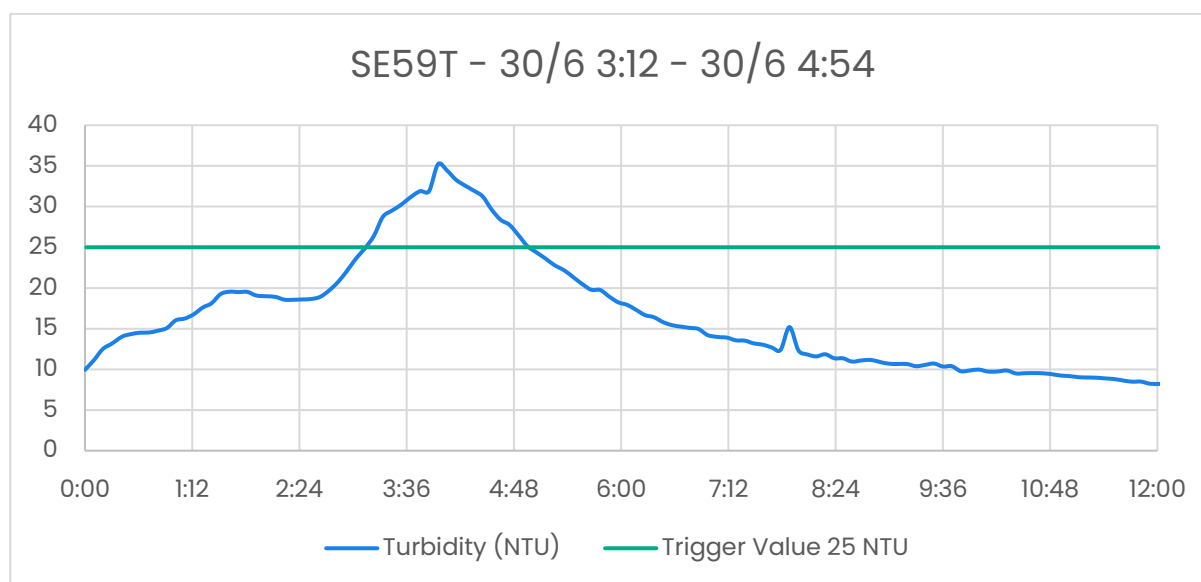
Figure 33 – SE59T 30<sup>th</sup> June

towards baseline levels. The rainfall recorded prior to the event is considered the most likely cause of the observed increase in turbidity. The event is characterised by a steady increase in turbidity followed by a gradual recession, indicative of the mobilisation and subsequent settling of suspended sediments associated with rainfall-driven runoff. This response is consistent with a genuine environmental event and does not indicate sensor malfunction.

*A review of the turbidity data shows a gradual rise in turbidity, corresponding with the measured rainfall trend. Following the peak turbidity value of 35.21 NTU and the cessation of rainfall, turbidity levels gradually declined, returning to pre-event background conditions approximately 15 hours later.*

*The monitoring site was inspected on 2 July 2026. Strong stream flow was observed, with turbulent water and air bubbles surrounding the sensor. Despite these conditions, the stream water remained clear, with a measured turbidity value of 3.2 NTU at the time of inspection.*

*An inspection of the SE59T catchment found no evidence of mining-related contributions to the turbidity event."*

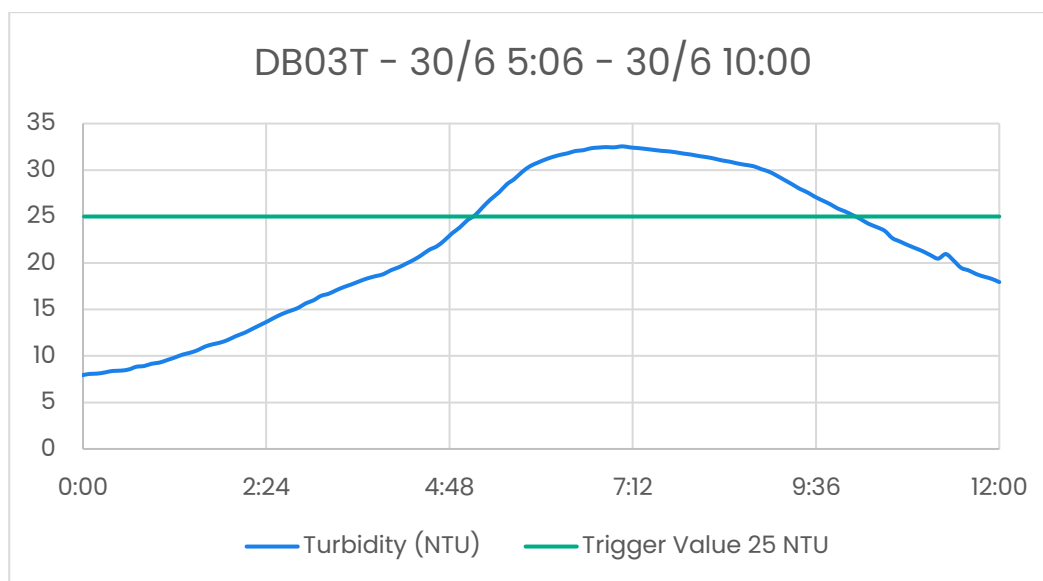
Figure 34 – DB03T 30<sup>th</sup> June

The turbidity exceedance event occurred at monitoring location DB03T between 5:06 AM and 10:00 AM on 30 June 2026. A total of 19.4 mm of rainfall was recorded during the 24 hours preceding the event, providing a plausible mechanism for increased sediment mobilisation and transport within the monitored waterbody. The turbidity graph (Figure 34) displays a response pattern consistent with a genuine turbidity event, with turbidity rising above the 25 NTU trigger value and reaching a peak of approximately 32 NTU before gradually declining towards baseline levels. The rainfall recorded prior to the event is considered the most likely cause of the observed increase in turbidity. The event is characterised by a gradual increase in turbidity followed by a broad peak and a sustained recession, indicative of the mobilisation and subsequent settling of suspended sediments associated with rainfall-driven runoff. This response is consistent with a genuine environmental event and does not indicate sensor malfunction.

*The DB03T monitoring site was inspected on 30 June 2026. At the time of inspection, stream depth had increased and strong stream flow was observed at the downstream bridge crossing. Stream observations indicated moderately turbid conditions, with a measured turbidity value of 20.88 NTU.*

*Inspection of the DB03T catchment commenced on 30 June 2026. Alcoa observed turbid water pooling north of the Warburton rehabilitation stream crossing. Turbid water was also present within several adjacent contour rip lines; however, there was no evidence of rip-line failure. At the time of inspection, a small diversion of stream flow from the main channel was contributing to waterlogging in the area. Further investigations identified a number of potential turbidity sources within the upstream catchment including neighbouring properties and public accessed areas. Subsequent inspections of the Warburton stream crossing found no evidence of failure of rehabilitation drainage controls or containment infrastructure. Based on the available evidence, no drainage incident was verified; however, the specific source of the elevated turbidity could not be conclusively determined. Ongoing catchment monitoring will continue to improve understanding of turbidity contributions within the catchment*
