# Huntly Bauxite Mine – WQMS Data Review

June 2025

Project Details	
Document Title	Huntly Bauxite Mine – WQMS Data Review
Document No	RP24050 HUN WQMS Data Review - June 2025
Project Name	SciDev WQ Data Processing
Project Number	RP24050
Client	SciDev
Client Reference	PO002447

# Willowdale – Water Quality Monitoring System Data Review

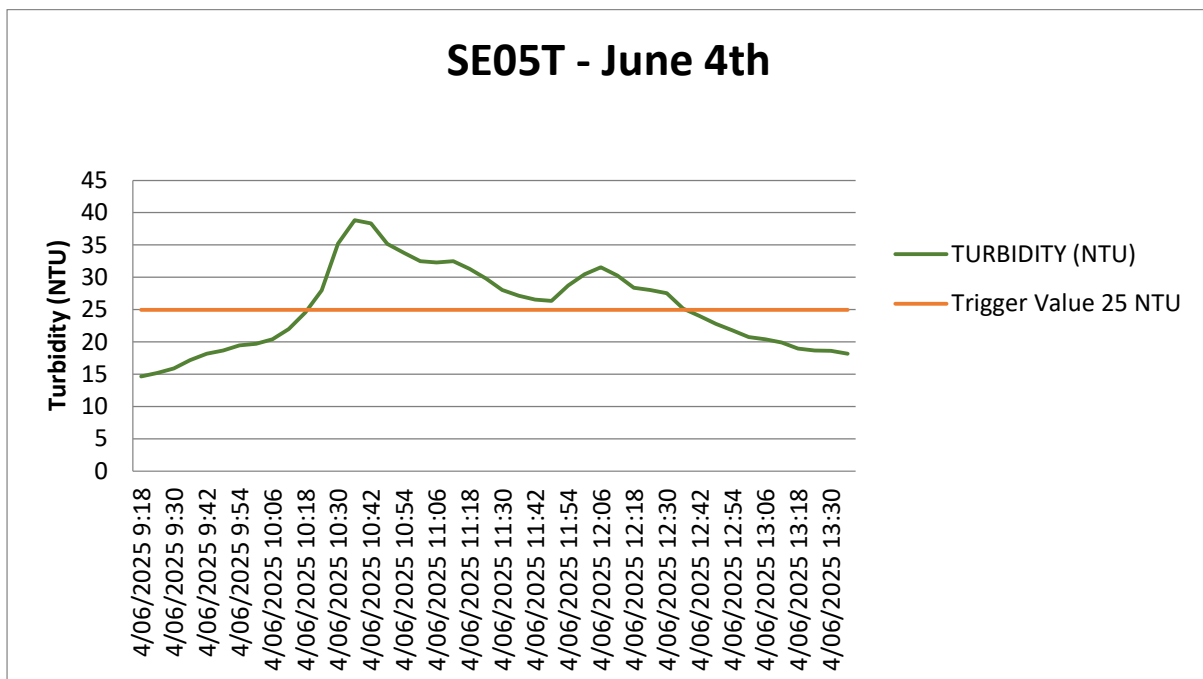
Figure 3 HUN-2506-012

The event, occurring between 10:24 and 12:36 on the 4<sup>th</sup> of June at SE05T exhibits a sharp, incline in turbidity levels followed by a gradual return to baseline levels in a pattern resembling a normal (Gaussian) distribution as shown in Figure 3 below. This criteria is in line with a typical true event as per the 'Turbidity Event Classification Guidelines'.

- Rainfall occurred in the 12 hours prior to the event, an inspection conducted on the 04/06/2025 identified a significant increase in flow however no signs of increased sediment deposits were observed.

*“Site was inspected on 4/06/2025 at approximately 1:45PM, turbidity reading on arrival was 17.83NTU and stream appearance was turbid from the disturbance of stream bed sediment. The sensor was removed and cleaned after which time turbidity values remained at ~16NTU until the next exceedance at 3:21PM as showers increased. Stream depth has risen, and the sensor was positioned higher in the stream profile. SE05T catchment was inspected, a drainage concern was identified at a site of previous concern in Doherty 3. Site inspections identified that repaired contour lines appeared to have experienced minor failure in several places, with no evidence of new material entering the forest and no impact to the stream. No mining-related contributions to the turbidity exceedances were observed during the SE05T catchment inspection.”*

Based on the field notes, and no evidence of increase sediment loading at the site this event is considered a false event. No additional investigation is required.

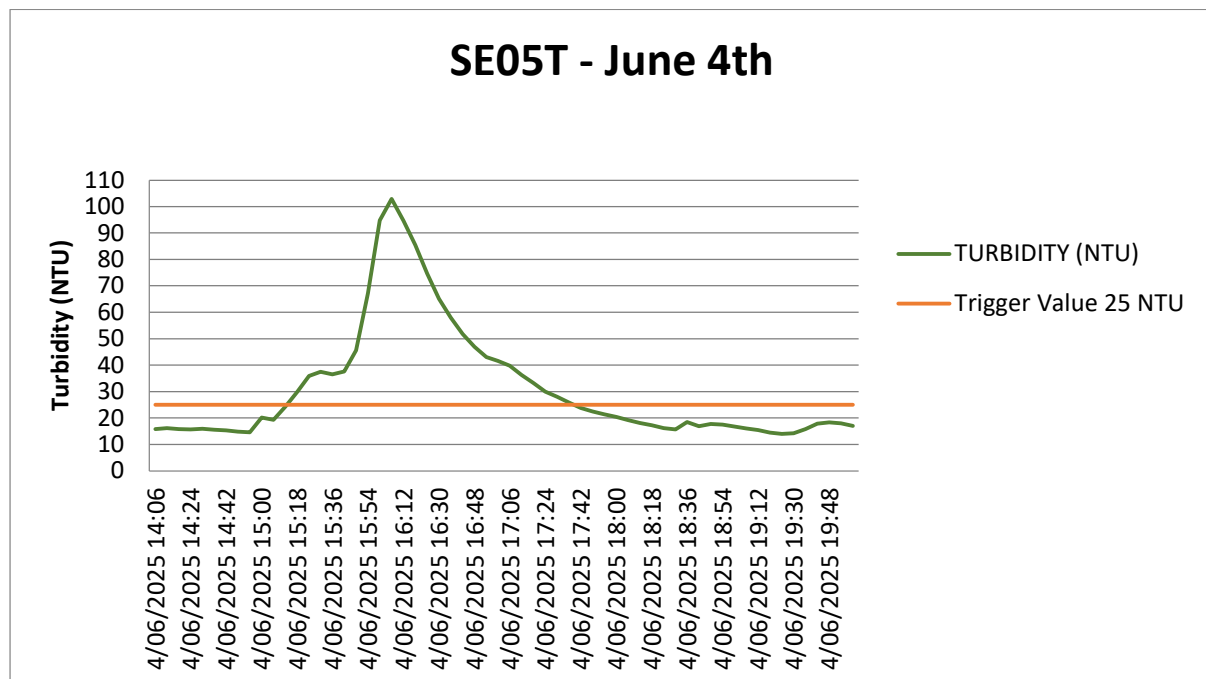
Figure 4 HUN-2506-013

The event, occurring between 15:18 and 17:36 on the 4<sup>th</sup> of June at SE05T exhibits a sharp, incline in turbidity levels followed by a gradual return to baseline levels in a pattern resembling a normal (Gaussian) distribution as shown in Figure 4 below. This criteria is in line with a typical true event as per the ‘Turbidity Event Classification Guidelines’.

- Rainfall occurred in the 12 hours prior to the event, an inspection conducted on the 04/06/2025 identified a significant increase in flow however no signs of increased sediment deposits were observed.

*"Site was inspected on 4/06/2025 at approximately 1:45PM, turbidity reading on arrival were 17.83NTU and stream appearance was turbid from the disturbance of stream bed sediment. The sensor was removed and cleaned after which time turbidity values remained at ~16NTU until the next exceedance at 3:21PM as showers increased. Stream depth has risen, and the sensor was positioned higher in the stream profile. SE05T catchment was inspected, a drainage concern was identified at a site of previous concern in Doherty 3. Site inspections identified that repaired contour lines appeared to have experienced minor failure in several places, with no evidence of new material entering the forest and no impact to the stream. No mining-related contributions to the turbidity exceedances were observed during the SE05T catchment inspection."*

Based on the field notes, and no evidence of increase sediment loading at the site this event is considered a false event. No additional investigation is required.

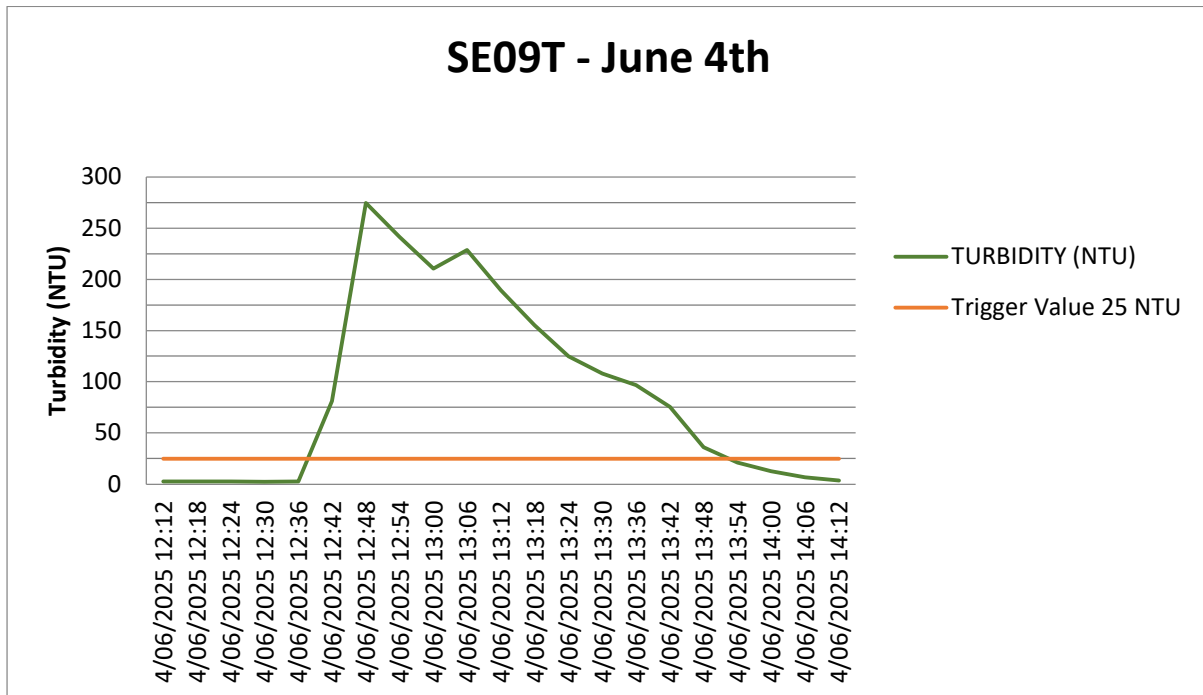
Figure 5 HUN2506-025

The event, occurring between 12:42 and 13:48 on the 4<sup>th</sup> of June at SE09T exhibits a sharp, incline in turbidity levels followed by a gradual return to baseline levels in a pattern resembling a normal (Gaussian) distribution as shown in Figure 5 below. This criteria is in line with a typical true event as per the 'Turbidity Event Classification Guidelines'.

- Rainfall occurred in the 12 hours prior to the event, an inspection conducted on the 06/06/2025 identified organic debris both upstream and downstream.
- No flow was recorded at downstream compliance monitoring location.

*“SE09T monitoring site was inspected on 06/06/2025, first stream flow observed. Water level was very low and only just covering the sensor. The stream was very clear, with no evidence of mining sediment in the stream bed or on the sensor. Turbidity value at the time of inspection was 1.2NTU. Organic debris was visible in the stream bed and around the sensor. Data trend shows turbidity values spiked from 2.5NTU to 80.9NTU within 6 minutes, with a high peak of 274.6NTU likely caused by debris impacting the lens. Downstream compliance turbidity monitor SE10T was still dry on 6/06/2025 and recorded first stream flow on 18/06/2025.”*

Based on the field notes, and no flow recorded at the downstream compliance monitoring location this event is considered a false event. No additional investigation is required.

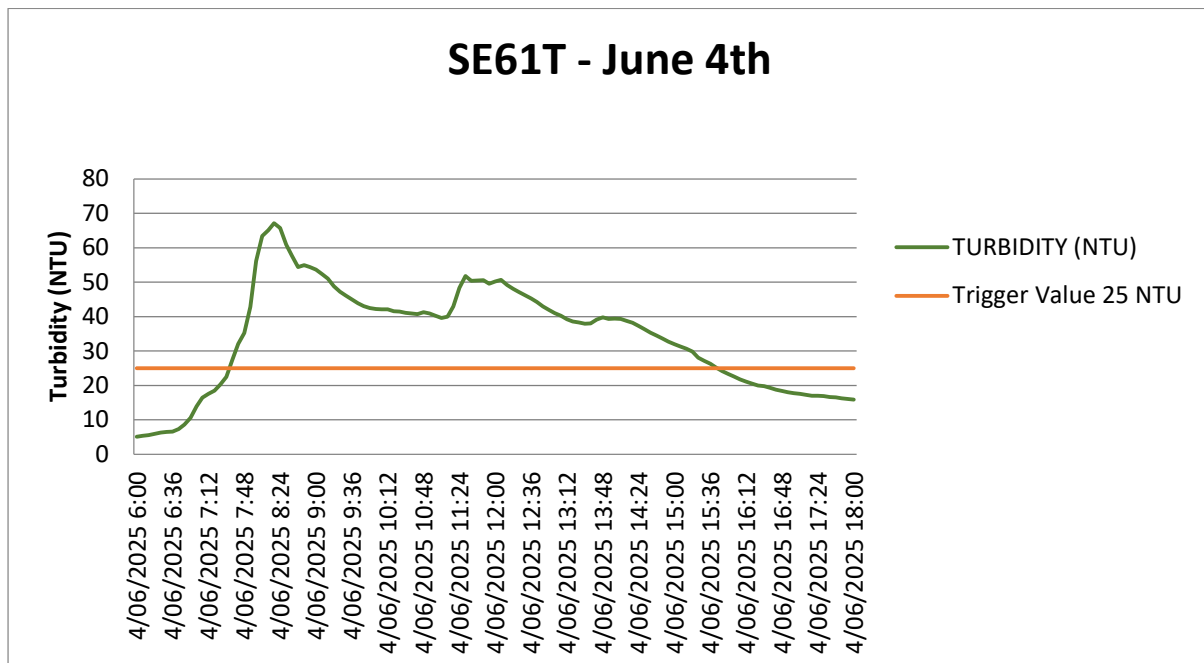
Figure 6 HUN2506-042

The event, occurring between 7:36 and 15:42 on the 4<sup>th</sup> of June at SE61T exhibits a sharp, incline in turbidity levels followed by a gradual return to baseline levels in a pattern resembling a normal (Gaussian) distribution as shown in Figure 6 below. This criteria is in line with a typical true event as per the ‘Turbidity Event Classification Guidelines’.

- Rainfall occurred in the 12 hours prior to the event, an inspection conducted on the 09/06/2025 confirmed the sensor was affected by algal growth, flow conditions were high, and the stream appeared clear with no signs of sediment build up.
- This location has had recurring issues with algal growth causing erroneous data.

*"Data trend shows a gradual incline and decline in turbidity values following 6.4mm of rainfall in the preceding 24 hours. The WQMS was inspected on 9/06/2025; the stream was fast flowing and the sensor was heavily impacted by algae. The placement of this WQMS is scheduled to be relocated due to concerns about false data attributed to moderately high levels of BOD and the year-round presence of red algae. The sensor is situated below a precipice, which is likely to be impacted by higher turbidity as stream flow increases. The SE61T catchment inspection was completed, no mining-related contributions were found. Downstream compliance turbidity monitoring site SE60T is currently dry."*

Based on the field notes, recurring issues at this location and no evidence of increase sediment loading at the site this event is considered a false event. No additional investigation is required.
