Huntly Bauxite Mine – WQMS Data Review

December 2025

Revision: Rev 01

Client: SciDev Pty Ltd

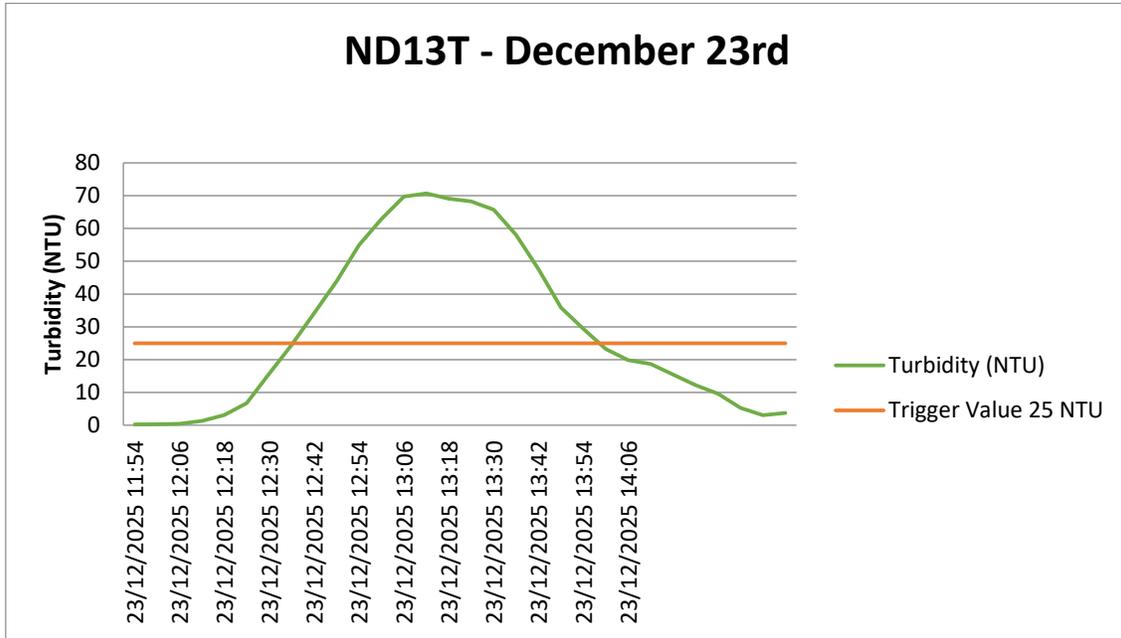
Figure 3 - HUN-2512-014

The events, occurring between 12:42 and 13:54, and 18:36 and 20:24 on the 23rd of December at ND13T do not exhibit the typical sharp, incline in turbidity levels however the initial spike and gradual return to baseline levels in a pattern resembling a normal (Gaussian) distribution as shown in Figure 3 and 4 below which indicates a potential drainage event.

- Two separate exceedance events were recorded on 23/12/2025.
- At the time of inspection, the stream was slowly flowing with low water levels, and the probe was observed positioned above the water line.

“The site was inspected 24/12/2025 due to exceedance notification. The stream was slowly flowing with a low level & on arrival the probe was positioned above the water line. The probe was clean and re-positioned under the water line.”

The two ND13T turbidity exceedances on 23/12/2025 occurred as short-duration elevations above the trigger and were followed by a site inspection that identified the probe sitting above the water line under low-flow, low-water conditions. This operating condition can produce non-representative turbidity readings due to partial exposure and unstable measurement. On this basis, the ND13T exceedances are interpreted as false events driven by low water level/probe exposure, rather than a true turbidity increase in the stream.
