Huntly Bauxite Mine – WQMS Data Review

September 2025

Revision: Rev 02

Project Details	
Document Title	Huntly Bauxite Mine – WQMS Data Review
Document No	RP24050 HUN WQMS Data Review - September 2025
Project Name	SciDev WQ Data Processing
Project Number	RP24050
Client	SciDev
Client Reference	PO002447

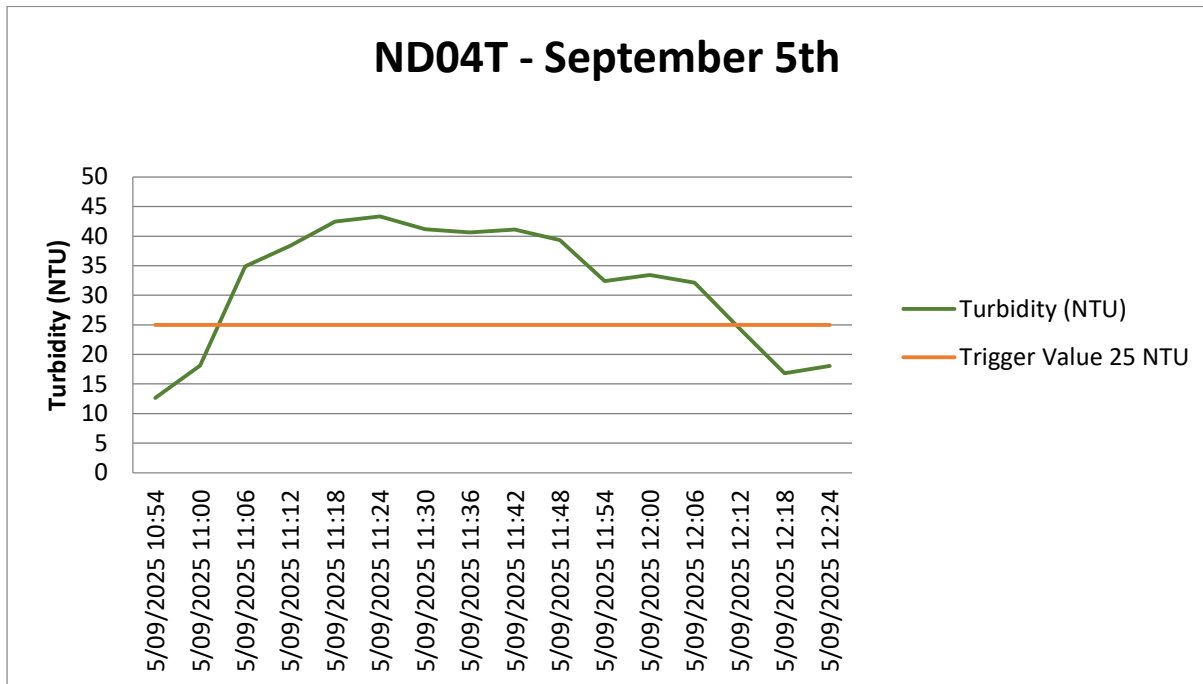
Figure 3 - HUN-2509-001

The event, occurring between 11:06 and 12:06 on the 5th of September at ND04T exhibits a sharp, incline in turbidity levels followed by a gradual return to baseline levels in a pattern resembling a normal (Gaussian) distribution as shown in Figure 3 below. This criteria is in line with a typical true event as per the ‘Turbidity Event Classification Guidelines’.

“ND04T recorded two turbidity events on 5 September 2025 at 11:06 AM and 1:42 PM. Alcoa’s maintenance contractor attended the site between approximately 10:30 AM and 11:30 AM and observed turbid water runoff originating from the adjacent gravel area upstream of the sensor. The contractor inspected the area and confirmed that the stream above the overflow weir, upstream of the gravel area, was clear. Data analysis indicates that both turbidity events declined following subsequent rainfall. These events have been assessed as True but determined to be unrelated to mining activities.”

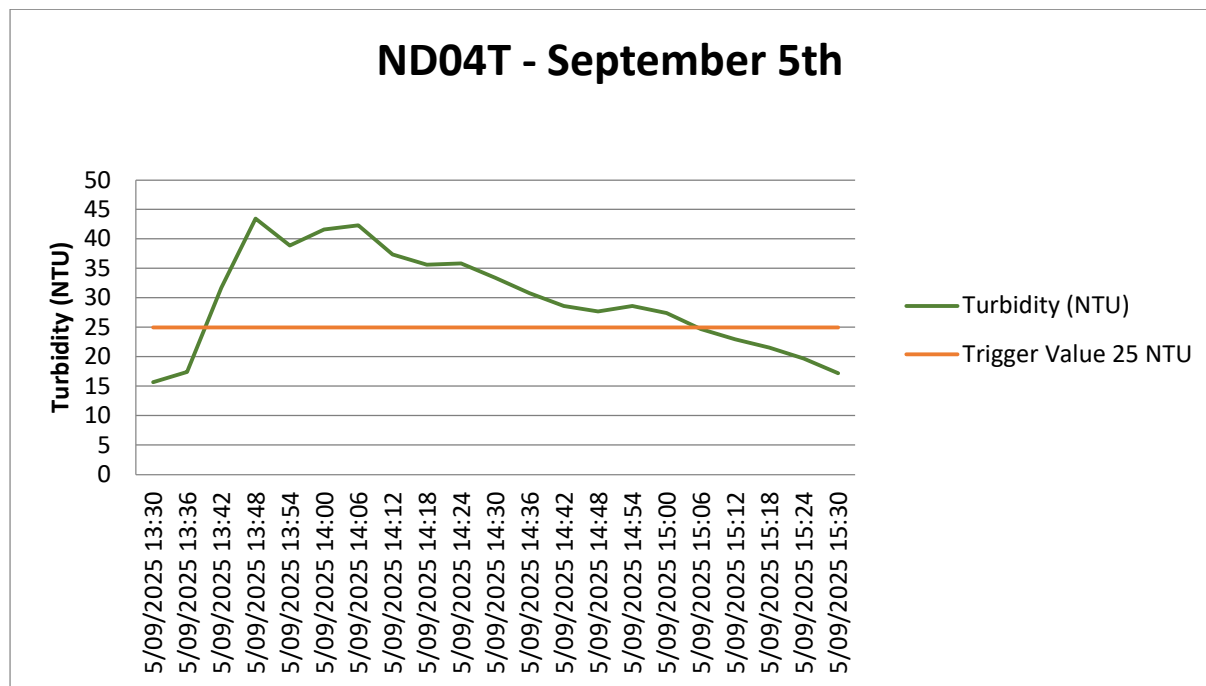
Figure 4 - HUN-2509-002

The event, occurring between 13:42 and 15:00 on the 5th of September at ND04T exhibits a sharp, incline in turbidity levels followed by a gradual return to baseline levels in a pattern resembling a normal (Gaussian) distribution as shown in Figure below. This criteria is in line with a typical true event as per the ‘Turbidity Event Classification Guidelines’.

“ND04T recorded two turbidity events on 5 September 2025 at 11:06 AM and 1:42 PM. Alcoa’s maintenance contractor attended the site between approximately 10:30 AM and 11:30 AM and observed turbid water runoff originating from the adjacent gravel area upstream of the sensor. The contractor inspected the area and confirmed that the stream above the overflow weir, upstream of the gravel area, was clear. Data analysis indicates that both turbidity events declined following subsequent rainfall. These events have been assessed as True but determined to be unrelated to mining activities.”

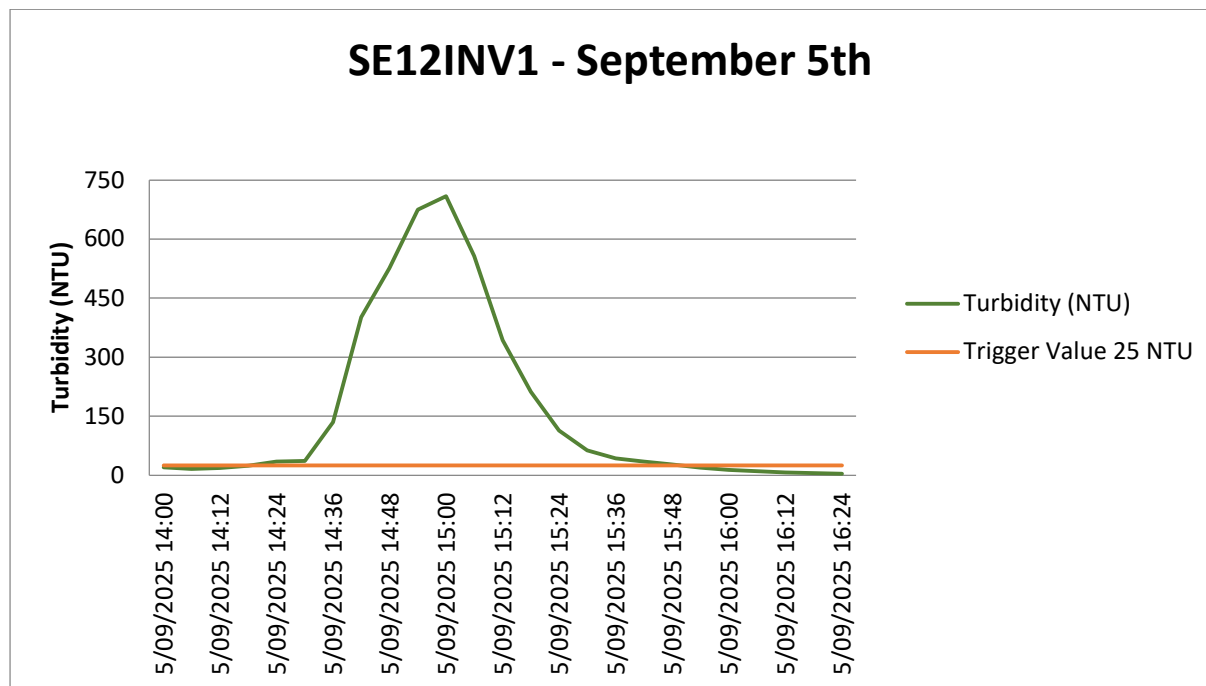
Figure 5 - HUN-2509-021

The event, occurring between 14:24 and 15:48 on the 5th of September at SE12INV1 does not exhibit the typical sharp, incline in turbidity levels however the initial spike and gradual return to baseline levels in pattern resembling a normal (Gaussian) distribution as shown in Figure 5 below indicates a potential drainage event.

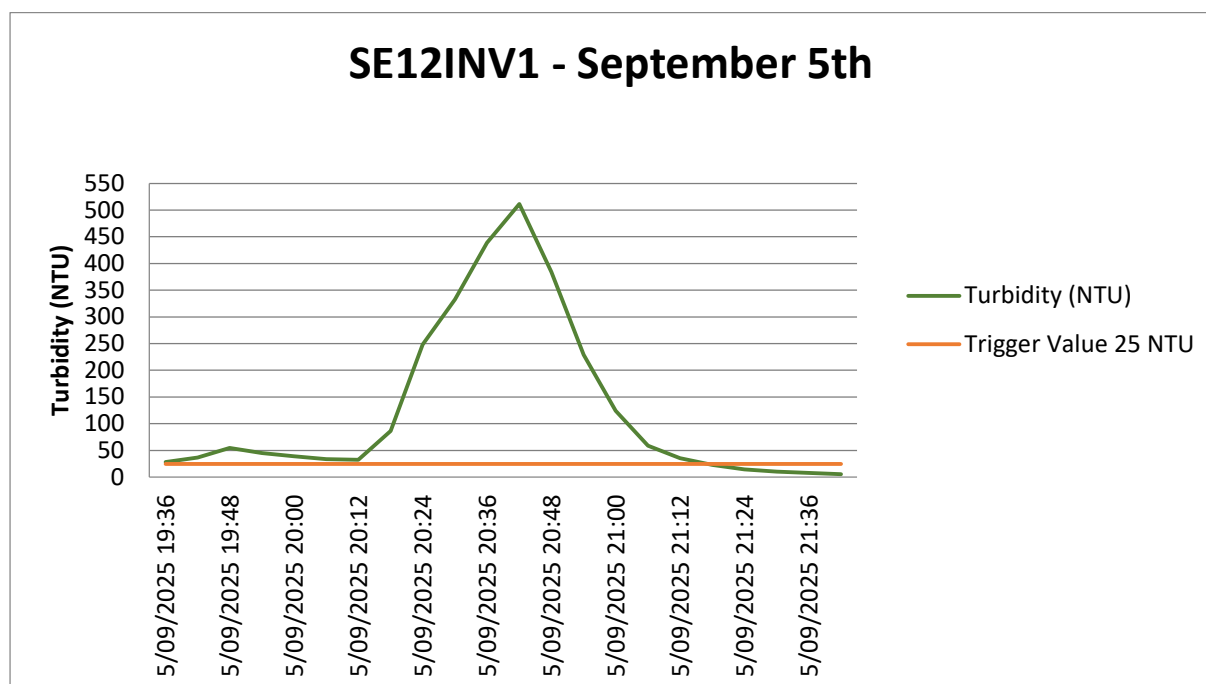
Figure 6 - HUN-2509-022

The event, occurring between 19:30 and 21:12 on the 5th of September at SE12INV1 does not exhibit the typical sharp, incline in turbidity levels however the initial spike and gradual return to baseline levels in pattern resembling a normal (Gaussian) distribution as shown in Figure 6 below indicates a potential drainage event.

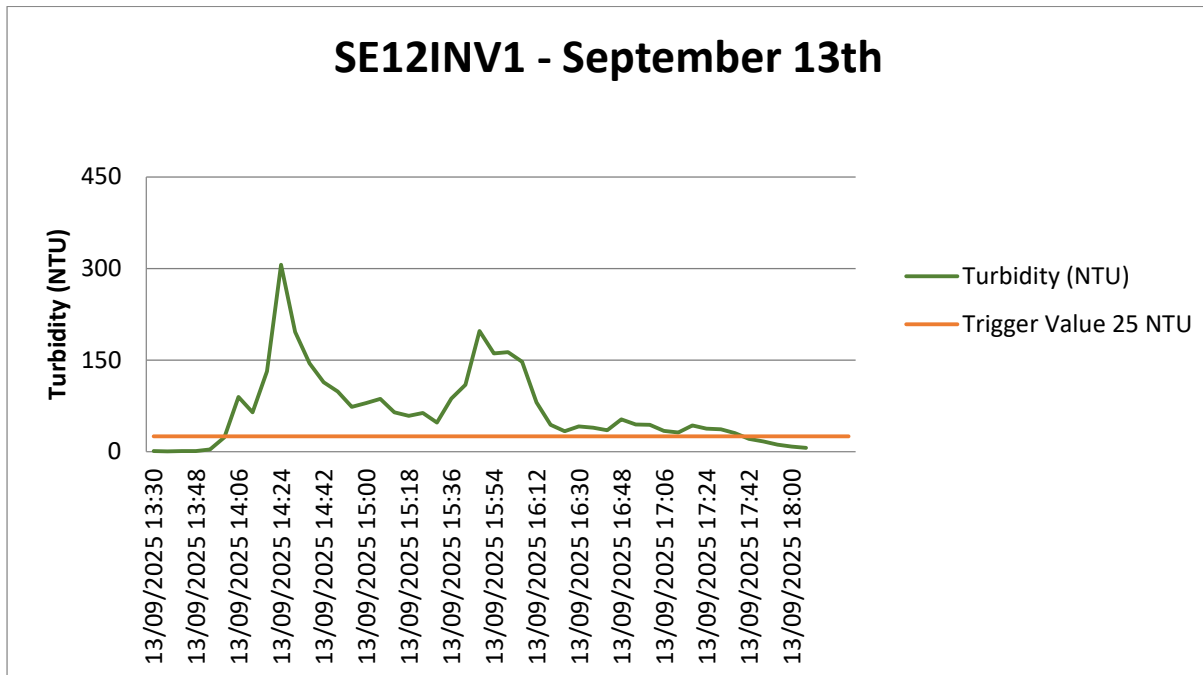
Figure 7 - HUN-2509-023

The event, occurring between 14:06 and 17:36 on the 13th of September at SE12INV1 exhibits a sharp, incline in turbidity levels followed by a gradual return to baseline levels in a pattern resembling a normal (Gaussian) distribution as shown in Figure 7 below. This criteria is in line with a typical true event as per the ‘Turbidity Event Classification Guidelines’.

The DBCA forest track was still noted to be a continuing concern. Wittwer 8, SE12INV forest track and Sump 30 were inspected. No evidence of mining related activity was identified.

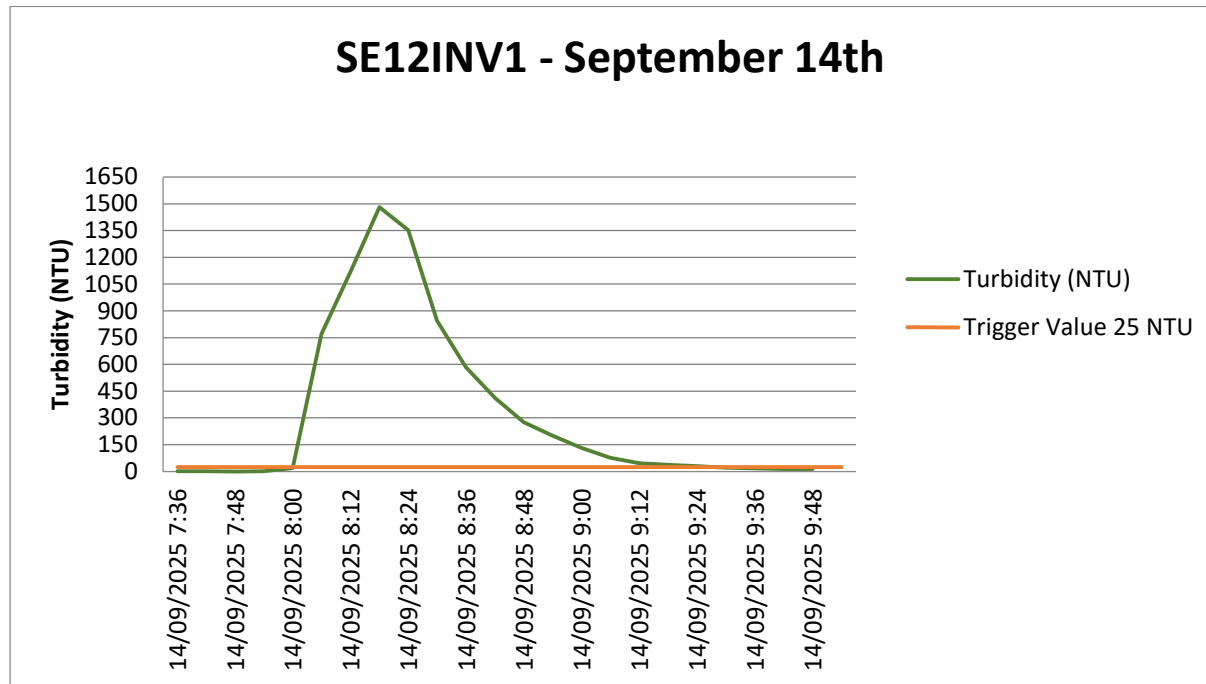
Figure 8 HUN-2509-024

The event, occurring between 8:06 and 9:30 on the 14th of September at SE12INV1 exhibits a sharp, incline in turbidity levels followed by a gradual return to baseline levels in a pattern resembling a normal (Gaussian) distribution as shown in Figure 8 below. This criteria is in line with a typical true event as per the ‘Turbidity Event Classification Guidelines’.

The DBCA forest track was still noted to be a continuing concern. Wittwer 8, SE12INV forest track and Sump 30 were inspected. No evidence of mining related activity was identified.

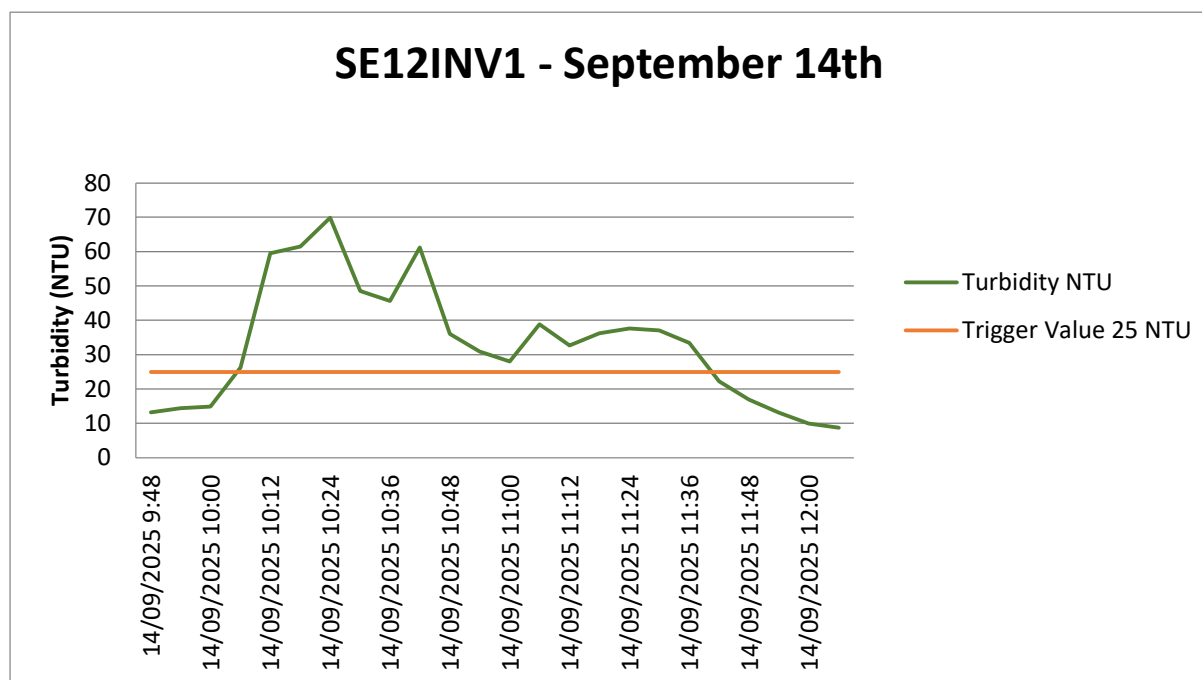
Figure 9 - HUN-2509-025

The event, occurring between 10:06 and 11:36 on the 14th of September at SE12INV1 exhibits a sharp, incline in turbidity levels followed by a gradual return to baseline levels in a pattern resembling a normal (Gaussian) distribution as shown in Figure 9 below. This criteria is in line with a typical true event as per the 'Turbidity Event Classification Guidelines'.

The DBCA forest track was still noted to be a continuing concern. Wittwer 8, SE12INV forest track and Sump 30 were inspected. No evidence of mining related activity was identified.

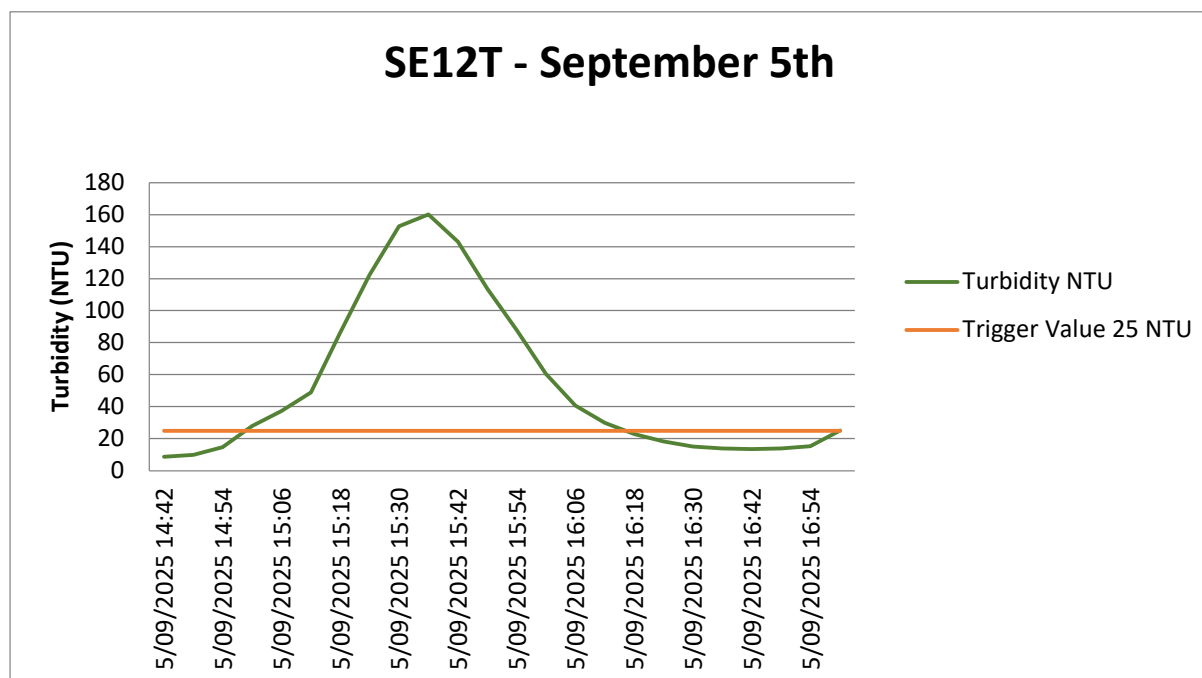
Figure 10 - HUN-2509-026

The event, occurring between 15:00 and 16:12 on the 5th of September at SE12T does not exhibit the typical sharp, incline in turbidity levels however the initial spike and gradual return to baseline levels in pattern resembling a normal (Gaussian) distribution as shown in Figure 10 below indicates a potential drainage event.

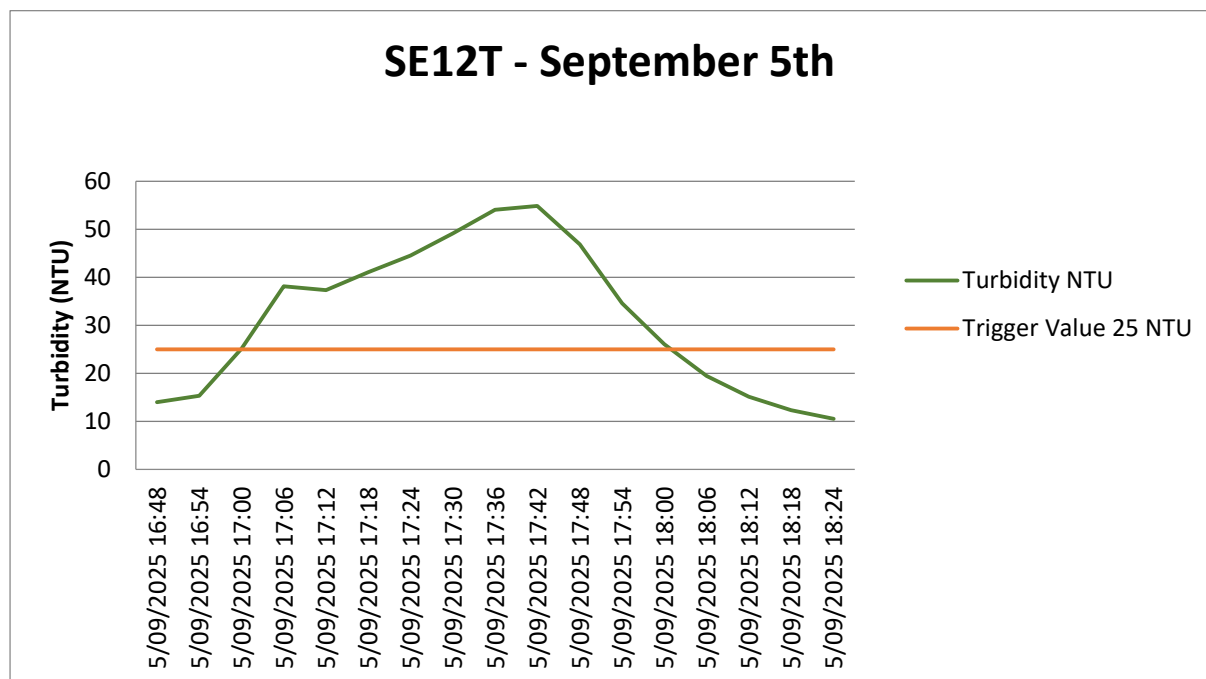
Figure 11 - HUN2509-027

The event, occurring between 17:00 and 18:00 on the 5th of September at SE12T does not exhibit the typical sharp, incline in turbidity levels however the initial spike and gradual return to baseline levels in pattern resembling a normal (Gaussian) distribution as shown in Figure 11 below indicates a potential drainage event.

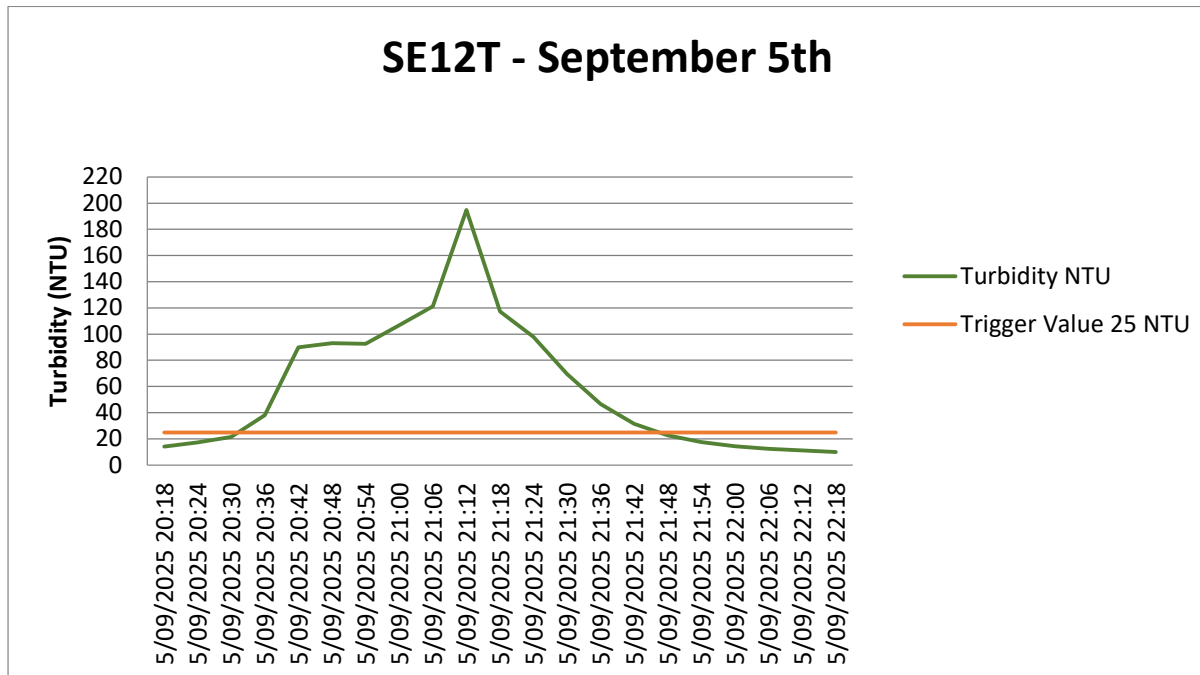
Figure 12 - HUN-2509-028

The event, occurring between 20:36 and 21:42 on the 5th of September at SE12T does not exhibit the typical sharp, incline in turbidity levels however the initial spike and gradual return to baseline levels in pattern resembling a normal (Gaussian) distribution as shown in Figure 12 below indicates a potential drainage event.

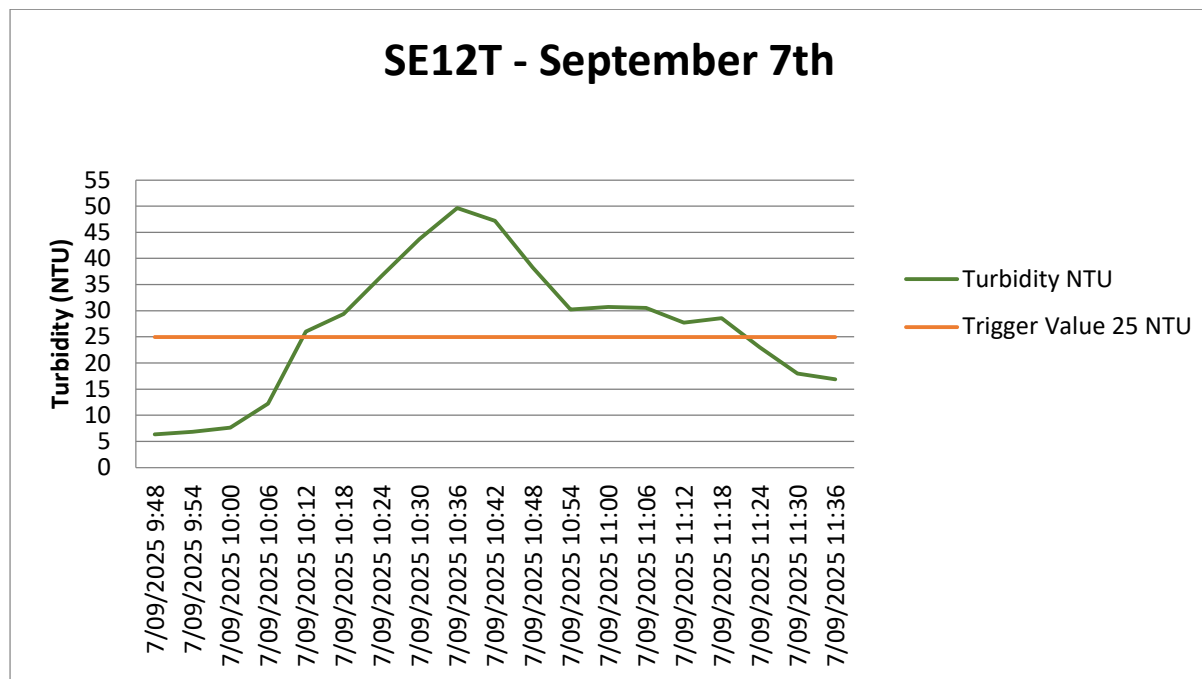
Figure 13 - HUN-2509-029

The event, occurring between 10:12 and 11:18 on the 7th of September at SE12T does not exhibit the typical sharp, incline in turbidity levels however the initial spike and gradual return to baseline levels in pattern resembling a normal (Gaussian) distribution as shown in Figure 13 below indicates a potential drainage event.

observed. The SE12T catchment area was inspected, no evidence of mining related contribution to the exceedances was found.”

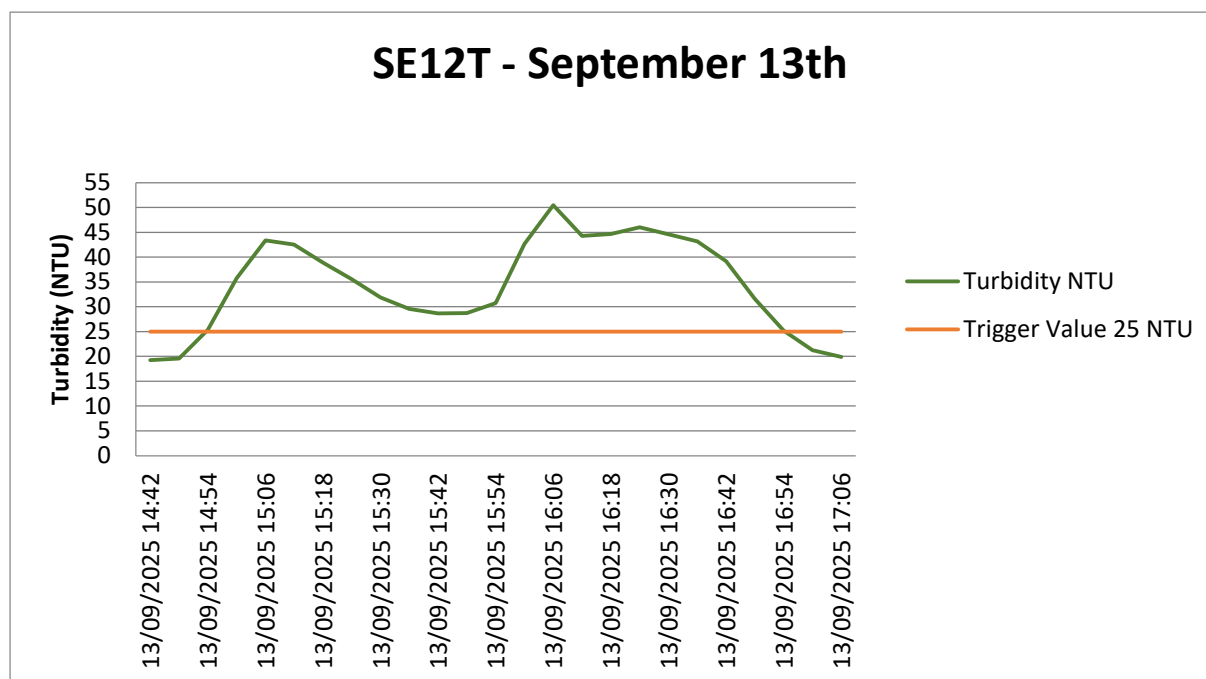
Figure 14 - HUN-2509-030

The event, occurring between 14:54 and 16:54 on the 13th of September at SE12T does not exhibit the typical sharp, incline in turbidity levels however the initial spike and gradual return to baseline levels in pattern resembling a normal (Gaussian) distribution as shown in Figure 14 below indicates a potential drainage event.

monitoring site was inspected on 15/09/2025, following another recorded exceedance on 14/09/2025. The stream was clear at the time of inspection, however the sensor (which was positioned vertically in the stream profile, inside a flow cell) was impacted by the stream bed and measuring 7.03NTU. Upstream investigation monitor SE12INV, which was installed within the SE12T catchment in 2024, was inspected on 16/09/2025. The stream was clear at the time of inspection, however evidence of the adjacent forest track erosion impacting the stream (as previously reported) was observed. The SE12T catchment area was inspected, no evidence of mining related contribution to the exceedances was found.”

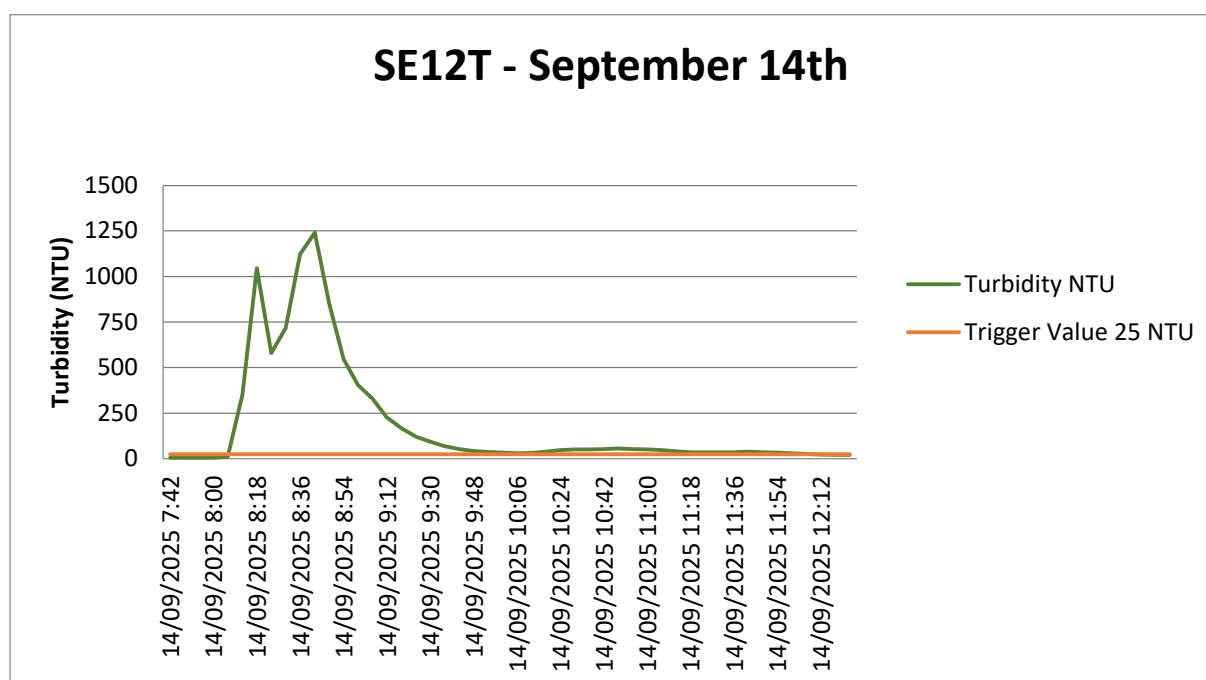
Figure 15 - HUN-2509-031

The event, occurring between 8:12 and 12:06 on the 14th of September at does not exhibit the typical sharp, incline in turbidity levels however the initial spike and gradual return to baseline levels in pattern resembling a normal (Gaussian) distribution as shown in Figure 15 below indicates a potential drainage event.

An inspection of the SE12T catchment area found no evidence of mining-related contributions to the turbidity exceedances.”

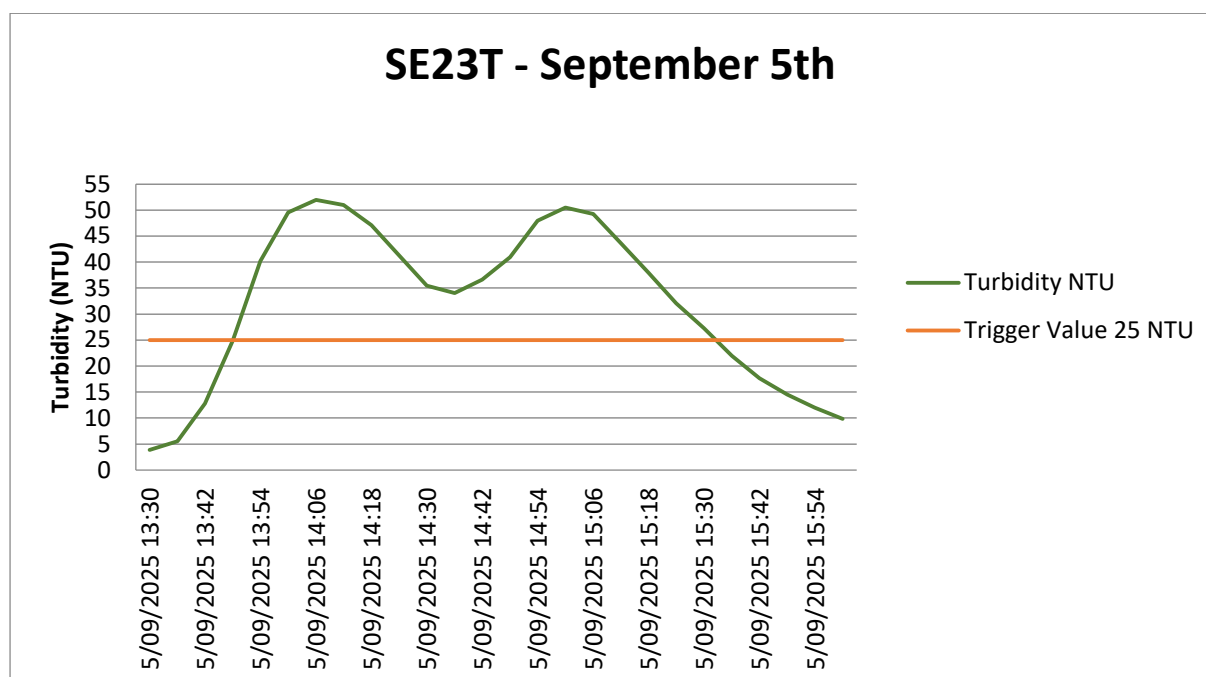
Figure 16 - HUN-2509-064

The event, occurring between 13:54 and 15:30 on the 5th of September at SE23T does not exhibit the typical sharp, incline in turbidity levels however the initial spike and gradual return to baseline levels in pattern resembling a normal (Gaussian) distribution as shown in Figure 16 below indicates a potential drainage event.

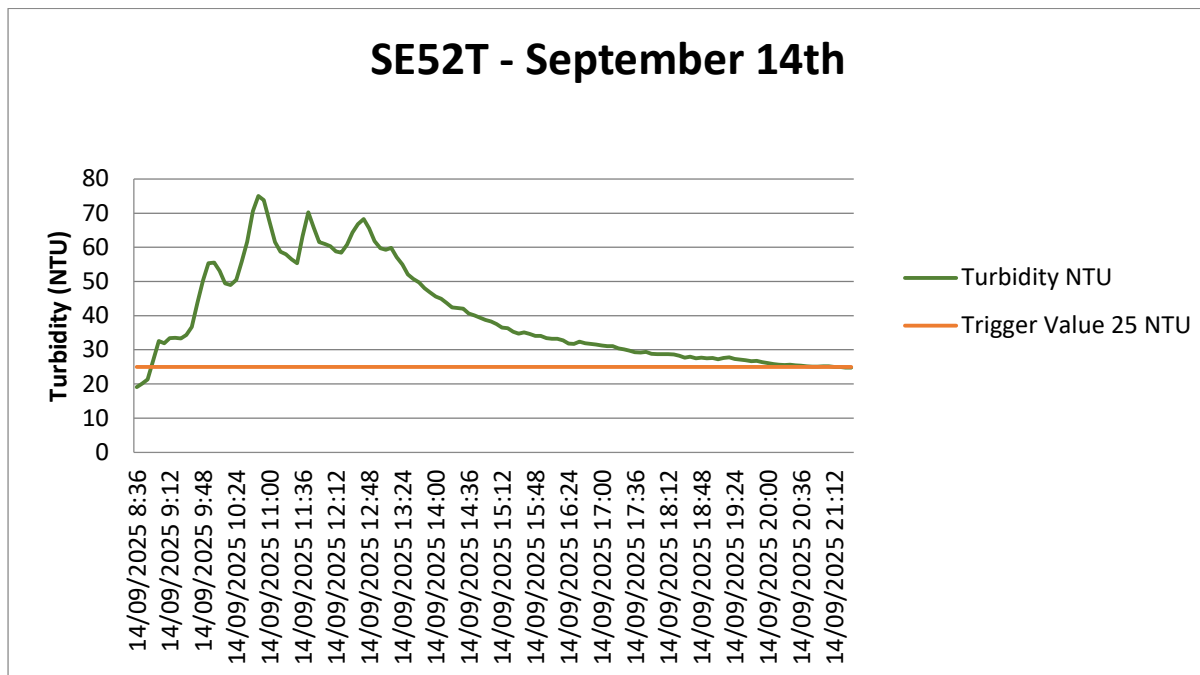
Figure 17 - HUN-2509-076

The event, occurring between 8:54 and 21:06 on the 14th of September at SE52T exhibits a sharp, incline in turbidity levels followed by a gradual return to baseline levels in a pattern resembling a normal (Gaussian) distribution as shown in Figure 17 below. This criteria is in line with a typical true event as per the ‘Turbidity Event Classification Guidelines’.

“Compliance turbidity monitoring site SE52T recorded a turbidity event exceeding 25 NTU for >1 hour on 14 September 2025 during a 30.4mm rain event. The event was recorded from 8:54 PM to 9:06 PM, with a duration of 12 hours and 12 minutes. The SE52T site was inspected 16 September 2025 which noted the stream was flowing and clear, however, the sensor and float switch were heavily impacted by debris. The average turbidity value during the event was 37.2 NTU, with a peak of 56.13 NTU. Data analysis indicates a rise in stream turbidity coinciding with a period of intense rainfall, indicating this is a true turbidity event and an inspection of the SE52T catchment was completed on the 16 September 2025, including surrounding pits, rehabilitation zones, tracks and sumps. No mining related contributions to the turbidity exceedance were found.”

This event coincided with rainfall and was characterised by a rapid rise in turbidity, followed by a return to background levels despite ongoing rain. Inspections of the surrounding areas found no evidence of mining-related contributions. On this basis, the event is assessed as a True, non-mining-related event, most likely due to catchment runoff mobilising sediment upstream of the monitor.

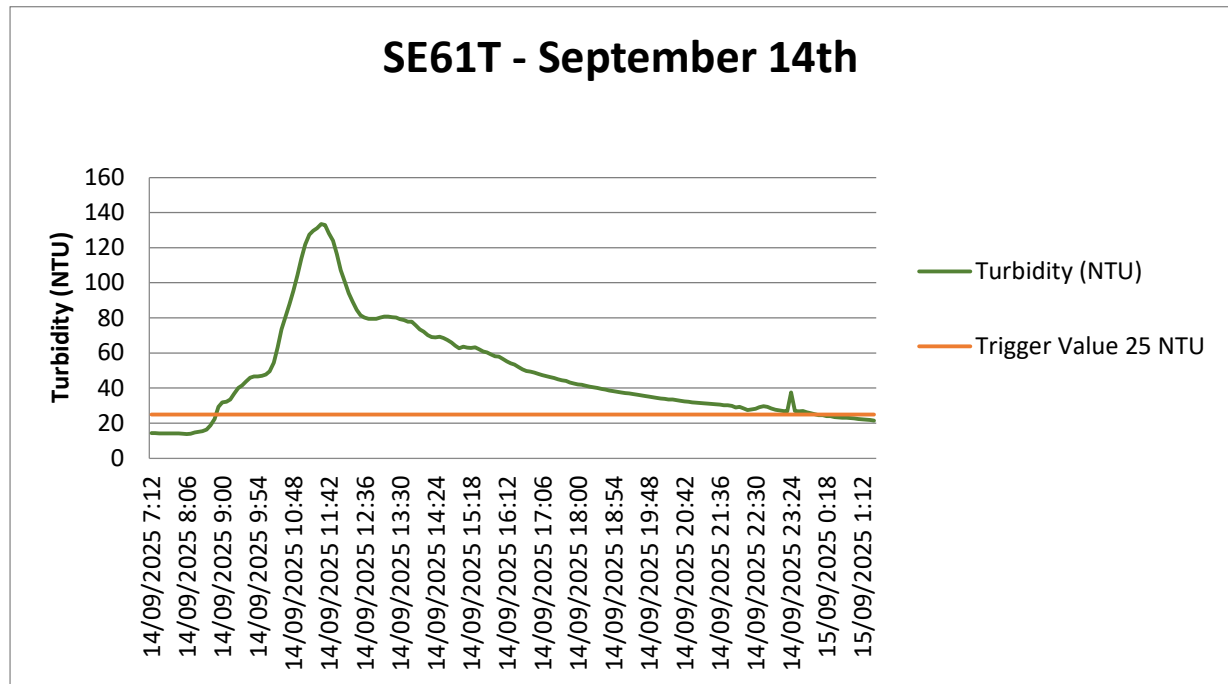
Figure 18 - HUN-2509-083

The event, occurring between 8:54 on the 14th of September and 0:00 on the 15th of September at SEE61T exhibits a sharp, incline in turbidity levels followed by a gradual return to baseline levels in a pattern resembling a normal (Gaussian) distribution as shown in Figure 18 below. This criteria is in line with a typical true event as per the ‘Turbidity Event Classification Guidelines’.
