Our Ref: A23.033-MEM-FSR_A.O_Myara_FINAL

Alcoa of Australia
Marmion St & Davy St
576 Marmion St
Booragoon
WA 6154

SUBJECT: TECHNICAL MEMO BLACK COCKATOO TARGETED ASSESSMENT, MYARA, MAY-JUNE 2024

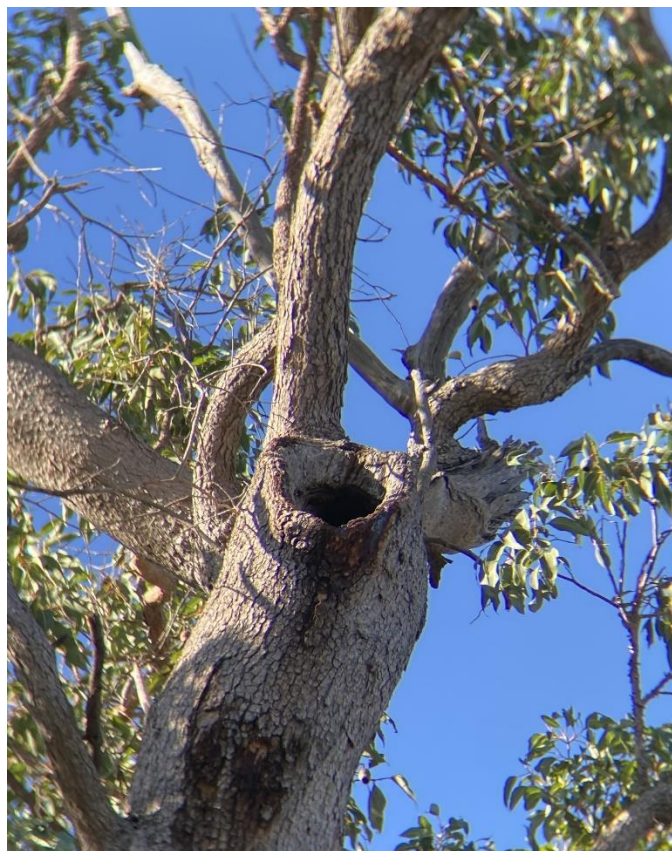
25 Bamford Class 2 trees which show signs of chew marks indicating they are a known nesting tree were recorded within the Survey Area. See Image 01 below for example of chew marks and hollow.

Image 01- Tree 153, a marri with a DBH of 100cm showing chew marks on rim of spout hollow
