# WQMS Data Review

## Huntly Bauxite Mine

JULY 2026

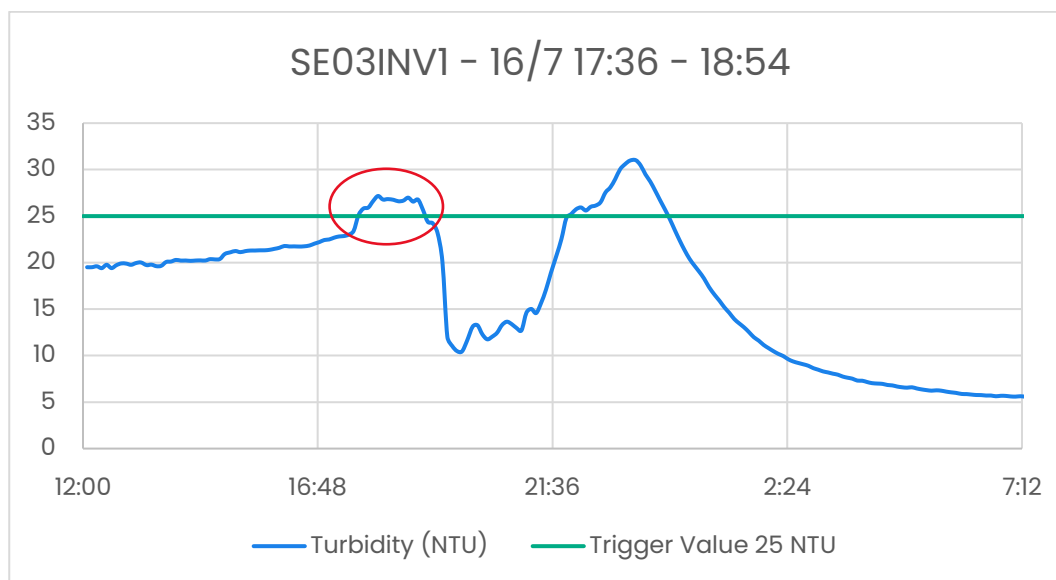
Figure 3 – SE03INV1 July 16<sup>th</sup>

As shown in Figure 3, turbidity increased above the 25 NTU trigger value, reaching an initial peak before declining sharply to below pre-event levels. Following this decline, turbidity recovered and a second exceedance event (HUN-2607-051) was recorded, during which turbidity increased to a peak of approximately 31 NTU. After the second peak, turbidity gradually receded towards baseline conditions, consistent with the settling and dispersion of suspended sediments.

The overall pattern of elevated turbidity, multiple peaks, and subsequent gradual recession is characteristic of a genuine environmental turbidity event associated with rainfall-driven runoff. While the brief decrease between the two exceedance events may reflect localised flow variability, temporary changes in suspended sediment concentrations, or minor sensor interference, the broader response remains coherent and consistent with natural environmental processes. Given the recorded rainfall and the characteristic turbidity response, the exceedance is considered to represent a genuine rainfall-induced turbidity event, rather than sensor malfunction.

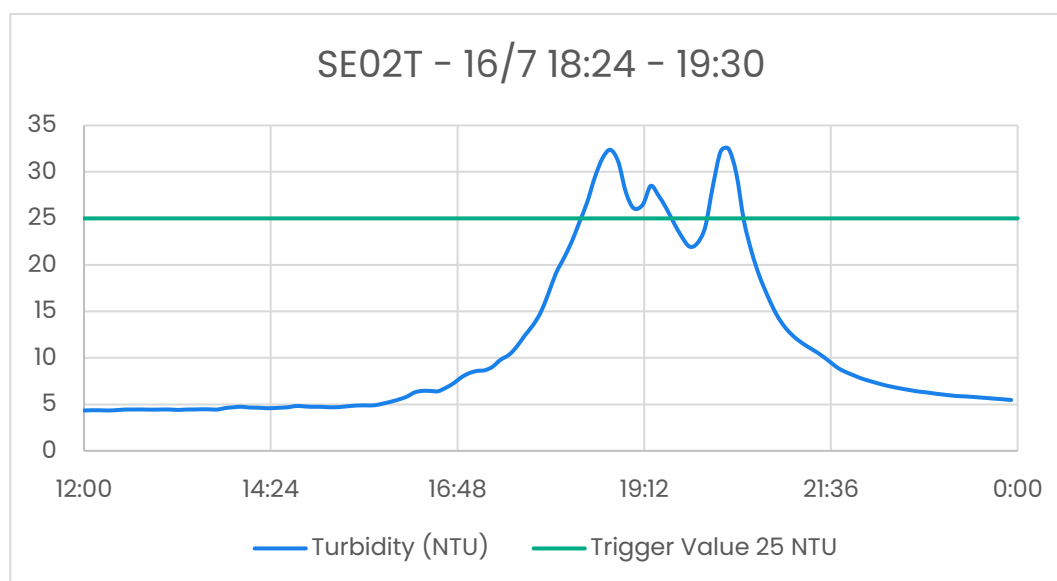
Figure 4 – SE02T July 16<sup>th</sup>

As shown in Figure 4, turbidity remained relatively stable at approximately 4 to 5 NTU throughout the early afternoon before gradually increasing from around 4:00 pm. The rate of increase accelerated during the evening, with turbidity exceeding the 25 NTU trigger value and reaching an initial peak of approximately 32 NTU. Following a brief decline, turbidity remained elevated and subsequently increased to a second peak of approximately 33 NTU. After the second peak, turbidity decreased steadily over several hours, gradually returning towards baseline conditions.

The observed response, characterised by a progressive rise in turbidity, multiple elevated peaks, and a smooth recession towards background levels, is consistent with the mobilisation, transport and subsequent settling of suspended sediments following rainfall-driven runoff. The short-term fluctuations observed between the two peaks likely reflect natural variability in flow conditions and sediment concentrations within the waterbody. Given the recorded 13.8 mm rainfall, the sustained turbidity response, and the gradual return to baseline conditions, the exceedance is considered to represent a genuine rainfall-induced turbidity event rather than sensor malfunction.

*SE02T catchment was inspected and no evidence of mining related drainage concerns were observed.'*

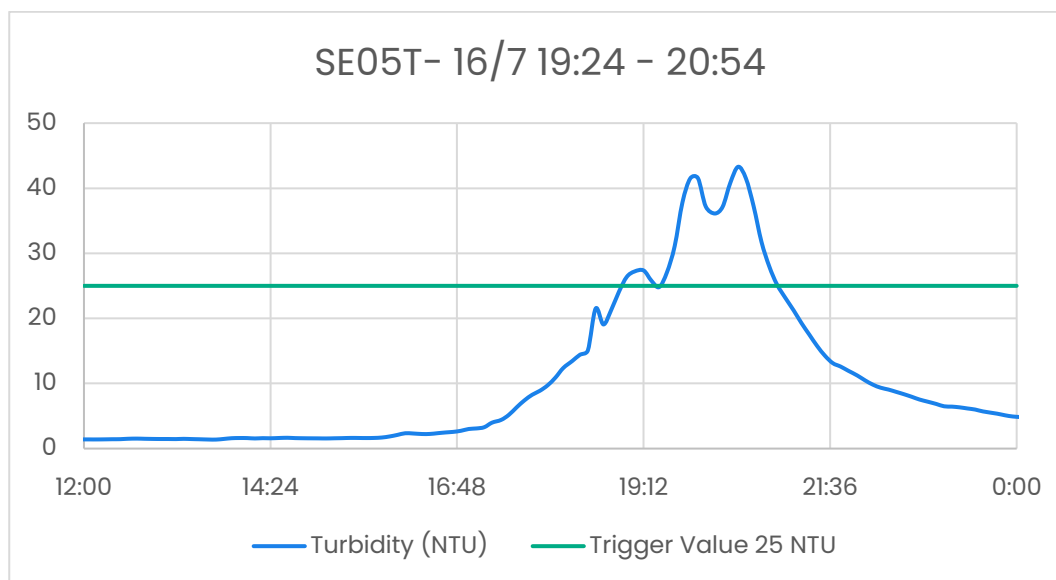
Figure 5 – SE02T July 16<sup>th</sup>

As shown in Figure 5, turbidity remained low and stable at approximately 1 to 2 NTU throughout the afternoon before increasing progressively from around 5:00 pm. The rate of increase accelerated during the evening, with turbidity exceeding the 25 NTU trigger value shortly after 7:00 pm. Following an initial peak of approximately 27 NTU, turbidity remained elevated and increased further, reaching two successive peaks of approximately 42 NTU and 43 NTU. After the second peak, turbidity declined steadily over several hours, gradually returning towards baseline conditions.

The observed response, characterised by a sustained increase in turbidity, multiple elevated peaks, and a smooth recession towards background levels, is consistent with the mobilisation, transport and subsequent settling of suspended sediments associated with rainfall-driven runoff. The fluctuations between the elevated peaks are indicative of natural variability in runoff inputs, flow conditions and sediment availability within the catchment, rather than instrumentation issues. Given the substantial antecedent rainfall (30 mm), the progressive rise in turbidity, the sustained period of elevated concentrations, and the gradual return to baseline conditions, the exceedance is considered to represent a genuine rainfall-induced turbidity event rather than sensor malfunction.

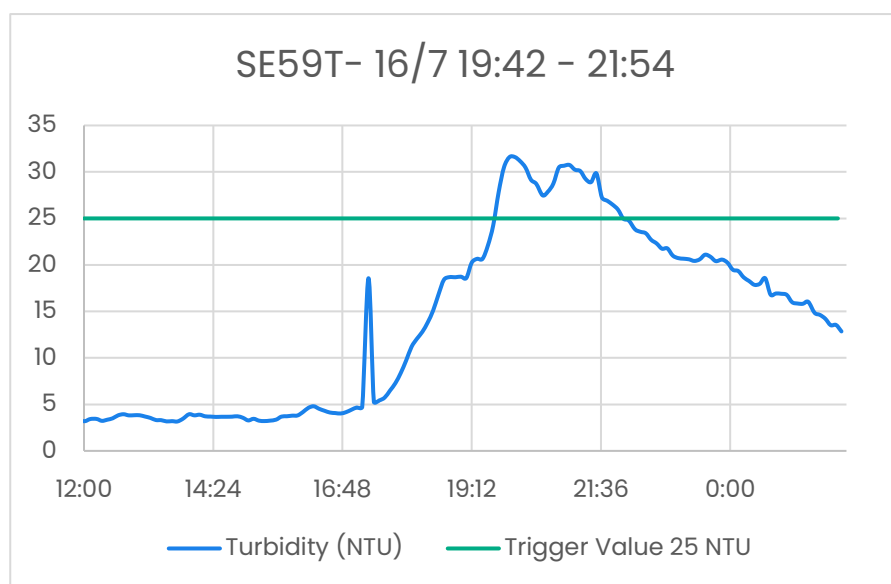
Figure 6 – SE59T July 16<sup>th</sup>

As shown in Figure 6, turbidity remained relatively stable at approximately 3 to 5 NTU throughout much of the day before increasing progressively during the evening. A brief isolated spike was observed at approximately 5:00 pm, after which turbidity returned to the prevailing trend and continued to rise. Turbidity exceeded the 25 NTU trigger value shortly before 7:30 pm, reaching a peak of approximately 32 NTU. Following a minor decline, turbidity remained elevated above the trigger value for an extended period, with concentrations fluctuating between approximately 28 and 31 NTU before gradually decreasing. After falling below the trigger value, turbidity continued to recede steadily towards baseline conditions.

The overall response, characterised by a sustained rise in turbidity, an extended period of elevated concentrations, and a gradual recession towards background levels, is consistent with the mobilisation, transport and subsequent settling of suspended sediments associated with rainfall-driven runoff. The brief isolated spike observed prior to the main event may reflect a short-term localised disturbance or transient sensor interference; however, it does not detract from the broader and well-defined turbidity response. Given the substantial antecedent rainfall (30.6 mm), the prolonged duration of elevated turbidity, and the gradual return to baseline conditions, the exceedance is considered to represent a genuine rainfall-induced turbidity event rather than sensor malfunction.

*SE59T catchment was inspected and no evidence of mining related drainage concerns were observed.'*

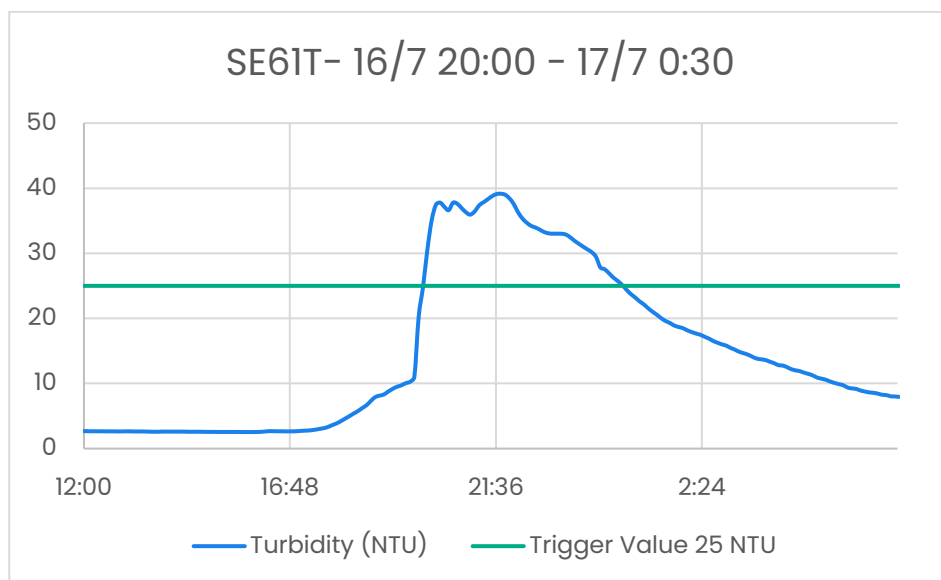
Figure 7 – SE02T July 16–17<sup>th</sup>

As shown in Figure 7, turbidity remained low and stable at approximately 2 to 3 NTU throughout most of the afternoon before increasing gradually during the early evening. The rate of increase accelerated markedly after approximately 7:15 pm, with turbidity rapidly rising above the 25 NTU trigger value. Turbidity reached an initial peak of approximately 38 NTU, briefly fluctuated, and then increased to a maximum concentration of approximately 39 NTU. Following the peak, turbidity decreased progressively over several hours, falling below the trigger value shortly after midnight and continuing to decline towards baseline conditions.

The observed response, characterised by a rapid rise in turbidity, a sustained period of elevated concentrations, and a gradual recession towards background levels, is consistent with the mobilisation, transport and subsequent settling of suspended sediments associated with rainfall-driven runoff. Minor fluctuations observed near the peak are consistent with natural variations in flow conditions and suspended sediment concentrations rather than instrumentation issues. Given the substantial antecedent rainfall (30.6 mm), the pronounced and sustained turbidity response, and the progressive return to baseline conditions, the exceedance is considered to represent a genuine rainfall-induced turbidity event rather than sensor malfunction.

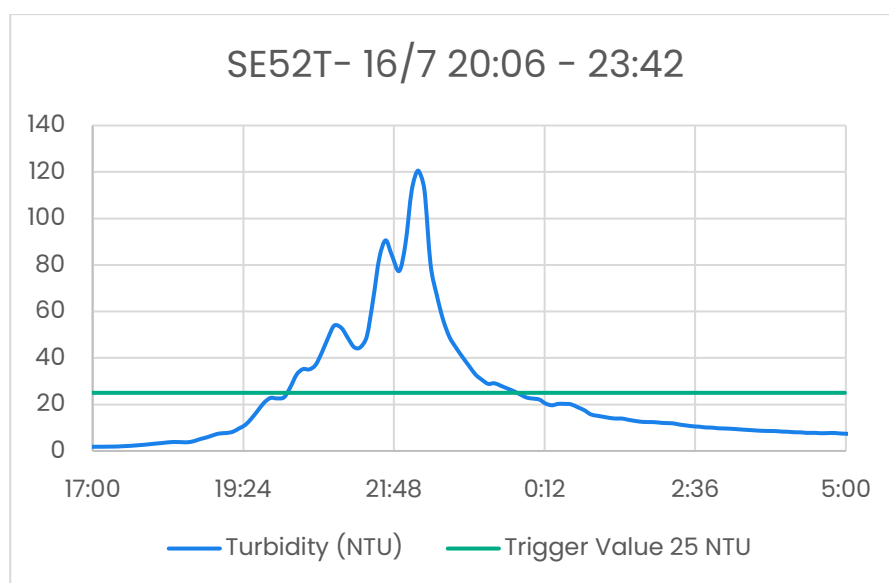
Figure 8 – SE52T July 16<sup>th</sup>

As shown in Figure 8, turbidity remained low throughout the late afternoon before increasing progressively from approximately 7:00 pm. The rate of increase accelerated markedly during the evening, with turbidity exceeding the 25 NTU trigger value shortly after 8:00 pm. Following the initial exceedance, turbidity continued to rise and exhibited several distinct peaks, reaching a maximum concentration of approximately 120 NTU at around 10:00 pm. Following the peak, turbidity decreased rapidly before transitioning to a more gradual recession. Turbidity fell below the trigger value shortly after midnight and continued to decline towards baseline conditions during the early hours of 17 July.

The observed response, characterised by a progressive rise in turbidity, multiple elevated peaks, a pronounced maximum concentration, and a gradual recession towards background levels, is consistent with the mobilisation, transport and subsequent settling of suspended sediments associated with rainfall-driven runoff. The multiple peaks likely reflect variations in runoff intensity, flow pathways, and sediment availability within the contributing catchment. Despite the magnitude of the response, the turbidity profile remains coherent and exhibits the characteristic rise-and-fall pattern expected from a genuine environmental event. Given the substantial antecedent rainfall (30.6 mm), the sustained period of elevated turbidity, and the gradual return towards baseline conditions, the exceedance is considered to represent a genuine rainfall-induced turbidity event rather than sensor malfunction.

*The data trend indicates turbidity NTU increased simultaneously with the rainfall, exceedance commenced after 30.6mm of rainfall and turbidity remained over 25 NTU with several rapid incline spikes until rainfall ceased, then gradually declined back down to <7 NTU. SE52T catchment was inspected and no evidence of mining related drainage concerns were observed.'*

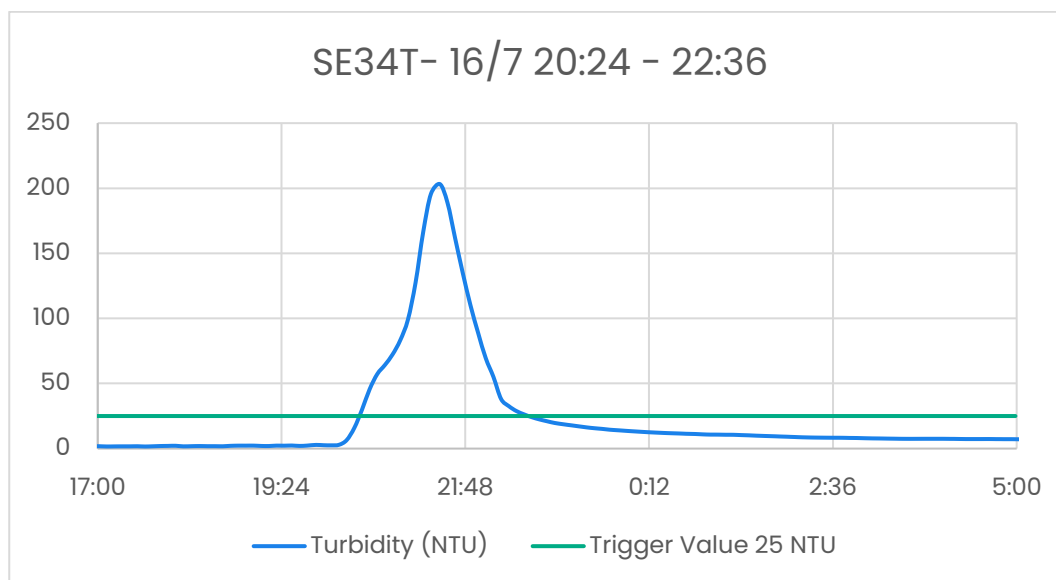
Figure 9 – SE34T July 16<sup>th</sup>

As shown in Figure 9, turbidity remained at low background concentrations of approximately 1 to 2 NTU throughout much of the afternoon and early evening before increasing rapidly from around 8:15 pm. Turbidity exceeded the 25 NTU trigger value shortly thereafter and continued to rise sharply, reaching a peak concentration of approximately 200 NTU at around 9:20 pm. Following the peak, turbidity declined rapidly before transitioning to a more gradual recession. Turbidity fell below the trigger value at approximately 10:36 pm and continued to decrease steadily towards baseline conditions during the early hours of 17 July.

The observed response, characterised by a rapid rise in turbidity, a pronounced peak concentration, and a progressive recession towards background levels, is consistent with the mobilisation, transport and subsequent settling of suspended sediments associated with rainfall-driven runoff. The smooth rise-and-fall pattern and gradual recovery following the peak are indicative of a genuine environmental response rather than instrumentation issues. Given the substantial antecedent rainfall (30.6 mm), the magnitude and shape of the turbidity response, and the sustained return towards baseline conditions, the exceedance is considered to represent a genuine rainfall-induced turbidity event rather than sensor malfunction.

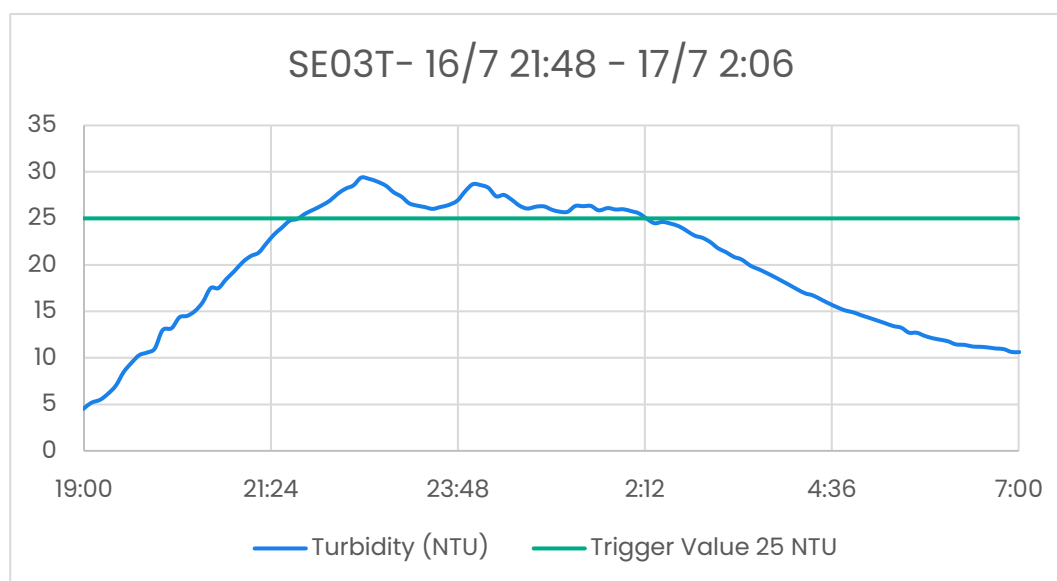
Figure 10 – SE03T July 16<sup>th</sup>

As shown in Figure 10, turbidity increased steadily from approximately 5 NTU during the evening, exceeding the 25 NTU trigger value shortly after 9:30 pm. Turbidity continued to rise, reaching an initial peak of approximately 29 NTU at around 10:30 pm. Following a minor decline, turbidity remained elevated above the trigger value for several hours, fluctuating between approximately 25 and 29 NTU. After approximately 2:00 am, turbidity fell below the trigger value and gradually receded towards baseline conditions, reaching approximately 11 NTU by 7:00 am.

The observed response, characterised by a gradual rise in turbidity, a sustained period of elevated concentrations above the trigger value, and a progressive recession towards background levels, is consistent with the mobilisation, transport and subsequent settling of suspended sediments associated with rainfall-driven runoff. The minor fluctuations observed during the elevated period are indicative of natural variability in flow conditions and suspended sediment concentrations rather than instrumentation issues. Given the substantial antecedent rainfall (30.6 mm), the extended duration of elevated turbidity, and the gradual return towards baseline conditions, the exceedance is considered to represent a genuine rainfall-induced turbidity event rather than sensor malfunction.

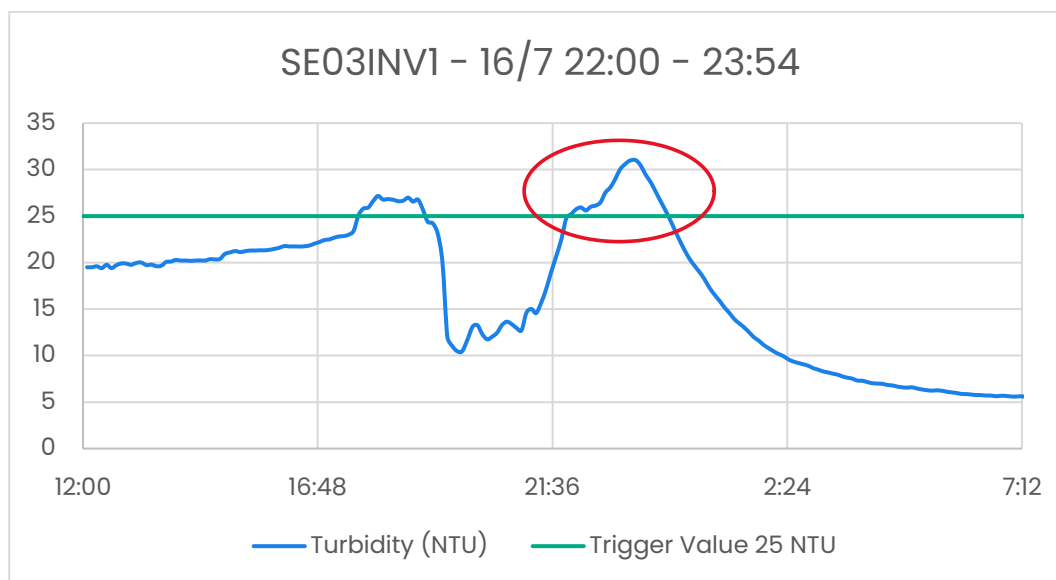
Figure 11 – SE03INV1 July 16<sup>th</sup>

As shown in Figure 11, following the conclusion of the preceding exceedance event, turbidity declined to approximately 10 NTU before recovering and increasing steadily during the evening. Turbidity exceeded the 25 NTU trigger value shortly after 9:30 pm and continued to rise, reaching a peak concentration of approximately 31 NTU shortly before midnight. Following the peak, turbidity decreased progressively, falling below the trigger value at approximately 11:54 pm and continuing to recede towards baseline conditions during the early hours of 17 July 2026.

The observed response, characterised by a sustained increase in turbidity, a distinct peak concentration, and a gradual recession towards background conditions, is consistent with the mobilisation, transport and subsequent settling of suspended sediments associated with rainfall-driven runoff. The event formed part of a broader turbidity response observed following substantial rainfall and exhibits the characteristic rise-and-fall pattern expected of a genuine environmental turbidity event. Given the recorded 30.6 mm rainfall, the coherent turbidity response, and the gradual return towards baseline conditions, the exceedance is considered to represent a genuine rainfall-induced turbidity event rather than sensor malfunction.

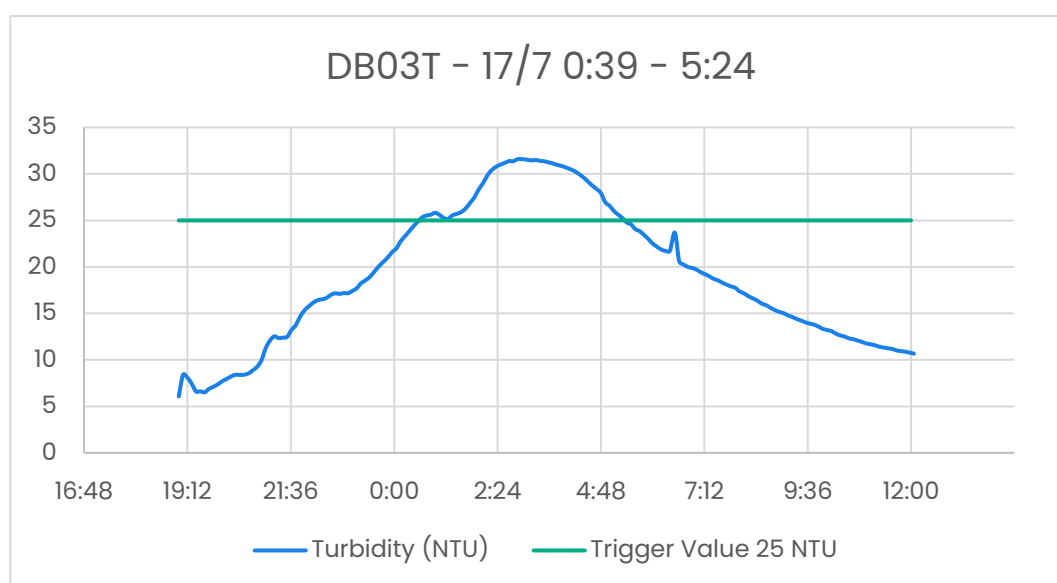
Figure 12 – DB03T July 17<sup>th</sup>

As shown in Figure 12, turbidity increased progressively from background levels of approximately 6 to 8 NTU during the evening of 16 July 2026. The rate of increase accelerated after midnight, with turbidity exceeding the 25 NTU trigger value shortly after 1:00 am. Turbidity continued to rise steadily, reaching a peak concentration of approximately 32 NTU at around 2:45 am. Following the peak, turbidity gradually decreased and fell below the trigger value shortly after 5:00 am. Concentrations continued to decline throughout the morning, trending towards baseline conditions.

The observed response, characterised by a gradual rise in turbidity, a sustained peak period, and a smooth recession towards background levels, is consistent with the mobilisation, transport and subsequent settling of suspended sediments associated with rainfall-driven runoff. Minor fluctuations observed during the rising and falling limbs of the event are consistent with natural variability in flow conditions and suspended sediment concentrations and do not indicate instrument malfunction. Given the substantial antecedent rainfall (31.4 mm), the coherent turbidity response, and the gradual return towards baseline conditions, the exceedance is considered to represent a genuine rainfall-induced turbidity event rather than sensor malfunction.

*The data trend indicates a gradual increase and decreases in turbidity aligned with a rainfall event. DB03T monitoring site was inspected on 21 July 2026. The stream was observed to be clear and flowing.*

*The DB03T catchment was inspected, and no evidence of mining related contribution or drainage control failure was identified.'*
