WQMS Data Review

Huntly Bauxite Mine

MARCH 2026

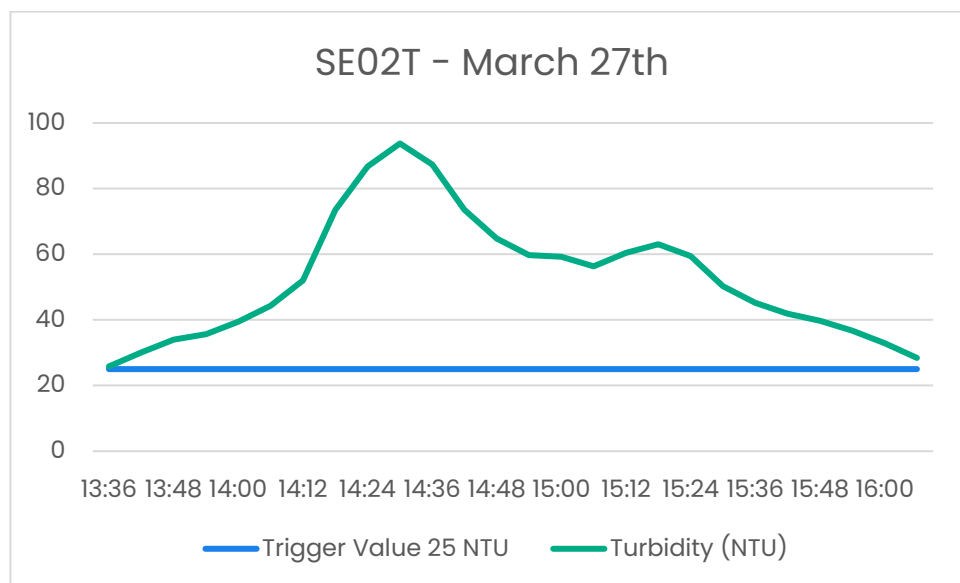
Figure 3 - SE02T - March 27th

SE02

subsequent decline in turbidity values, which correlates with recorded rainfall. An inspection of the SE02T catchment found no evidence of mining related contributions to the turbidity exceedance.

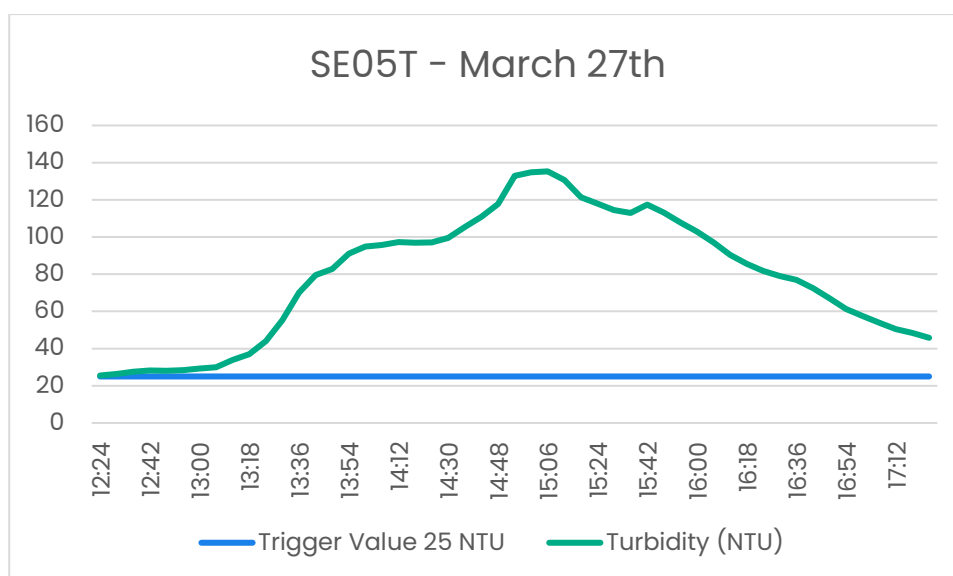
Figure 4 - SE05T - March 27th

The event, occurring between 12:24 PM to 7:24 PM on the 27th of March 2026 at SE05T. Trend analysis of the monitoring data is shown in Figure 4 below. The turbidity graph displays a response pattern characteristic of a true turbidity exceedance event, with progressively increasing turbidity followed by a gradual return toward baseline conditions rather than abrupt fluctuations typical of false exceedance events.

The extended event duration and elevated peak turbidity indicate a sustained inflow of suspended sediments and organic material within the catchment following rainfall. 3.6mm of rainfall was recorded in the 24hrs preceding the event. The recorded rainfall is considered to have contributed to increased surface runoff and the mobilisation of fine sediments and organic particulates within the catchment.

An inspection of the SE05T monitoring site commenced on 28 March 2026. Stream flow velocity had increased significantly, resulting in turbulent conditions around the sensor and the accumulation of organic debris and algae. Turbidity was measured at 29.14 NTU.

Trend analysis indicates a gradual rise and subsequent decline in turbidity values, which correlates with recorded rainfall. The SE05T catchment area was inspected, no evidence of mining related contribution to the turbidity exceedance was found.

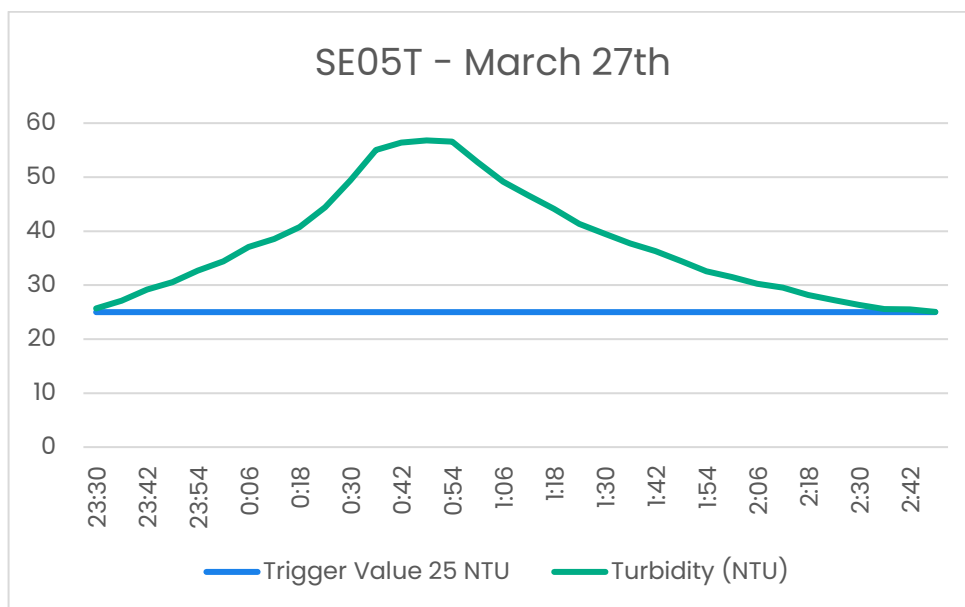
Figure 5 – SE05T – March 27th

The event, occurring between 11:30 PM 27 March 2026 and 2:48 AM 28 March at SE05T. Trend analysis of the monitoring data is shown in Figure 5 below. The turbidity graph displays a response pattern characteristic of a true turbidity exceedance event, with progressively increasing turbidity followed by a gradual return toward.

Trend analysis indicates a gradual rise and subsequent decline in turbidity values, which correlates with recorded rainfall data. A total of 41.3 mm of rainfall was recorded during the 24 hours preceding the event. This rainfall is considered to have contributed to increased surface runoff and the mobilisation of fine sediments and organic particulates within the catchment.

An inspection of the SE05T monitoring site commenced on 28 March 2026. Stream flow velocity had increased significantly, resulting in turbulent conditions around the sensor and the accumulation of organic debris and algae. Turbidity was measured at 29.14 NTU. Trend analysis indicates a gradual rise and subsequent decline in turbidity values, which correlates with recorded rainfall. The SE05T catchment area was inspected; no evidence of mining related contribution to the turbidity exceedance was found.

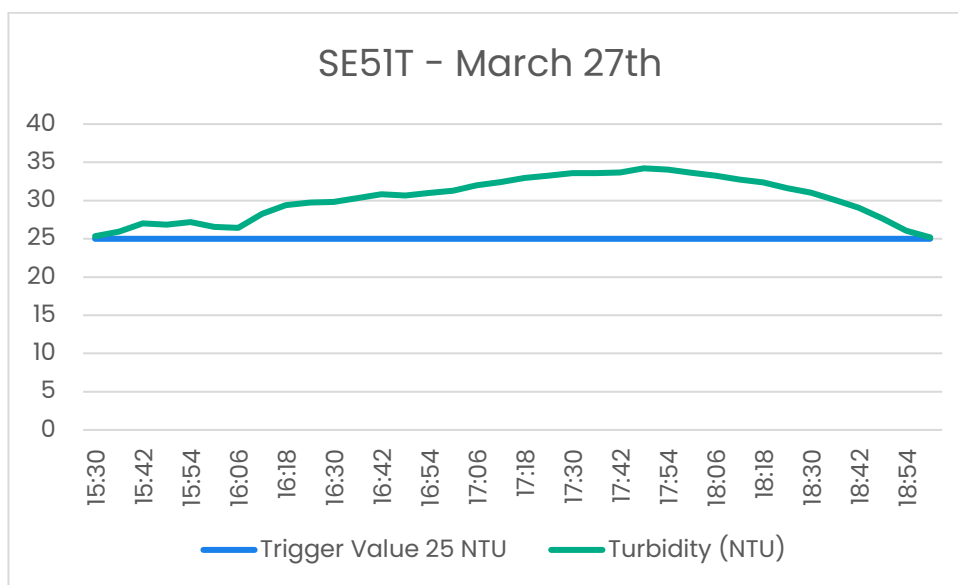
Figure 6– SE51T – March 27th

The event, occurring between 3:30 PM and 7:00 PM on the 27th of March at SE51T. Trend analysis of the monitoring data is shown in Figure 6 below. The turbidity graph displays a response pattern characteristic of a genuine turbidity exceedance event, with progressively increasing turbidity levels followed by a gradual return toward baseline conditions.

Trend analysis indicates a gradual rise and subsequent decline in turbidity values, which correlates with recorded rainfall data. A total of 20 mm of rainfall was recorded during the five hours preceding the event. This rainfall is considered to have contributed to increased surface runoff and the mobilisation of fine sediments and organic particulates within the catchment.

Data analysis indicates an increase in stream turbidity following approximately 20 mm of rainfall over a five-hour period, corresponding with a rapid rise in stream flow and depth after an extended period of low water levels associated with warmer conditions. Following this event, turbidity levels gradually declined to approximately 7.7 NTU, despite a further ~20 mm of rainfall. Within the 24 hours following the event, an additional approximately 53 mm of rainfall was recorded, and turbidity values remained below 25 NTU throughout this

The SE51T catchment area was inspected; no mining related contributions to the turbidity exceedances were found.”

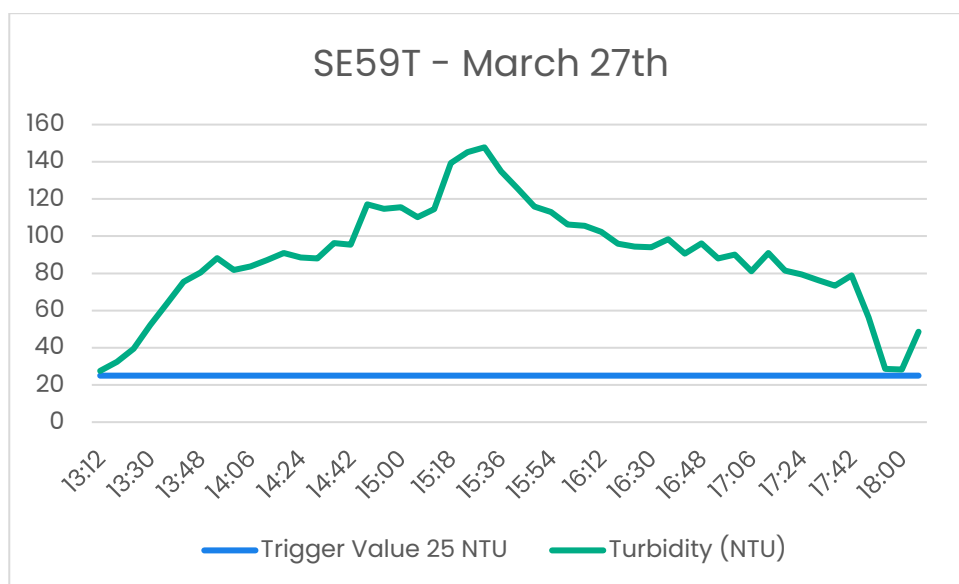
Figure 7– SE59T – March 27th

The event, occurring between 1:17 PM and 6:08 PM on the 27 March 2026 at SE59T. Trend analysis of the monitoring data is shown in Figure 7 below. The turbidity graph displays a response pattern characteristic of a genuine turbidity exceedance event, with progressively increasing turbidity levels followed by a gradual return toward baseline conditions.

Trend analysis indicates a gradual rise and subsequent decline in turbidity values, which correlates with recorded rainfall data. A total of 28mm of rainfall was recorded in the 24 hours preceding the event. This rainfall is considered to have contributed to increased surface runoff and the mobilisation of fine sediments and organic particulates within the catchment.

The SE59T catchment inspection was completed, no mining related contributions to the turbidity exceedances were found.

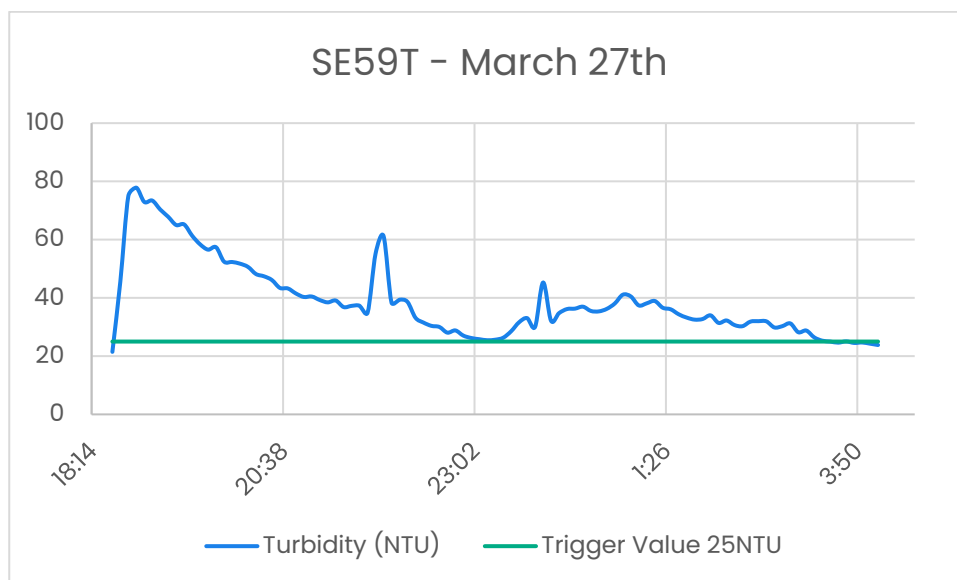
Figure 8– SE59T – March 27th

The event, occurring between 6:38 PM 27 March 2026 and 3:31 AM 28 March at SE59T. Trend analysis of the monitoring data is shown in Figure 8 below. The turbidity graph displays a response pattern characteristic of a genuine turbidity exceedance event. The turbidity profile shows a rapid initial increase, followed by a gradual decline, interspersed with minor fluctuations and a secondary peak. A smaller tertiary rise is observed before turbidity levels continue a steady and gradual return toward baseline conditions.

Trend analysis indicates a gradual rise and subsequent decline in turbidity values, which correlates with recorded rainfall data. A total of 28mm of rainfall was recorded in the 24 hours preceding the event. This rainfall is considered to have contributed to increased surface runoff and the mobilisation of fine sediments and organic particulates within the catchment.

Data trend shows a gradual incline and decline, coinciding with an increase in rainfall. The SE59T catchment inspection was completed; no mining related contributions to the turbidity exceedances were found.

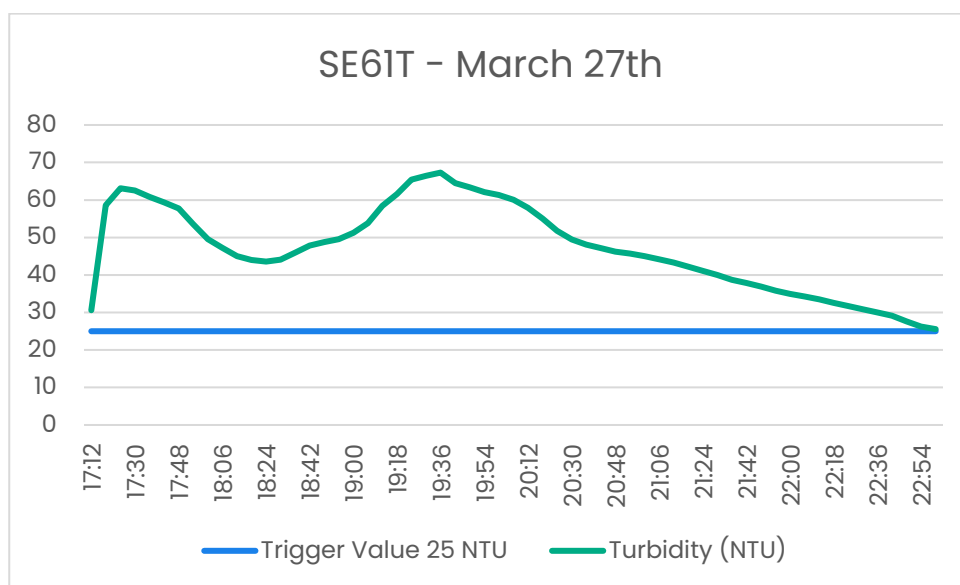
Figure 9 – SE61T – March 28th

The event, occurring between 5:12 PM and 11:00 PM on the 27 March at SE61T. Trend analysis of the monitoring data is shown in Figure 9 below. The turbidity graph displays a response pattern characteristic of a genuine turbidity exceedance event, with rapid initial increase followed by a brief fluctuation and a secondary peak turbidity level followed by a steady and gradual return toward baseline conditions.

Trend analysis indicates a clear correlation between turbidity response and preceding rainfall conditions. A total of 67.3 mm of rainfall was recorded in the 24 hours prior to the event, representing a significant precipitation input. This rainfall is considered to have generated substantial surface runoff, resulting in the mobilisation and transport of fine sediments, organic matter, and suspended particulates from the surrounding catchment into the monitoring location.

The SE61T monitoring site was inspected on 28 March 2026. On arrival, rainwater on the adjacent bush track was flowing into the surrounding vegetation and subsequently into the stream. Stream flow velocity had increased significantly, resulting in turbulent conditions around the sensor and the accumulation of organic debris and algae.

An inspection of the SE6IT catchment area was completed; no evidence of mining contribution to the turbidity exceedance was found.”

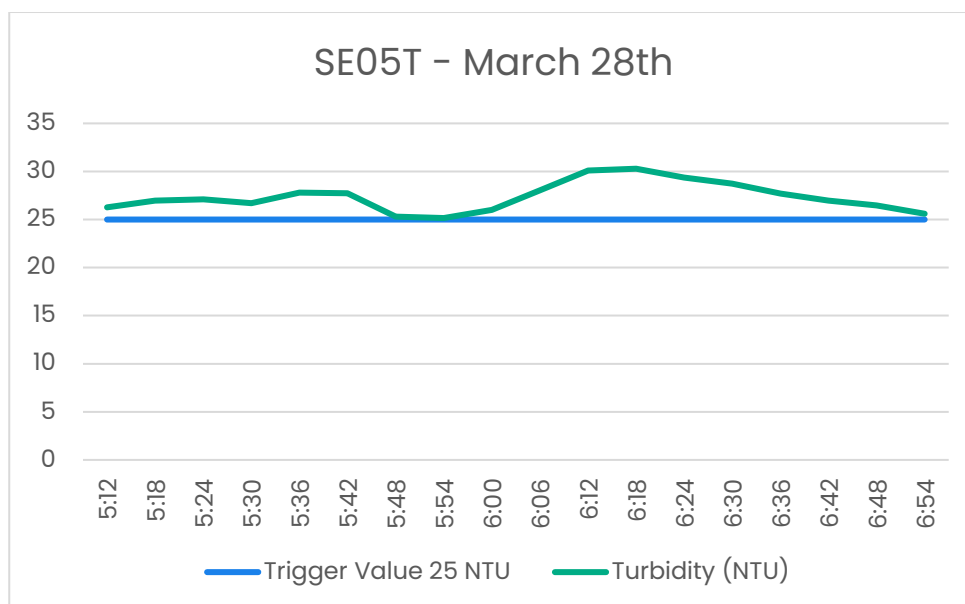
Figure 10 – SE05T – March 28th

The event, occurring between 5:12 AM and 6:54 AM on the 28 March at SE05T. Trend analysis of the monitoring data is shown in Figure 10 below. The turbidity graph displays a response pattern characteristic of a genuine turbidity exceedance event, with progressively increasing turbidity levels followed by a brief fluctuation and a secondary peak turbidity level followed by a steady and gradual return toward baseline conditions.

Trend analysis indicates a clear correlation between turbidity response and preceding rainfall conditions. A total of 52.8 mm of rainfall was recorded in the 24 hours prior to the event, representing a significant precipitation input. This rainfall is considered to have increased stream flow velocity, resulting in turbulent conditions around the sensor and the mobilisation and accumulation of organic debris and algae within the monitoring location.

An inspection of the SE05T monitoring site commenced on 28 March 2026. Stream flow velocity had increased significantly, resulting in turbulent conditions around the sensor and the accumulation of organic debris and algae. Turbidity was measured at 29.14 NTU. Trend analysis indicates a gradual rise and subsequent decline in turbidity values, which correlates with recorded rainfall.

The SE05T catchment area was inspected; no evidence of mining related contribution to the turbidity exceedance was found.

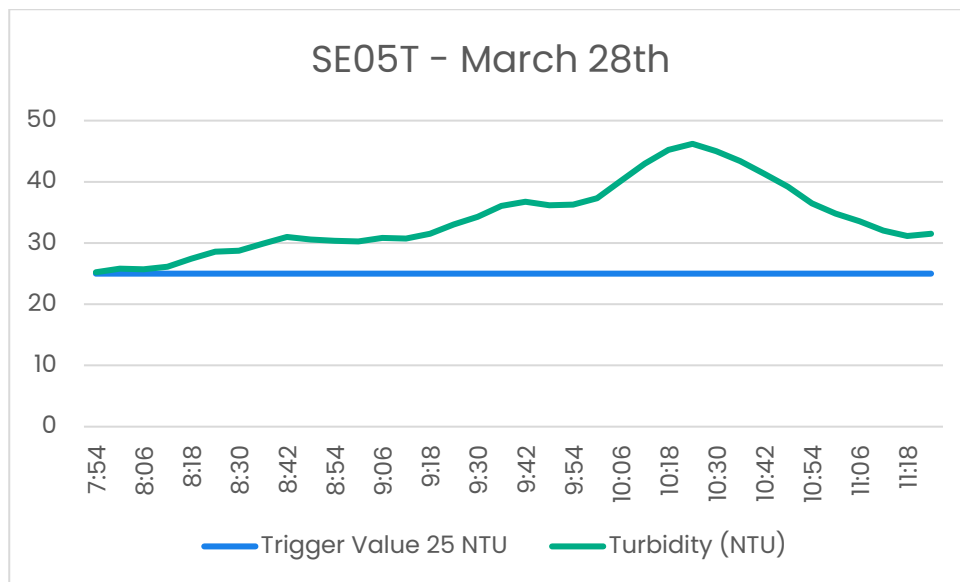
Figure 11 - SE05T - March 28th

The event, occurring between 7:54 AM and 11:24 AM on the 28 March at SE05T. Trend analysis of the monitoring data is shown in Figure 11 below. The turbidity graph displays a response pattern characteristic of a genuine turbidity exceedance event, with progressively increasing turbidity levels followed by a steady and gradual return toward baseline conditions.

Trend analysis indicates a clear correlation between turbidity response and preceding rainfall conditions. A total of 66.3 mm of rainfall was recorded in the 24 hours prior to the event, representing a significant precipitation input. This rainfall is considered to have substantially increased stream flow velocity, resulting in turbulent conditions at the monitoring site and the

mobilisation and transport of fine sediments, organic material, and suspended particulates within the monitoring location.

An inspection of the SE05T monitoring site commenced on 28 March 2026. Stream flow velocity had increased significantly, resulting in turbulent conditions around the sensor and the accumulation of organic debris and algae. Turbidity was measured at 29.14 NTU. Trend analysis indicates a gradual rise and subsequent decline in turbidity values, which correlates with recorded rainfall.

The SE05T catchment area was inspected; no evidence of mining related contribution to the turbidity exceedance was found.

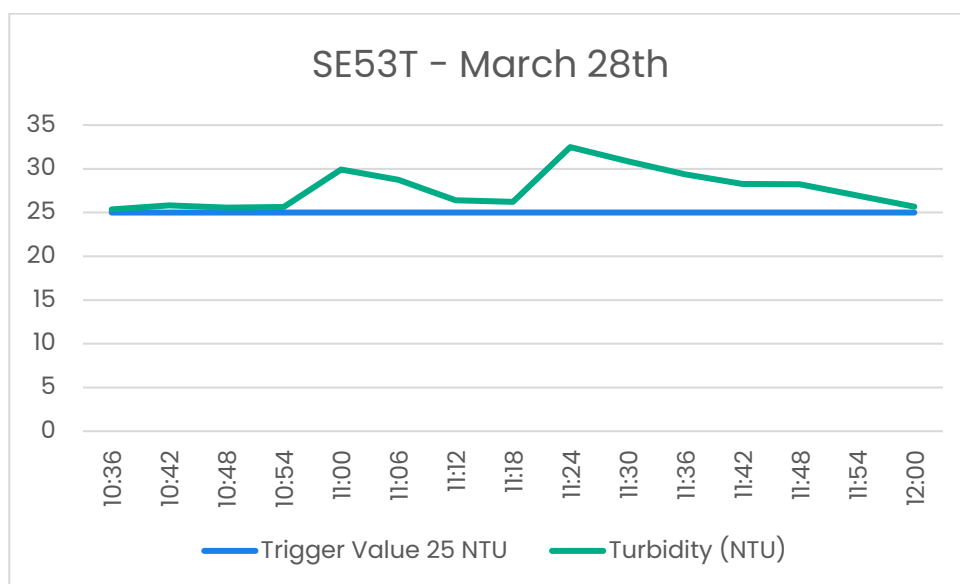
Figure 12 – SE53T – March 28th

The event, occurring between 10:36 AM and 12:00 PM on the 28 March at SE053T. Trend analysis of the monitoring data is shown in Figure 12 below. The turbidity graph displays a response pattern characteristic of a genuine turbidity exceedance event, with progressively increasing turbidity levels followed by a brief fluctuation and a secondary peak turbidity level followed by a steady and gradual return toward baseline conditions.

Trend analysis indicates a clear correlation between turbidity response and preceding rainfall conditions. A total of 73.9 mm of rainfall was recorded in the 24 hours prior to the event, representing a significant precipitation input. This rainfall is considered to have contributed to increased surface runoff and the mobilisation of fine sediments and organic particulates within the catchment.

The SE53T catchment was inspected; no evidence of mining impact was observed. SE53T is located within OCA 2 of Serpentine Dam. 422191 E; 6411914 N GDA 1994 Zone 50."

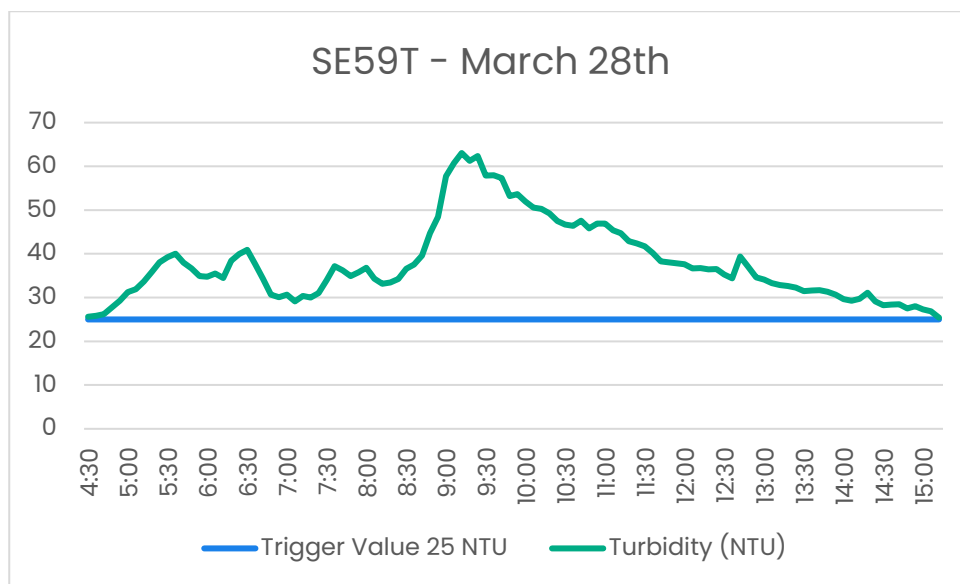
Figure 13 – SE59T – March 28th

Trend analysis indicates a gradual rise and subsequent decline in turbidity values, which correlates with recorded rainfall data. A total of 51.4mm of rainfall was recorded in the 24 hours preceding the event. This rainfall is considered to have contributed to increased

surface runoff and the mobilisation of fine sediments and organic particulates within the catchment.

Trend analysis indicates a gradual rise and subsequent decline in turbidity values, which correlates with recorded rainfall. The SE59T catchment inspection was completed; no mining related contributions to the turbidity exceedances were found.

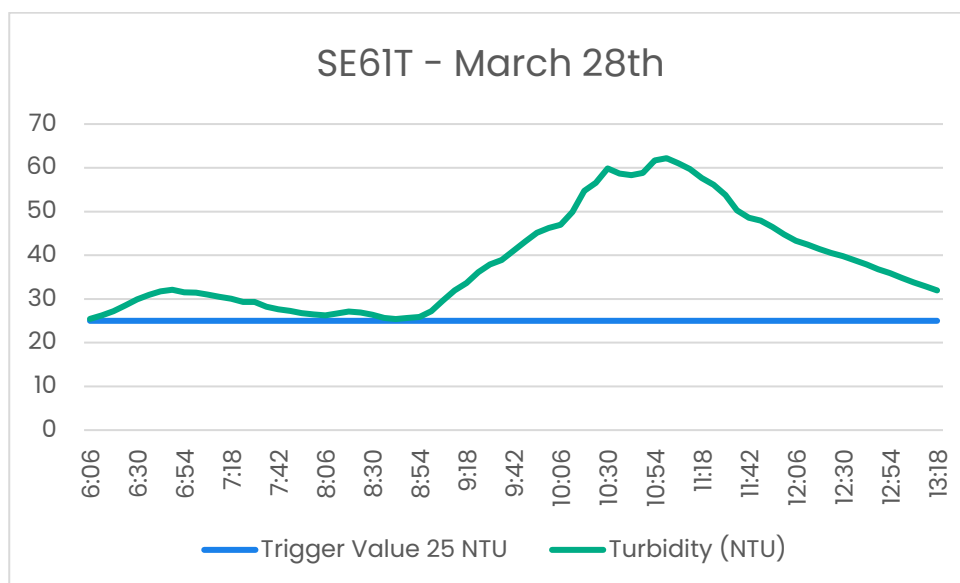
Figure 14 – SE61T – March 28th

The event, occurring between 6:06 AM and 1:18 PM on the 28 March 2026 at SE59T. Trend analysis of the monitoring data is shown in Figure 14 below. The turbidity profile shows a minor initial rise in the early morning, followed by a brief stabilisation near the trigger threshold. Turbidity levels increase steadily, forming a well-defined peak, following this peak, turbidity levels gradually decline over several hours, returning to below trigger conditions.

Trend analysis indicates a gradual rise and subsequent decline in turbidity values, which correlates with recorded rainfall data. A total of 57.2mm of rainfall was recorded in the 24 hours preceding the event. This rainfall is considered to have substantially increased stream flow velocity, resulting in turbulent conditions at the monitoring site and the mobilisation and transport of fine sediments, organic material, and suspended particulates within the monitoring location.

The SE61T monitoring site was inspected on 28 March 2026. On arrival, rainwater on the adjacent bush track was flowing into the surrounding vegetation and subsequently into the stream. Stream flow velocity had increased significantly, resulting in turbulent conditions around the sensor and the accumulation of organic debris and algae. Trend

An inspection of the SE61T catchment area was completed, no evidence of mining contribution to the turbidity exceedance was found.”

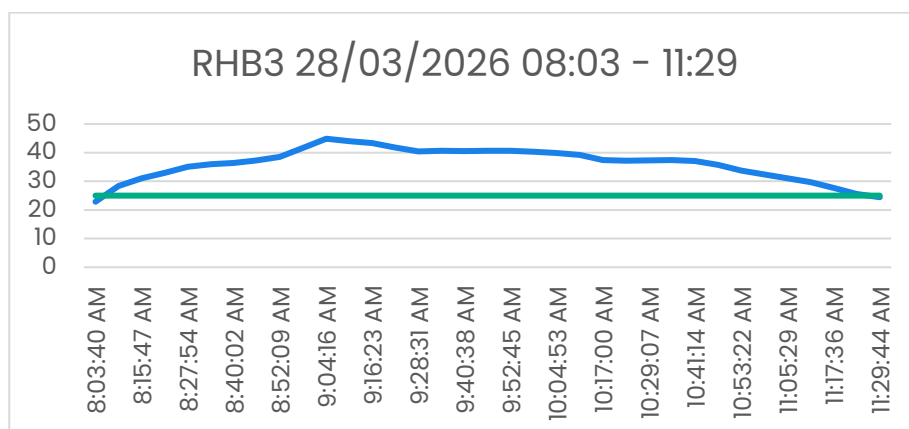
Figure 3 - RHB3 28/03/2026 08:03 - 11:29

The event, occurring between 8:09 AM and 11:29 AM on the 28th of March at RHB3. Trend analysis of the monitoring data is shown in Figure 3 below. The turbidity graph displays a response pattern characteristic of a genuine turbidity exceedance event, with progressively increasing turbidity levels followed by a gradual return toward baseline conditions.

Trend analysis indicates a clear rise-and-fall pattern, which correlates with recent rainfall conditions. A total of 86.8 mm of rainfall was recorded within the 24-hour period preceding the event. This substantial rainfall likely resulted in increased surface runoff across the catchment.
