# WQMS Data Review

## Huntly Bauxite Mine

MAY 2026

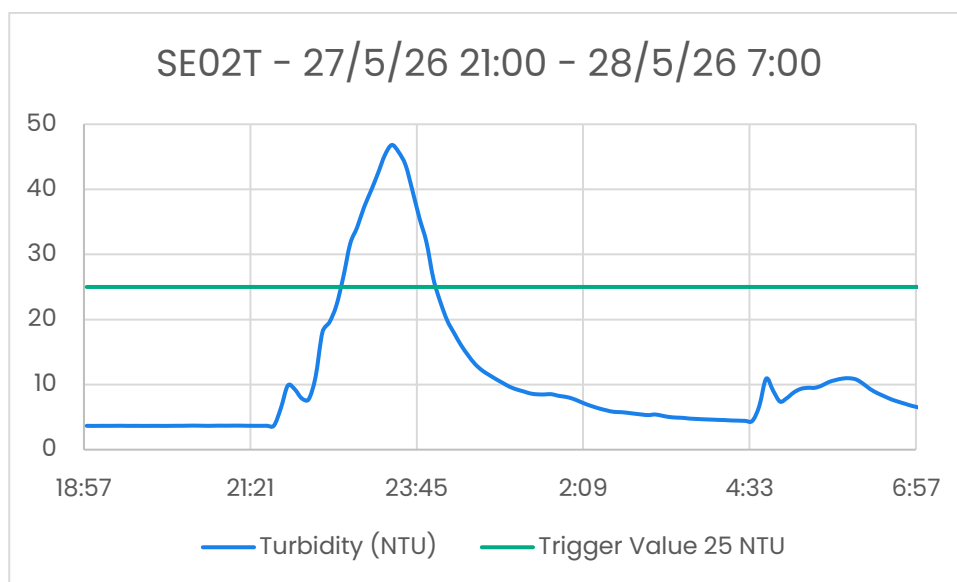
Figure 3- SE02T - May 27th

The turbidity exceedance event occurred between 10:42 PM on 27 May 2026 and 12:10 AM on 28 May 2026 at monitoring location SE02T. The turbidity graph (Figure 3) displays a response pattern characteristic of a true turbidity exceedance event, with progressively increasing turbidity followed by a gradual return toward.

Trend analysis indicates a gradual rise and subsequent decline in turbidity values, which correlates with recorded rainfall data. A total of 8.3 mm of rainfall was recorded during the 24 hours preceding the event. This rainfall is considered to have contributed to increased surface runoff and the mobilisation of fine sediments and organic particulates within the catchment.

*The SE02T catchment area was inspected, no evidence of mining related contribution was found.*

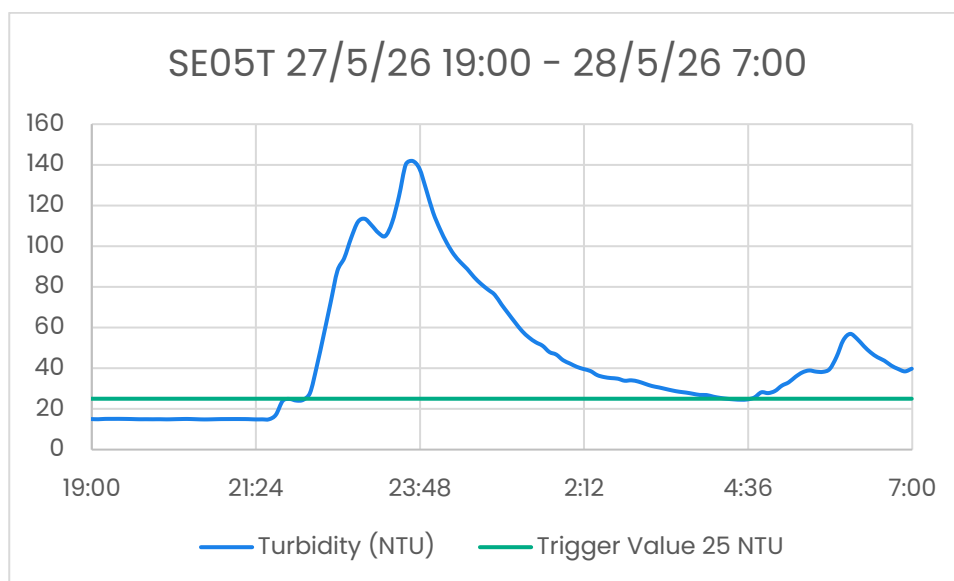
Figure 5- SE05T – May 27th

The turbidity profile (Figure 5) shows a rapid initial increase, followed by a second peak. Following this secondary peak, turbidity levels show a consistent and gradual decline over several hours, returning to below the trigger threshold of 25 NTU.

Trend analysis indicates a clear correlation between turbidity response and preceding rainfall conditions. A total of 5 mm of rainfall was recorded in the 24 hours prior to the event. While relatively moderate, this rainfall is considered sufficient to have generated surface runoff, particularly under potentially wet antecedent conditions.

*The SE05T catchment area was inspected, no evidence of mining related contribution was found.*

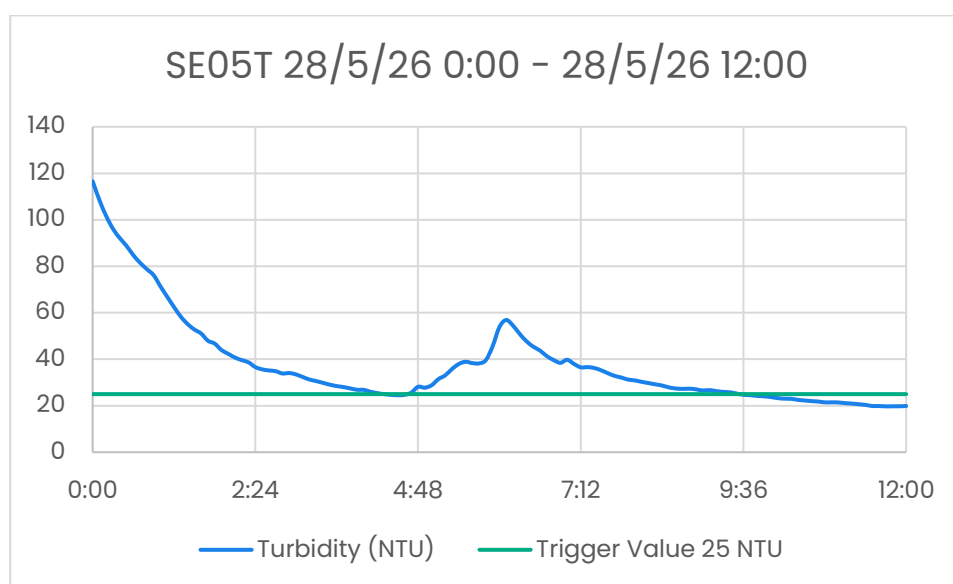
Figure 6- SE05T- May 28th

The turbidity profile (Figure 6) shows a progressive initial increase, followed by a more rapid increase to a primary peak. Subsequent to this peak, turbidity levels show a consistent and gradual decline over several hours, returning to below the trigger threshold of 25 NTU.

This response pattern is consistent with a runoff-driven turbidity event. A rainfall total of 22.6 mm recorded in the preceding 24 hours is considered sufficient to generate surface runoff, particularly under potentially wet antecedent conditions, resulting in the mobilisation and transport of suspended sediments to the monitoring location. The presence of both a primary peak and secondary elevated phase suggests an initial flush of sediments followed by continued or delayed contributions from the catchment.

*The SE05T catchment area was inspected, no evidence of mining related contribution was found.*

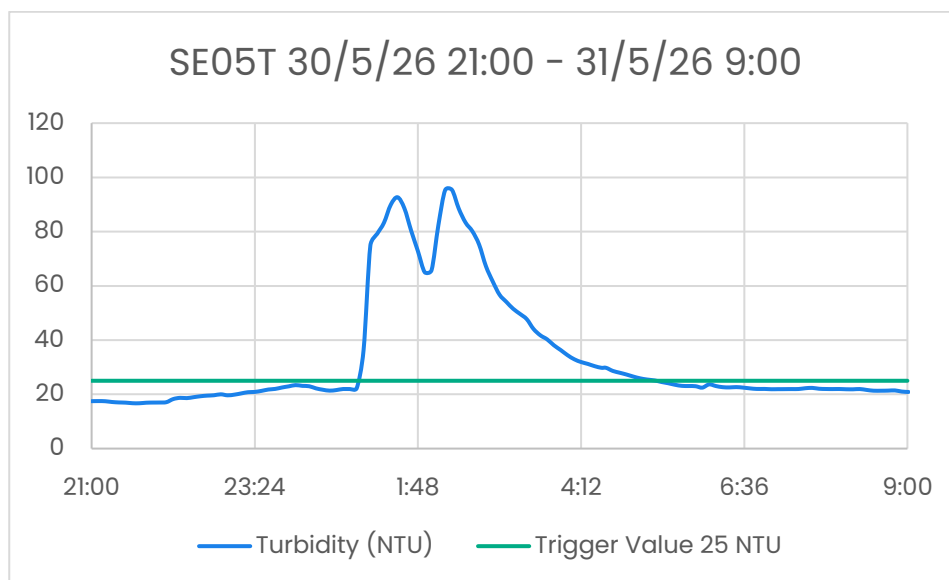
Figure 7- SE05T - May 31st

Following the secondary peak, turbidity levels decreased in a steady and continuous manner, with a well-defined recession limb. Concentrations progressively declined until returning below the trigger threshold.

The observed turbidity response demonstrates a clear relationship with preceding rainfall conditions. A total of 8.7 mm of rainfall was recorded in the 24 hours prior to the event. Although relatively low, this rainfall is considered sufficient to generate localised surface runoff, particularly under potentially wet antecedent conditions. The presence of two distinct peaks suggests an initial mobilisation of readily available fine sediments followed by a secondary contribution, potentially due to delayed runoff pathways or continued sediment transport within the catchment.

*The SE05T monitoring site was inspected on 02 June 2026, the stream was fast flowing. The SE05T catchment area was inspected, no evidence of mining related contribution was found.*

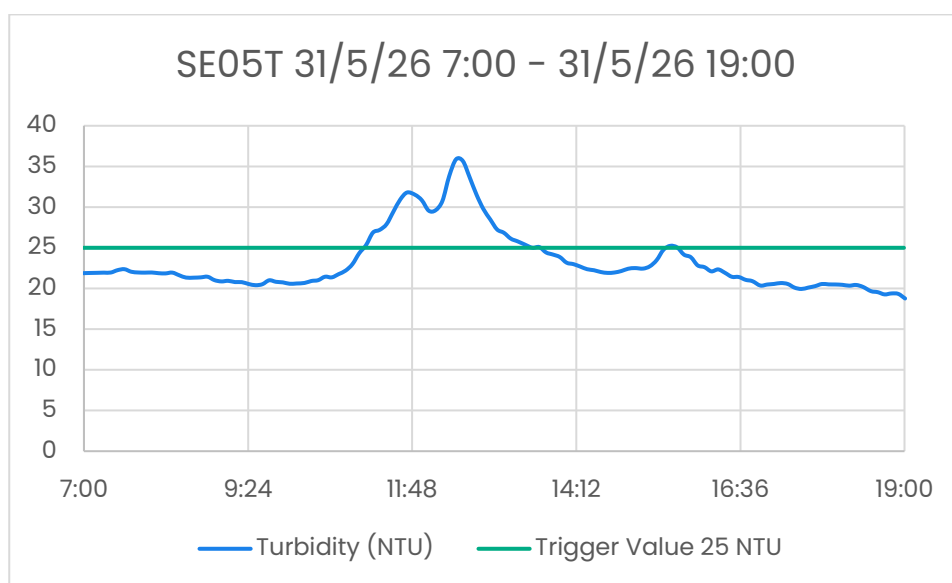
Figure 8- SE05T - May 31st

again to a secondary peak. Following this secondary peak, turbidity levels showed a steady and continuous decline.

The observed turbidity response is consistent with rainfall-driven runoff processes. A total of 16.5 mm of rainfall was recorded in the 24 hours preceding the event. While moderate, this rainfall is sufficient to generate localised surface runoff, particularly under potentially wet antecedent conditions. The presence of a secondary peak suggests either staggered runoff inputs or delayed mobilisation of sediments within the catchment.

*The SE05T monitoring site was inspected on 02 June 2026, the stream was fast flowing. The SE05T catchment area was inspected, no evidence of mining related contribution was found.*

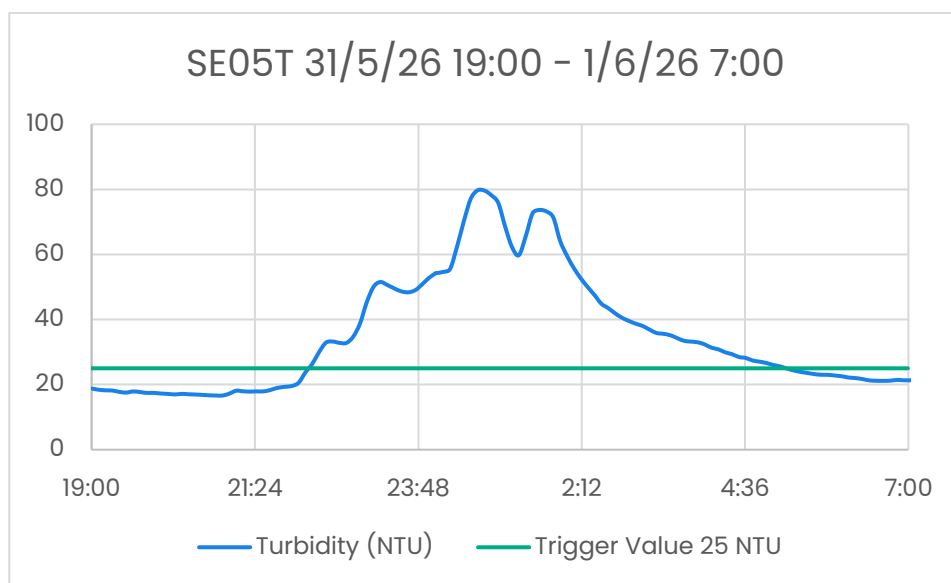
Figure 9- SE05T - May 31st

Following this secondary peak, turbidity levels exhibited a steady and continuous decline, forming a well-defined recession limb. Concentrations progressively decreased over several hours.

The observed turbidity response is consistent with rainfall-driven runoff processes. A total of 20.6 mm of rainfall was recorded in the 24 hours preceding the event. This rainfall is sufficient to generate localised surface runoff, particularly under potentially wet antecedent conditions. The presence of multiple peaks suggests staggered runoff inputs and/or delayed mobilisation of sediments within the catchment.

*The SE05T catchment area was inspected, no evidence of mining related contribution was found.*

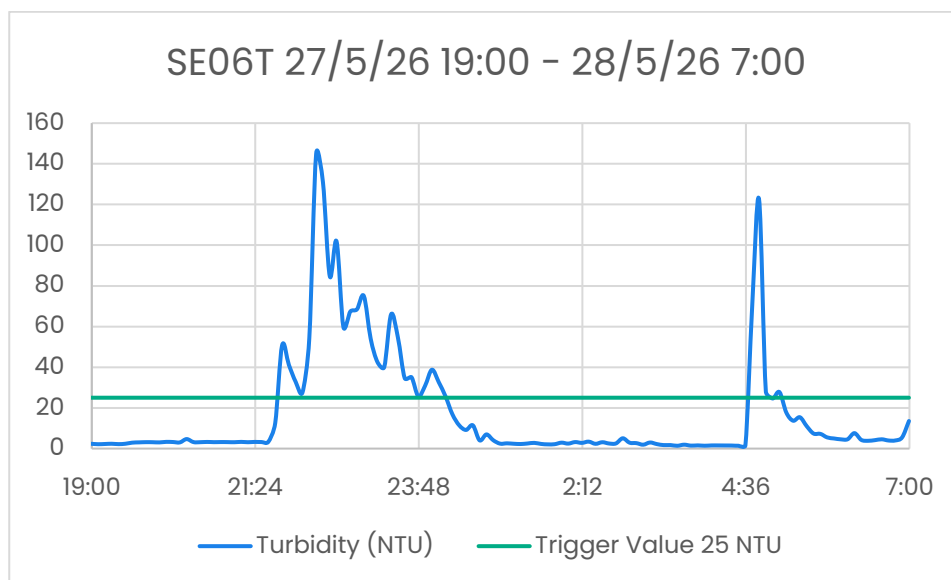
Figure 10- SE06T - May 27th

Trend analysis of the monitoring data (Figure 10) indicates a highly dynamic, multi-peaked response. Turbidity increased rapidly from below the trigger threshold (25 NTU) to approximately 50 NTU, followed by a brief decline before a sharp rise to a primary peak of approximately 145–150 NTU. This was followed by a rapid decrease and subsequent fluctuations, including secondary and tertiary peaks of approximately 100 NTU and 70–75 NTU, respectively. After this series of peaks, turbidity levels steadily declined, returning toward baseline conditions by the end of the monitoring period.

A total of 3.5 mm of rainfall was recorded in the 24 hours prior to the event; however, this rainfall occurred over a short duration of approximately 20 minutes, representing a relatively high-intensity rainfall burst. Despite the low total rainfall volume, the intensity is considered sufficient to generate rapid surface runoff and mobilise fine sediments.

The pronounced and rapid turbidity peaks are therefore consistent with an intense, short-duration runoff event. The multi-peaked response suggests successive pulses of sediment-laden inflow, likely reflecting rapid catchment connectivity, localised flow pathways, and/or remobilisation of previously deposited sediments. This behaviour indicates a system that is highly sensitive to short-duration, high-intensity rainfall events.

*The SE06T catchment area was inspected, no evidence of mining related contribution was found.*

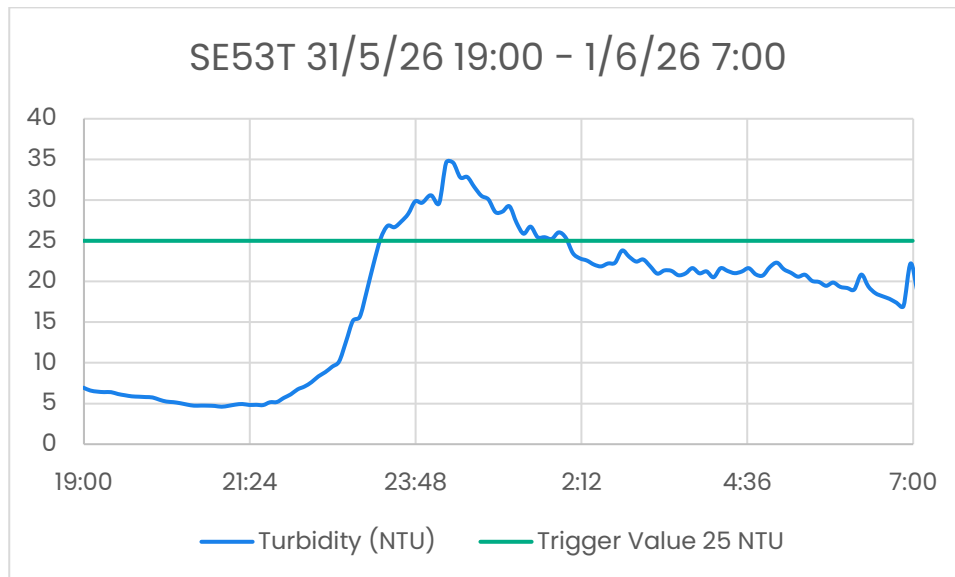
Figure 11- SE053T - May 31st

Following the primary peak, turbidity levels gradually declined, with minor fluctuations observed during the recession phase. Concentrations then continued to decrease steadily, returning to below the trigger threshold.

The observed turbidity response is consistent with rainfall-driven runoff processes. A total of 29.3 mm of rainfall was recorded in the 24 hours preceding the event. This relatively high rainfall volume is sufficient to generate sustained surface runoff and sediment mobilisation across the catchment.

*The data trend indicates a gradual incline in turbidity NTU commencing midway through the rain event and a gradual decline post rainfall. SE53T monitoring site was inspected on 03 June 2026, stream was clear and flowing with vegetation surrounding the sensor location. On arrival, the sensor pole was observed to have vertically dropped and therefore the sensor appeared to be sitting close to the stream bed. The sensor face was covered in a light film of algae.*

*The SE53T catchment area was inspected, no evidence of mining related contribution was found.*

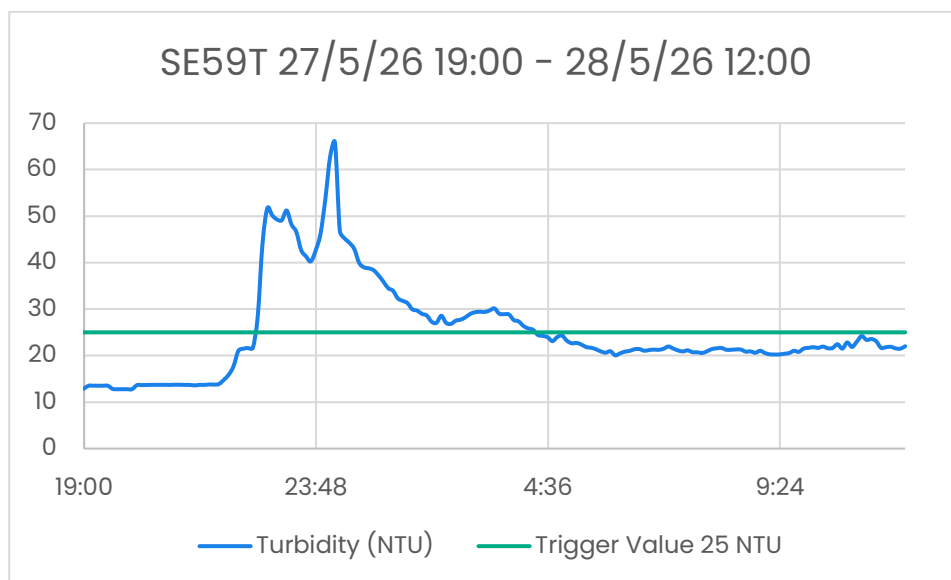
Figure 12- SE59T - May 27th

Following the peak, turbidity levels declined steadily, with a gradual. Minor fluctuations were observed during the recession phase, including a small secondary rise. Turbidity levels continued to decrease thereafter, reaching and remaining below the trigger threshold for the latter part of the monitoring period.

The observed turbidity response is consistent with rainfall-driven runoff processes. A total of 6.9 mm of rainfall was recorded in the 24 hours preceding the event. While relatively low, this rainfall is considered sufficient to generate localised surface runoff, particularly under potentially wet antecedent conditions. The sharp initial increase and distinct peak suggest rapid mobilisation of fine sediments, while the extended recession indicates gradual settling and dilution within the system.

*The data trend indicates a gradual increase in turbidity following a eight-hour period of sustained rainfall. In the hours following the rainfall, turbidity values rapidly declined to consistent readings <7 NTU. The SE59T monitoring site was inspected on 28 May 2026, during which elevated stream flow conditions and built-up organic debris were observed. The sensor was cleaned, resulting in turbidity readings rapidly decreasing from 21 to 8 NTU.*

*The SE59T catchment area was inspected, no evidence of mining related contribution was found.*

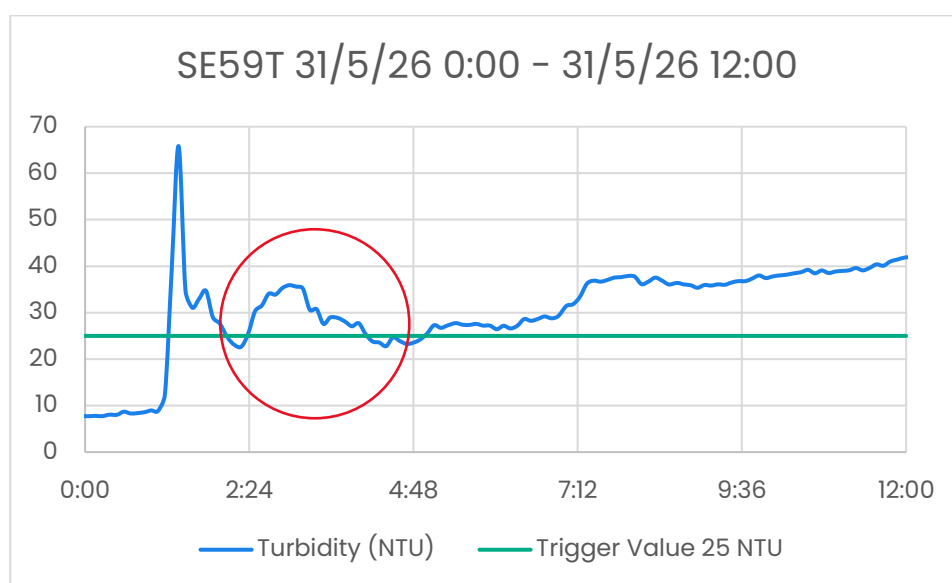
Figure 13- SE59T - May 31st

Trend analysis of the monitoring data (Figure 13) indicates a moderate, multi-phase response. Turbidity increased followed by a broad primary peak. After the peak, turbidity levels declined sharply, followed by minor fluctuations, including a brief secondary rise. Subsequently, turbidity levels decreased steadily, with a well-defined recession limb, returning to below the trigger threshold.

The observed turbidity response is consistent with rainfall-driven runoff processes. A total of 9 mm of rainfall was recorded in the 24 hours preceding the event. While relatively modest, this rainfall is sufficient to generate localised surface runoff, particularly under potentially wet antecedent conditions.

*sensor cage was heavily impacted with sediment on inspection potentially impacted from stream bank adjacent which had evidence of animal activity and erosion of bank. The sensor was cleaned and returned into flow cell in the stream. The turbidity NTU pre clean was 19.94 rapidly decreased to turbidity 3.12 NTU post clean. The SE59T catchment area has been inspected and no evidence of mining related drainage concerns observed.*

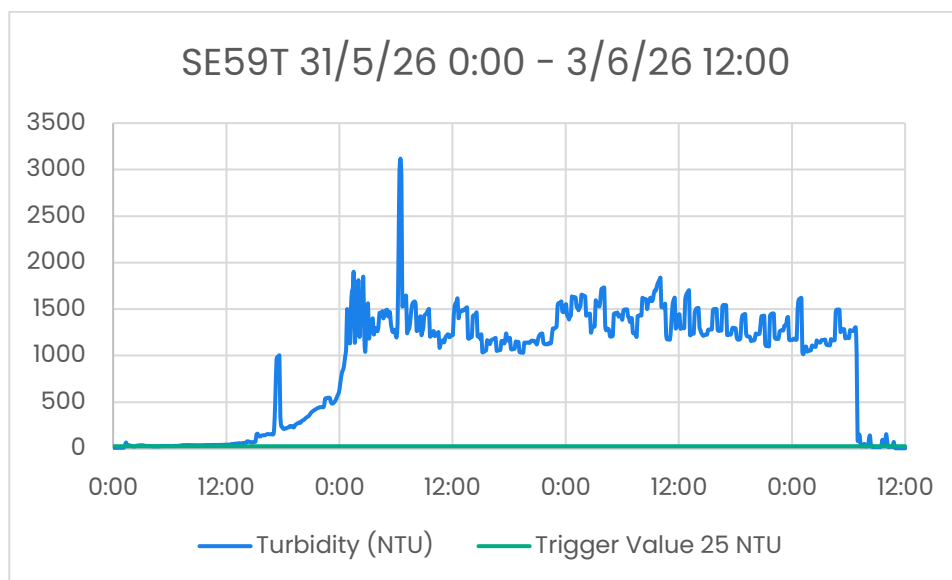
Figure 14- SE59T - May 31st

Trend analysis of the monitoring data (Figure 14) indicates an atypical and highly elevated turbidity response compared to standard rainfall-driven events. Turbidity levels initially increased from near the trigger threshold (25 NTU) to several hundred NTU, followed by a rapid escalation to sustained concentrations generally ranging between approximately 1,000 and 1,500 NTU. A pronounced isolated spike exceeding 3,000 NTU was also recorded. These elevated levels persisted for an extended period exceeding 24 hours before rapidly declining back to near baseline conditions toward the end of the monitoring period.

A total of 10.6 mm of rainfall was recorded in the 24 hours preceding the event. While this rainfall is sufficient to generate surface runoff, the magnitude, duration, and variability of the turbidity response are disproportionate to typical rainfall-driven behaviour observed at this site.

Instead, the sustained high turbidity levels, extreme peak values, and highly erratic fluctuations strongly indicate significant localised disturbance within close proximity to the monitoring location. The observed pattern is most consistent with animals (as noted by Alcoa) entering and disturbing the waterbody or channel bed, resulting in prolonged resuspension of fine sediments. The abrupt return to baseline conditions further supports this interpretation, indicating cessation of the disturbance rather than gradual attenuation typical of runoff-driven events.

*The SE59T catchment area has been inspected and no evidence of mining related drainage concerns observed.*

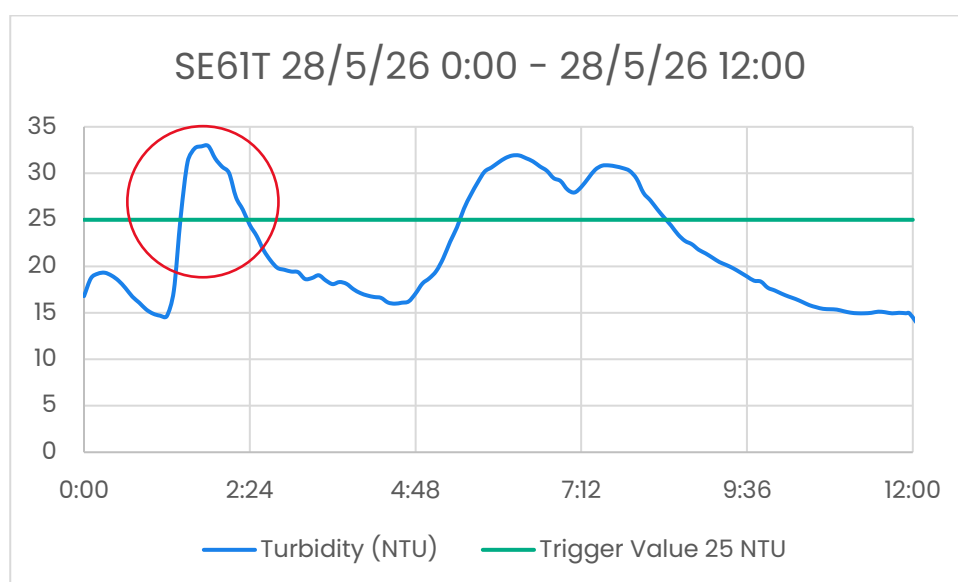
Figure 15- SE61T - May 28th

Following this peak, turbidity levels declined gradually, with a smooth and continuous recession limb. Concentrations fell below the trigger threshold by approximately 2:25 AM and continued decreasing toward baseline levels thereafter.

The observed turbidity response is consistent with rainfall-driven runoff processes. A total of 13.2 mm of rainfall was recorded in the 24 hours preceding the event. This rainfall is sufficient to generate localised surface runoff and sediment mobilisation.

*The SE61T monitoring site was inspected on 28 May 2026. Stream flow velocity had increased significantly, resulting in turbulent conditions around the sensor and the accumulation of organic debris and algae.*

*An inspection of the SE61T catchment area was completed, no evidence of mining contribution to the turbidity exceedance was found*

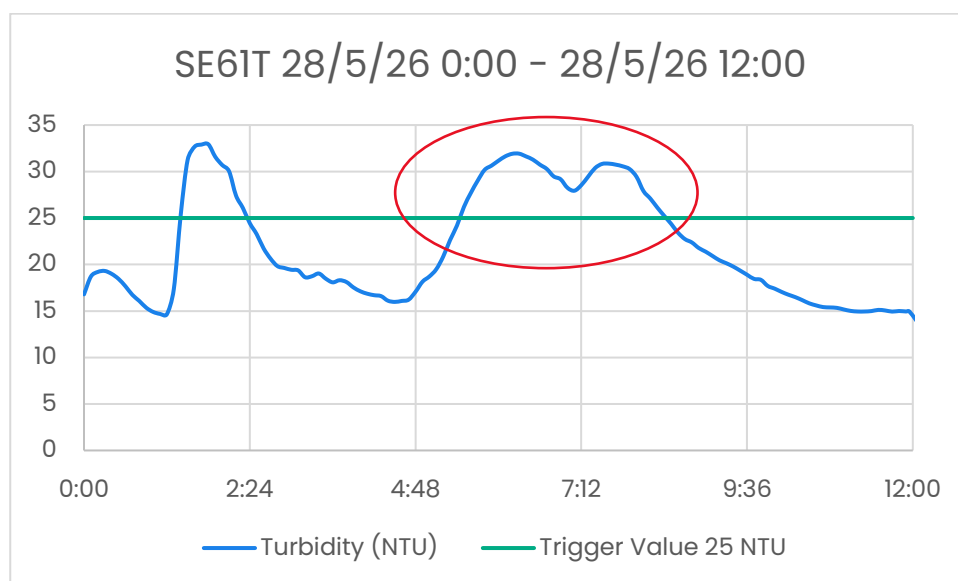
Figure 16- SE61T - May 28th

The turbidity trend (Figure 16) indicates a moderate, multi-phase response. Turbidity initially increased, followed by a slight decline and brief fluctuation, before rising again to a secondary peak. Following this secondary peak, turbidity levels exhibited a steady and continuous decline toward baseline conditions.

The observed turbidity response is consistent with rainfall-driven runoff processes. A total of 27.2 mm of rainfall was recorded in the 24 hours preceding the event. This rainfall is sufficient to generate localised surface runoff, particularly under potentially wet antecedent conditions. The presence of a secondary peak suggests either staggered runoff inputs or delayed mobilisation of sediments within the catchment.

*The SE61T monitoring site was inspected on 28 May 2026. Stream flow velocity had increased significantly, resulting in turbulent conditions around the sensor and the accumulation of organic debris and algae.*

*An inspection of the SE61T catchment area was completed, no evidence of mining contribution to the turbidity exceedance was found.*

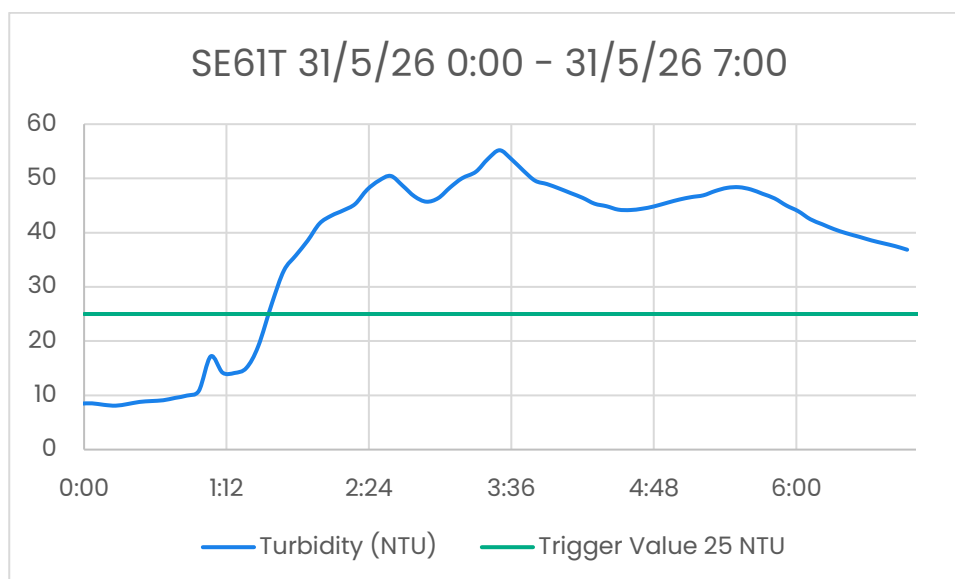
Figure 17- SE61T - May 31st

The turbidity trend (Figure 17) indicates a complex, multi-phase response. Turbidity initially increased rapidly following a slight decline, reaching a primary peak. This was followed by a decrease, before rising again to a secondary peak. After the secondary peak, turbidity levels showed a steady decline, with a brief minor increase observed prior to a continued and consistent downward trend until the data logger ceased recording.

The observed turbidity response is consistent with rainfall-driven runoff processes. A total of 8.8 mm of rainfall was recorded in the 24 hours preceding the event. While relatively moderate, this rainfall is sufficient to generate localised surface runoff, potentially mobilising sediments into the monitored system. The presence of multiple peaks suggests staggered inflows or delayed sediment transport within the catchment.

*The SE61T monitoring site was inspected on 03 June 2026. Stream was flowing clear and sensor face was impacted with a light film of algae and heavily stained. The forest track running parallel with the stream is impacted with groundwater and heavily eroded upstream of sensor. During the rain event it is possible water flow from the forest track is deviating towards the stream through vegetation.*

*An inspection of the SE61T catchment area has been inspected and no evidence of mining related drainage concerns observed.*

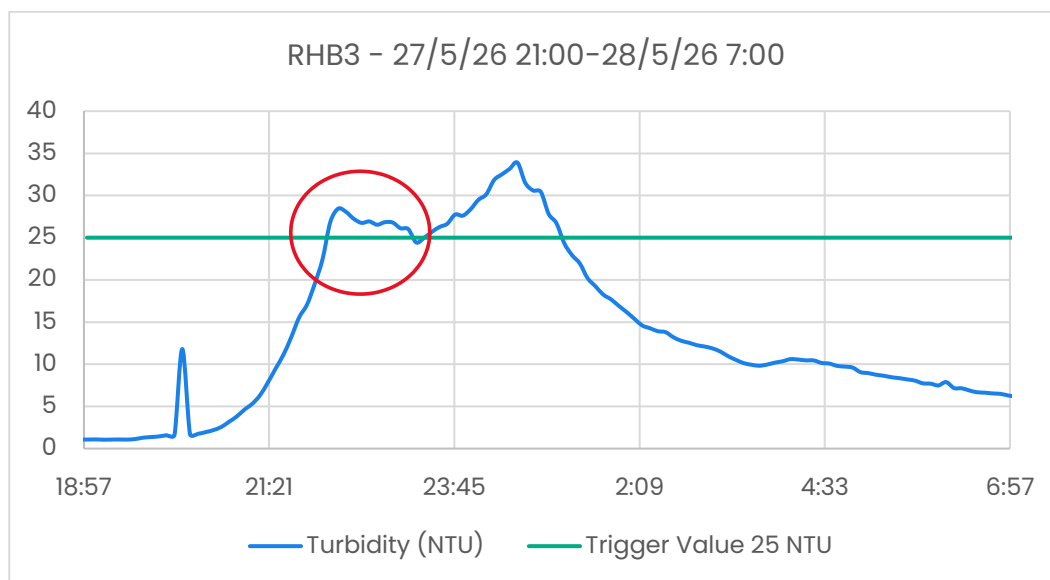
Figure 3 RHB3 27/05/2026 22:09-23:15

Trend analysis indicates a strong correlation between turbidity response and preceding rainfall conditions. A total of 54.2 mm of rainfall was recorded in the 24 hours prior to the event, representing a substantial precipitation input. This rainfall is considered to have significantly increased surface runoff and stream flow velocity, resulting in turbulent conditions and the mobilisation of fine sediments, organic material, and suspended particulates within the catchment.

The moderate peak magnitude and short-duration exceedance, combined with the smooth and well-defined turbidity profile, support the interpretation that the event was driven by rainfall-induced runoff processes, rather than instrumentation issues or localised disturbance.

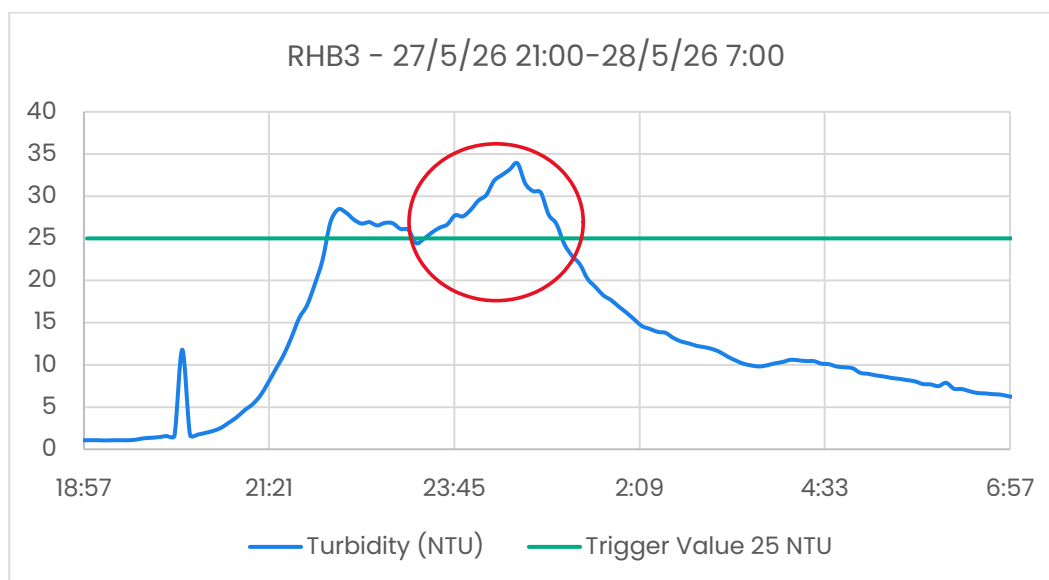
Figure 4 RHB3 27/05/2026 23:27- 28/05/2026 1:11

Trend analysis indicates a strong correlation between turbidity response and preceding rainfall conditions. A total of 54.2 mm of rainfall was recorded in the 24 hours prior to the event, representing a significant precipitation input. This rainfall is considered to have substantially increased runoff volumes and stream flow velocity, leading to the mobilisation and transport of fine sediments, organic material, and suspended particulates into the monitoring location.

The moderate peak magnitude combined with the extended duration above the 25 NTU trigger threshold suggests a sustained but less intense turbidity response, consistent with prolonged runoff contributions rather than a short, high-intensity pulse.
