WESTERN
ENVIRONMENTAL

WILLOWDALE MINESITE

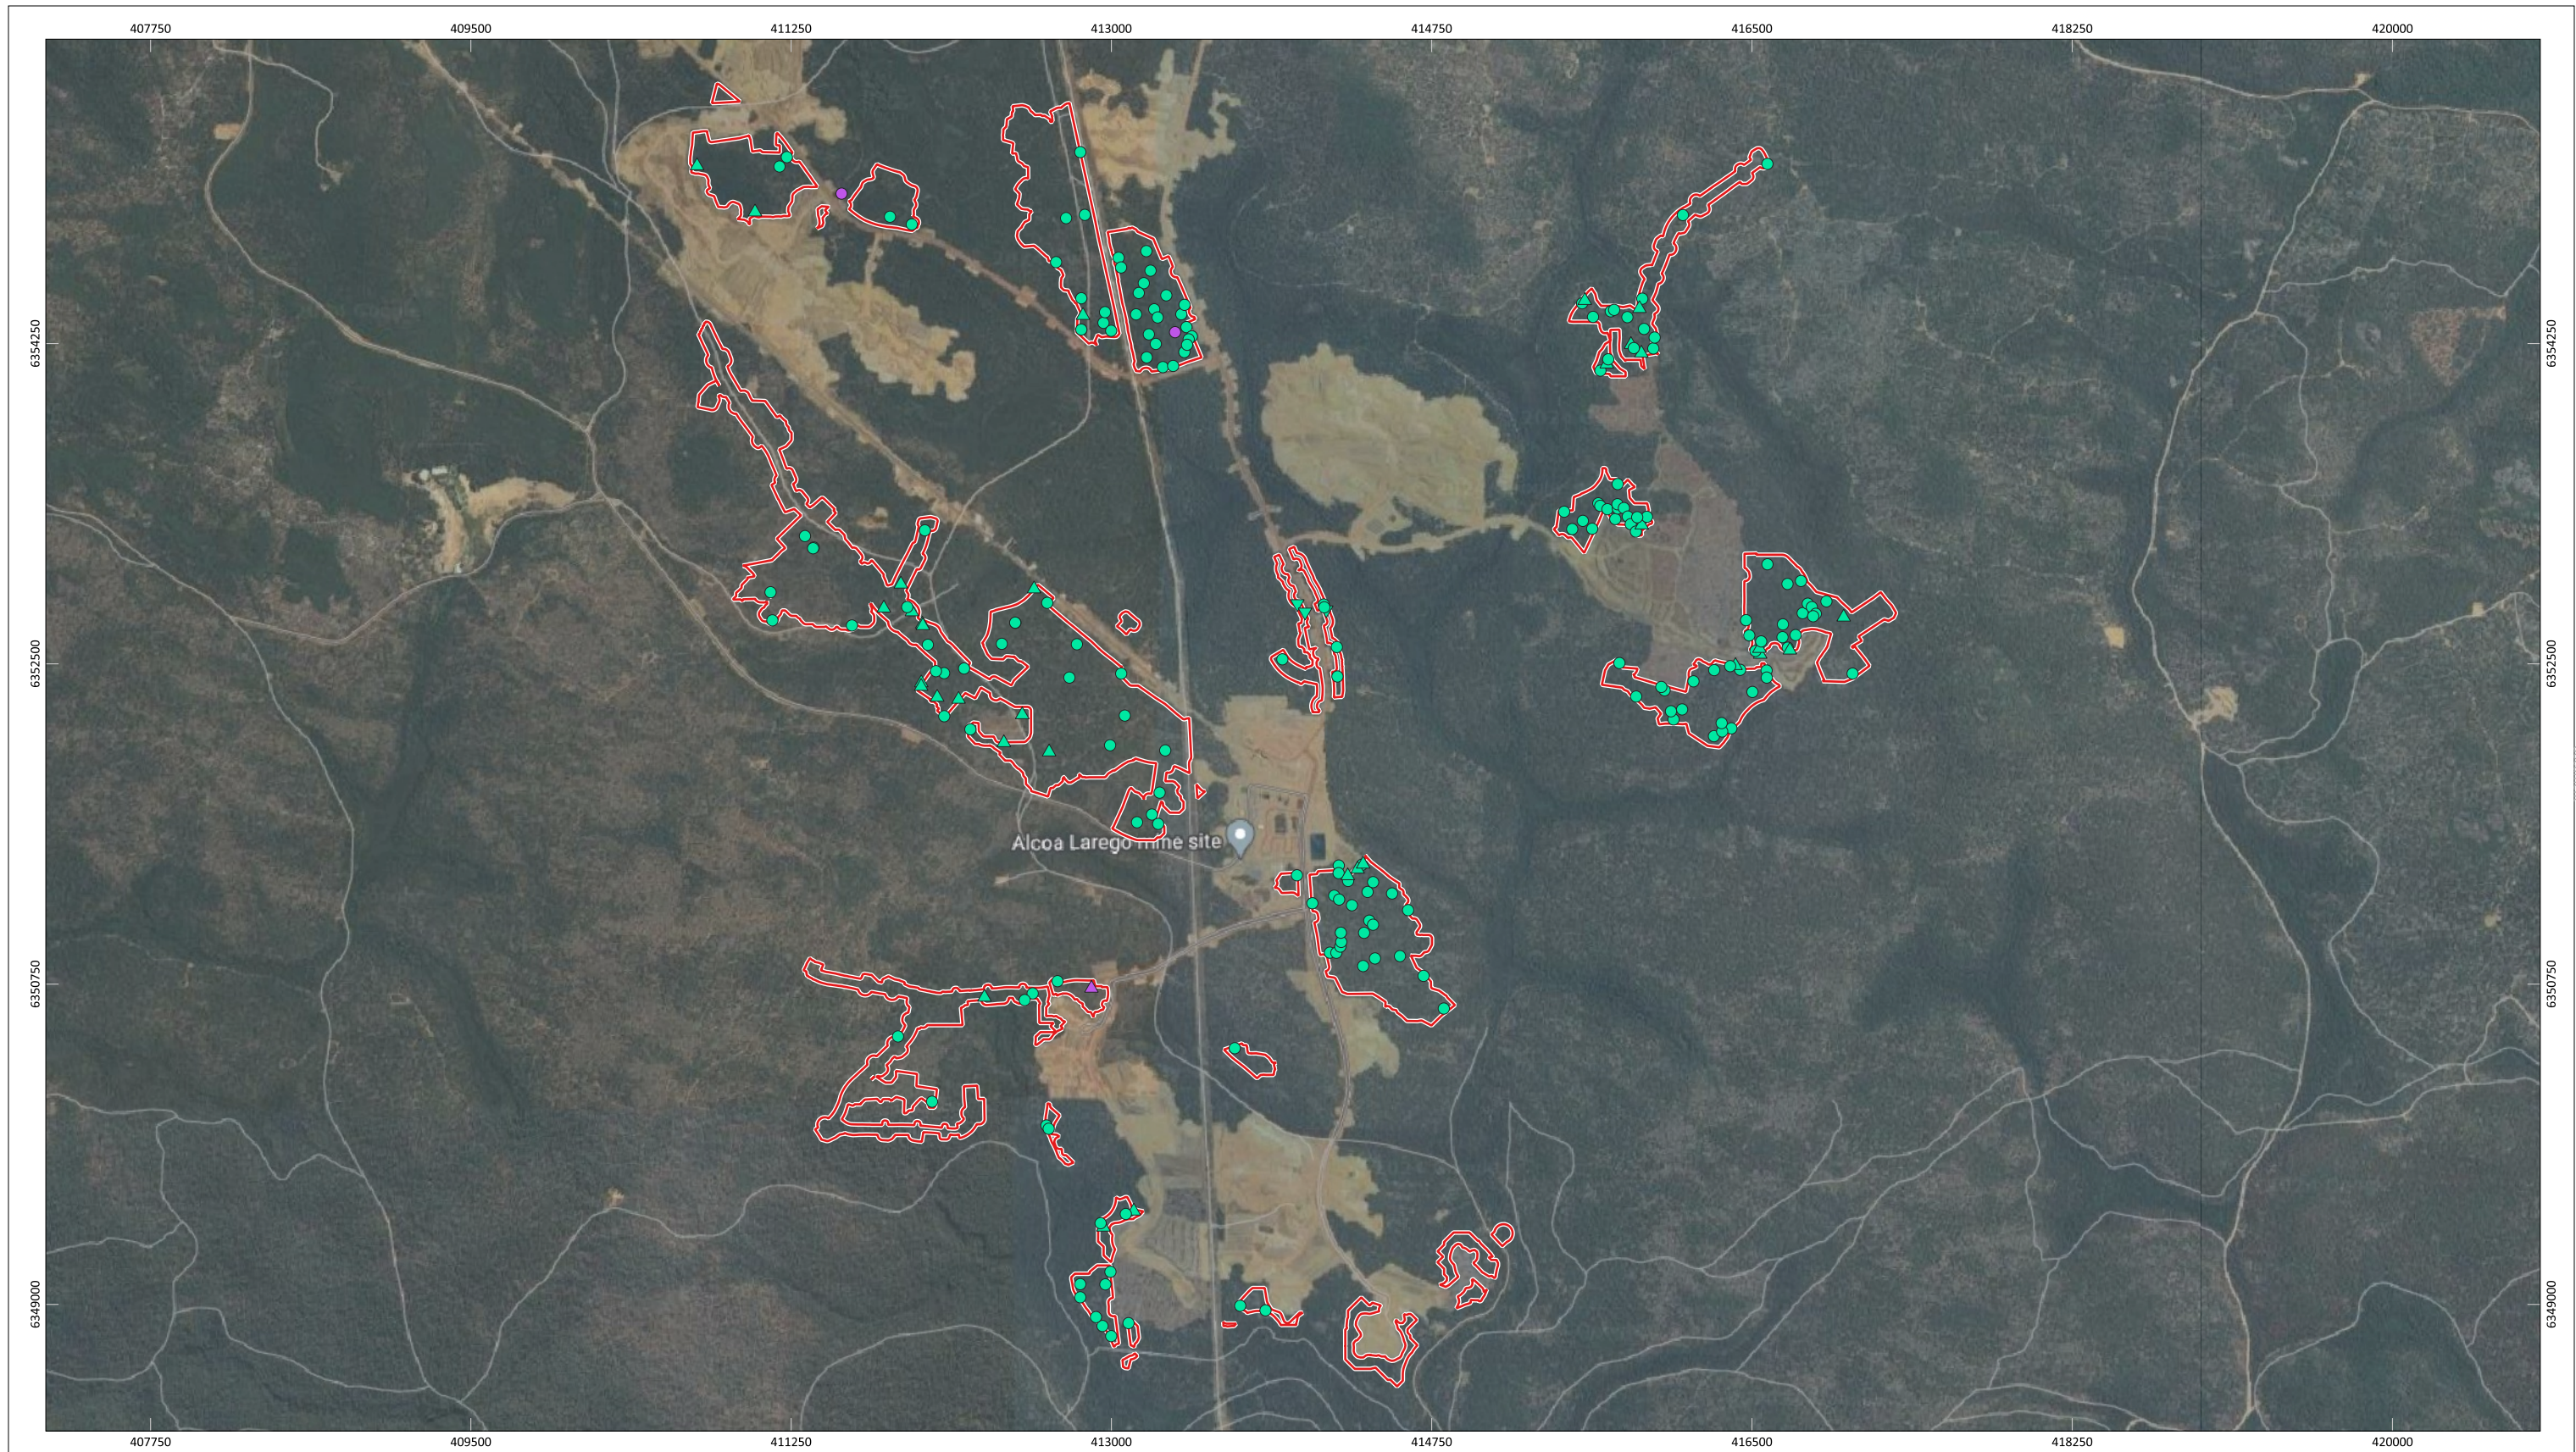
Figure 3: Black Cockatoo Observations

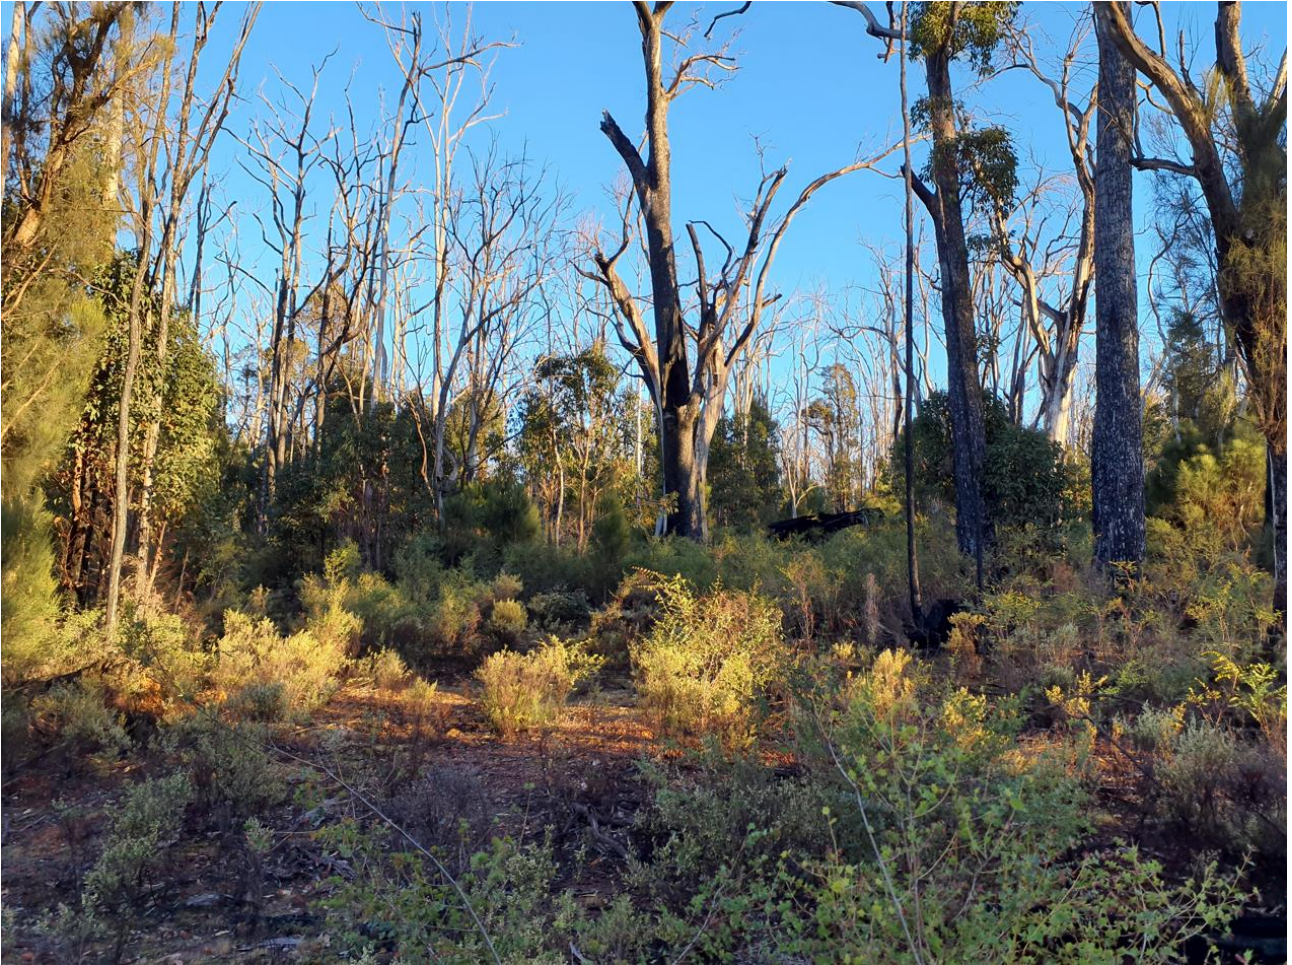
Image 02- Fire Impacted Habitat

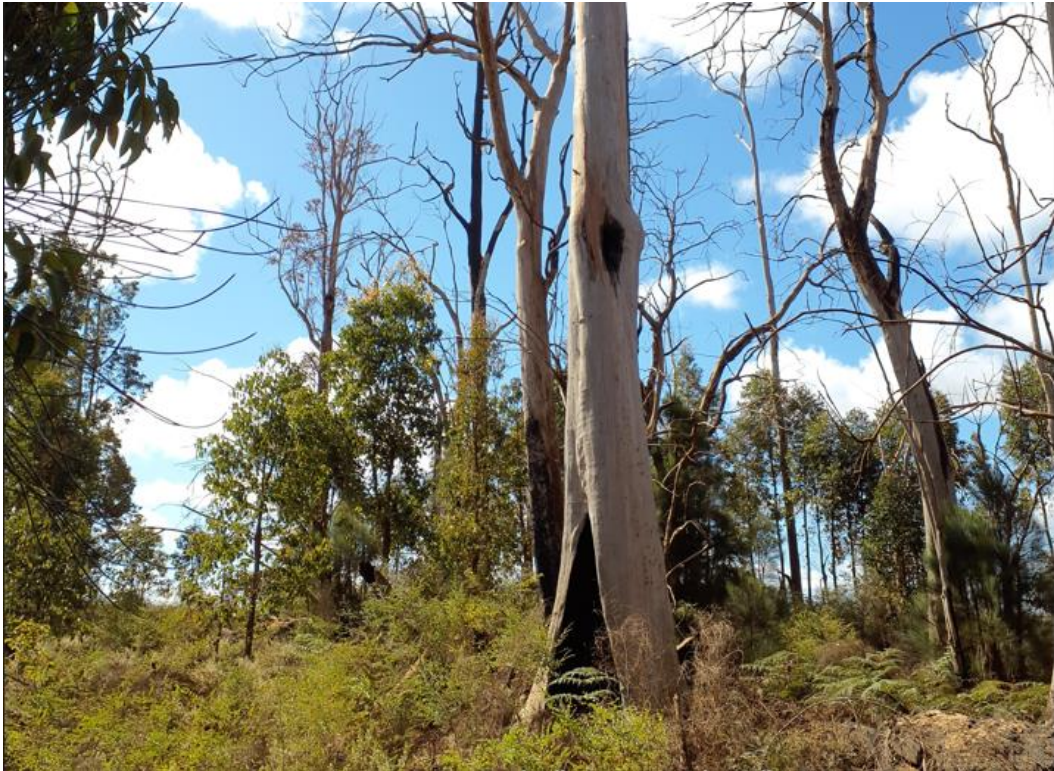
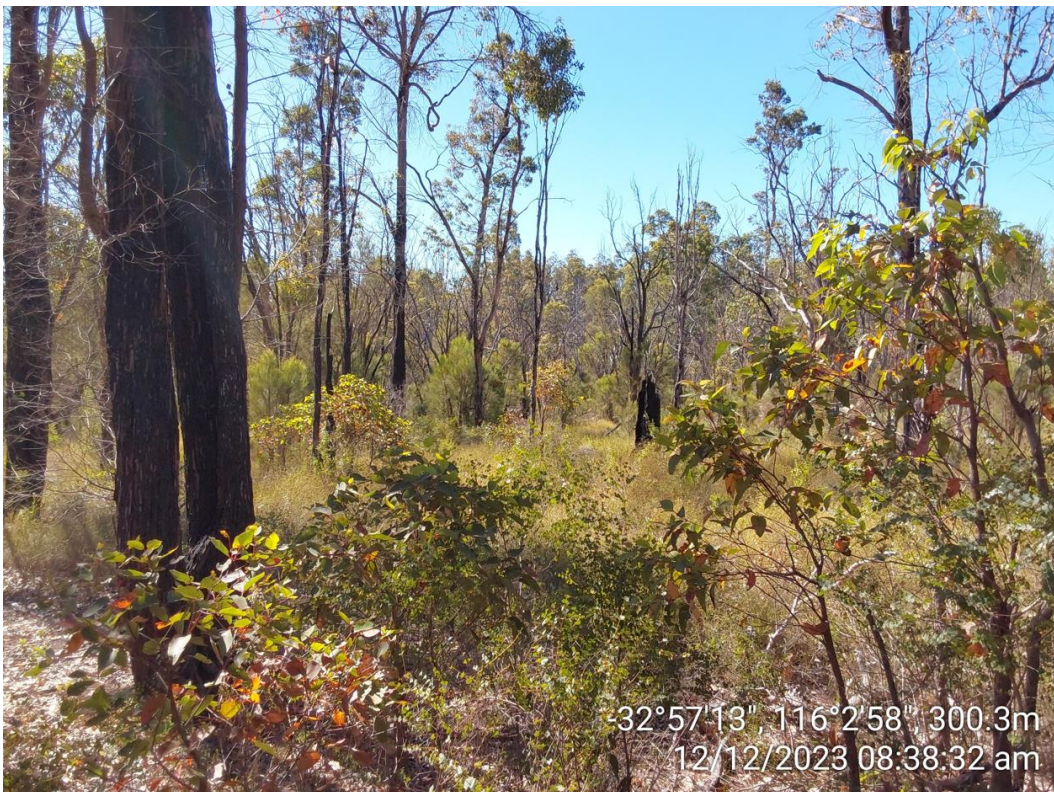
Site Condition 4-Moderate. Marri-Jarrah Forest or woodlands with 20-30% projected foliage cover; OR Marri-Jarrah Forest with 40-60% projected foliage cover but vegetation condition reduced due to tree deaths

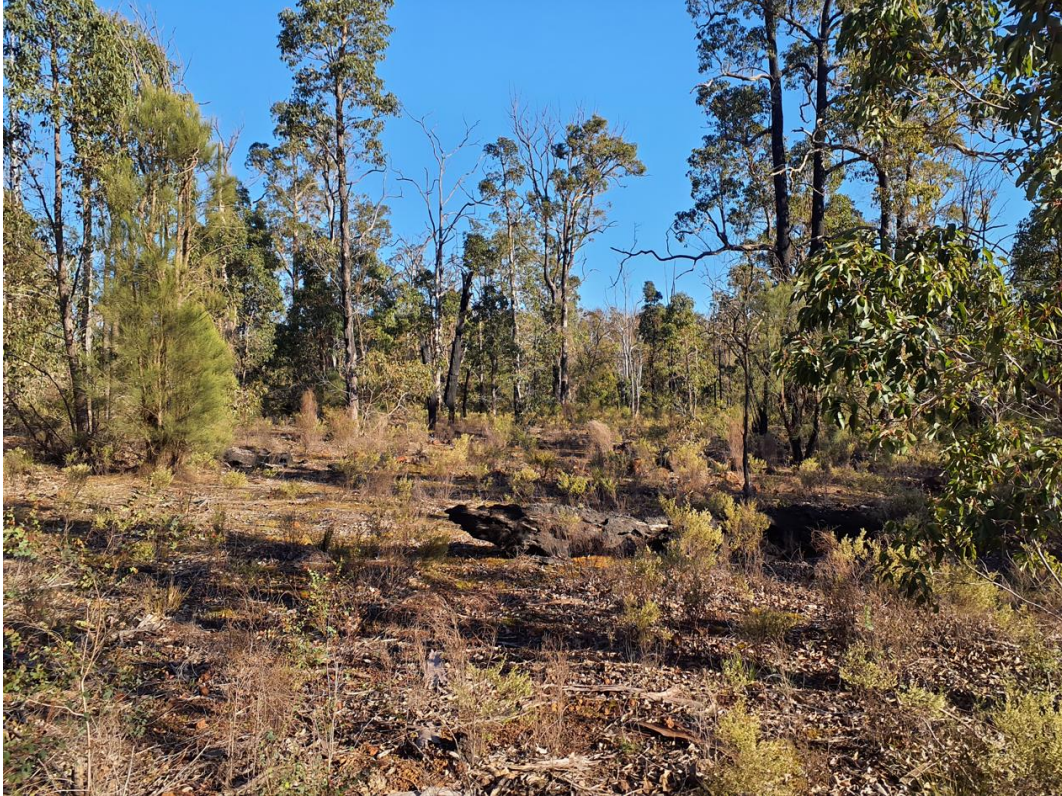
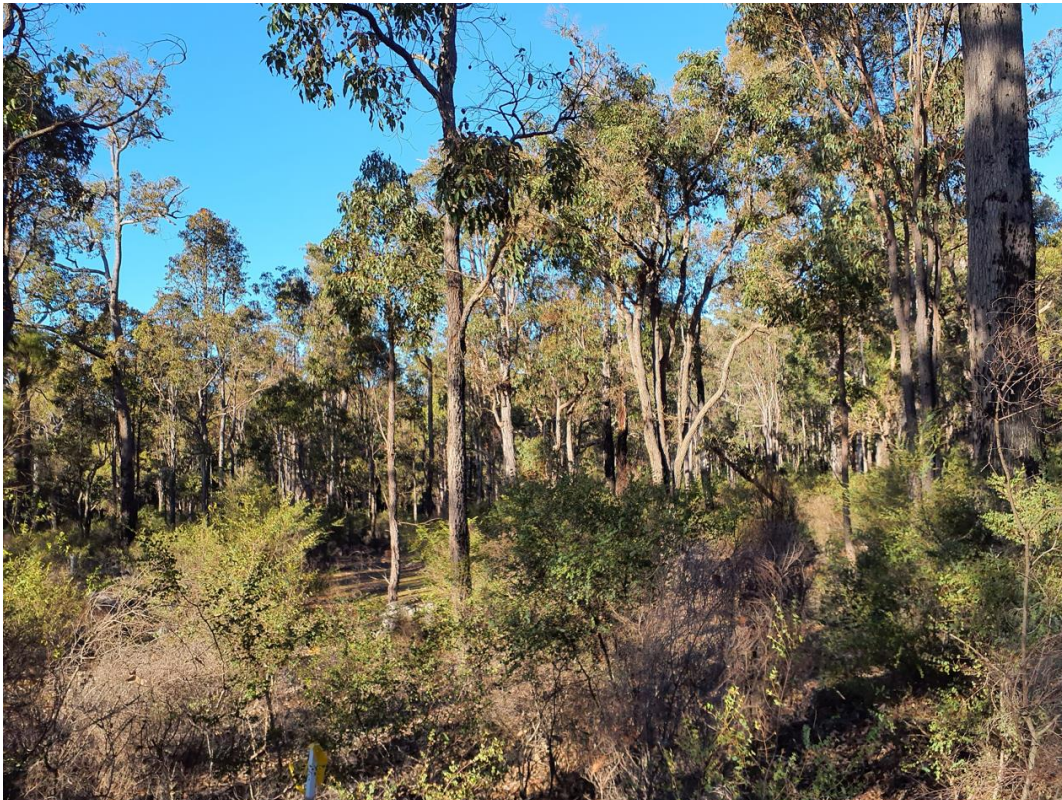
Site Condition 5- Moderate to High. Marri-Jarra Forest or woodlands with 30-40% projected foliage cover; OR > 60% projected foliage cover but veg. condition reduced due to tree deaths (up to 20%).

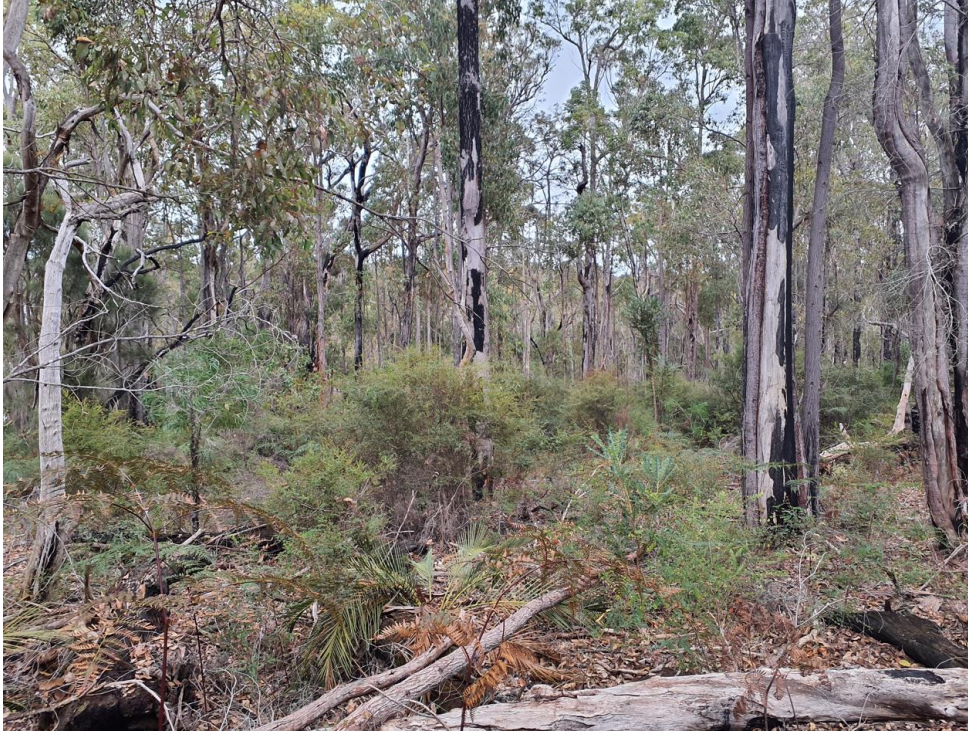
Site Condition 6-High. Marri-Jarrah Forest and woodlands with >40% projected foliage cover. Low percentage (< 10%) of tree deaths.

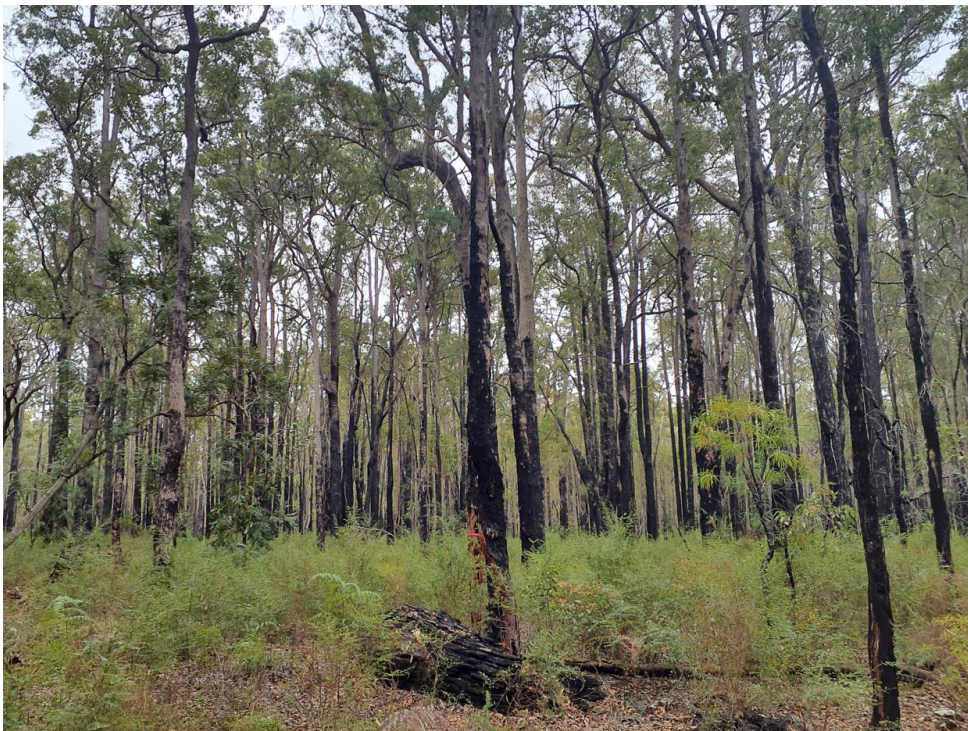
Site Condition 7- Very High. Marri-Jarrah Forest and woodlands with >50% projected foliage cover. Low percentage (< 5%) of tree deaths.

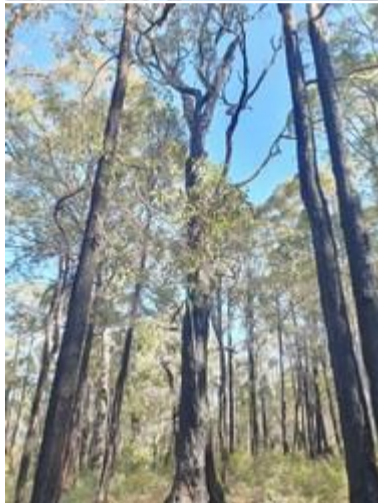
966	Marri	3	80	Tony. Mid trunk upwards facing hollow 15 cm by 25 cm. Wear marks, no chew.	414494.7872	6350949.686

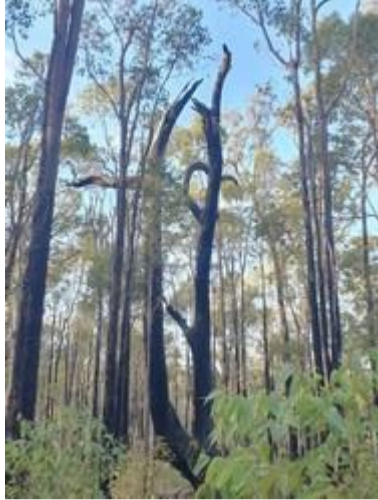
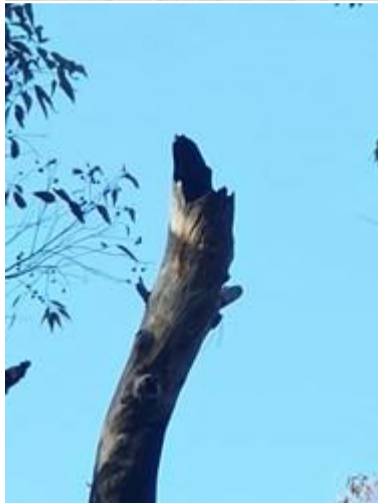
1008	Jarrah	3	100	Tony. Potential large chimney hollow in snapped off dead trunk section	414514.8255	6351151.517

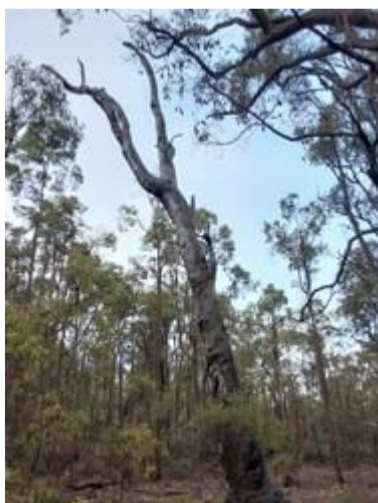
Merge Tree Number	Species	Class Bamford	DBH (cm)	Hollow Comments	Easting (AGD84/AMG zone 50)	Northing (AGD84/AMG zone 50)	Images
1133	Dead	3	100	Snapped off tree, potential hollow in broken spot. No evidence of weather.	413239.255	6351675.845

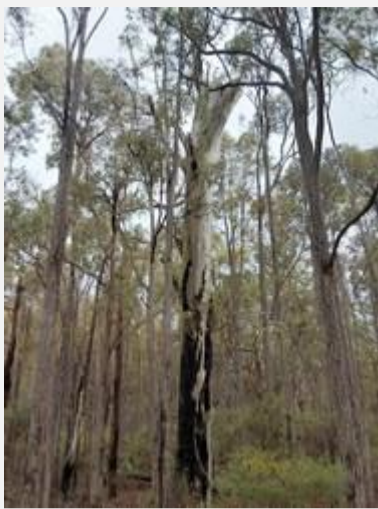
1144	Dead	3	50	Snapped off tree, potential chimney hollow, no sign of wear.	413252.6794	6351728.856

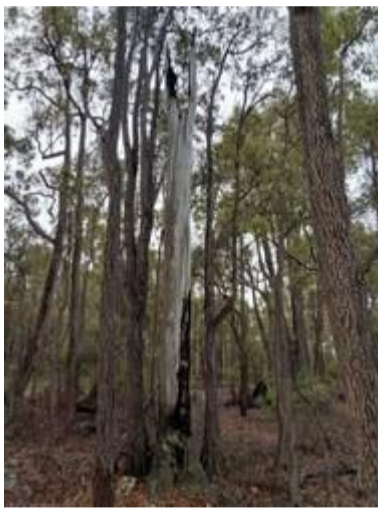
1145	Marri	3	120	Potential mid trunk hollow and spout hollow	413252.792	6351586.668

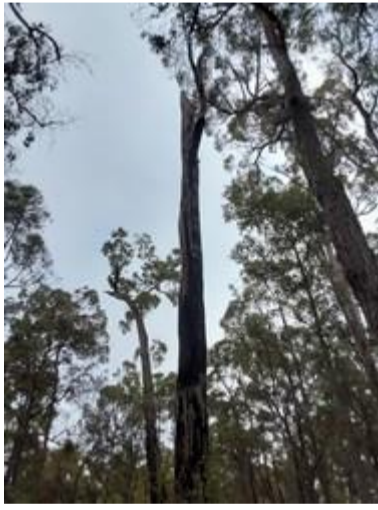
1171	Jarrah	3	70	10-15 cm mid trunk and downward facing hollows. No sign of wear.	413290.352	6351765.69

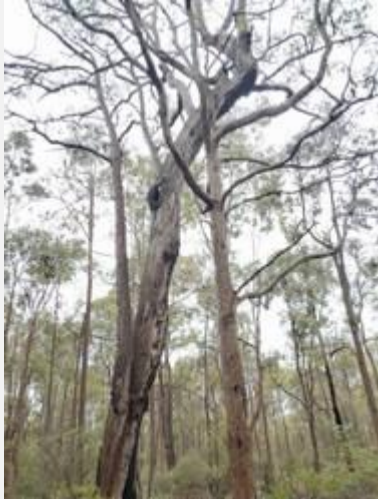
Merge Tree Number	Species	Class Bamford	DBH (cm)	Hollow Comments	Easting (AGD84/AMG zone 50)	Northing (AGD84/AMG zone 50)	Images
1194	Marri	3	90	10-15 cm spout opening present, potential hollow	413335.5787	6351730.886

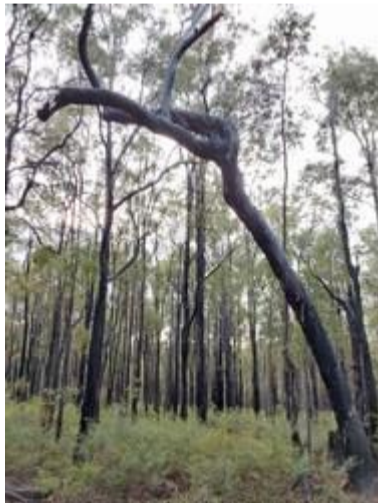
1326	Jarrah	3	80	Broken branches with potential hollow development and potential mid trunk hollow	414586.3238	6350750.503

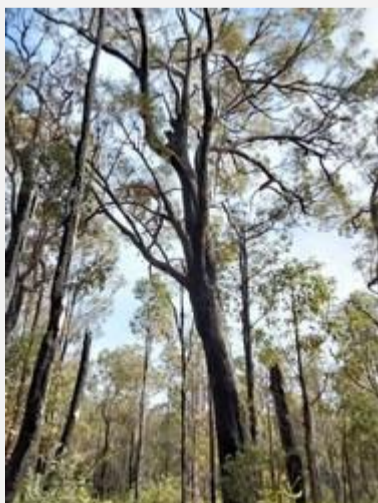
Merge Tree Number	Species	Class Bamford	DBH (cm)	Hollow Comments	Easting (AGD84/AMG zone 50)	Northing (AGD84/AMG zone 50)	Images
1353	Jarrah	3	180	Tony. Potential chimney hollow at the top, can't confirm.	414597.011	6351153.209

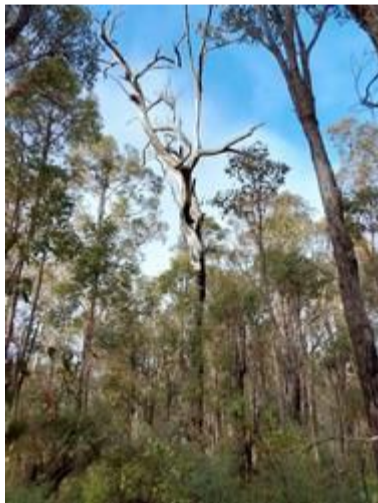
1377	Dead	3	85	Potential spout hollow from broken branches, appears 15-20 cm	414607.0906	6351187.381

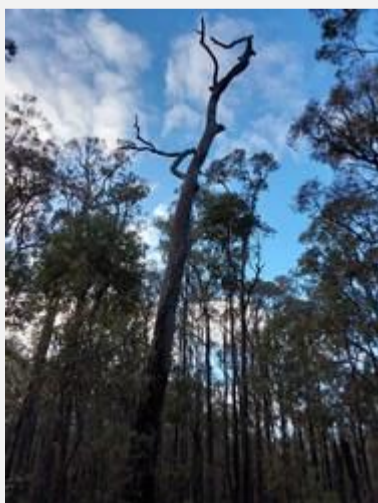
Merge Tree Number	Species	Class Bamford	DBH (cm)	Hollow Comments	Easting (AGD84/AMG zone 50)	Northing (AGD84/AMG zone 50)	Images
1396	Jarrah	3	110	Snapped off 12 m high, potential chimney hollow, cant confirm. No chewing evidence.	414613.9826	6351150.807	 
1421	Dead	3	85	Tony. Snapped off tree with potential chimney hollow, can't confirm	414621.4483	6351115.001	 
1429	Jarrah	3	100	Tony. One 25cm side opening. Other potential upwards	414625.3802	6351078.404

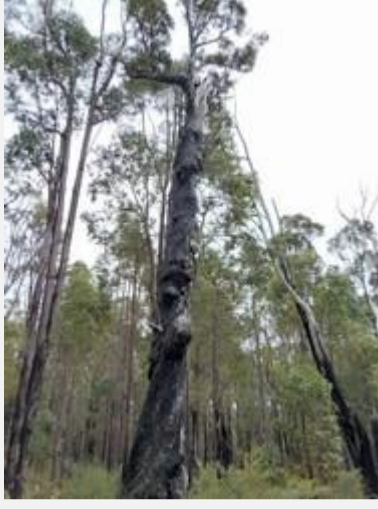
1638	Jarrah	3	110	Tony. >30cm spout hollow. Wear marks no chew. Angle and access potentially reduces likelihood. Other small hollows present	414840.8826	6350627.3

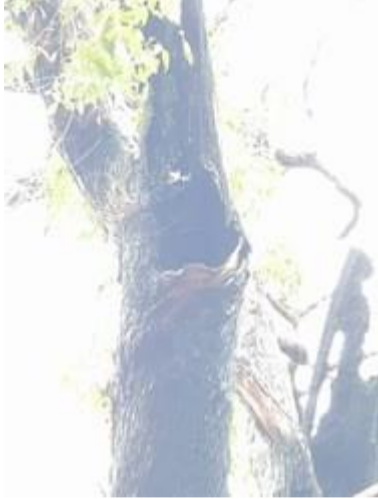
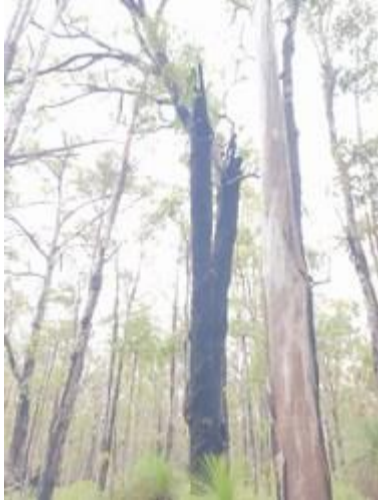
1642	Dead	3	80	Has several 10-15 cm openings, potential hollow	414852.7995	6350661.405

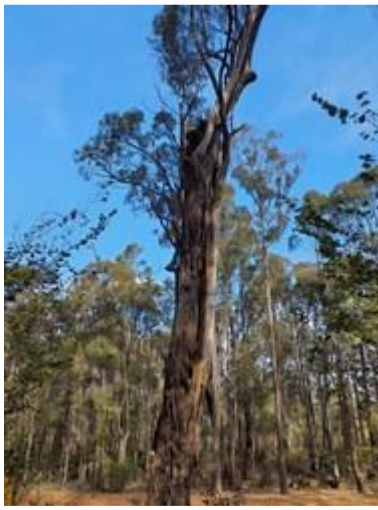
1671	Jarrah	3	160	Has several snapped off big branches, one opening is not very developed 10-	412614.1162	6351969.547

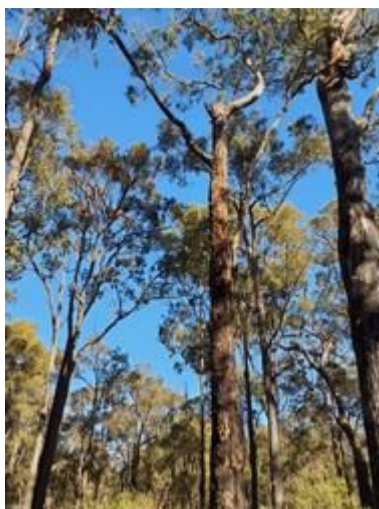
1690	Jarraah	3	70	Potential chimney hollow about 20 cm. No chew marks visible	412643.9137	6351842.806	
1752	Jarraah	3	75	One 10-15 cm mid trunk hollow. No evidence of chew marks.	412736.2571	6352157.774	
1824	Dead	3	100	Has a mid trunk hollow 10-15 cm. No chew marks.	412852.06	6351895.032	
1898	Jarraah	3	85	Has small <10 cm hollow and potential 10-15 cm hollows in broken branches up in canopy.	412982.4387	6352132.441	
1921	Jarraah	3	120	Tony. Potential chimney hollow from snapped off tree top. No visible chewing evidence present	413052.1538	6351972.002

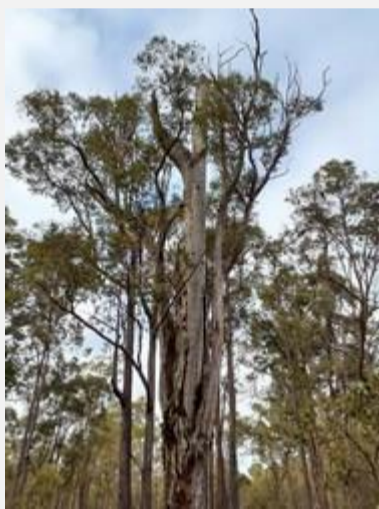
1923	Jarraah	3	100	Potential chimney hollow 20+ cm, however sides has cracks. No chew marks observed.	413066.8467	6352156.684

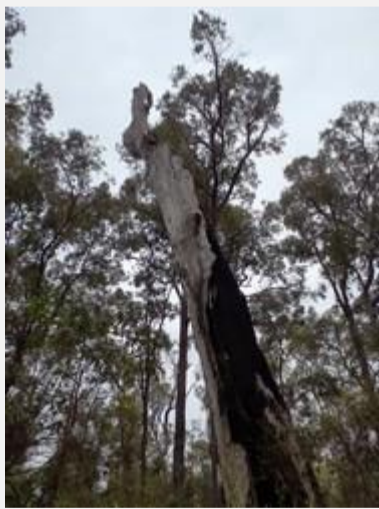
2126	Dead	3	160	Has several potential chimney hollows <20 cm. None has smooth edges, signs of wear or chew marks.	412695.5096	6352381.246

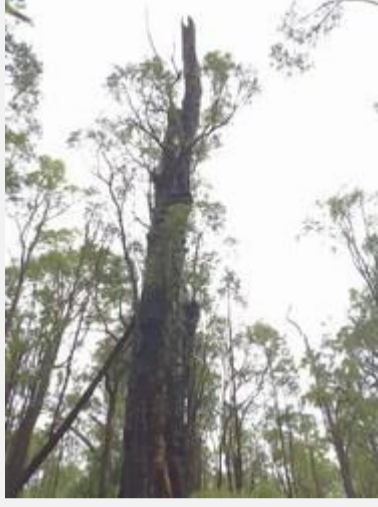
3083	Jarrah	3	80	One potential >20 cm chimney hollow at top, upwards facing and can't confirm. One side has a Crack and no chew marks or other signs of wear visible. Also one undeveloped spout hollow in broken branch.	412744.7192	6352694.693

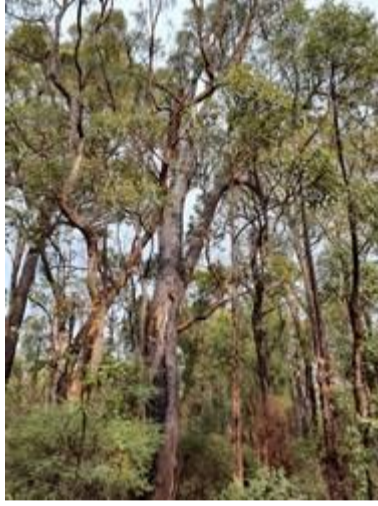
3102	Jarrah	3	50	One potential >20 cm hollow in fork, can't confirm from ground. No signs of wear. Also two undeveloped spout hollows in branches.	412786.7344	6352523.543

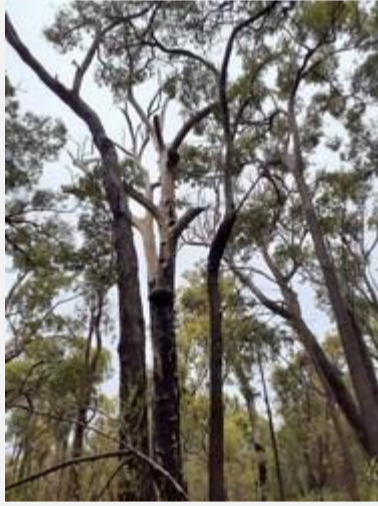
3103	Jarrah	3	50	Tony. One potential spout hollow >20 cm, upwards facing cant confirm. Also Potentially two >10 cm spout hollows, upwards facing, can't confirm.	412787.7288	6352540.53

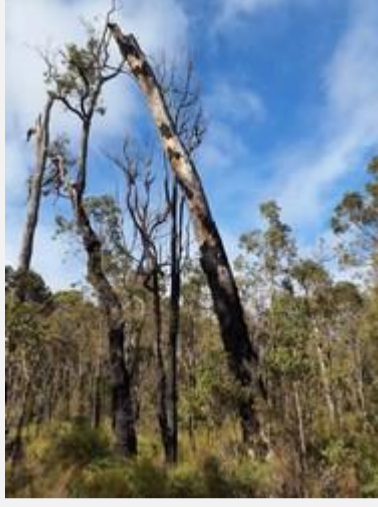
3492	Jarrah	3	90	Potential for mid trunk upwards opening in burnt out section at 6m up. Likely not developed to a hollow and too low to ground but can't confirm	411856.5604	6352874.353	 
3498	Marri	3	65	One 10-15 cm knot hollow, one <10 cm knot hollow and two 10-15 cm undeveloped spout hollows.	411859.8929	6352688.829

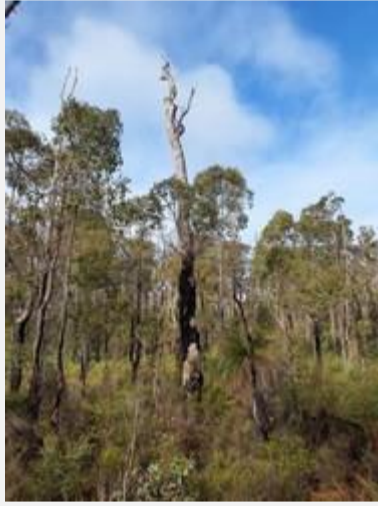
3514	Jarrah	3	100	Potential upwards angle opening 15-20cm hollow forming in large slit type scar mid trunk 15m up. Wear marks no chew. Think unlikely bc size chamber present.	411881.9852	6352872.532

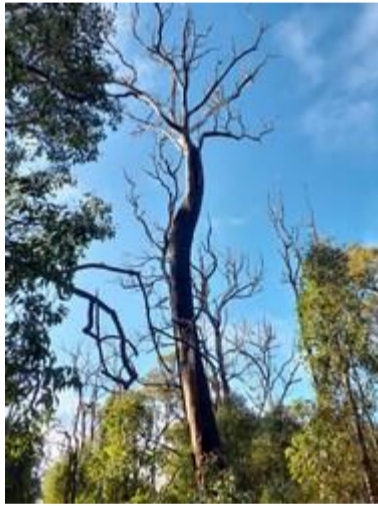
3521	Jarrah	3	125	One potential >30cm opening spout type hollow. On horizontal alignment. Think unlikely to have suitable chamber but can't confirm. Other large snapped branches potential to form future hollows	411887.7046	6352788.827

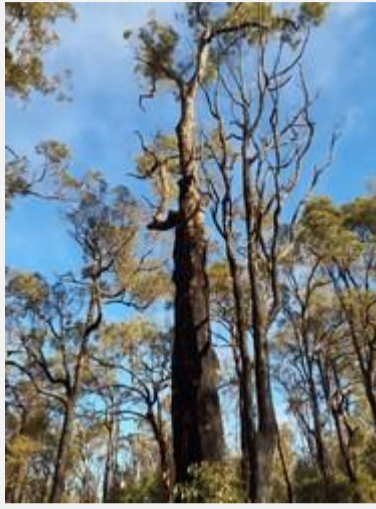
3678	Jarrah	3	110	One 15 cm sideways opening knot type hollow. 15m up in 40 cm diameter branch. Branch large enough to potentially develop chamber. Think unlikely to have suitable chamber	411122.8866	6352727.616

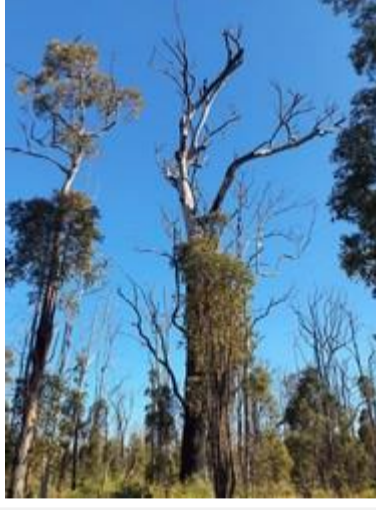
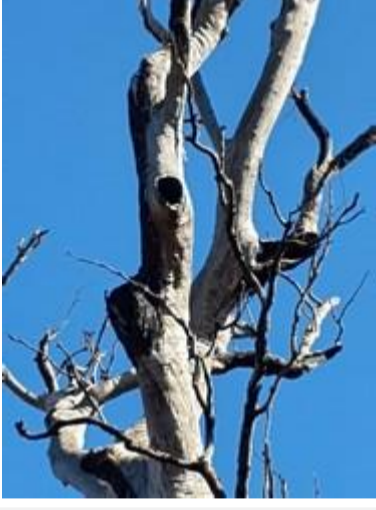
3681	Jarrah	3	95	One potential >20 cm chimney hollow about 30 m from the ground. No signs of wear and has spiky edges. Also has one broken branch with undeveloped hollow.	411125.1649	6352915.274

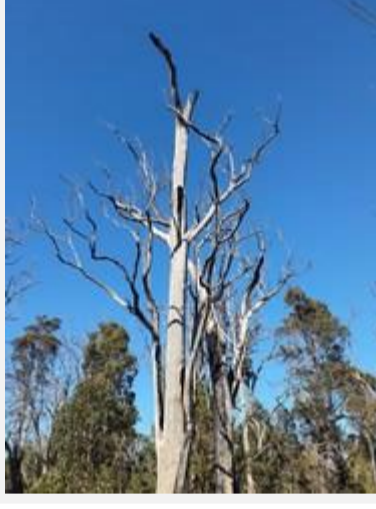
3691	Dead	3	155	Potential upwards opening hollow in fork at 13m. Entry 20cm by 25 cm. Going into main trunk. Think unlikely to have BC size chamber, can't confirm	411139.3078	6352757.613

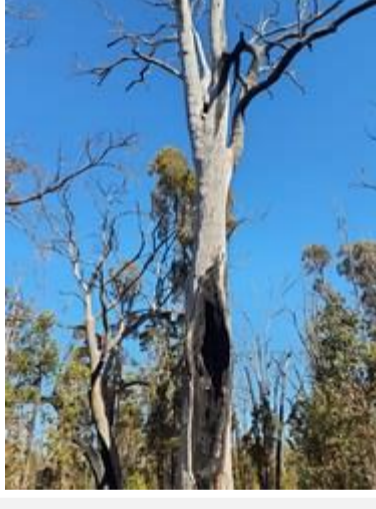
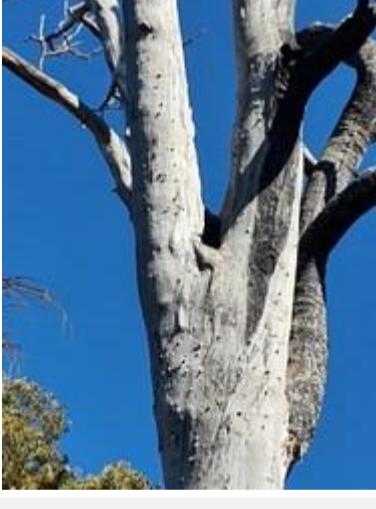
3798	Jarrah	3	75	One >20 cm potential knot hollow, however edges are very uneven and now signs of wear. about 25 m above ground.	411308.8651	6353290.285

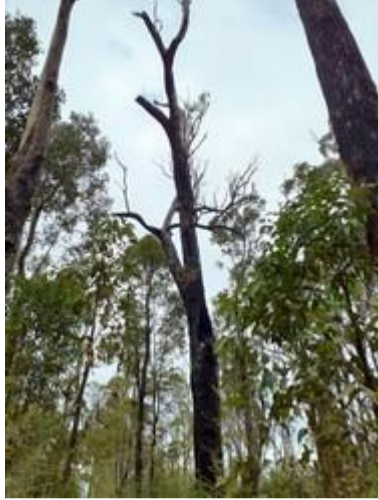
4283	Dead	3	110	Has three >10 cm potential spout hollows. One has cracks along the side and appear unstable. Also has a cup formation that appears to have sticks in it and other broken burnt out branches with undeveloped hollows	413165.6099	6354338.984	 
4287	Dead	3	90	Main trunk snapped at 17m. Potential for chimney hollow formation.	413166.0407	6354435.378	 
4318	Jarrah	3	90	Large snapped branch at 12m with potential for chimney hollow. Branch large enough to have BC size hollow. Think unlikely to be developed	413179.9843	6354584.996

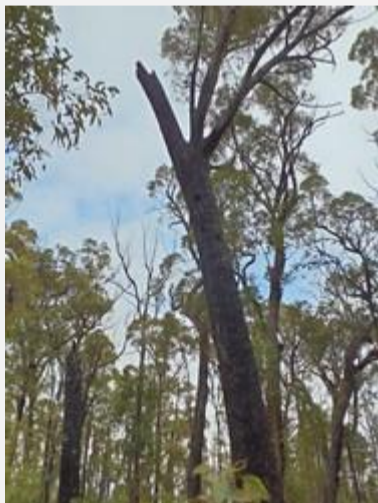
4331	Marri	3	85	Dead main trunk snapped off at 8m. Potential chimney hollow in trunk. Rim suggests some hollow formation. Think unlikely deep enough.	413185.2853	6354383.898

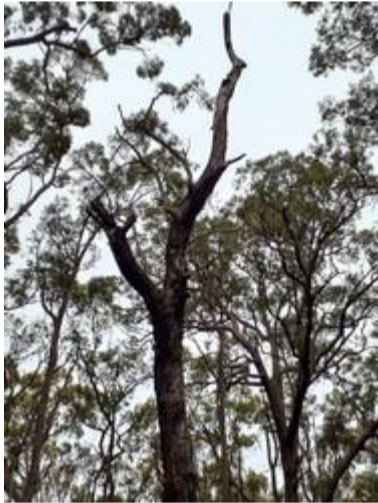
4828	Dead	3	190	Snapped off tree at about 30 m with >20 cm potential chimney hollow. No chew marks or sign of wear.	413351.0074	6354249.134	
4884	Dead	3	125	Potential for upwards opening hollow mid main trunk in old fork at 12m. Trunk suitable size for BC hollow formation	413376.3332	6354413.117

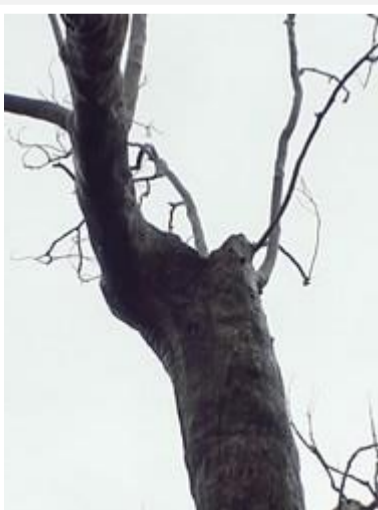
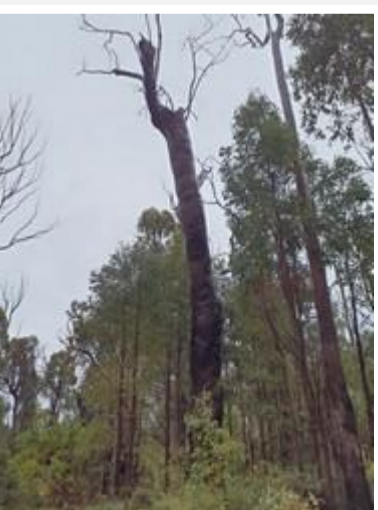
Merge Tree Number	Species	Class Bamford	DBH (cm)	Hollow Comments	Easting (AGD84/AMG zone 50)	Northing (AGD84/AMG zone 50)	Images
5141	Jarrah	3	250	Very large tree. Dead central trunk burnt out fully internally. Large upwards branch with potential chimney opening at top. Branch big enough for BC hollow	412600.7405	6355411.11

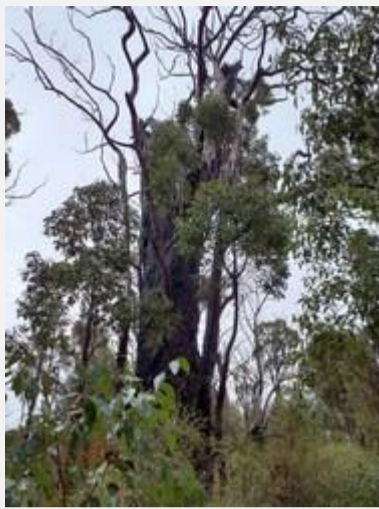
5142	Dead	3	100	Tony. Dead marri. Trunk snapped at 18m. Potential side entry hollow 40cm opening at 15m. Also Potential chimney hollow at top. Suitable size to support BC hollow	412601.0664	6355362.797	
5176	Dead	3	110	Tony. Snapped off tree at about 35 m. has potential >20 cm chimney hollow with smooth edges. No chew marks present.	412641.5251	6355483.396

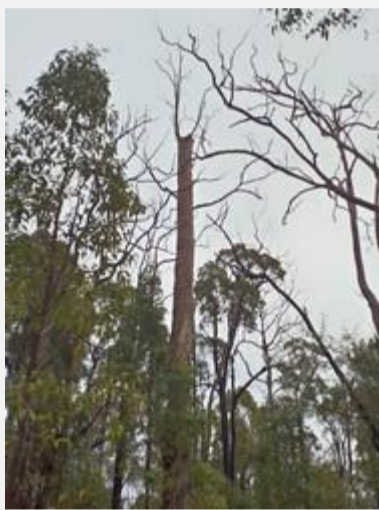
5202	Dead	3	90	Has several burnt out branches with undeveloped hollows. One appear to be >10cm spout hollow about 20 m above ground however it is has an obstructed entry	412675.9756	6355486.783

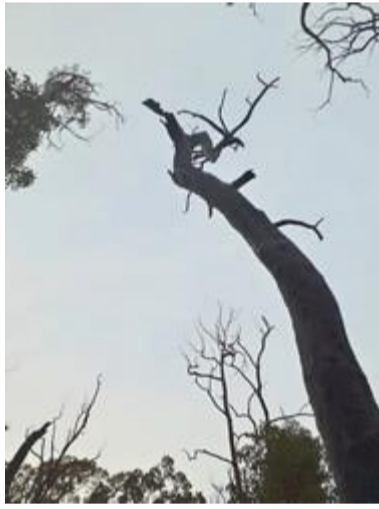
5328	Marri	3	120	Tony. Likely chimney hollow in snapped trunk at 14m. Rim smooth and narrow looking. Trunk suitable diameter to have BC hollow	412807.2034	6355213.29

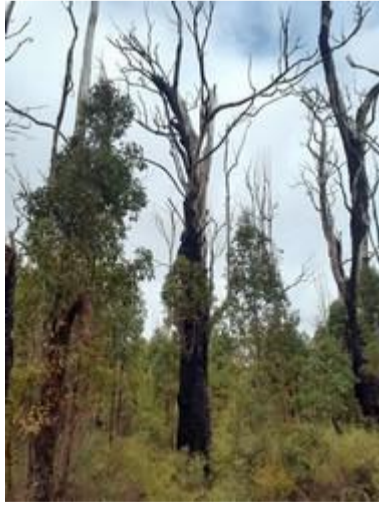
5390	Dead	3	120	One >10 cm mid branch hollow up top in the canopy about 40 m up. Has	412625.1367	6354781.346

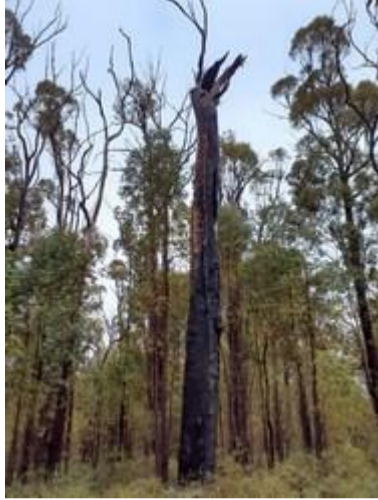
5844	Dead	3	60	Burnt and snapped off tree, potential >10 chimney hollow at ~15 m up. Also potetial >10 cm knot hollow at ~10 m.	411655.1644	6355062.744

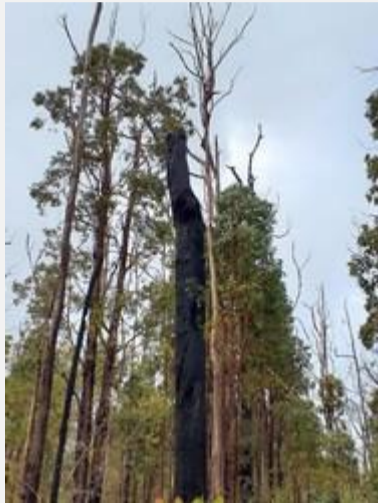
5857	Dead	3	105	One side entry hollow at 8m off ground. 40cm opening. Bottom edge looks thin with wear. Large burnt out upper branches. Potential spout hollows. Not preferred angle.	411679.9305	6354995.094

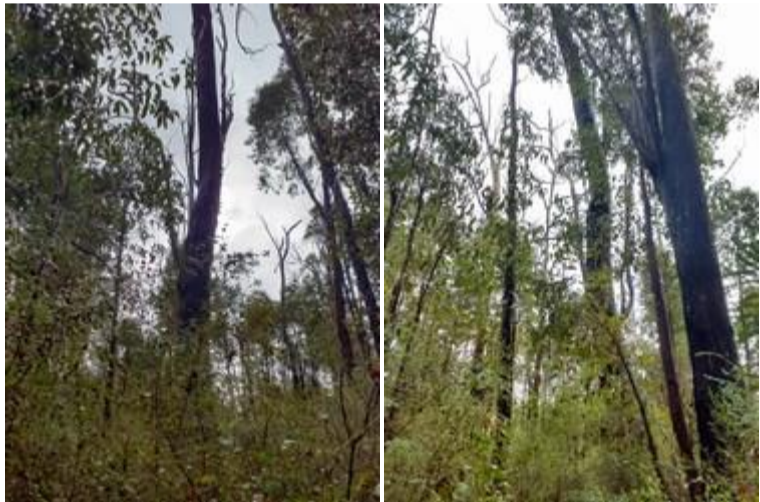
5911	Dead	3	110	Broken branches in canopy with undeveloped hollows	411753.3045	6355080.002	
5979	Dead	3	90	Dead trunk snapped at 16m. Potential for two chimney hollows at top. Can't confirm. No evidence of clear rim forming.	411834.4453	6354959.088

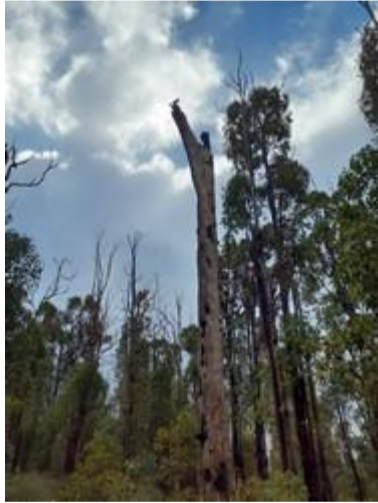
5989	Marri	3	100	One upwards opening 15cm entry knot hollow at 15m going into main trunk. Think unlikely to haave BC size chamber. Upper trunk dead with large snapped branches	411847.4197	6354919.265

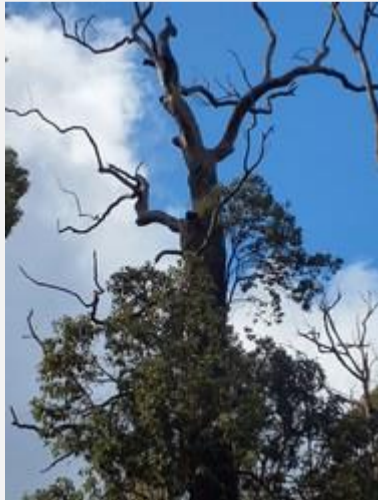
Merge Tree Number	Species	Class Bamford	DBH (cm)	Hollow Comments	Easting (AGD84/AMG zone 50)	Northing (AGD84/AMG zone 50)	Images
6069	Dead	3	120	Potential >10 cm spout hollow ~15 m up, upwards facing so cannot confirm. edges are somewhat smooth but no chew marks visible. Also broken branches at top with undeveloped hollows	412564.7814	6355071.047

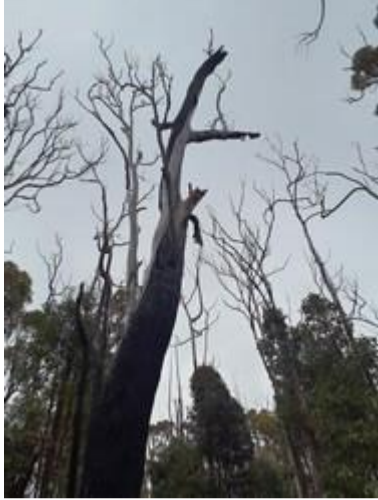
6084	Jarrah	3	100	Has one potential >10 cm hollow in fork ~30 m up. The opening travel down the trunk about 10 cm, smooth edges but no visible chew marks. Opening obstructed by minor branch and leaves. Also broken branches with undeveloped hollows	412605.8003	6355103.978

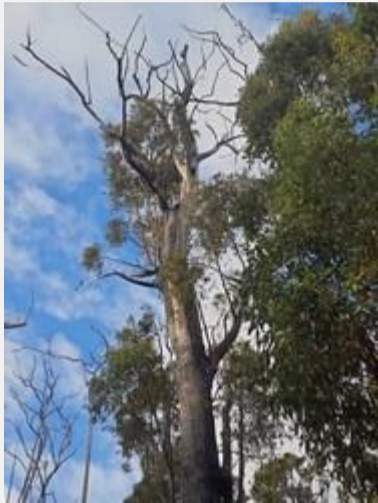
6096	Dead	3	70	Has one >10 cm mid branch hollow ~30 m up and one >10 cm knot hollow ~25 m up that is obstructed by loose bark. Also have a broken branch with undeveloped hollows	412633.0679	6355043.042

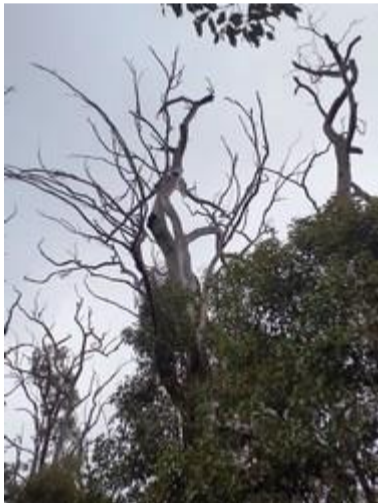
6120	Jarrah	3	130	Large dead central trunk snapped at 15m. One upwards opening hollow 25cm entry top main trunk. Also potential for two 20cm opening spout hollows. Think unlikely developed to depth	412673.1962	6354925.447

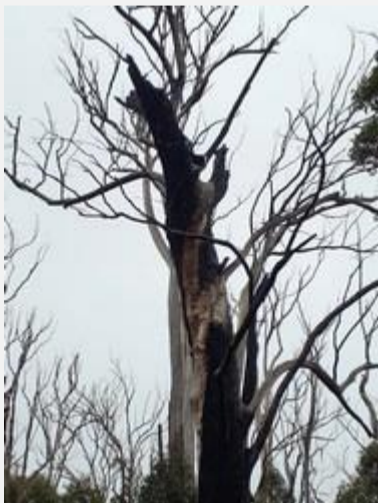
6153	Dead	3	70	Has one >10 cm potential spout hollow ~15 m up. It's burnt out can't confirm if present. smooth edges but no visible chew marks	412735.8675	6355051.648

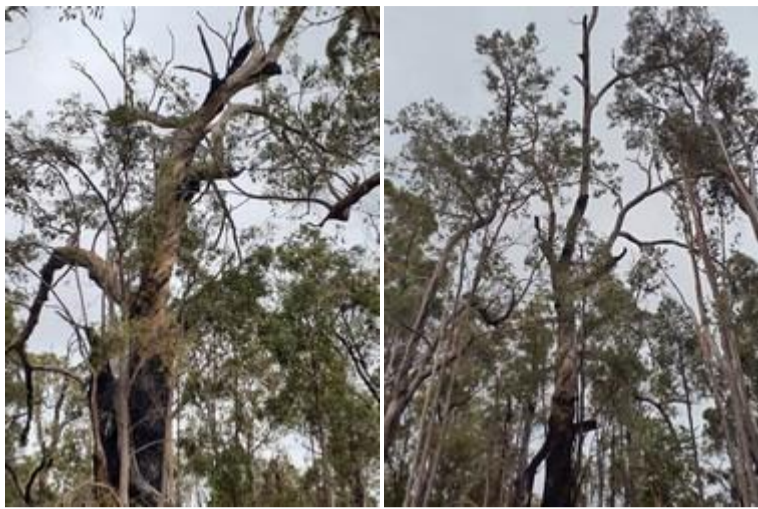
6501	Dead	3	80	Has one potential >10 cm spout hollow 15-20 m up, upwards facing and can't confirm from ground. It has rough edges and no signs of wear. Also several undeveloped hollows from broken branches.	413955.4982	6348889.289

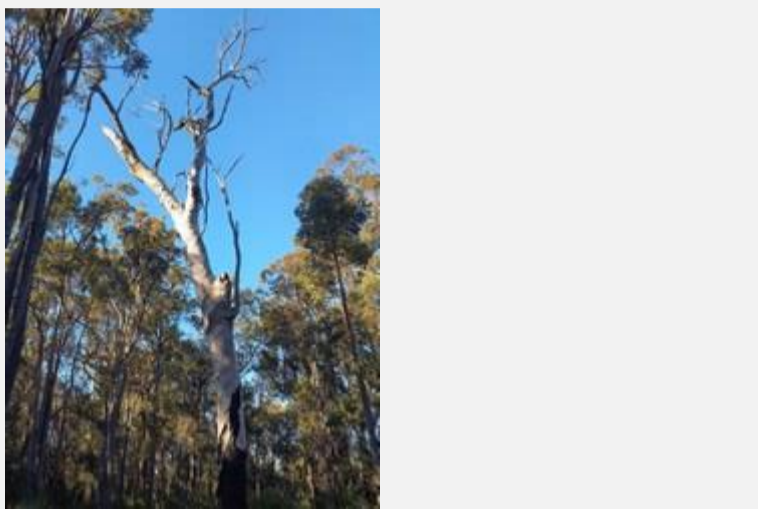
6502	Dead	3	175	Has three >20 cm potential spout hollow up top in canopy approx 20 m up. No signs of wear or chew marks, all have rough edges.	413989.0769	6348915.749
