WESTERN
ENVIRONMENTAL

WILLOWDALE MINESITE

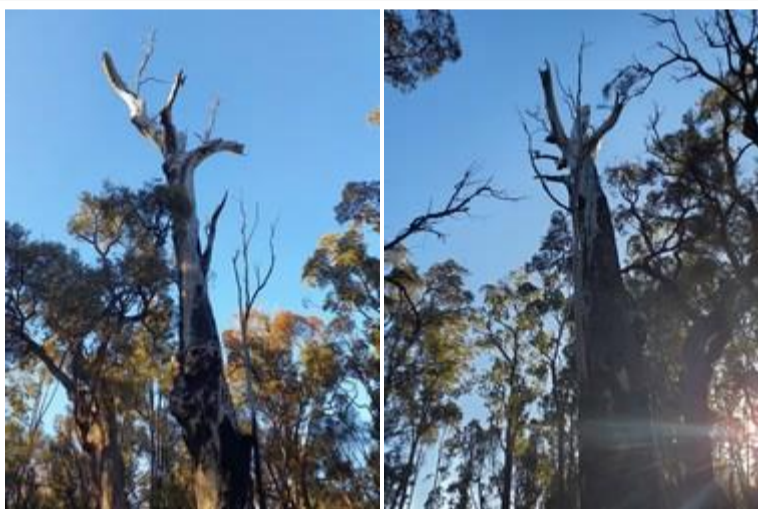
6579	Jarrah	3	160	One 10cm upward facing entry in dead side branch at 18m. Branch diameter is 30 cm. Think highly unlikely forming BC size chamber.	412932.3815	6350739.773

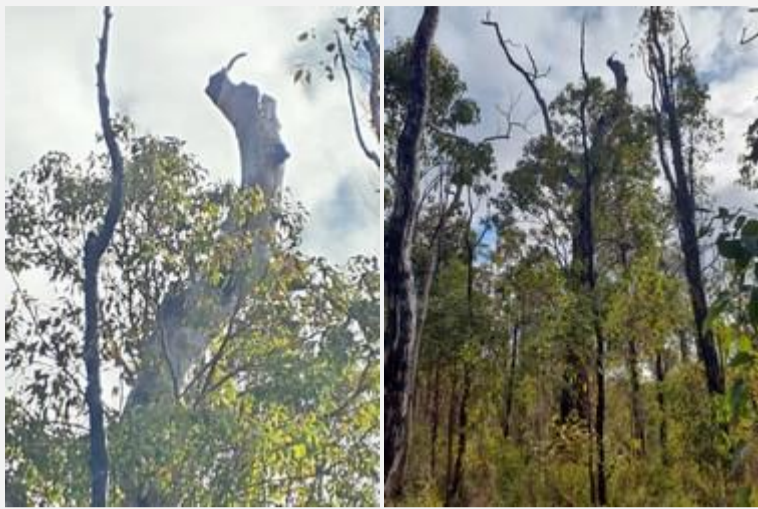
7808	Marri	3	90	Dead central trunk. Snapped at 10m. Potential chimney hollow in 40cm diameter top. Edge of rim looks thin but jagged. Should be checked from top	416023.0452	6354766.769

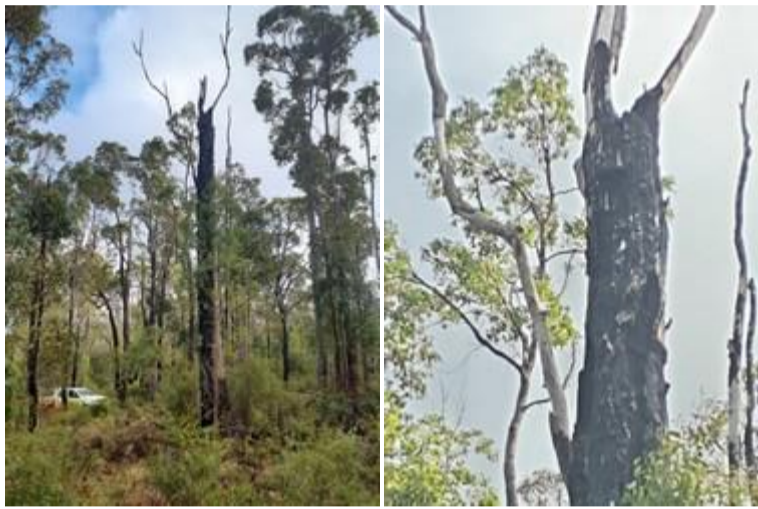
7844	Jarrah	3	100	One potential >10 cm slit hollow along a branch in canopy, can't confirm if developed depth. Also two >10 cm broken branches with hollows	416095.4501	6354882.908

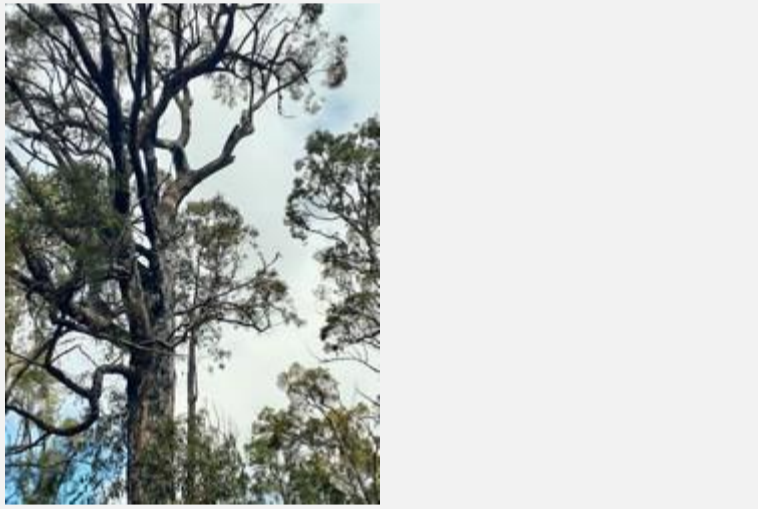
7850	Dead	3	120	One >10 cm potential spout hollow ~30 m up, can't confirm. One <10 cm knot hollow ~20 m up. One large undeveloped knot hollow from broken branch at ~25 m	416108.8225	6354854.394

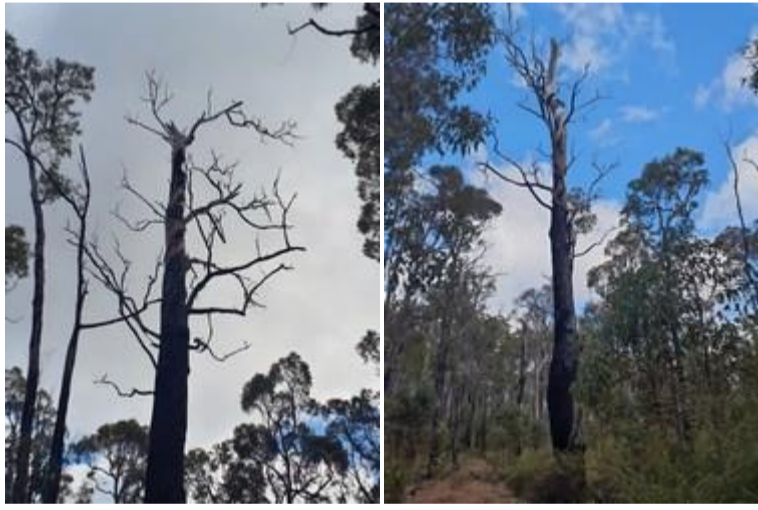
7851	Dead	3	100	Has two larger broken branches that are burnt out. One has a crack along the side. The other can potentially be a spout hollow, can't confirm from ground.	416110.073	6354899.96

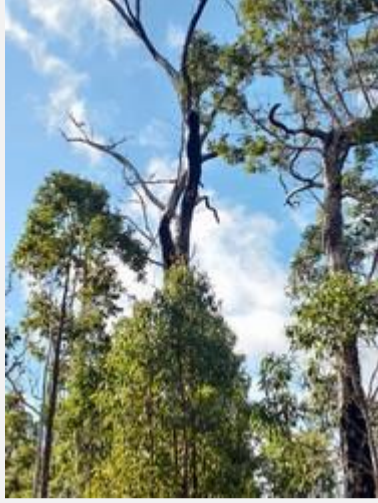
7964	Marri	3	95	Tony. 40cm side entry hollow opening at 10m in damaged main trunk. Rim of hollow smoothed off and we'll defined. Can see back of hollow angle forward. Potential not developed to depth.	416472.8923	6352433.706

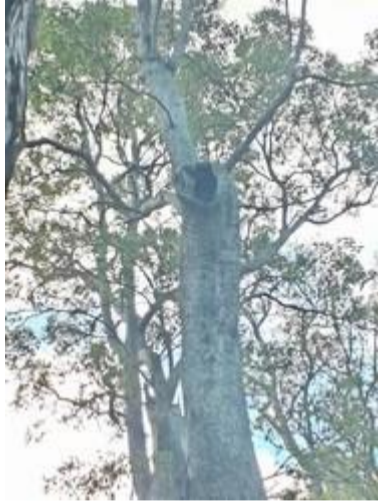
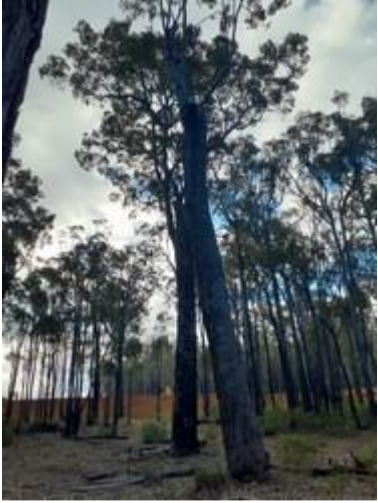
7967	Marri	3	90	. Tony. Main trunk old break at 10m. 50cm diameter chimney type opening present. Edges of hollow are thin with vertical cracks and parts where edge of hollow has broken. Potential to be too open to be suitable.	416478.1277	6352439.14

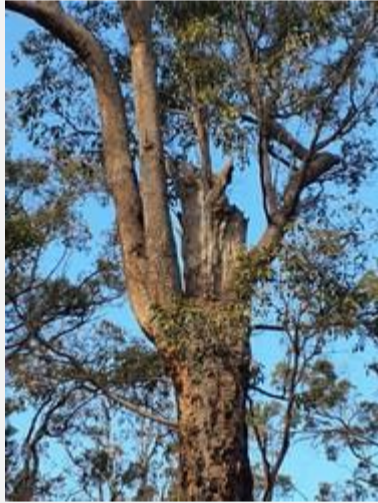
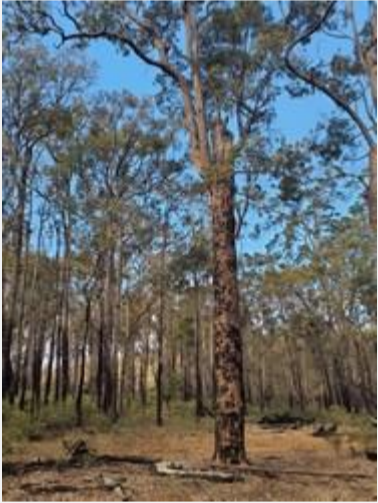
7989	Jarrah	3	115	One well defined 20cm side entry hollow in main trunk at 15m. Edges rounded and smooth. Potential for upwards facing hollows in two large snapped off branches	416515.2279	6355306.907

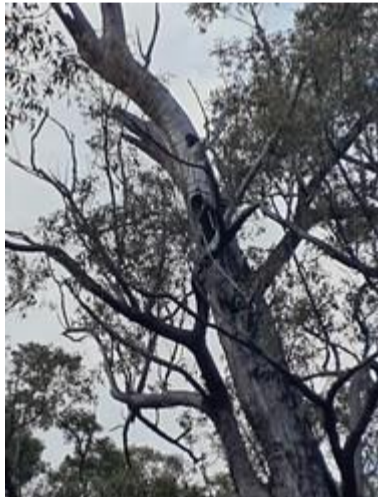
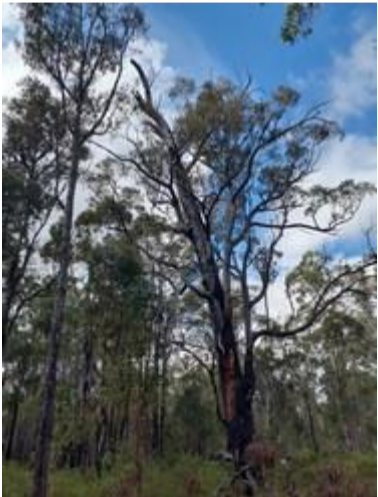
Merge Tree Number	Species	Class Bamford	DBH (cm)	Hollow Comments	Easting (AGD84/AMG zone 50)	Northing (AGD84/AMG zone 50)	Images
8025	Dead	3	70	Potential chimney hollow 40cm diameter branch. Rim is thin. Think unlikely developed hollow but can't confirm	416579.0215	6355241.372	 
8036	Jarrah	3	110	Mallee with 110 cm DBH Has one >10 cm knot hollow 10-15 m up. Smooth edges but can't confirm from ground. Trunk with 95 cm DBH has one <10 cm mid branch hollow and broken branches with undeveloped hollows	416618.7143	6352347.599	 
8043	Dead	3	70	Potential suitable >20 cm chimney hollow from snapped off tree at ~20 m. no signs of wear or chew marks.	415739.95	6354405.293	 
8056	Marri	3	100	Potential >10 cm fork hollow 25-30 m up, can't confirm. where visible, it appears to have rough edges, potential cup formation	416027.3841	6352278.012

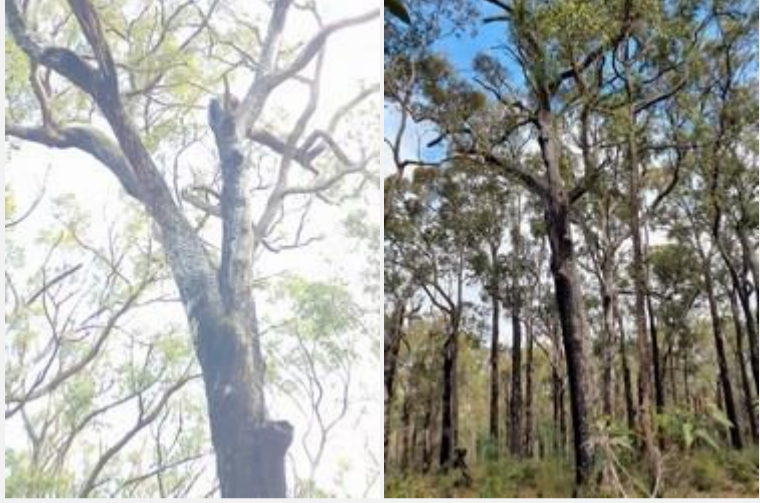
8076	Dead	3	140	Two potential >10 cm spout hollows 20-25 m up, can't confirm from ground	416054.368	6352229.793

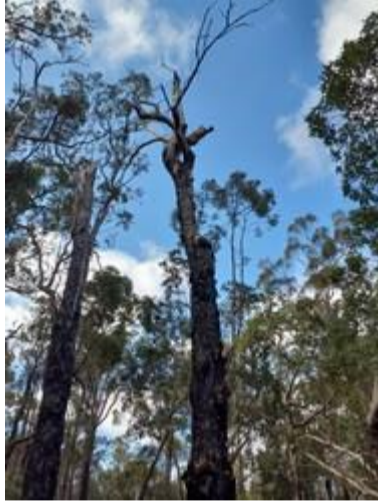
8082	Jarrah	3	110	Tony. One potential >20 cm chimney hollow from snapped off tree top. Can't confirm, no signs of wear or chew marks visible.	416058.9014	6352261.558

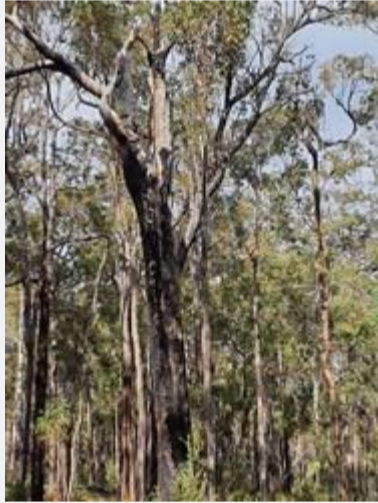
8092	Jarrah	3	100	One potential >10 cm knot hollow ~15 m up. Has rough edges and appears to have wood coming out of it. Also have one >10 cm knot hollow ~20 m up and broken branches scattered.	416079.1834	6352311.827

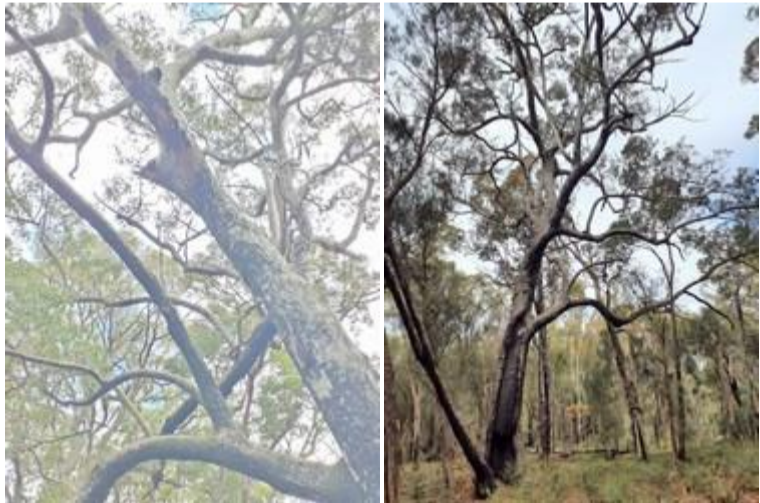
8096	Jarrah	3	115	One >10 cm knot hollow ~10 m up and a few broken branches with undeveloped hollows in canopy	416083.3139	6352184.124

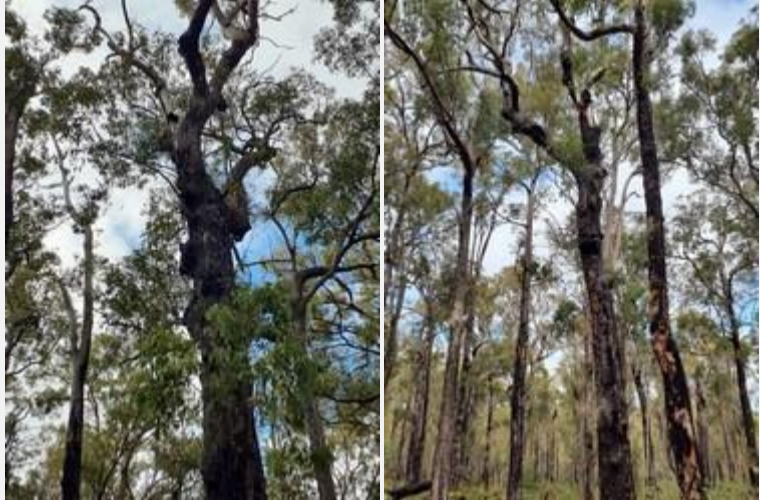
8111	Jarrah	3	105	One pote tial >10 cm hollow 20-25 m up. Can't confirm. Also broken branches and undeveloped knot hollows along the trunk. One <10 cm knot hollow ~30 m up.	416104.7795	6352183.771	 
8116	Jarrah	3	210	Tony. One well defined 18 cm side entry hollow opening in 50 cm diameter branch at 15m. Snapped branches with shallow and small spout type hollow forming.	416112.9196	6352335.585

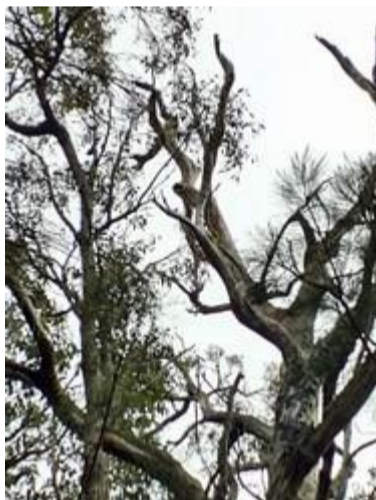
8557	Jarrah	3	120	One potential >10 cm spout hollow ~30 m up, upwards facing so cant confirm. Has rough edges. below it's a <10 cm knot hollow. Also other broken branches with undeveloped hollows in canopy	416335.9026	6352471.457

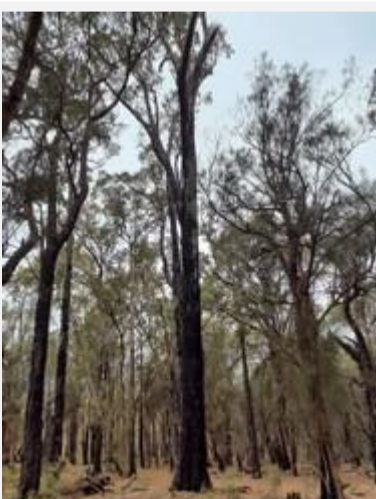
8581	Jarrah	3	150	One >10 cm mid trunk hollow~10 m up with smooth edges. One pote tial >10 cm knot hollow ~15 m up, has rough edges. Can't confirm depth from ground. Also have broken branches with undeveloped hollows	416351.0917	6352152.203

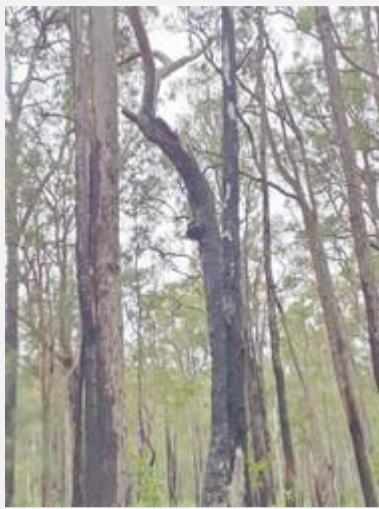
8603	Jarrah	3	135	Two potential >10 cm spout hollows, one ~30 m up and the other ~20 m up. Both has rough edges and no signs of wear however can't confirm from ground. Also have other broken branches with undeveloped hollows	416371.6782	6352371.65

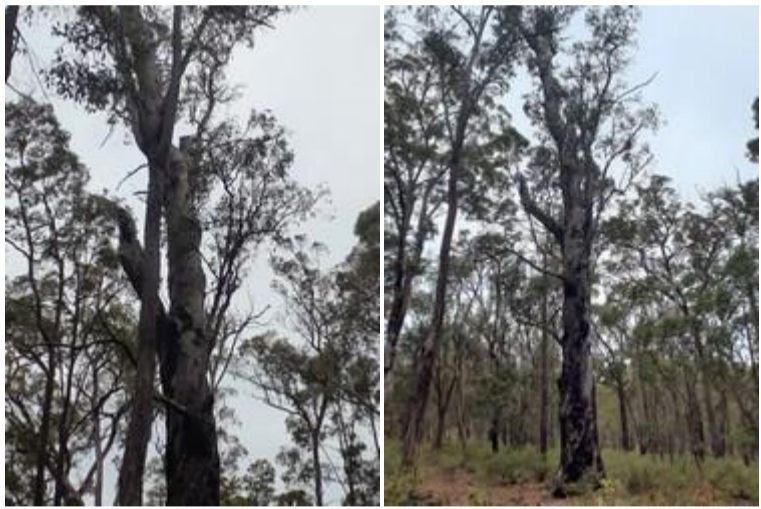
8672	Marri	3	85	Dead central trunk snapped at 8m. Has chimney opening 30cm diameter at top. Can see rim is thin and wall thin in upper sections indicates hollow. Joins to sideways trunk section 40 cm below. Think likely shallow and ends at join	415689.22	6352445.667

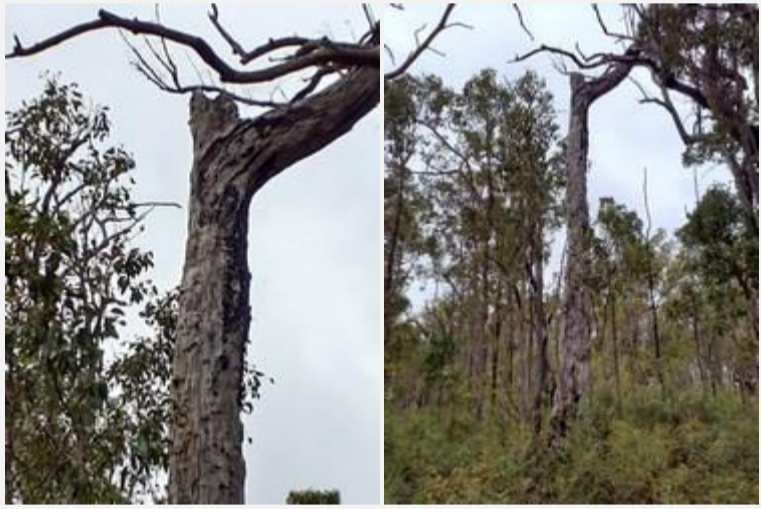
8734	Jarrah	3	80	One 10x15 cm side entry opening in 25cm diameter branch at 20m upper canopy. Entry rim looks well defined smooth and worn at base. Think branch is likely too small to support BC chamber development	415817.5527	6352447.155

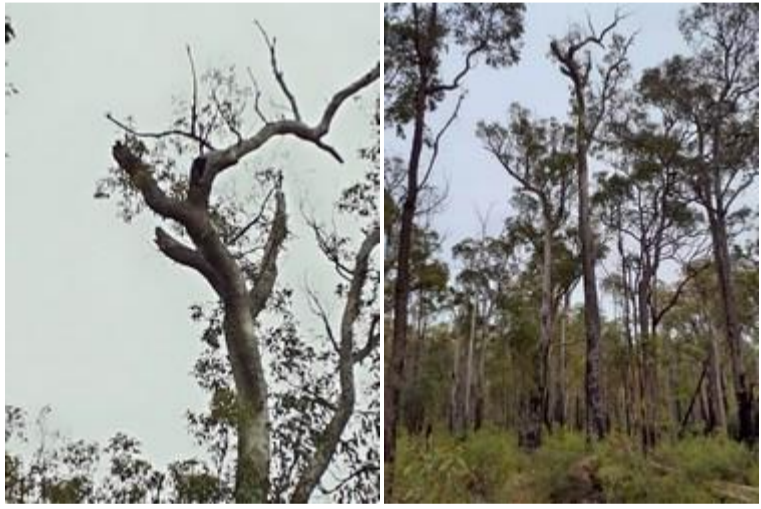
8737	Jarrah	3	100	One side entry 20x30cm opening mid main trunk at 14m. Well defined smooth rim. Second 20x40cm opening 1m below. Can see back looks shallow. Think unlikely openings developed into chamber with depth	415825.6337	6352349.901

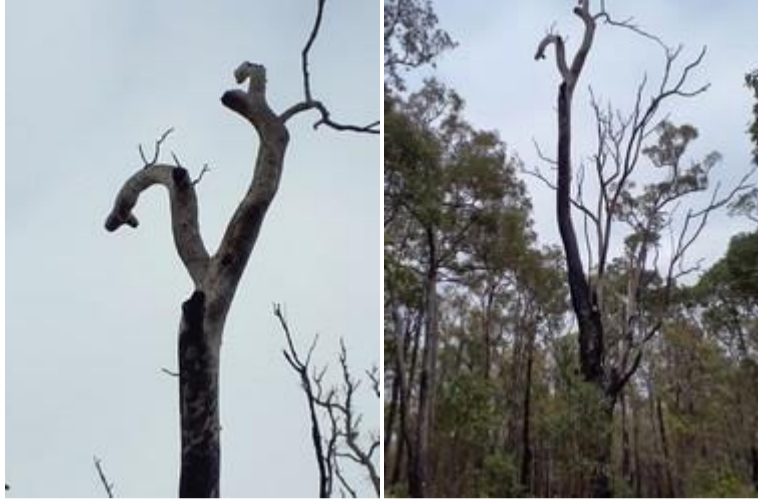
8776	Jarrah	3	80	Tony. 30x40cm side entry hollow upper main trunk at 14m. Rim of hollow smooth well defined. Minor chew marks on upper edge of rim galaha or BC investigate chew rather than nesting. Second 40 cm side entry opening on west side. Can see back is shallow	415896.1794	6352417.702	 
8802	Jarrah	3	80	Tony. Has one >20 cm mid branch hollow 30-35 m up. Has smooth edges and pote tially some chew marks.	415933.4797	6352404.891	 
8803	Jarrah	3	80	One >10 cm mid branch hollow at 20 m up. Has smooth edges and appear to have some type of wear around the edges. One <10 cm mid trunk hollow <10 m up and broken branches with beginning to develop-undevelop3d hollows.	415933.73	6352325.041

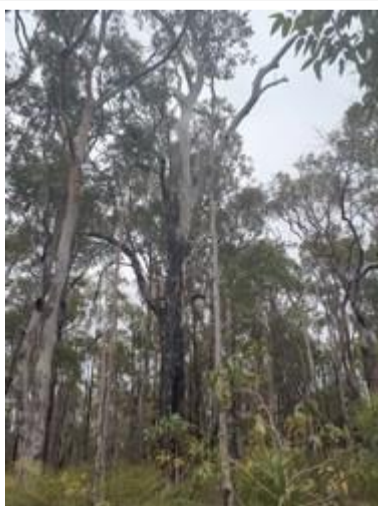
8806	Jarrah	3	100	One ~10 cm mid branch hollow 20-25 m up. Smooth edges but too small? For bc. Also broken branches with undeveloped hollows in canopy	415937.8048	6352387.599

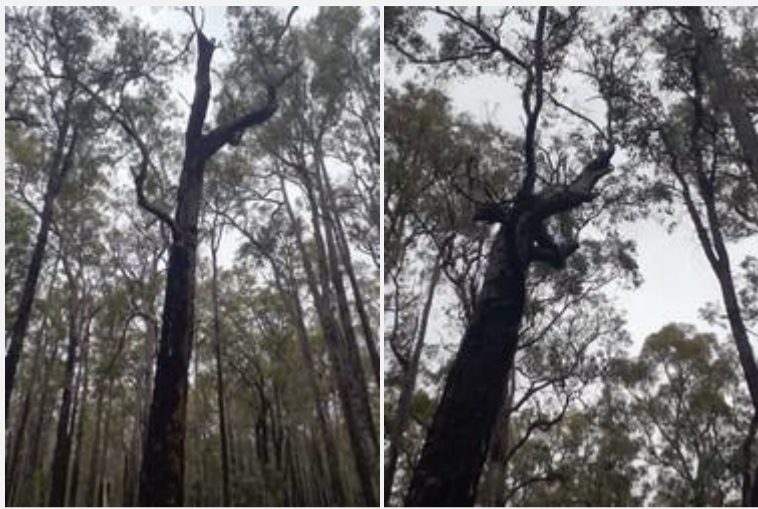
8882	Dead	3	150	A few >10 cm broken branches up in the canopy >30 m, with potential hollows, can't confirm from ground. All branches have rough edges and are unlikely to have well developed hollow that is used. x2 <10 cm mid branch hollows. Broken branch Undeveloped	416778.174	6352703.912	 
8890	Dead	3	115	One potential >20 cm knot hollow at 20 m up. Its burnt out and somewhat smooth edges. No signs of wear. Two >10 cm at 25-30 m up Broken branches that appears undeveloped hollows with rough edges, however can't confirm.	416784.6885	6352846.066

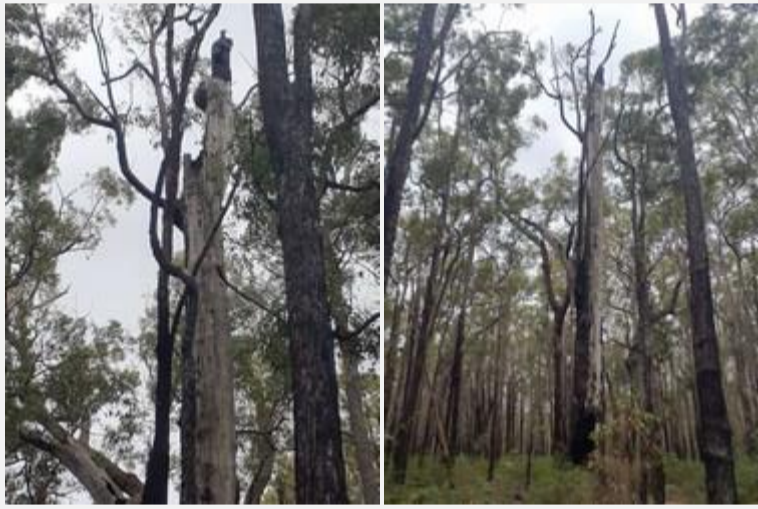
8965	Jarrah	3	125	Several larger broken branches, all appear undeveloped. The broken branches in the canopy appears also to be undeveloped but cannot confirm from ground.	416841.7575	6352783.484

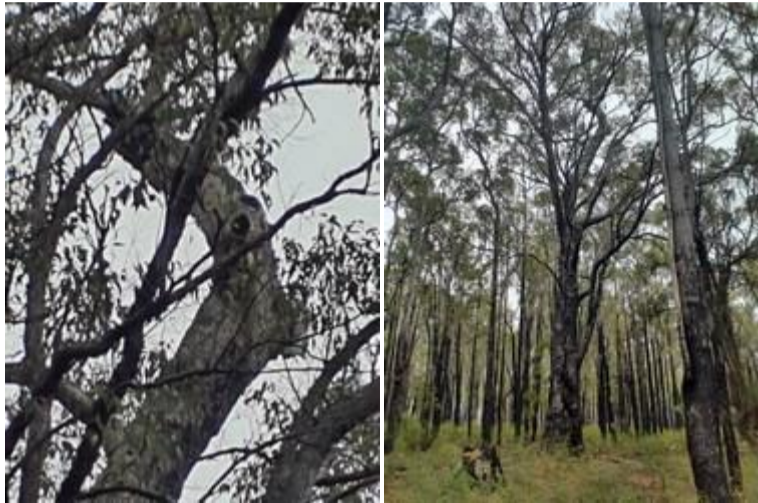
9465	Dead	3	180	Three 30-40cm potential upwards facing knot type openings in main trunk from 12-15m. Think likely open shallow cups. One well defined 15cm horizontal spout opening in large branch at 10m. Think shallow	416624.0775	6352716.269

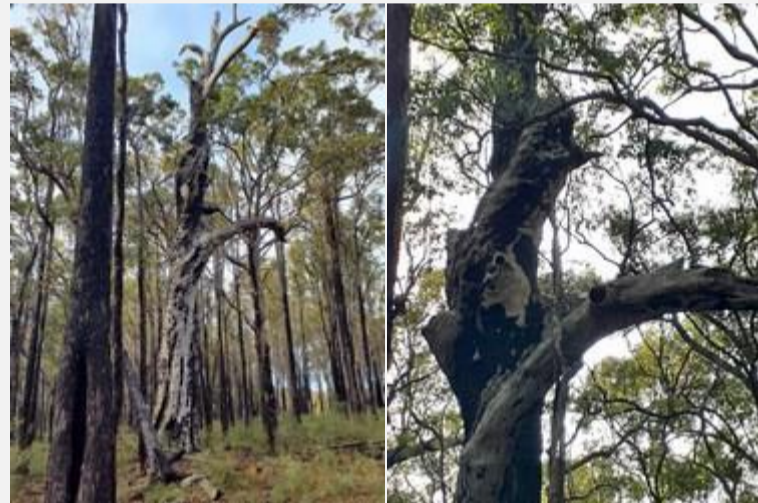
9569	Jarrah	3	120	One 12cm horizontal opening spout type hollow at 12m in dead main trunk. Rim is thin and well defined with wear marks at base Minor chew marks on rim. Think very unlikely to support a BC size chamber internally.	416674.8121	6352671.905

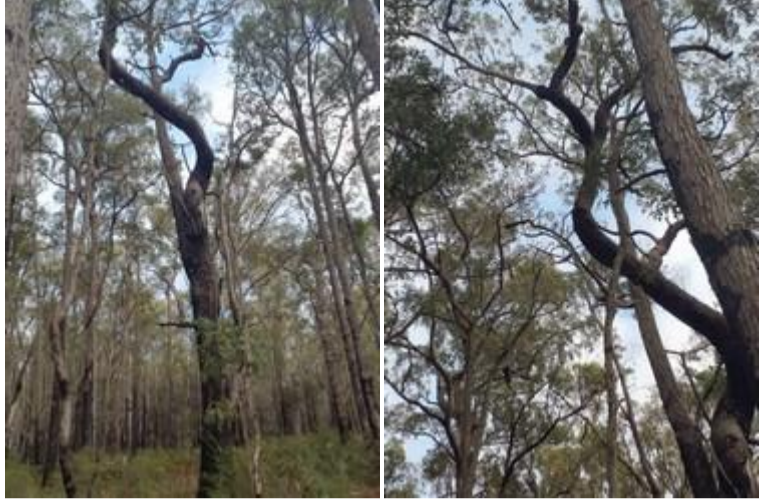
9684	Marri	3	110	Snapped at 15m . Top has 40-50cm upwards chimney opening. Edges are tin and rotted indicating some depth development. Some regrowth branches growing over top. Think lower likely that a suitable hollow present, think too wide and open	416735.0857	6352668.77	 
9690	Jarrah	3	130	One spout type 20cm 45 degree angle opening main trunk at 10m. Bottom rim smooth, think unlikely developed to depth. dead snapped branches, burnt out sections, cavities and shallow cups in branch ends.	416741.0965	6352733.145

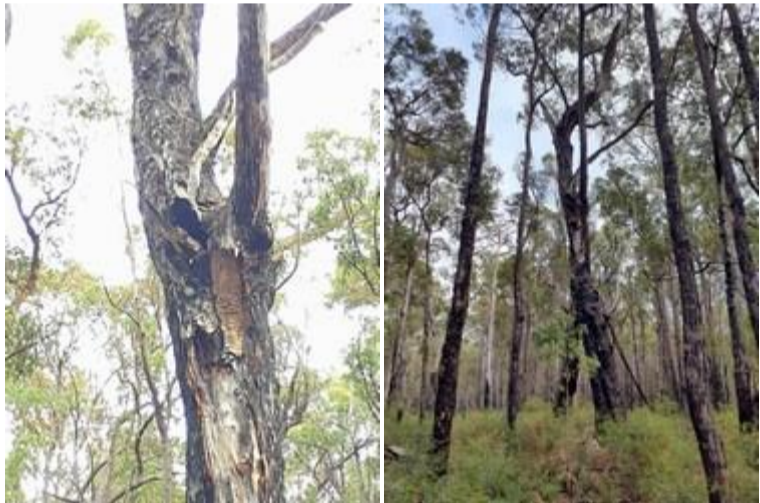
9706	Jarrah	3	145	Potential for upwards angle 30cm slit type opening occurring in fork of dead main trunk at 18m. Can't get view to check depth. Rim looks well defined and smooth. Think unlikely BC size chamber present	416748.3435	6352760.56

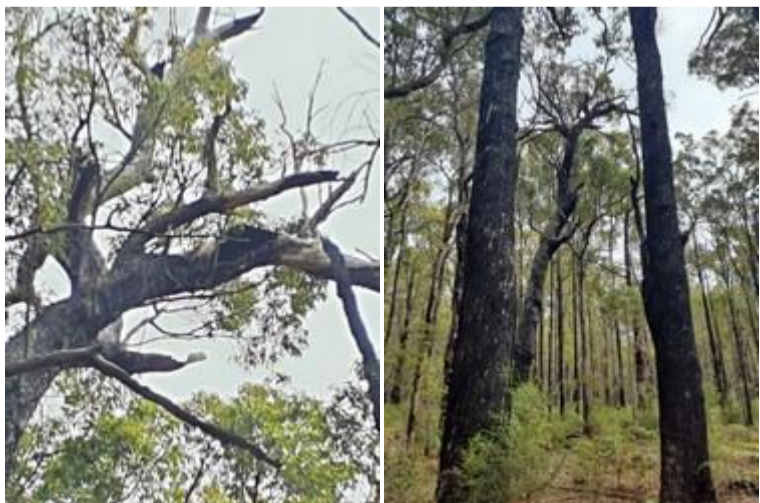
Merge Tree Number	Species	Class Bamford	DBH (cm)	Hollow Comments	Easting (AGD84/AMG zone 50)	Northing (AGD84/AMG zone 50)	Images
9734	Jarrah	3	110	One potential >20 cm spout hollow 15-20 m up, can't confirm from ground. Walls appear thin but edges are rough. A cup formation at 8 m. One potential <10 cm spout hollow in canopy and other broken branches with undeveloped hollows	416763.152	6352879.668	 
9844	Dead	3	110	One potential chimney hollow 25-30 m up from broken off branch. Walls appear thin but edges are mainly rough with no signs of wear. Unlikely to have developed depth.	410889.8082	6355629.298	 
9980	Marri	3	75	One potential >10 cm hollow in fork 10-15 m up. Could potentially also be a cup formation, can't confirm. Appears not worn on the bottom edge of entry so unlikely developed a depth.	416713.4601	6353032.449

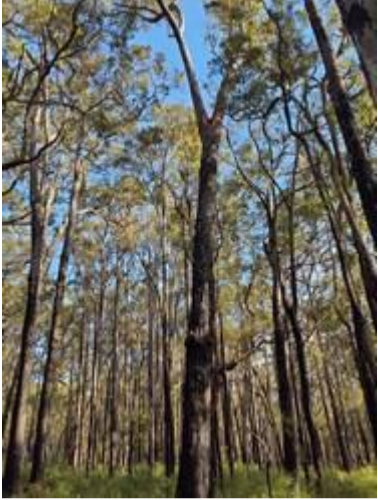
10020	Dead	3	240	Appears to have a cup formation 25 m up from snapped off tree top. Also potential >30 cm knot hollow 20 m up from broken off branch. No evidence of wear and bottom on entrance is rough.	416918.8818	6352418.613	   
10036	Dead	3	90	One potential >20 cm chimney hollow 30 m up. Edges are rough and the walls appears thin. No signs of wear. Can't confirm from ground.	416934.8983	6352589.607

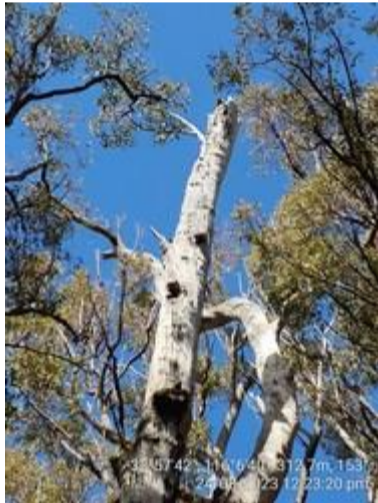
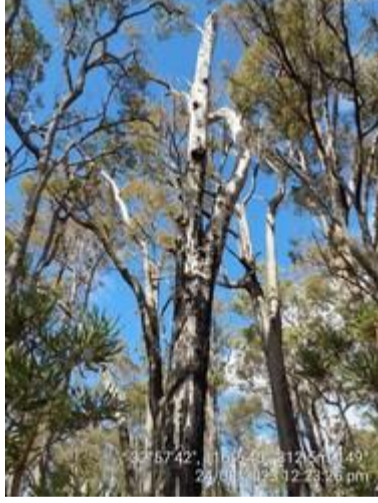
10104	Marri	3	60	Snapped off tree at 15 m potential >10 cm chimney hollow. Walls appear thin however the edges are rough and have no signs of wear. ~50 cm down is a broken branch with an undeveloped hollow	416997.682	6352529.838

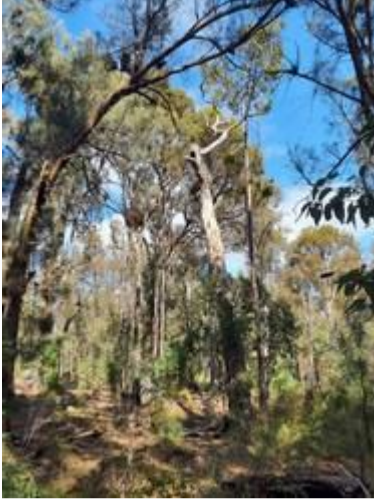
10428	Jarrah	3	80	Large upwards facing 40cm diameter dead snapped branches. Potential for chimney hollow formation. Rim looks thin and smooth. Think unlikely developed to depth	411425.4899	6350791.126

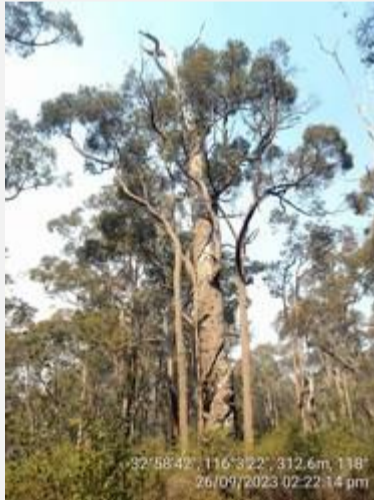
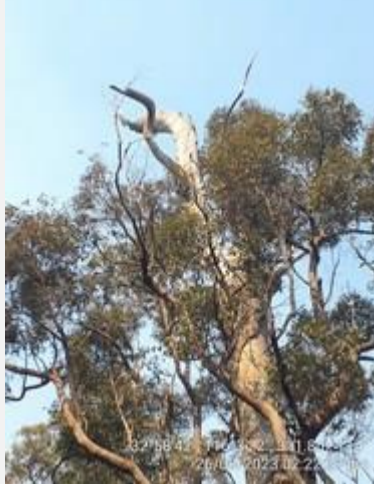
10458	Jarrah	3	95	One potential >20 cm chimney hollow 30 m up. Edges are rough but walls appear thin. Can't confirm depth. However it is a jarrah so probably unlikely.	411817.9678	6350692.717

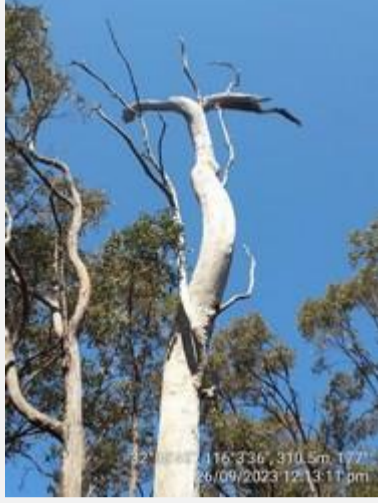
10586	Marri	3	160	Snapped trunk with >30cm chimney hollow. Chew from BC at entrance. BC observed chewing hollow edge. Departed in group. Think prospecting rather than nesting	412351.0873	6352053.565	
10588	Marri	3	100	Dead central trunk. Chimney type opening 10-20cm diameter in 30cm diameter branch. Thin around rim, no chew. Think unlikely developed to BC depth or chamber diameter.	411188.066	6353686.692

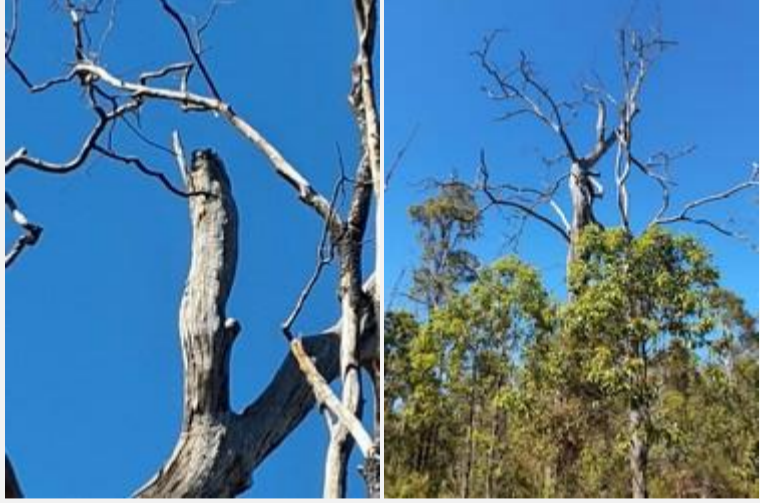
10589	Marri	3	85	Dead central trunk. One 20cm upwards facing opening in 40degree angle branch 45cm diam. At m 13high. Think unlikely developed to BC chamber depth and size	411251.1085	6353726.46

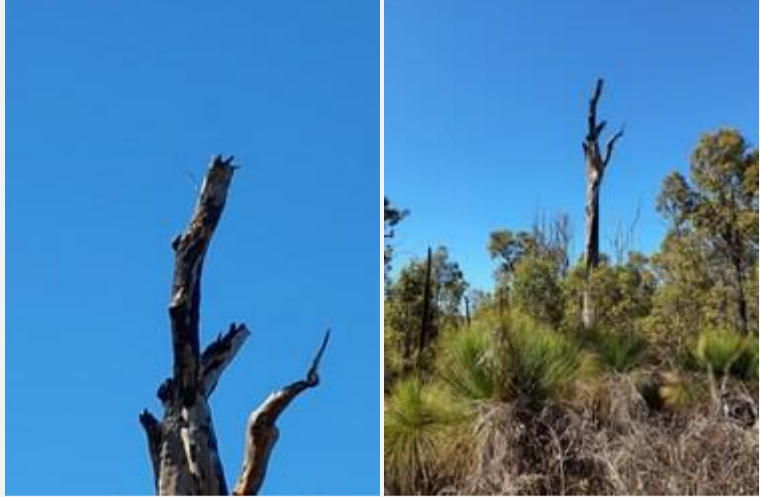
Merge Tree Number	Species	Class Bamford	DBH (cm)	Hollow Comments	Easting (AGD84/AMG zone 50)	Northing (AGD84/AMG zone 50)	Images
10591	Jarrah	3	90	30cm spout opening at 15m in 45 cm diameter branch. At 30 degrees Blackened and burnt. Think unlikely hollow deep and angle not preferred	411169.7156	6353721.328

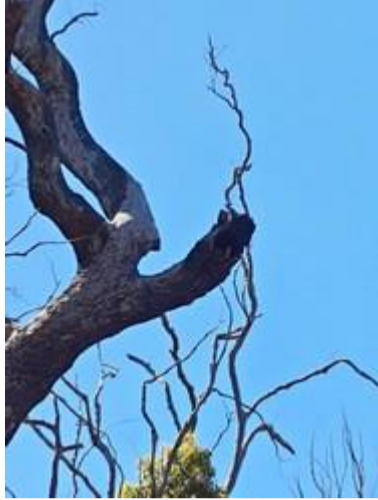
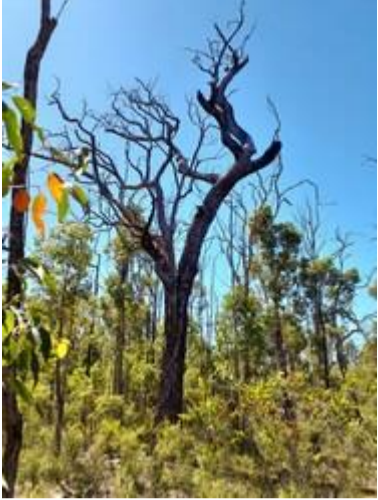
10592	Marri	3	90	Tony. Dead central trunk. 25-30cm upwards facing opening in 40cm diameter branch. At 60 degrees angle. 12m up. Rim thin hollow appears present	410992.1175	6353964.406

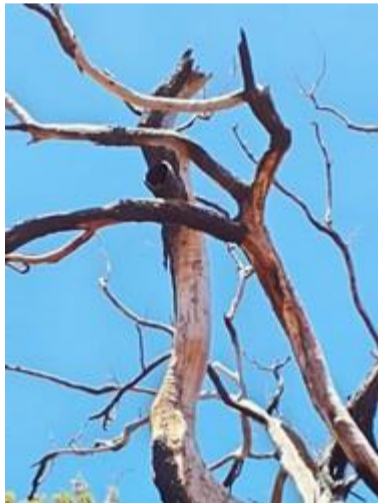
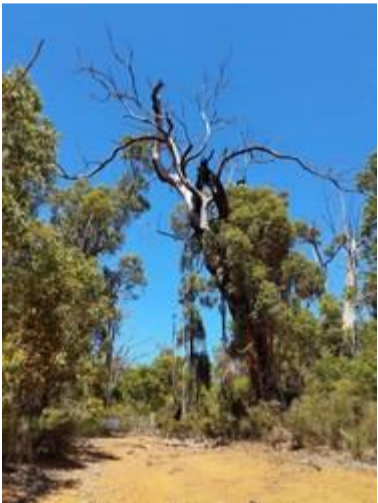
10594	Marri	3	70	Chimney hollow 40cm diameter at 10m in dead central trunk. Partially burnt out and collapsed. Think unlikely developed deep hollow in remaining trunk sections	411027.1315	6353870.343	
10595	Marri	3	80	Chimney hollow entry 15cm in 25cm diameter branch at 12m. Advanced decomp and white ant mud visible. Think unlikely developed suitable chamber	412306.1259	6350008.554

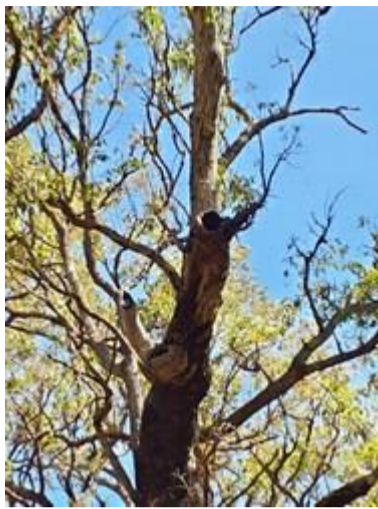
10604	Dead	3	80	Chimney opening 20cm in 30cm diameter trunk. Has wear marks around rim. Also wear marks in tree forks. Potential roosting tree ?	414057.608	6352490.975

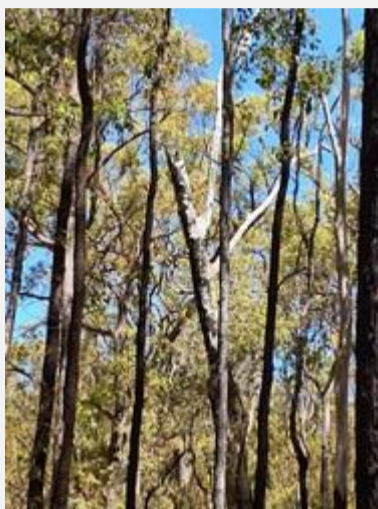
10605	Jarrah	3	120	Tony. 25cm upwards facing hollow in knot mid main trunk at 12m. Rim well defined with wear marks	414232.6364	6352414.488

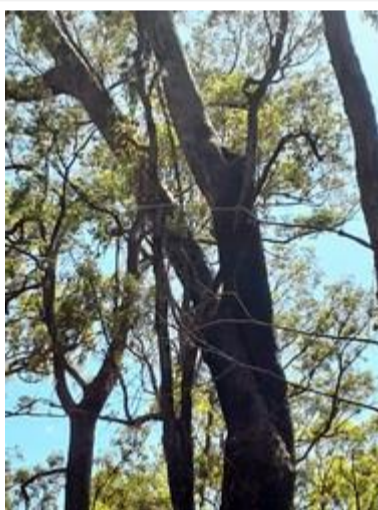
10613	Marri	3	105	Tree snapped at 10 m. Potential for chimney hollow 30cm. Does not appear to be developed	413115.7231	6352031.508	
10616	Jarrah	3	90	One mid trunk 15-20cm upwards knot hollow. Can't tell depth	412955.9962	6352009.238	
10617	Jarrah	3	150	Several potential 30 cm upwards opening entrances. Can't estimate depth. Sig tree.	412582.3365	6352049.282

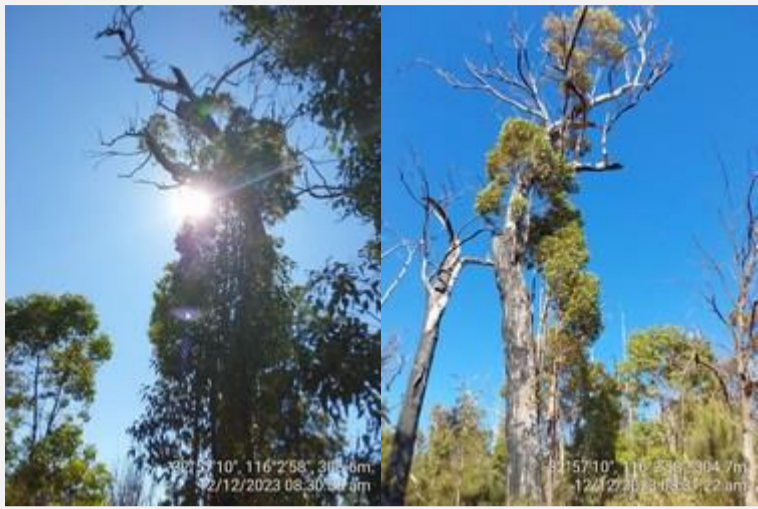
10630	Dead	3	70	One potential >10 cm spout hollow 20 m up. Upwards facing so can't confirm from ground. Edges are rough and no sign of chew marks or other wear. One 10 cm spout hollow 15 m up. No signs of wear.	410931.4688	6353935.02

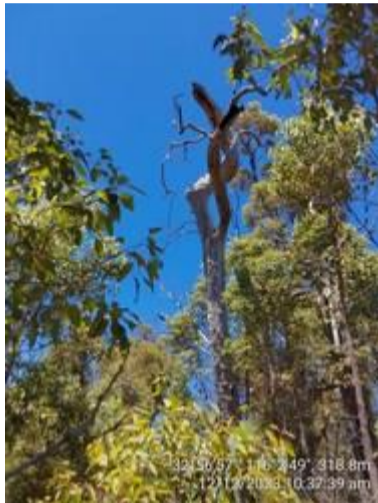
10631	Dead	3	195	Four Broken >10 cm branches 25 m up in canopy with potential hollows cant confirm from ground. No sign of wear.	410861.6094	6354007.718

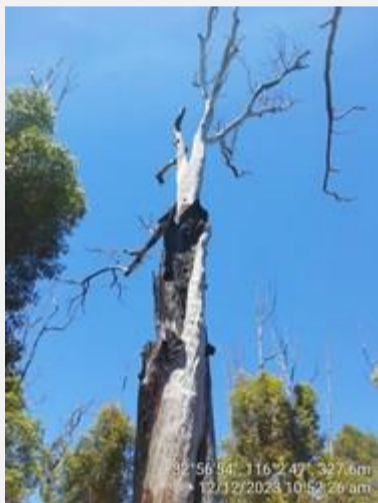
10632	Dead	3	155	One >10 cm potential knot hollow 20 m up. Potentially not developed depth, wood is poking out. Can't confirm from ground. No sign of wear is visible. Also broken branches with potential 10 cm spout hollow up in canopy, can't confirm from ground.	410807.3913	6354169.938

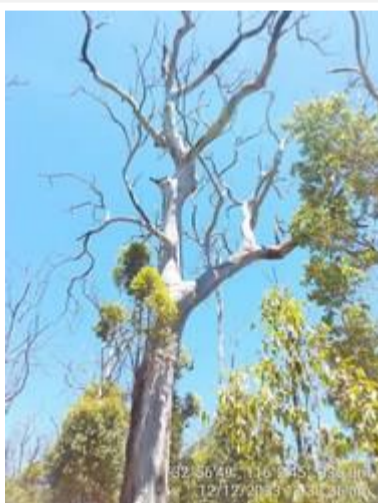
10633	Jarrah	3	100	Three potential >10 cm hollows (knot, fork and spout). Can't confirm from ground. Fork and spout hollow appears undeveloped hollow.	410803.1408	6354256.693

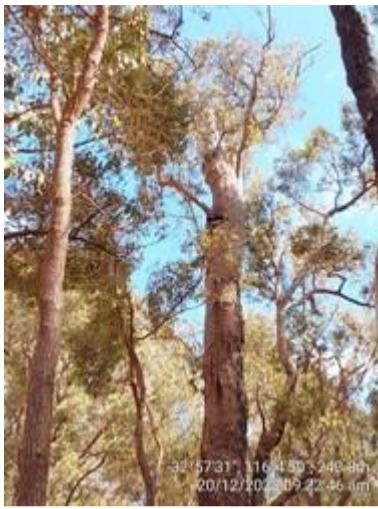
10645	Dead	3	115	One >10 cm mid trunk hollow. Potentially shallow as some type of texture is a bit noticeable, can't confirm depth from ground. Also some broken branches, none appear hollow formation.	414051.2916	6353063.72

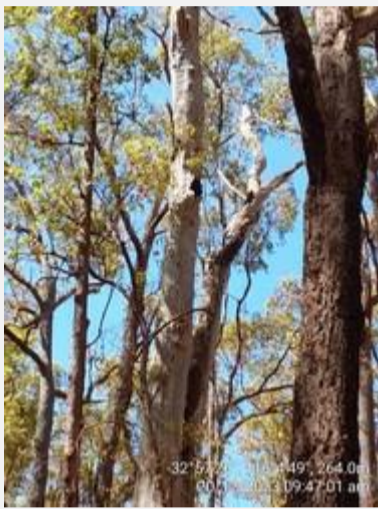
10646	Dead	3	70	Tony. Snapped off tree 15 m up. Potentially >10 cm chimney hollow. Edges rough, walls appear thin with cracks.	414095.117	6352932.346

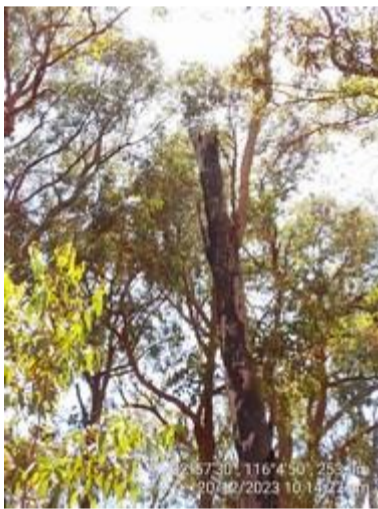
10647	Jarrah	3	90	Tony. One >20 cm might branch hollow 10 m up, has somewhat smooth edges. One potential >10 cm chimney hollow 20 m up. Has somewhat rough edges and small cracks along the side.	414116.6321	6352934.722

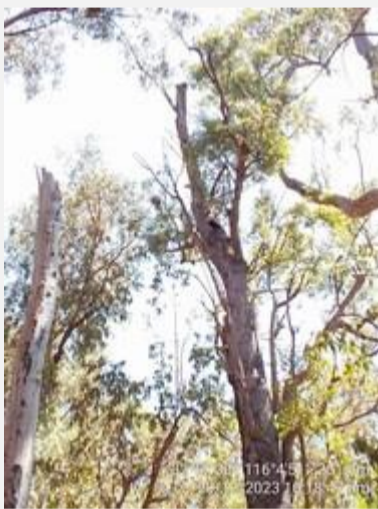
10648	Dead	3	55	Potential >10 cm spout hollow 10 m up, can't confirm from ground but unlikely. Edges are rough, walls have cracks and appear thin.	414147.1015	6352853.127
