Huntly Bauxite Mine – WQMS Data Review

December 2025

Revision: Rev 01

Client: SciDev Pty Ltd

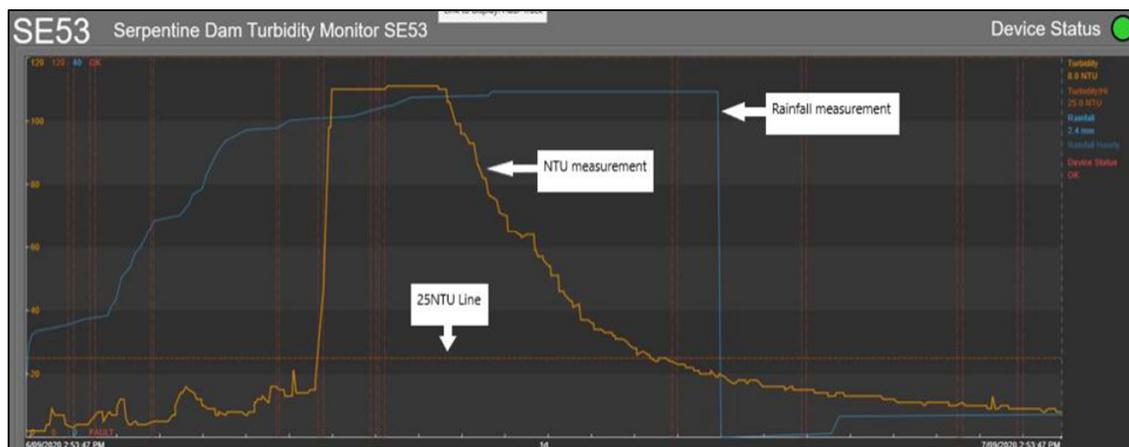
These events are caused by an actual increase in stream turbidity. Per Alcoa's "Turbidity Event Classification Guidelines" true exceedance events typically exhibit:

- A sharp, sudden incline in turbidity levels.
- A return to baseline turbidity levels in a pattern resembling a normal (Gaussian) distribution.

Figure 1 Typical 'true' exceedance event showing the sharp incline and gradual return to background levels.

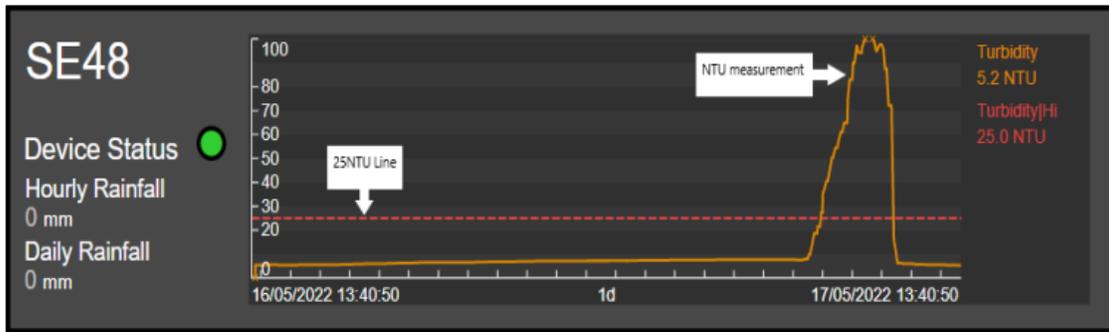
These events are caused by factors unrelated to actual turbidity increase, such as:

- Organic debris (e.g., leaves, sticks, algae) obstructing the sensor
- Air bubbles or water turbulence near the sensor
- Fluctuating water levels intermittently covering and uncover the sensor lens.

False events typically exhibit sharp inclines and declines without the characteristic bell curve shape of true events.

Figure 2 Typical 'false' exceedance event showing both a sharp incline and decline

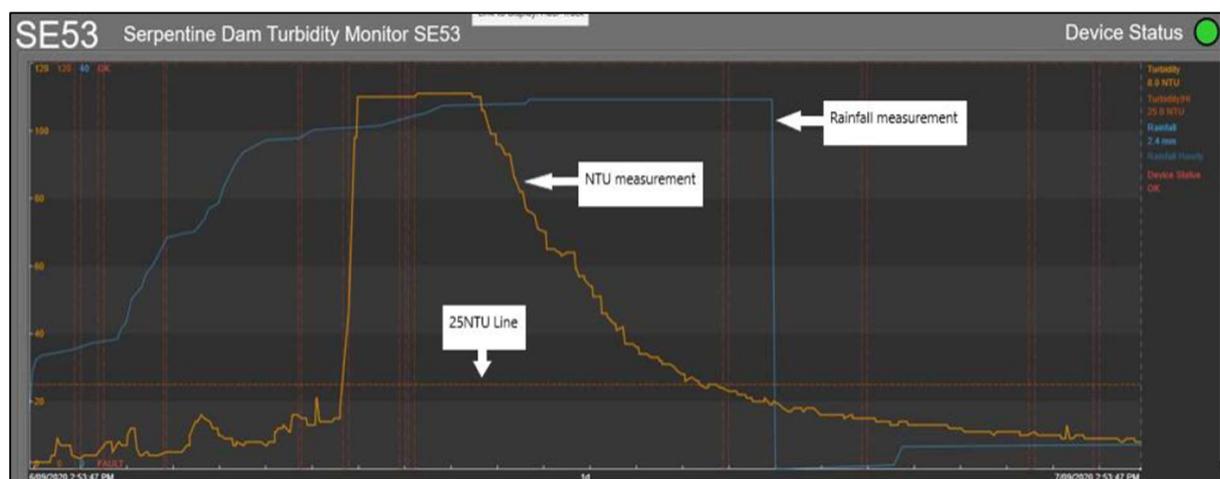
These events are caused by an actual increase in stream turbidity. Per Alcoa's "Turbidity Event Classification Guidelines" true exceedance events typically exhibit:

- A sharp, sudden incline in turbidity levels.
- A return to baseline turbidity levels in a pattern resembling a normal (Gaussian) distribution.

Figure 1 Typical 'true' exceedance event showing the sharp incline and gradual return to background levels.

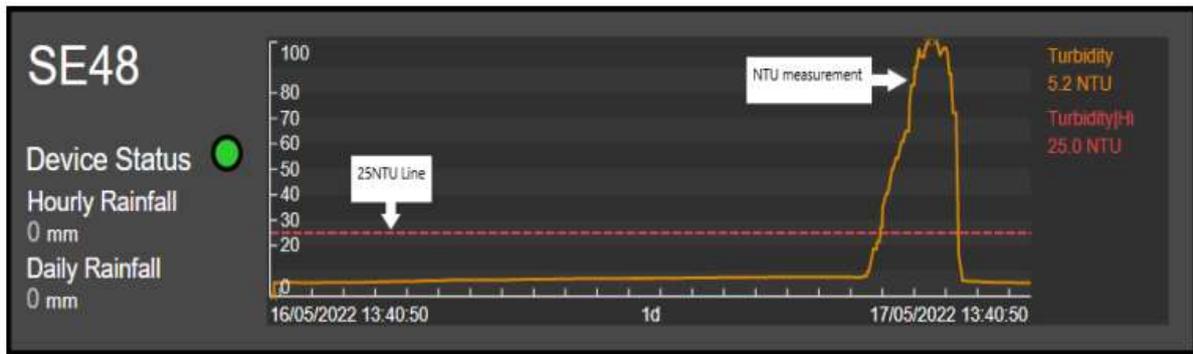
- Organic debris (e.g., leaves, sticks, algae) obstructing the sensor
- Air bubbles or water turbulence near the sensor
- Fluctuating water levels intermittently covering and uncover the sensor lens.

False events typically exhibit sharp inclines and declines without the characteristic bell curve shape of true events.

Figure 2 Typical 'false' exceedance event showing both a sharp incline and decline
