Huntly Bauxite Mine – WQMS Data Review

February 2026

Revision: Rev 02

Client: SciDev Pty Ltd

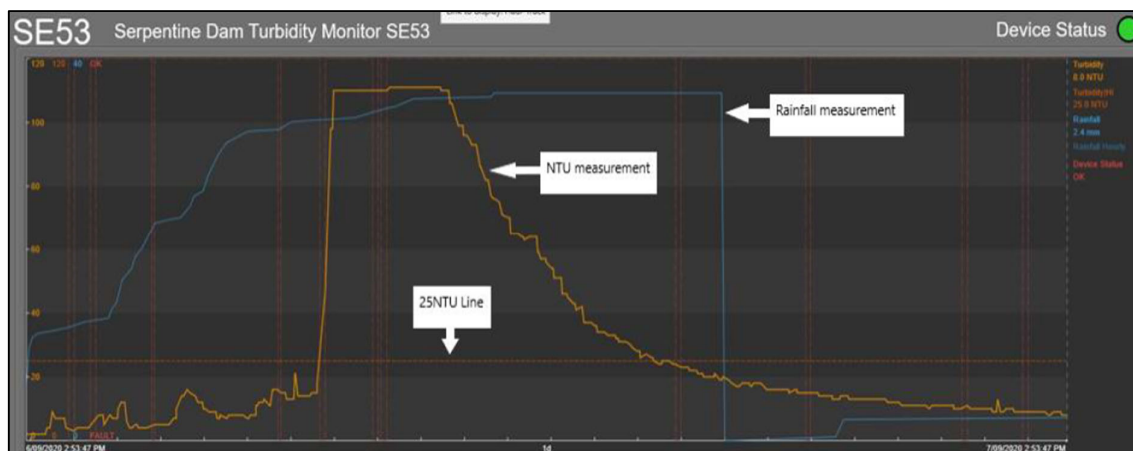
- A sharp, sudden incline in turbidity levels.
- A return to baseline turbidity levels in a pattern resembling a normal (Gaussian) distribution.

Figure 1 Typical 'true' exceedance event showing the sharp incline and gradual return to background levels.

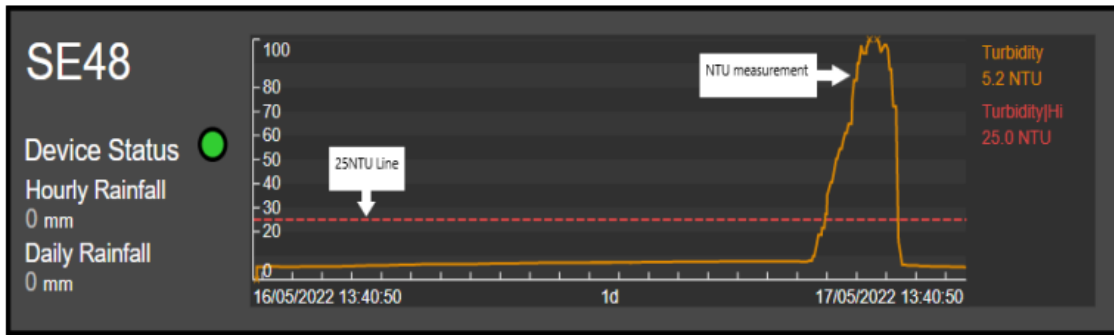
- Organic debris (e.g., leaves, sticks, algae) obstructing the sensor.
- Air bubbles or water turbulence near the sensor
- Fluctuating water levels intermittently covering and uncover the sensor lens.

False events typically exhibit sharp inclines and declines without the characteristic bell curve shape of true events.

Figure 2 Typical 'false' exceedance event showing both a sharp incline and decline.

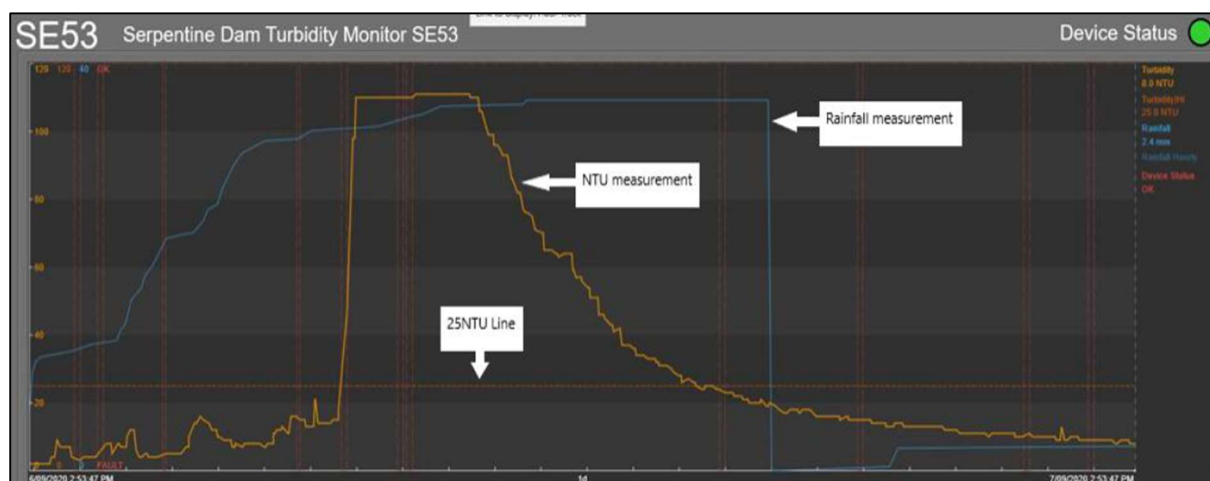
- A sharp, sudden incline in turbidity levels.
- A return to baseline turbidity levels in a pattern resembling a normal (Gaussian) distribution.

Figure 1 Typical 'true' exceedance event showing the sharp incline and gradual return to background levels.

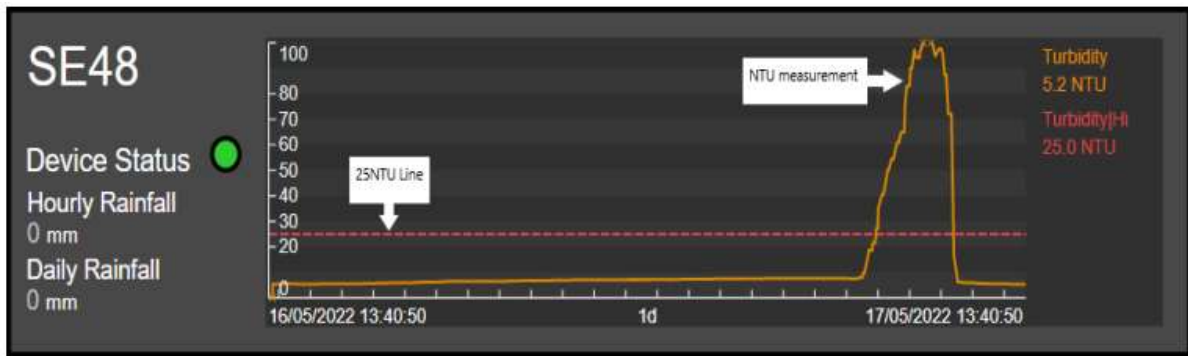
- Organic debris (e.g., leaves, sticks, algae) obstructing the sensor
- Air bubbles or water turbulence near the sensor
- Fluctuating water levels intermittently covering and uncover the sensor lens.

False events typically exhibit sharp inclines and declines without the characteristic bell curve shape of true events.

Figure 2 Typical 'false' exceedance event showing both a sharp incline and decline
