Document type
Compliance Assessment Report (CAR)

Alcoa of Australia Limited – WA Operations

2024 – 2028 Mining and Management Program - Compliance Assessment Report 2025

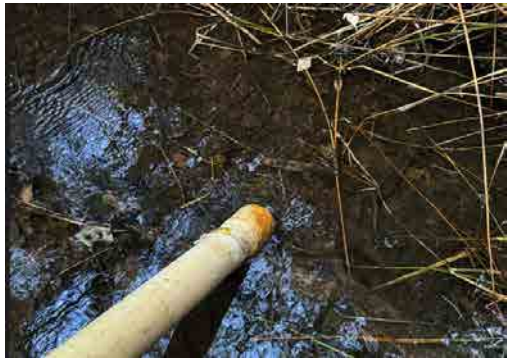
Condition number(s)	Task and Purpose	PNC Issues	Notes	Photo taken
4(d)	Turbidity monitor SM46 <ul style="list-style-type: none"> False events recorded on the 5th and 9th of June (average NTU between 25- 33 for 24hr period) Event attributed to branch and potential debris on pole respectively Closest pits are Diamond 4 and 5 	None identified	<ul style="list-style-type: none"> Clear running water in the stream, no visible disturbance or surface run of towards the monitor from the area.

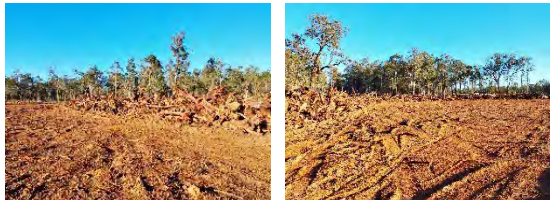
4(d)	Check drainage control at Flinders 6 <ul style="list-style-type: none"> Check drainage control in area – Harvesting and clearing has occurred in these pits Check for presence of BC tree 1433 	None identified	<ul style="list-style-type: none"> timber windrows along the harvested area edges closer to the forest edge in the southwestern edge are present The north to south gradient rest of the harvested area is not drainage controlled currently.

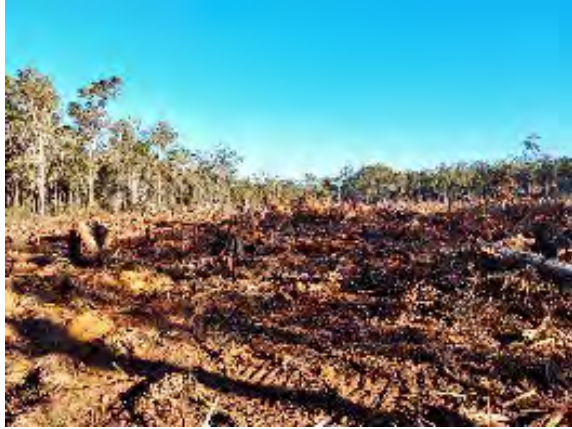
Condition number(s)	Task and Purpose	PNC Issues	Notes	Photo taken
4(d)	Check drainage control and for presence of BC tree #2634 at Flinders 1 <ul style="list-style-type: none"> Harvesting has occurred in this pit Check for presence of BC tree #4143 and #907 and on west side of pit 	None identified	<ul style="list-style-type: none"> Area has been cleared, rough surface present, low erosion risk and no observed sediment runoff from the pit.

<p>View of the pit during inspection</p>

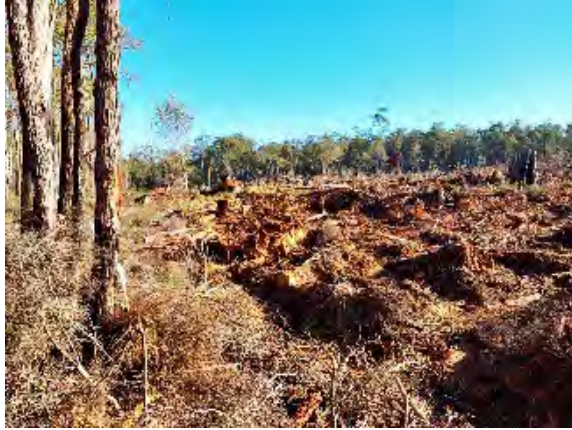
<p>The bottom of the pit with forest edge</p>

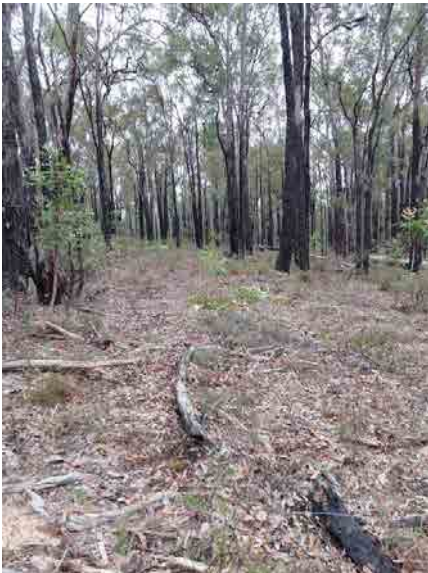
Condition number(s)	Task and Purpose	PNC Issues	Notes	Photo taken
5	Exploration drill holes at White 1 <ul style="list-style-type: none"> Check that disturbance at exploration drill holes is acceptable Check drill holes have been filled in Check for presence of large trees Trees are not within survey legacy area 	None identified

<p>No potentially significant trees identified Viewed 5 drill holes not within black cockatoo survey area – no big trees encountered within area</p>	8.14

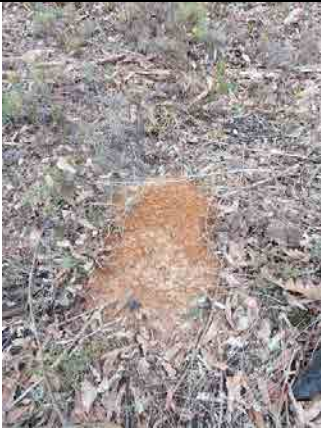
<p>Exploration drill holes filled in as above.</p>	
5	Wittwer 3 <ul style="list-style-type: none"> Stripping scheduled to occur jun 20. Check drainage control is adequate. – area is within the 1.5km buffer of mount solus Check for presence of black cockatoo trees close to clearing area - #6339 already checked #1710 and #961 (fallen). However these may have been checked before clearing occurred. BC trees 1707 and 1702 have not been checked yet Check clearing boundaries against native vegetation disturbance footprint (green) 	None identified	<p>Viewed stripping at Wittwer 3.</p>

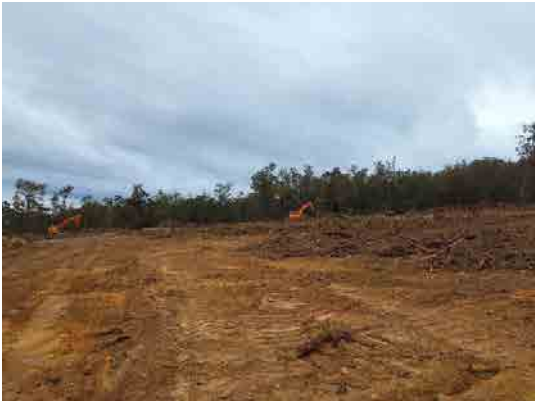
<p>Windrows on contour present on eastern side of pit for drainage control.</p>	9.20

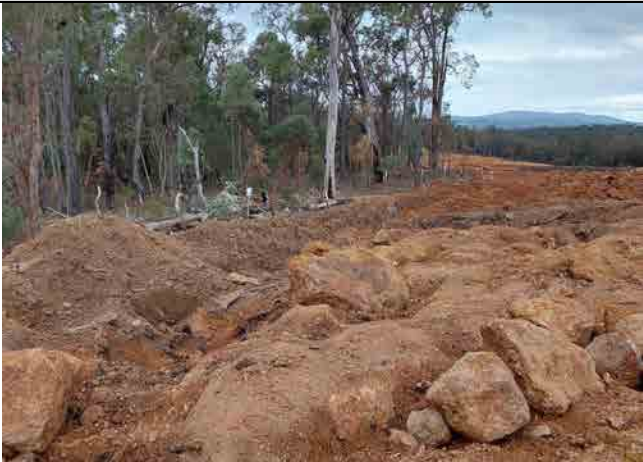
<p>Bund at edge of pit is about up to 1m in some places for drainage control</p>

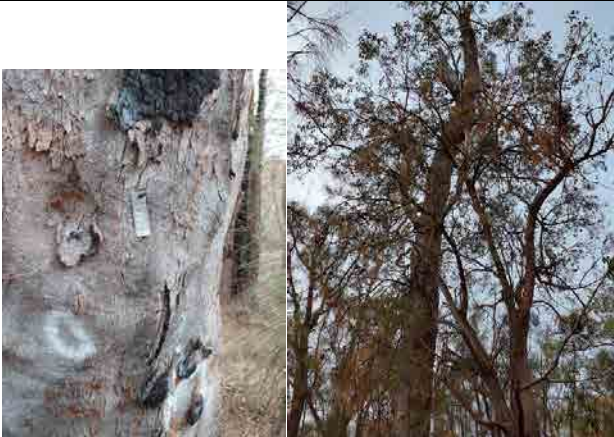
<ul style="list-style-type: none"> Sighted black cockatoo tree 1707 In uncleared forested area

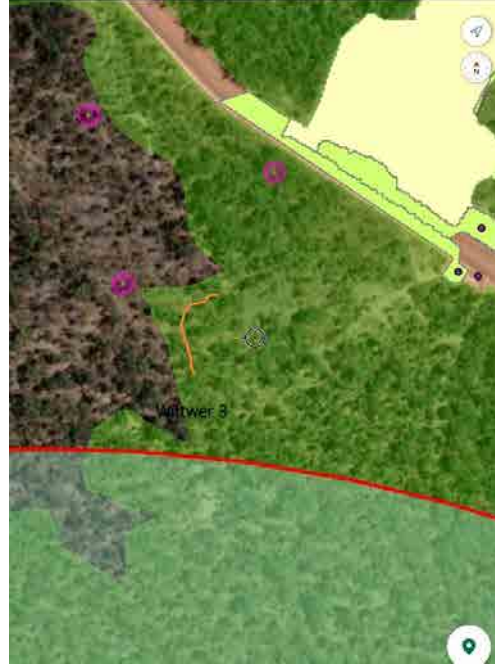
<p>Wittwer3_NV_BC</p> <p>Wittwer 3</p> <p>Walked boundary of stripping at pit. Confirmed to not go outside native vegetation disturbance footprint.</p>	
4(d)	Turbidity monitor SE52T <ul style="list-style-type: none"> 50.11 average turbidity recorded on Check <25% drainage capacity dc area at Downes 9 for signs of drainage failure . Pit is <400m from turbidity monitor. 	None identified	No runoff sighted from haul road down access track. No runoff sighted down walking track to turbidity monitor.	10.10

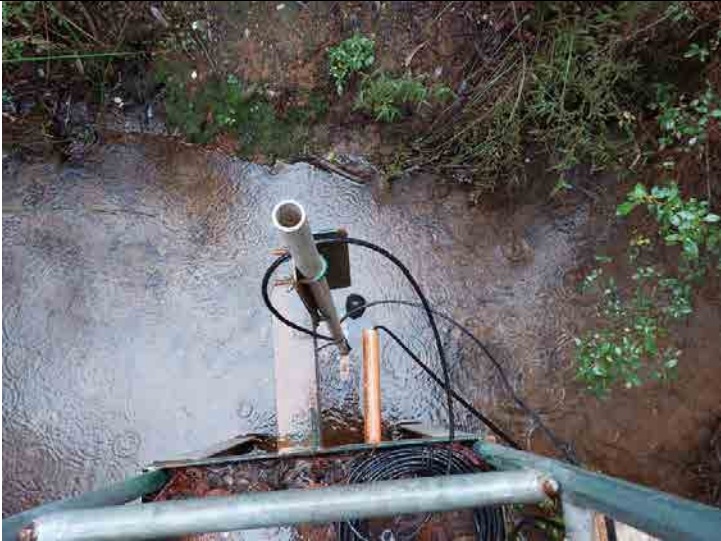
<p>Water was clear and running, minimal veg around turbidity monitor in stream.</p>

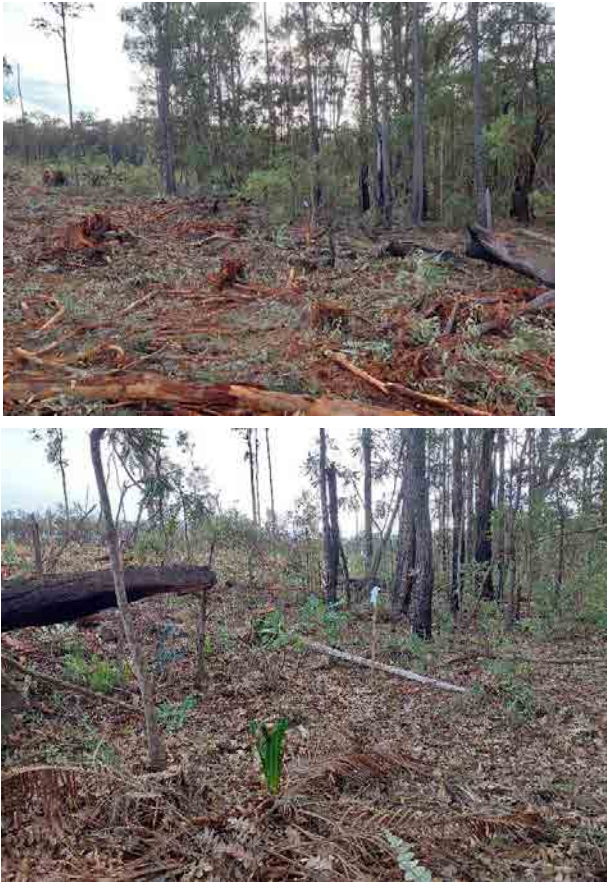
Condition number(s)	Task and Purpose	PNC Issues	Notes	Photo taken
5(d)	Rhodes 5 <ul style="list-style-type: none"> Check that clearing is within the native vegetation disturbance footprint Check for presence of BC tree 4633 (circled) 	None identified	All clearing within pegged boundary. Boundary checks done, clearing aligned with clearing envelope.

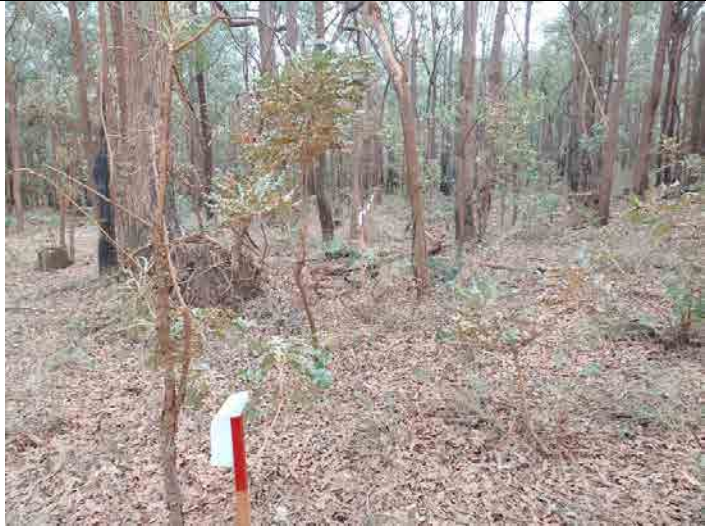
Condition number(s)	Task and Purpose	PNC Issues	Notes	Photo taken
5	Mccarthy 6 <ul style="list-style-type: none"> Stockpile relocation occurring Check that clearing has only occurred within the native vegetation disturbance footprint)	None Identified	<ul style="list-style-type: none"> Boundary checks done. New pegged area in forest aligned with green transparent shape file.

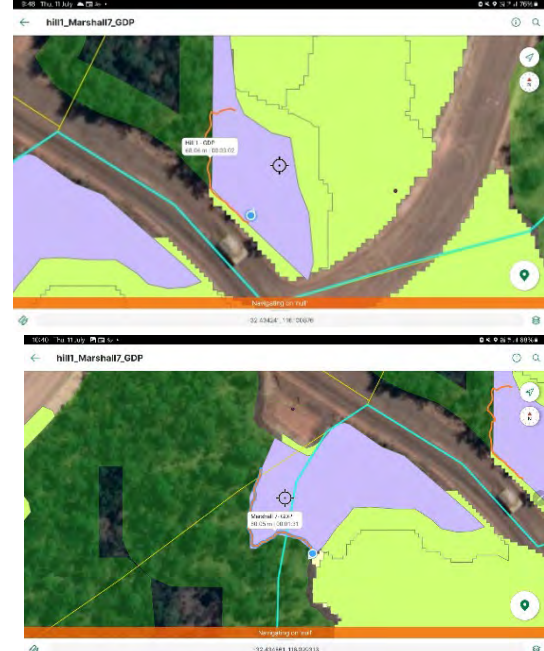
Condition number(s)	Task and Purpose	PNC Issues	Notes	Photo taken
5	Hill 1 / Marshall 7 GDP <ul style="list-style-type: none"> Within RPZ – part of GDP is in >16% slope area area is in RPZ and steep area check approved boundaries do not go outside of Native vegetation disturbance footprint on northern side of GDP. Check no large trees in area 		<ul style="list-style-type: none"> Walked small area flagged in Hill 1. No large trees in the area. Southern GDP in Marshall 7 checked and tracked, GDP within native vegetation disturbance area.

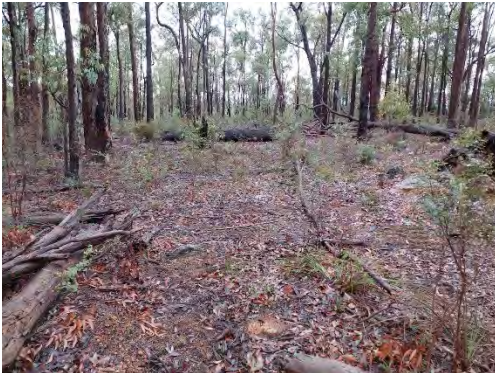
Condition number(s)	Task and Purpose	PNC Issues	Notes
5	Iannetta 1 – GRID ref K4207 <ul style="list-style-type: none"> Inspect drainage control at pit – trenches mentioned to be scheduled in pit in meeting minutes – check drainage control Inspect exploration drill holes at area. Drill holes north west of pit are not within black cockatoo legacy survey area 	None Identified

<p>Minimal disturbance around area.</p>

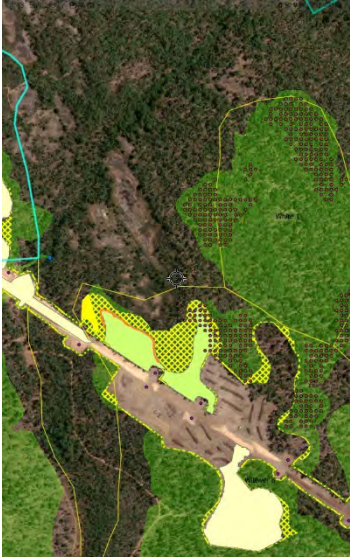
Condition number(s)	Task and Purpose	PNC Issues	Notes
5	Wittwer 8 – Grid ref L4213 <ul style="list-style-type: none"> Stripping occurring at this pit – check that it does not go outside of pit boundary Check that stripping does not go outside of native veg disturbance footprint Exploration drill holes at east side of pit are not within legacy survey area 	None identified

<p>Walked GDP boundary – all within the native vegetation disturbance boundary</p>

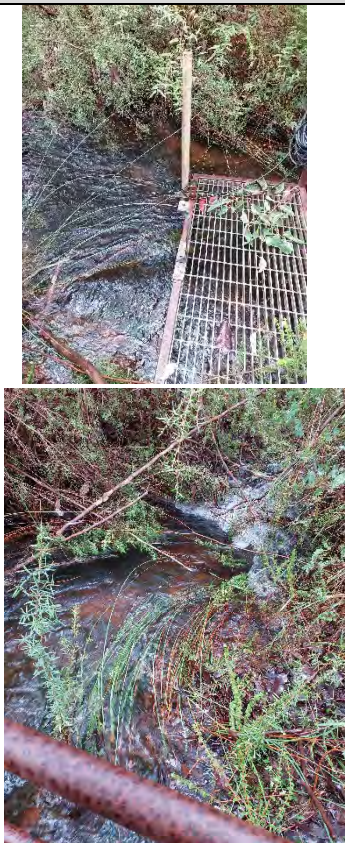
MMP 4	Sm46	None Identified	<ul style="list-style-type: none"> • 6.7 ntu • Water clear and running 	2

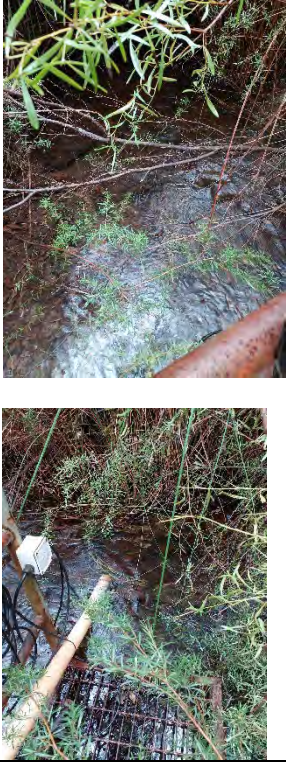
4	Sm06	None Identified	<ul style="list-style-type: none"> 1.3 ntu on logger. Stream clear and running. 	1 9.30

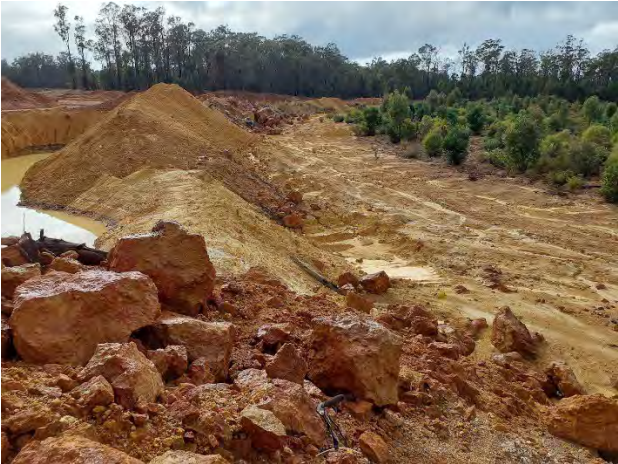
Condition number(s)	Task and Purpose	PNC Issues	Notes	Photo taken
			<ul style="list-style-type: none"> Area past Sump at bardick 1 pit adjacent to rehab has severe erosion which flows into overflow sump.

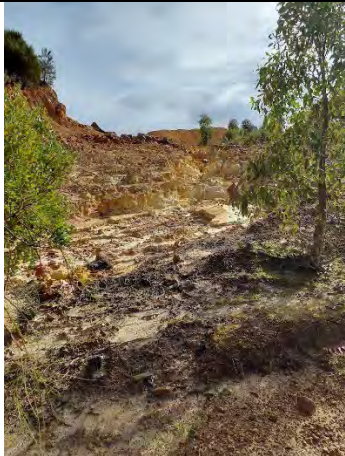
<ul style="list-style-type: none"> Picture from rehab Runoff reports to this second sump – no overflow from this area

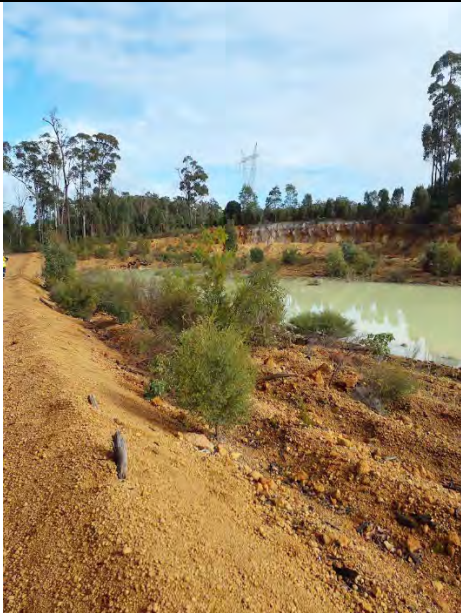
<ul style="list-style-type: none"> Sumps at end of Diamond Road no drainage failure

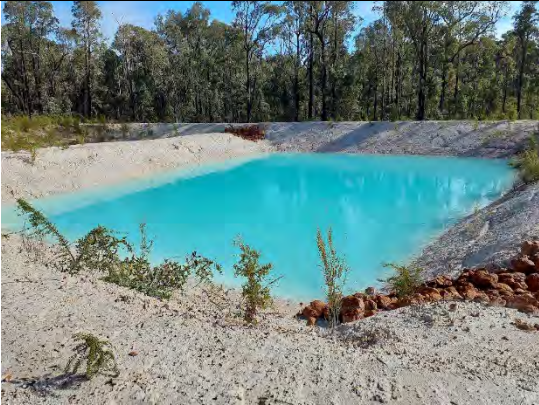
Turbidity monitor HV08, sumps upstream of monitor and bottom end of Central 7.

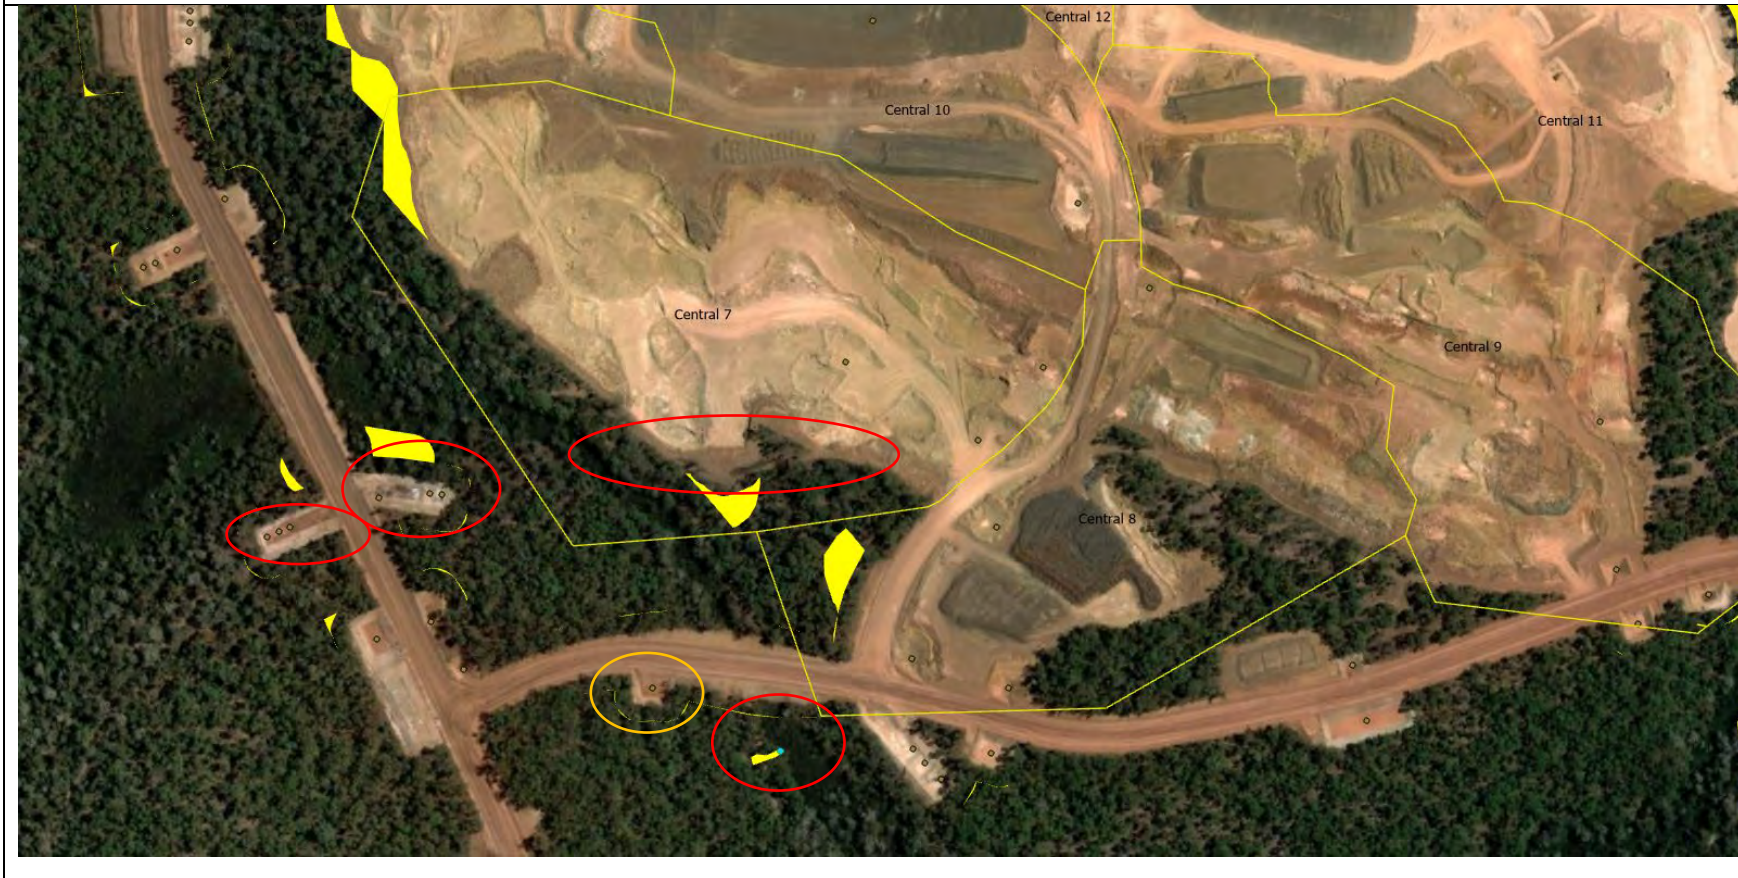
Drainage capacity at Central 7 and around turbidity monitor

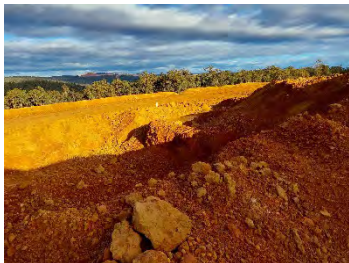
<p>Erosion has occurred down slope of pit in less than 100% drainage capacity area but has been contained within Bund at bottom of the pit.</p>

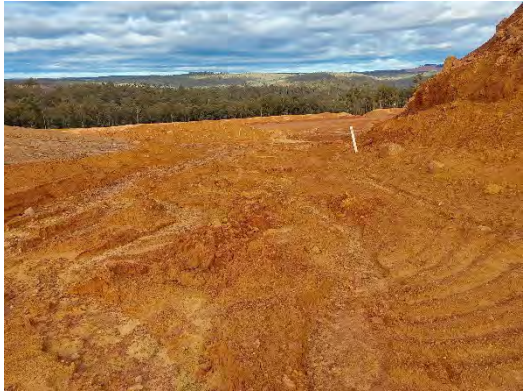
<p>Martin 1 cleared area within marked approved area</p>

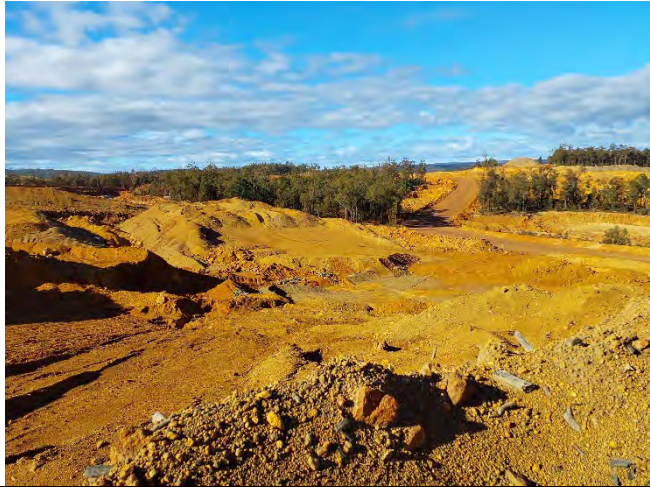
Condition number(s)	Task and Purpose	PNC Issues	Notes	Photo taken
			<p>Less than 25% dc area of pit is stockpile area. Bunding present at bottom of area for drainage control. Basin present at pit on opposite side of haul road.</p>

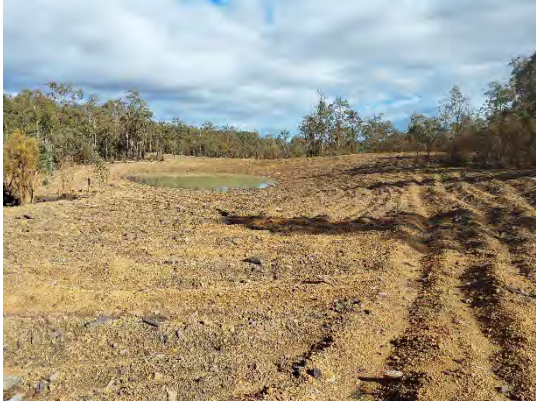
<p>Road within Bennett 1 pit area has been contour ripped.</p> <p>Sighted black cockatoo tree 1744 on tree island in Bennett 1 pit</p> <div>

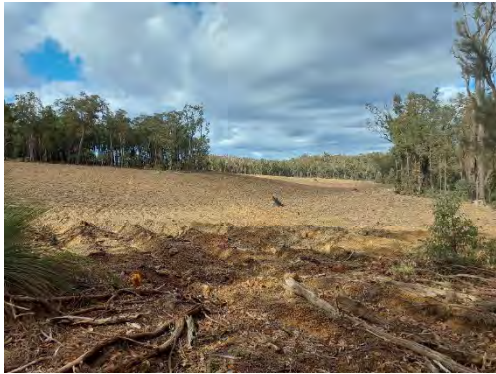
<p>Red dc area Bennett 1. No signs of drainage failure observed.</p>

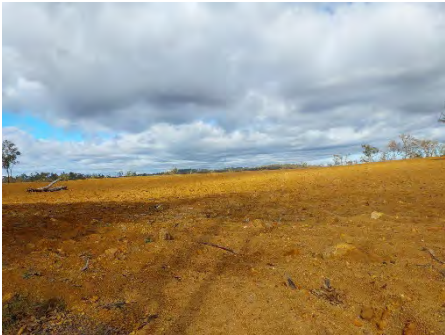
<p>Bennett 2 Bennett 2 pit. Contour ripped and rehabbed with bowls. Bottom end of pit. Presence of small Bund for drainage containment.</p>

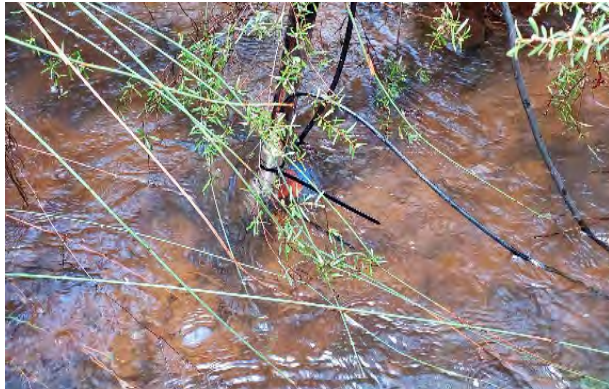
Condition number(s)	Task and Purpose	PNC Issues	Notes	Photo taken
4 (d)	SE03T Turbidity monitor - J4222 <ul style="list-style-type: none"> True event recorded on 28/07/2024. Catchment inspection currently in progress as of turbidity register for 1st of August (wc_20240729 RFI) Avg turbidity 29.86 NTU, rainfall in prev 24 hours 26.4 mm 	None Identified	Reading 7 NTU. Visibly clear water in the stream. No visible disturbance or run off to the stream around.

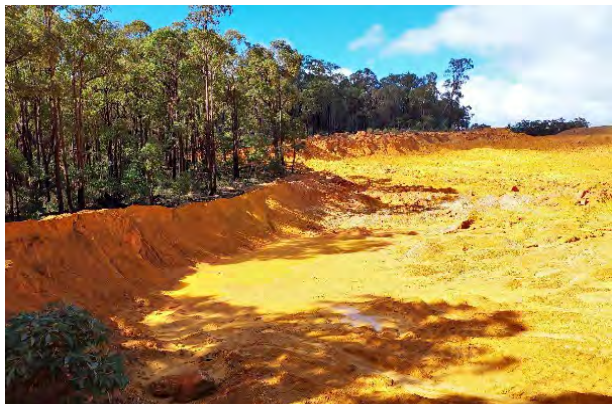
<p>Blacklock 10 pit bottom sump.</p>
			Two open blast holes at Blacklock 10 between pit edge and forest.

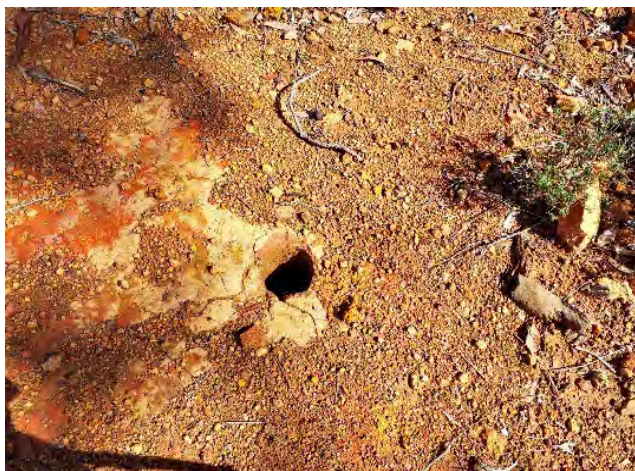
<p>Open blast hole at Blacklock 10. (-32.484269°; 116.181317°)</p>

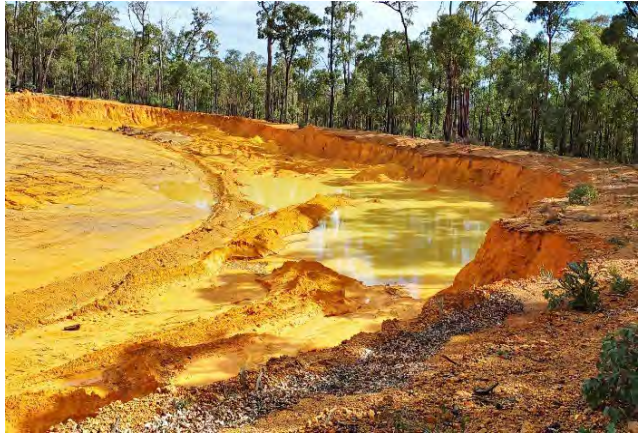
<p>Blacklock 11 bottom pit DC.</p>

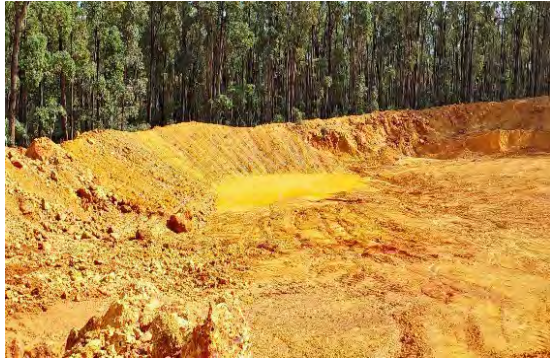
<p>Blacklock 11 pit western end DC</p>

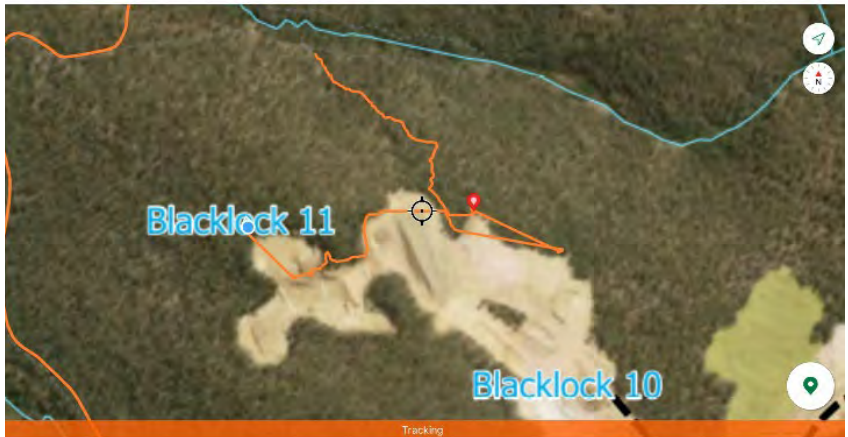
<p>Checked areas at Blackloc 10 and 11. Red dot shows unplugged blast hole</p>	
5	Downes 8 - J4218 <ul style="list-style-type: none"> Pit is approx. 400m north of turbidity monitor Check bottom end for signs of drainage failure. Majority of pit currently marked as <100% drainage capacity. Some area attend of pit marked as <50% drainage capacity. Confirm no mining occurring in this pit – within top 1km water level margin 	No	<p>No mining activity occurring in the pit. Walked to the bottom pit to check drainage risk. No issues noted.</p>

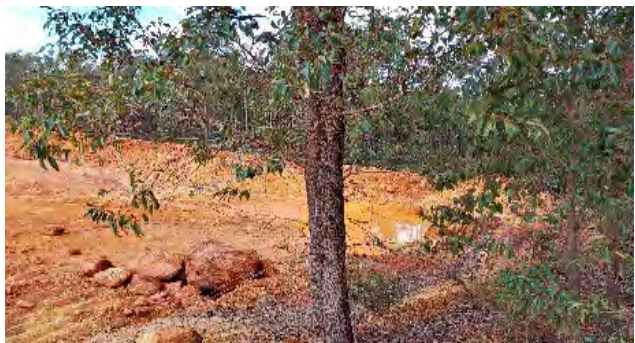
<p>Downes 8 bottom DC</p>

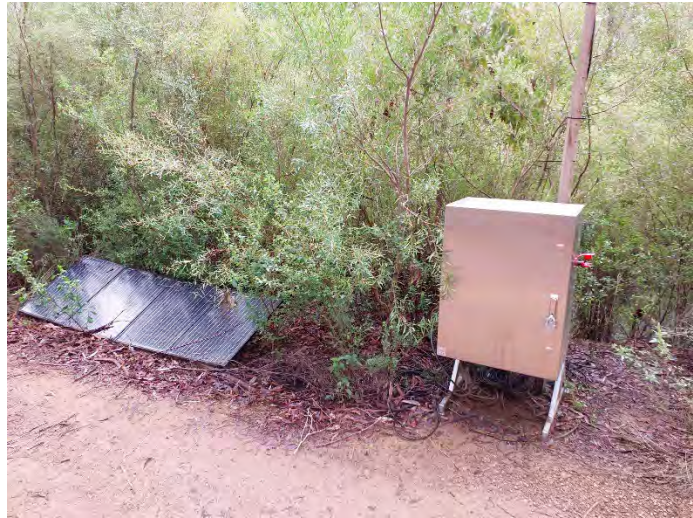
4	<p>Turbidity monitor SE60 (J4111)</p> <ul style="list-style-type: none"> • Monitor has not been visited before • Recorded false event between 23/07/2024 – 29/07/2024, Avg turbidity of 32.36 – false event classification due to monitor error. 		<p>Turbidity monitor located at coordinates provided.</p> <p>Stream water is clear and flowing. Water level is above average due to heavy rainfall overnight. Approx 40mm in past 24 hours.</p> <p>Organic sediment and debris observed on stream floor.</p> <p>Significant amount of sediment runoff observed that had washed down hill towards the stream in which the turbidity monitor is located. Location provided.</p> <p>Sediment runoff exacerbated by overland flow down the track towards the stream and turbidity monitor.</p>

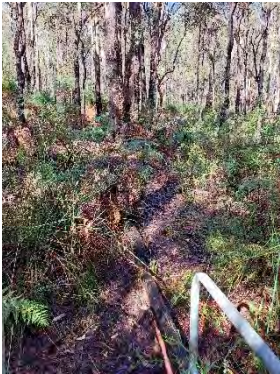
<p>Bottom end of dellamaddalena 5. Closest pit on same side of stream to turbidity monitor</p>

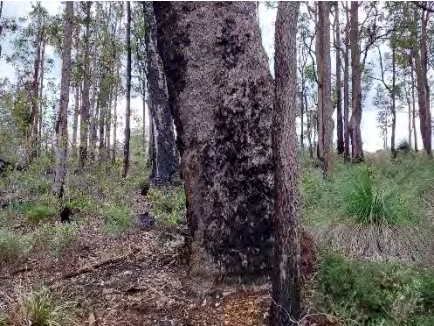
<p>Pit rehabbed</p>

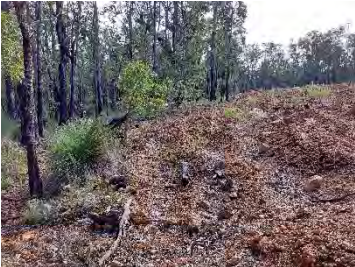
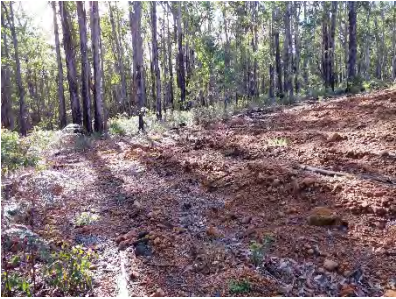
Condition number(s)	Task and Purpose	PNC Issues	Notes	Photo taken
			<p>Native vegetation boundary walked. Gps 2.5m accuracy. Pit disturbance is within the native vegetation disturbance boundary.</p> <p>No signs of runoff along boundary or pooling of water along bottom of pit.</p> <div>

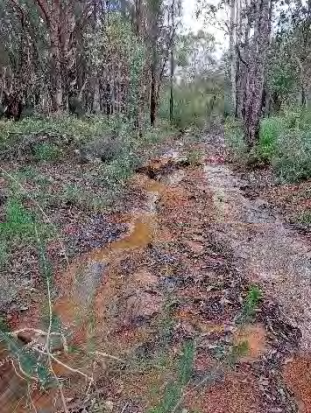
Running water down bush track adjacent to Marshall 14 and 15 Water is clear and appears to originate from stream and not pit.

</div> <div>Water ends in bush</div>

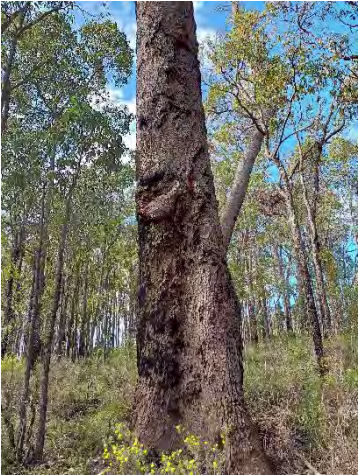
Condition number(s)	Task and Purpose	PNC Issues	Notes	Photo taken
			<div>Black cockatoo tree 1387. In an uncleared area.</div> <div>

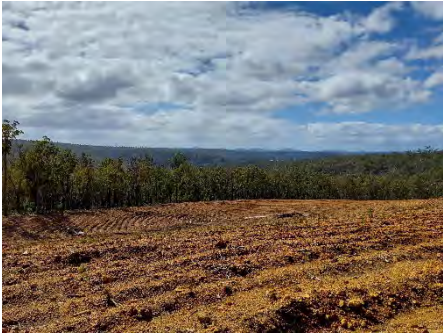
</div> <div>Bottom of pit within top 1k. Buffer.</div> <div>

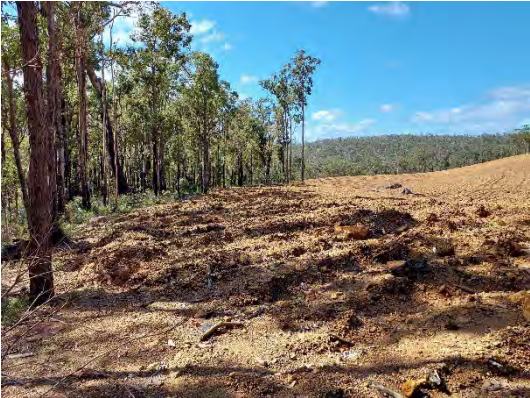
Condition number(s)	Task and Purpose	PNC Issues	Notes	Photo taken
			<p>Bottom end of pit. Drainage capacity is in good condition. Bowls in pit and no sign of runoff</p>

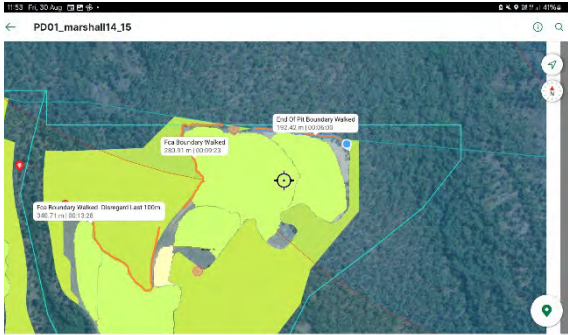
</div> <div>Pit boundaries walked</div> <div>

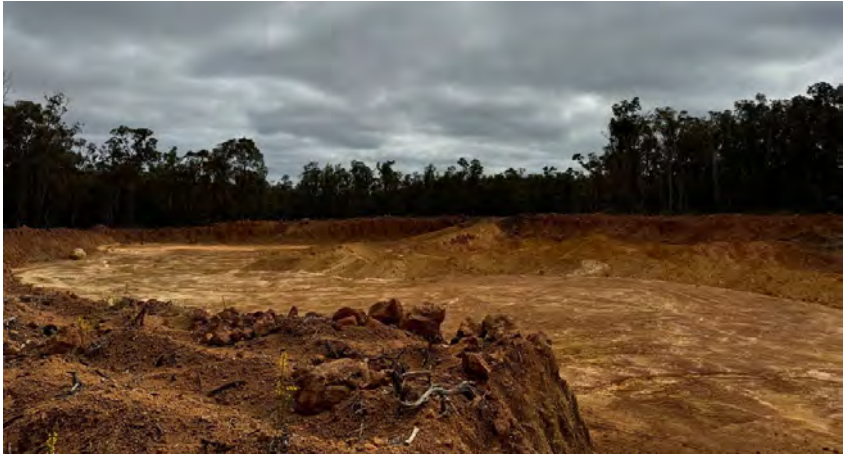
<p>Northern pit face of the Downes 10.</p>

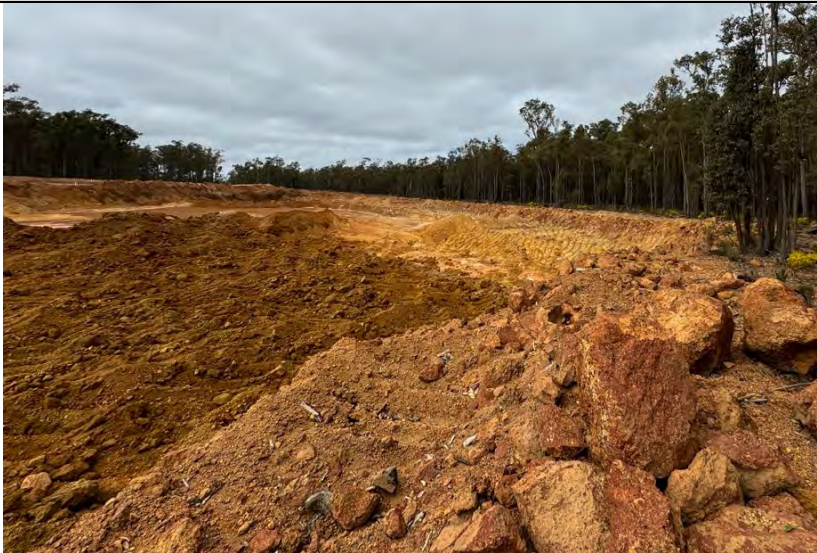
<p>Loosened pit floor surface in the middle part of the northern pit for drainage control. South-west edge of the pit.</p>	
2	MMP 4	Downes 10 (J4219, J4218) <ul style="list-style-type: none"> pit on Red Alert Checklist on 15/08/24 for heavy rainfall event. Check sumps for DC failure and that DC in pit is adequate. Southern side of pit has been rehabbed – check northern end 	no	<p>The northern part of the pit has high mine pit face containing runoff to the mined pit. Recently harvested area in the northern part has loosened soil and dirt bund for run off control. No issues noted.</p> <p>Walked through the area marked in red to inspect any drainage failure issues. The inspected red area is steeper than the bottom areas. Inspected areas have been rehabilitated and contour ripped perpendicular to the gradient. No drainage concerns noted. See below photos with notes.</p>

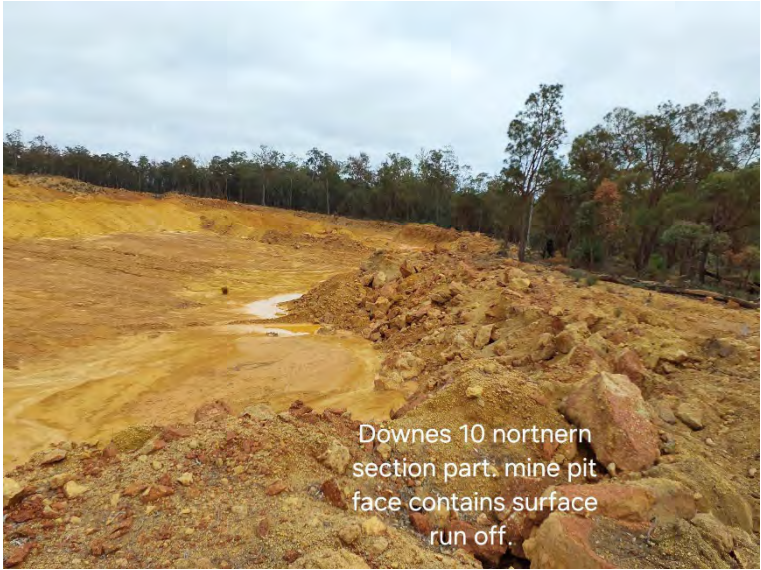
<p>Downes 10 northern section part. mine pit face contains surface run off.</p>

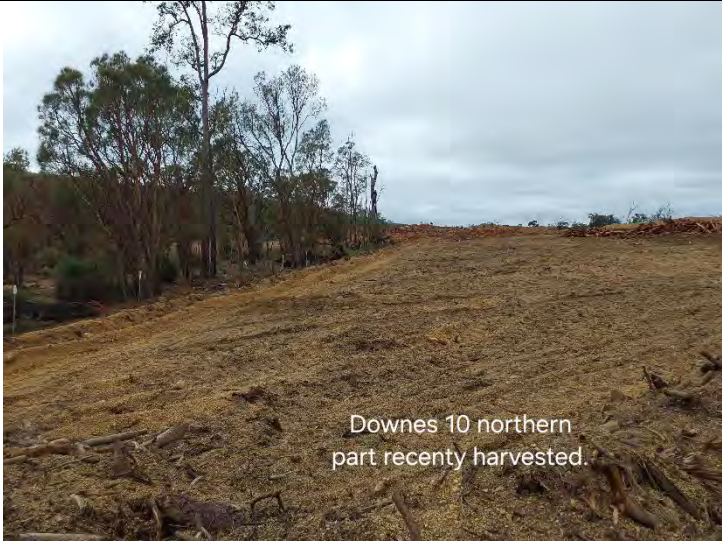
<div>Downes 10 northern part recently harvested.</div> </div>

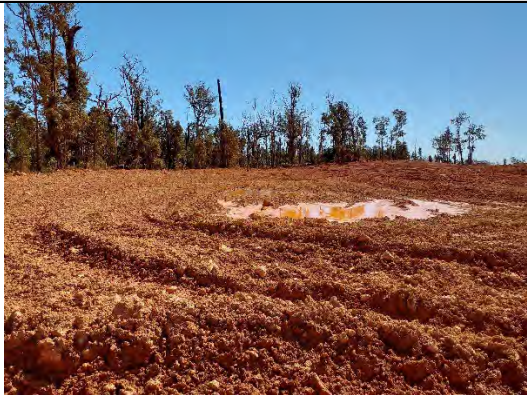
Condition number(s)	Task and Purpose	PNC Issues	Notes	Photo taken
4 (d)	<p>Gibber 15 (G5404, G5328)</p> <ul style="list-style-type: none"> From follow up notes - pit floor ripped areas are to be inspected during rainy season. According to Alcoa specialist for drainage Control, the pit floor ripping is an interim measure for drainage control. Check DC in pit is adequate and check sumps for DC failure. 		<p>Ripping in pit has provided adequate drainage control.</p> <p>Pooling of water in low lying area in north of pit.</p> <p>Groundwater was observed flowing into the where the water was pooling.</p> <p>No signs that the water had breached the pit boundary.</p> <p>Sumps in pit had adequate freeboard.</p>

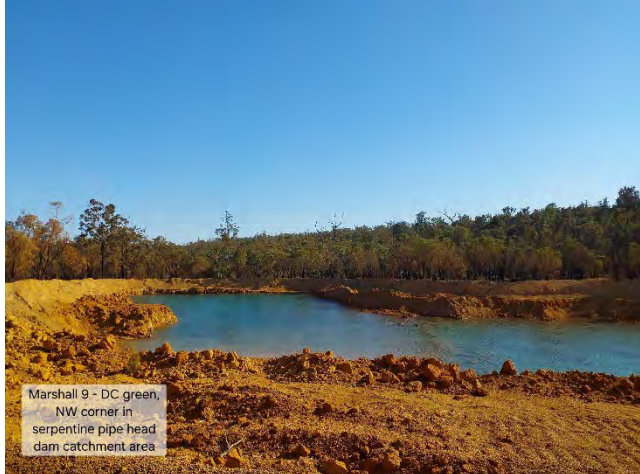
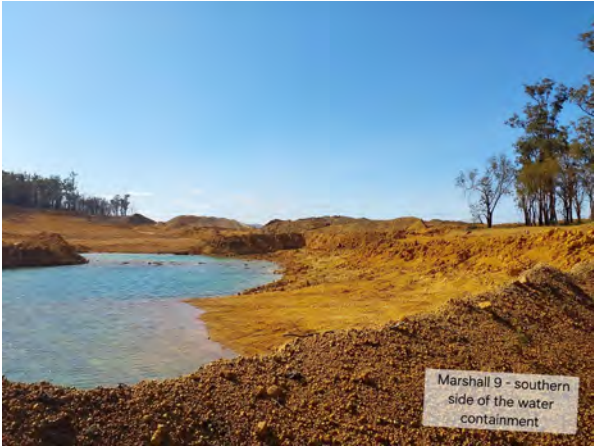
Condition number(s)	Task and Purpose	PNC Issues	Notes	Photo taken
5(b)	Marshall 9 (G4117) <ul style="list-style-type: none"> Confirm no works are occurring within the Serpentine pipehead dam catchment area on the northwestern end of the pit. Charging/ drilling and stockpile relocation/stripping has occurred in last 2-3 weeks. Check Drainage control in <50% drainage capacity areas and at bottom of pit close to serpentine pipehead dam catchment area Opportunistically check drainage capacity at sumps. 		<p>Green drainage control inspected in the northwest corner; pit runoff retained within the pit.</p> <p>There are high bunds (freeboard >5m) along the Native vegetation boundary preventing water of entering the forest.</p> <p>Bunds appear to be in a good condition. Area is within Serpentine pipe head dam catchment area.</p> <p>The area from western side of the water containment has been ripped. Winterisation has occurred on the southern side of the water containment. Both areas slope towards the northwest corner.</p>

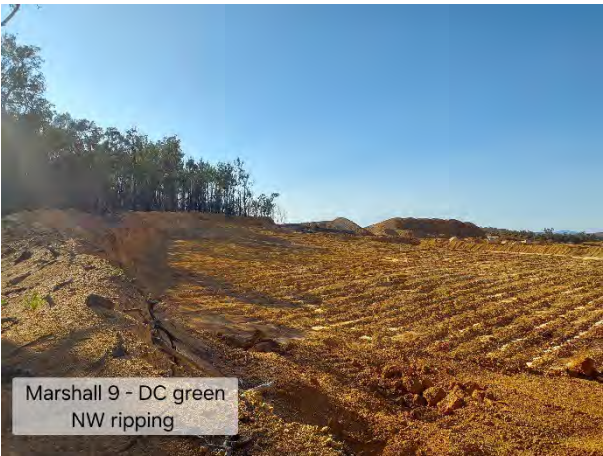
<div>Marshall 9 - DC green NW ripping</div> </div> <div>

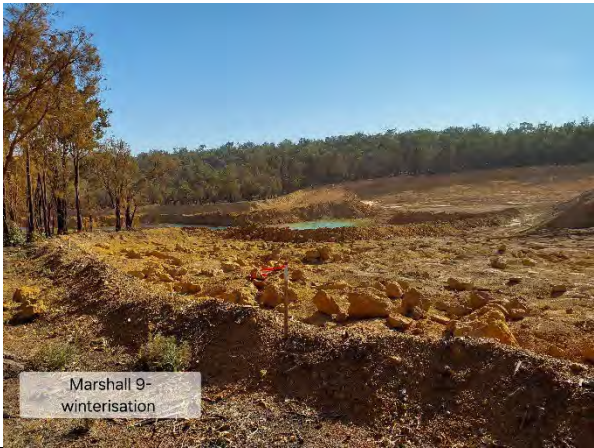
<div>Marshall 9- winterisation</div> </div>

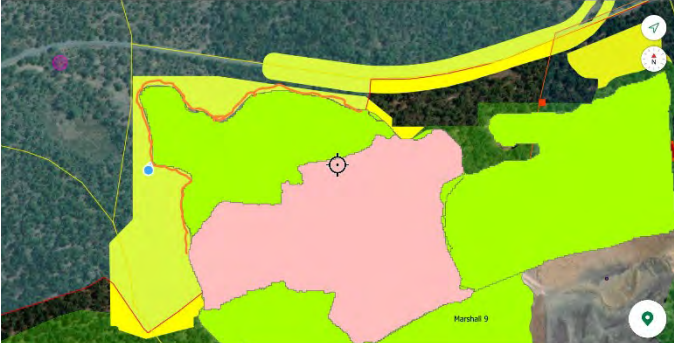
</div> <div> <div>Works occurring in the green DC area near Black Cockatoo tree #1463 on the eastern side of the pit.</div> </div> </div>

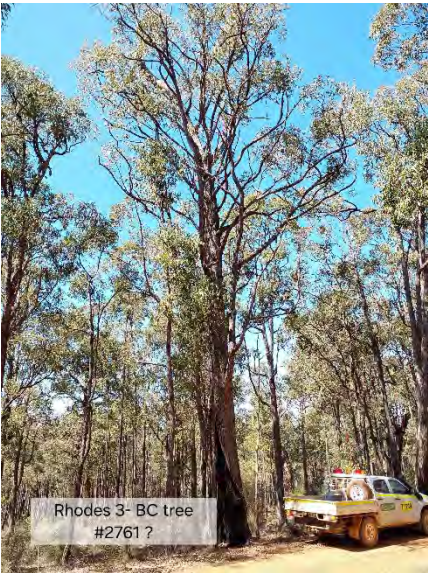
<p>Exploration drill hole area inspected. See tracking and photos. Exploration drill hole noted outside of the marked exploration area in GIS data, but still within the exploration disturbance footprint. Location marked in the snip with coordinates.</p>

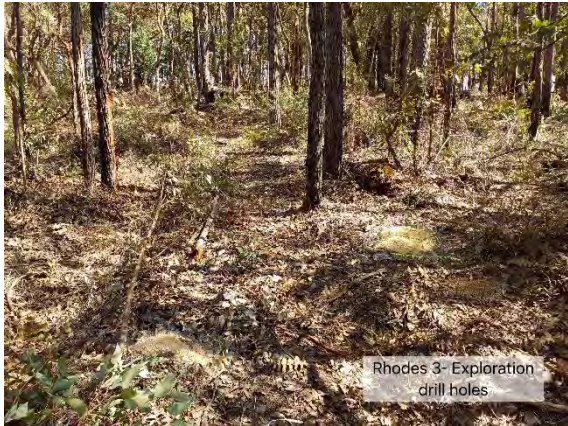
<p>Rhodes 3- Exploration drill holes</p>

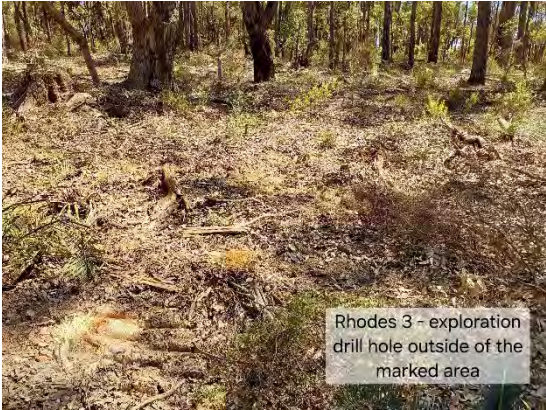
<p>Rhodes 3 - exploration drill hole outside of the marked area</p>

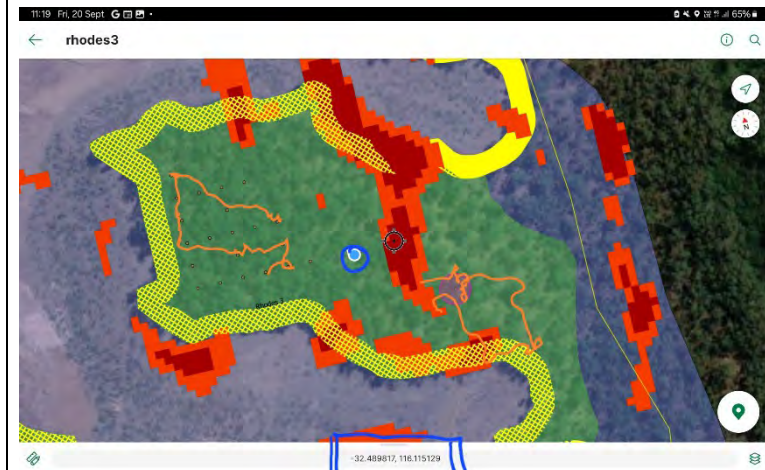
Large tree near (approx. 10m) exploration drill hole outside of the marked exploration drill hole area in GIS data.

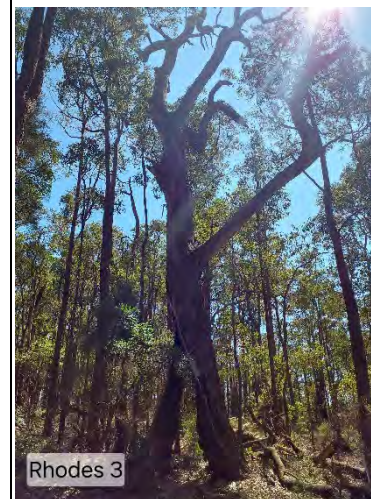
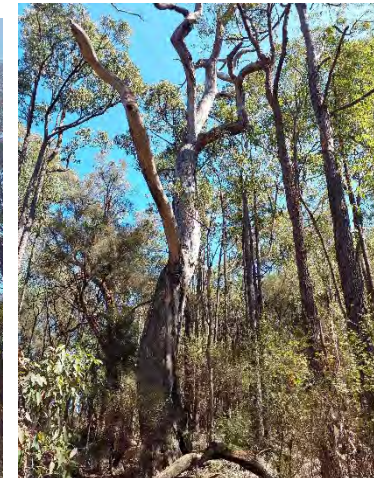
Condition number(s)	Task and Purpose	PNC Issues	Notes	Photo taken
			Tree has a hollow bottom. Coordinates and photos taken.

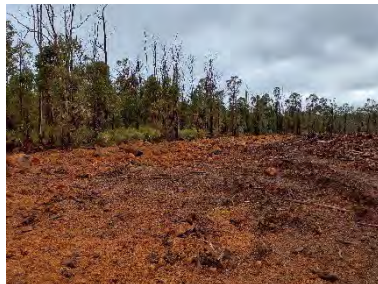
Condition number(s)	Task and Purpose	PNC Issues	Notes	Photo taken
4(d)	Blaxland 10 (F5426) <ul style="list-style-type: none"> Area is being stripped – check dc Check sump capacity Area has been recently harvested 		<p>Area has been stripped.</p> <p>blasting has occurred around entire low end of pit at the perimeter for drainage control</p>

<p>Bunding present. Sump at pit entrance checked. >1m freeboard</p>

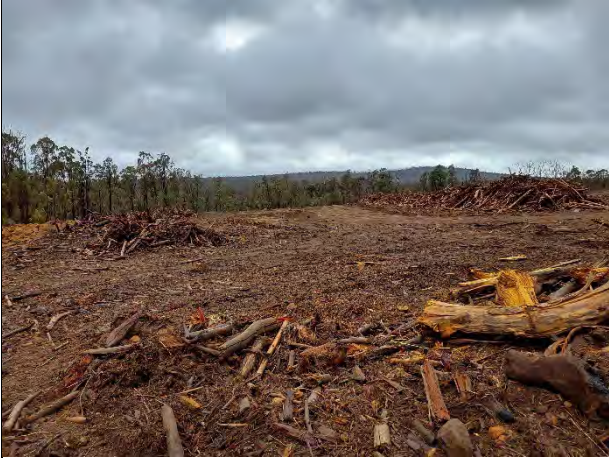
<p>Cleared area Walked. No drainage concerns observed.</p> <p>Watershot at bottom northern end of pit</p>

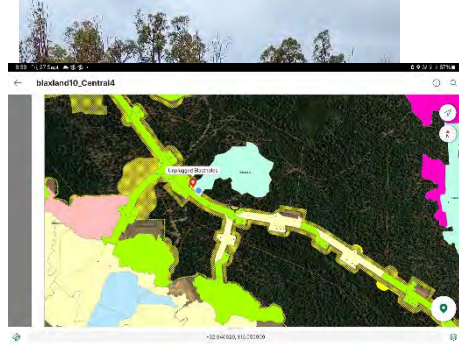
4(d) 5(d)	Central 4 (F5427, F5428, F5504, F5503) <ul style="list-style-type: none"> • Check drainage control at sumps • Area has been recently harvested • Area has been stripped – check DC • Note BC tree is dead 		Watershot along perimeter of East end of pit at bottom of slope.

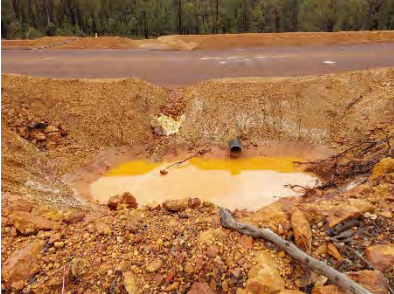
<p>Sumps across road drainage control is adequate. Presence of pump.</p>

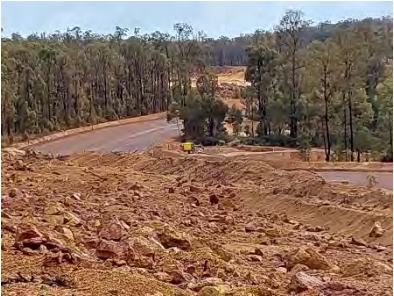
<p>Topsoil still present across majority of harvested area</p>

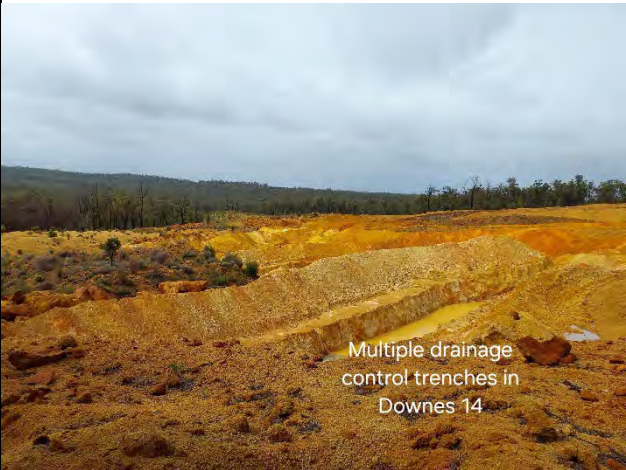
<p>Multiple drainage control trenches in Downes 14</p> </div> <div>

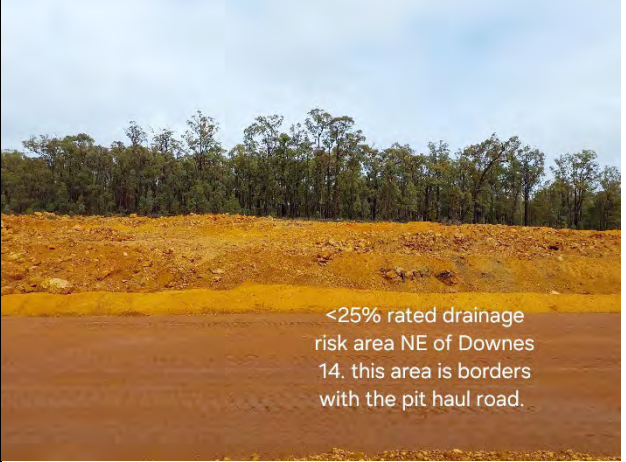
<p><25% rated drainage risk area NE of Downes 14. this area is borders with the pit haul road.</p> </div>

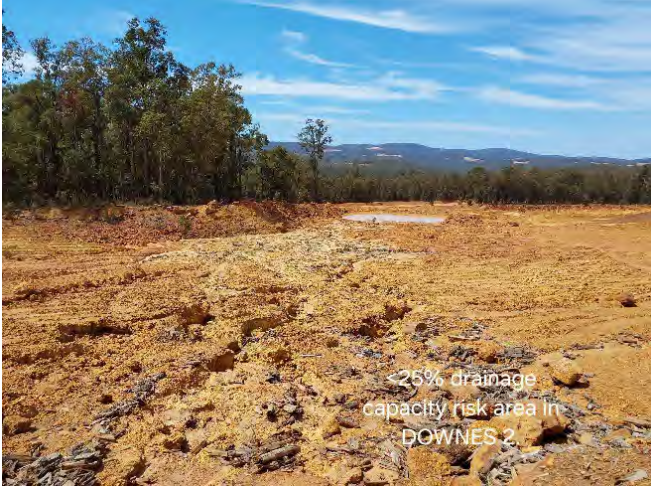
<p><25% drainage capacity risk area in DOWNES 2.</p>

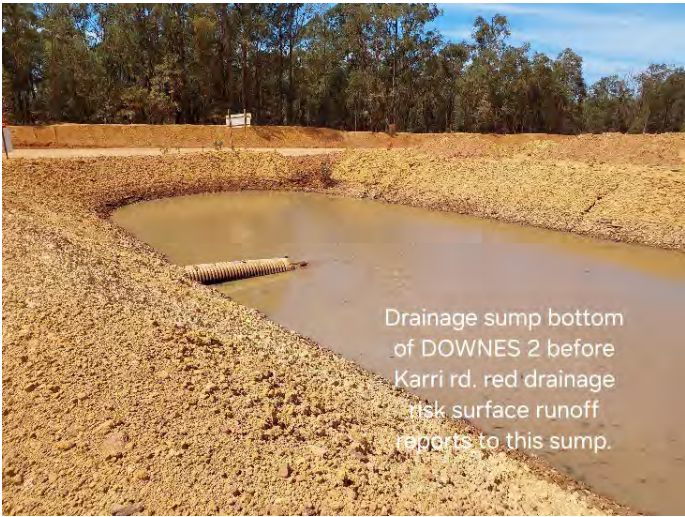
<p>Drainage sump bottom of DOWNES 2 before Karri rd. red drainage risk surface runoff reports to this sump.</p>
