Document type
Compliance Assessment Report (CAR)

Alcoa of Australia Limited – WA Operations

2024 – 2028 Mining and Management Program - Compliance Assessment Report 2025

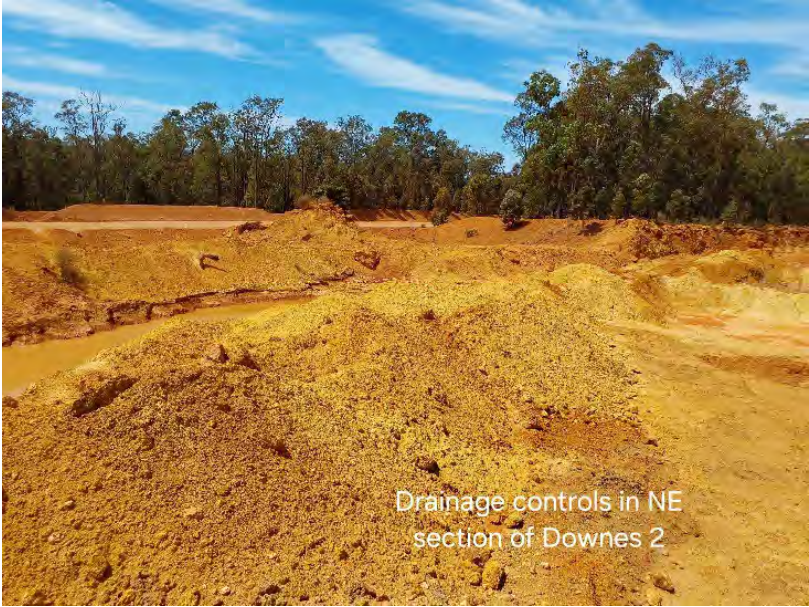
<p>Drainage controls in NE section of Downes 2</p>

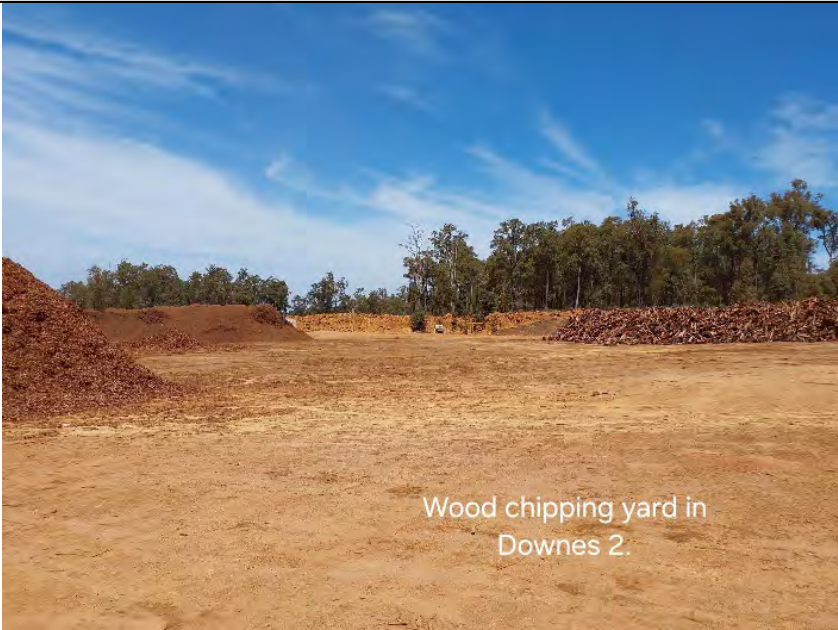
<p>Wood chipping yard in Downes 2.</p>	
5	Lloyd 1 (G4212, G4211, G4207, G4208) <ul style="list-style-type: none"> Check approved GDP area does not enter FCA relinquished area on north west side of pit Check GDP approved area is within native vegetation disturbance footprint (green transparent layer) 	<i>Non identified</i>	Demarcated proposed disturbance area is within the Vegetation Disturbance Area 10 m inside the approved GDP boundary.

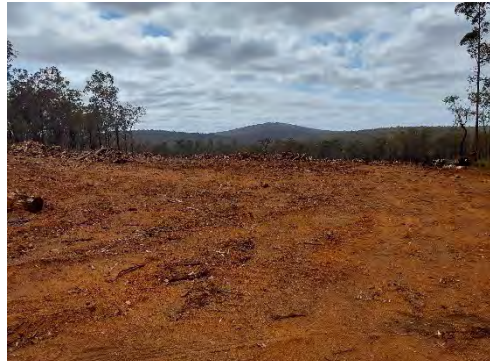
Condition number(s)	Task and Purpose	PNC Issues	Notes	Photo taken
			<p>Approved clearing boundary walked.</p>   <p>Black cockatoo tree 1400 in uncleared area</p>

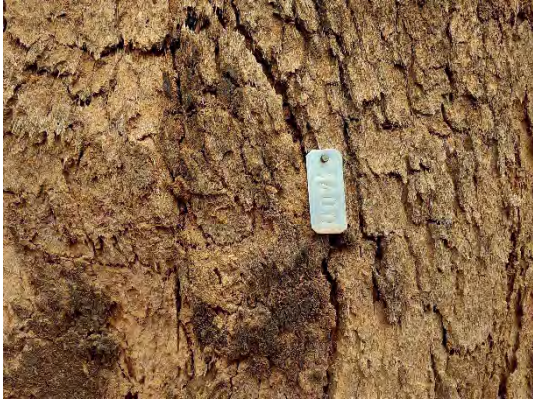
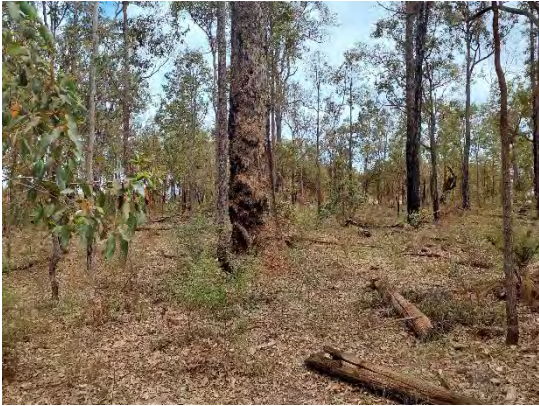
<p>Black cockatoo tree 2081 in uncleared area. No tag</p>

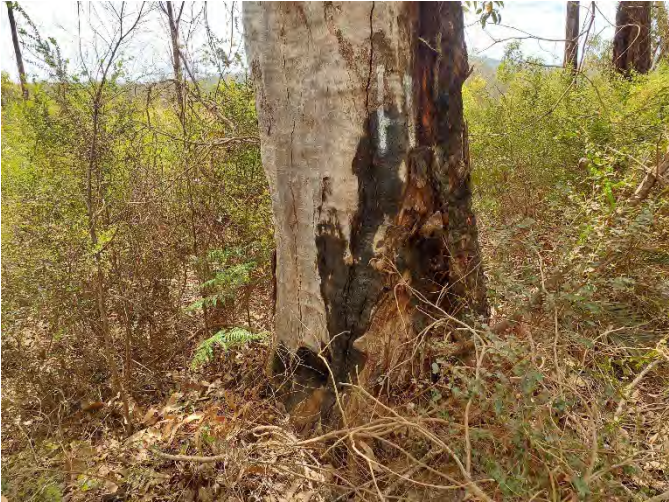
<p>Black cockatoo tree 2108 in uncleared area</p>

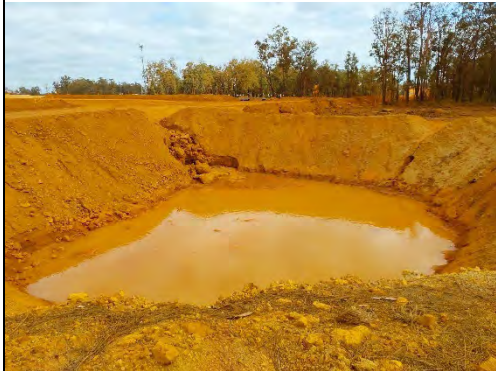
4(d)	<p>Oxley 9 (G5525)</p> <ul style="list-style-type: none"> Check drainage capacity in harvested area and at sumps 	None identified	<p>Sump at northern side of pit checked</p>

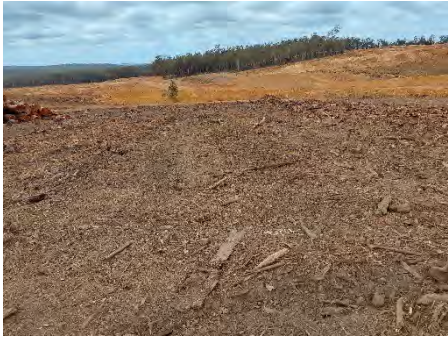
<p>Bund present separating stripped area and topsoil.</p>

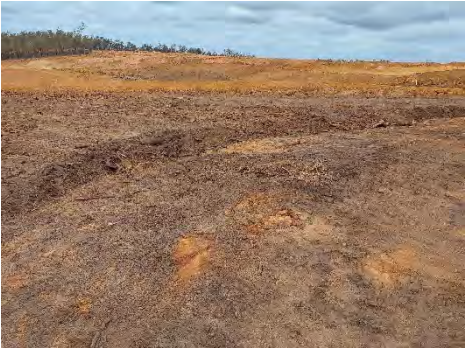
<p>Harvested boundary walked. Clearing matched provided harvesting. Shp</p>

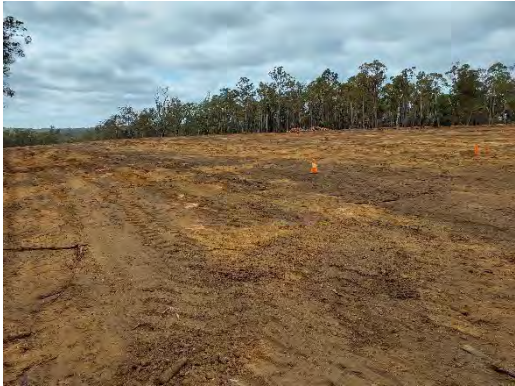
<p>Watershot at bottom of oxley 9</p> </div>

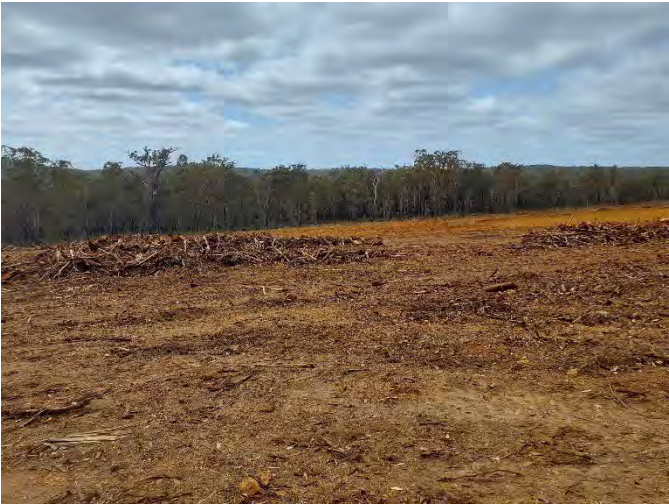
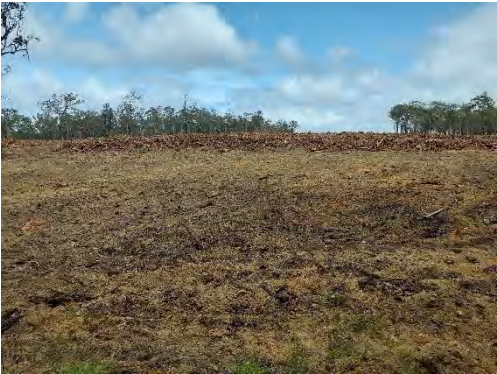
</div> <div> <p>Bottom east end of pit. Topsoil still present and windrows for dc</p>

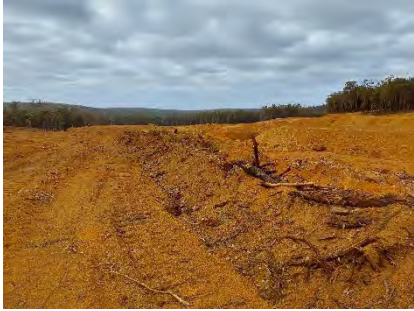
Condition number(s)	Task and Purpose	PNC Issues	Notes	Photo taken
4(d)	Oxley 10	<i>None Identified</i>	<p>Pit has been harvested. Presence of bund around pit boundary as well as topsoil Bund surrounding harvested area.</p>

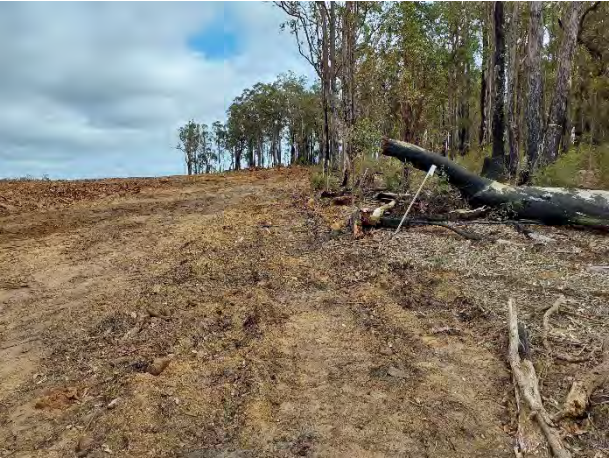
</div> <div> <p>Ground has not been stripped yet. Topsoil still present for drainage control.</p> </div> <div>

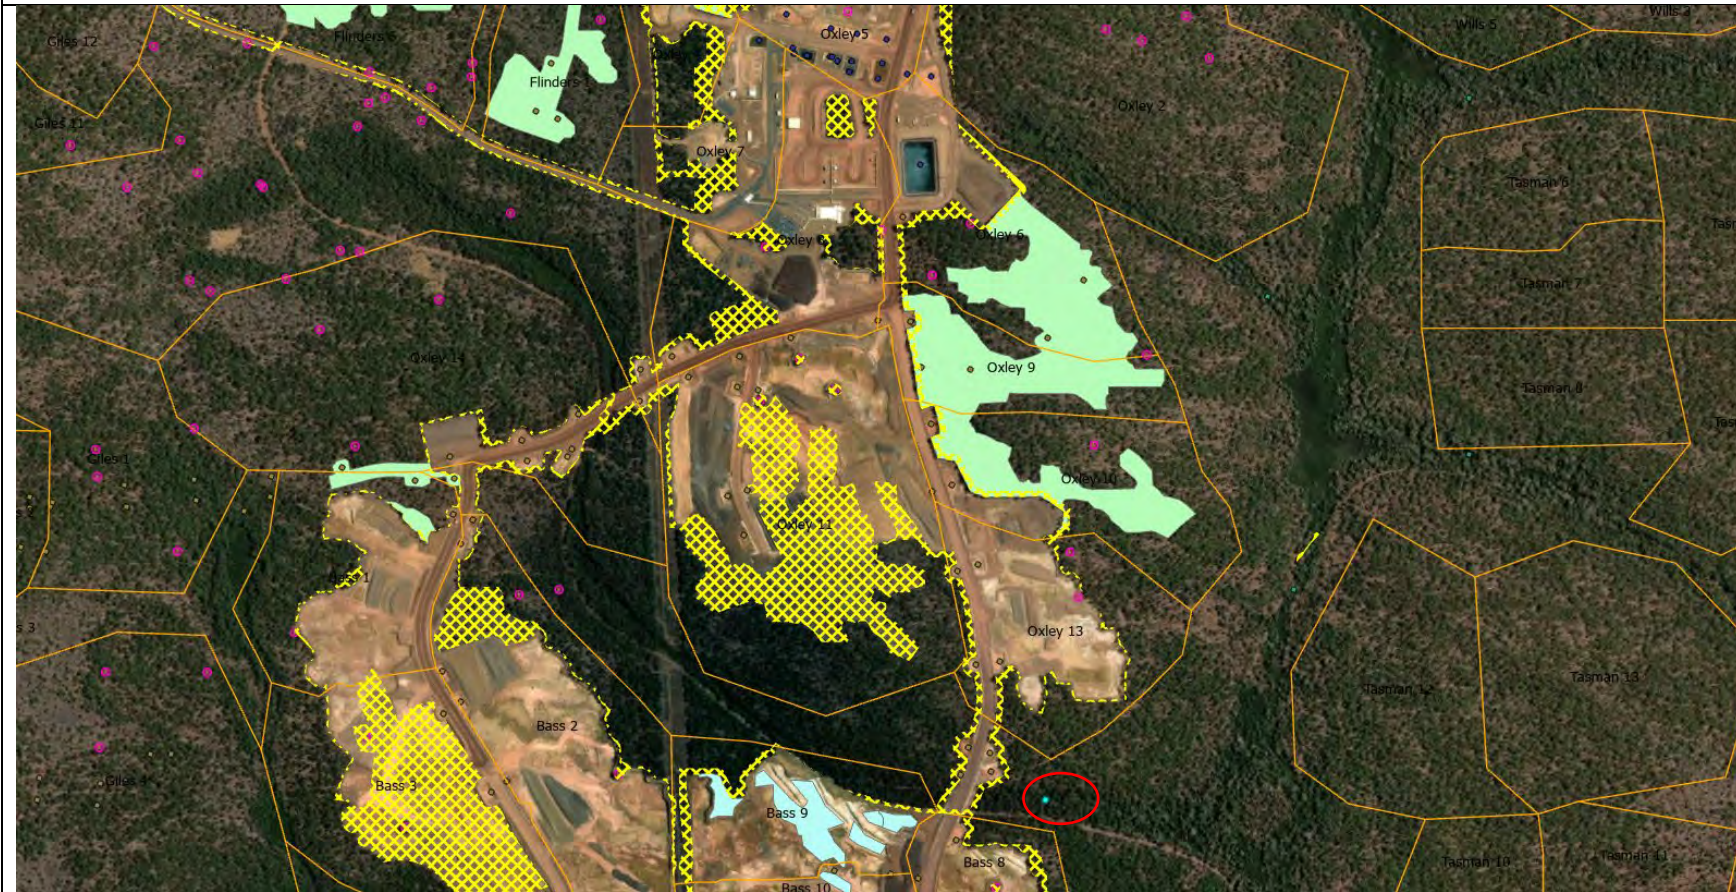
PTM03

4(d)	<p>PTM03 –and surrounding sumps (G5605)</p> <ul style="list-style-type: none"> Turbidity event recorded 2/10/24 and 4/10/24 – rainfall >20mm in preceding 24 hours 	None Identified	Unable to visit ptm03. Usual track has hole and alternative track requires key.

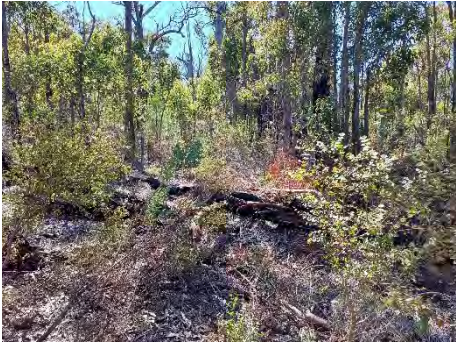
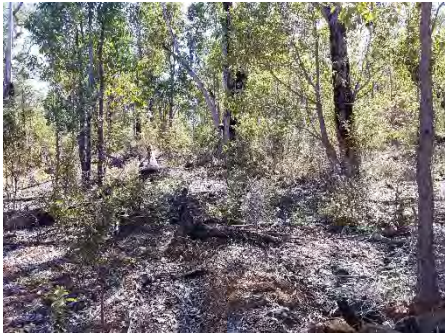
<p>11 drill holes sighted within exploration disturbance footprint. All holes filled in.</p> <p>No potentially or confirmed significant or black cockatoo trees Sighted within 10m of drill holes</p>

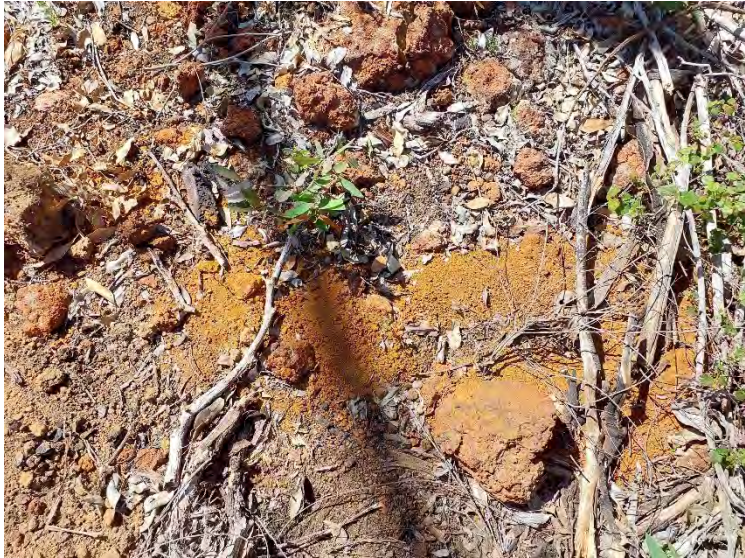
Condition number(s)	Task and Purpose	PNC Issues	Notes	Photo taken
			<p>Example of drill hole</p>

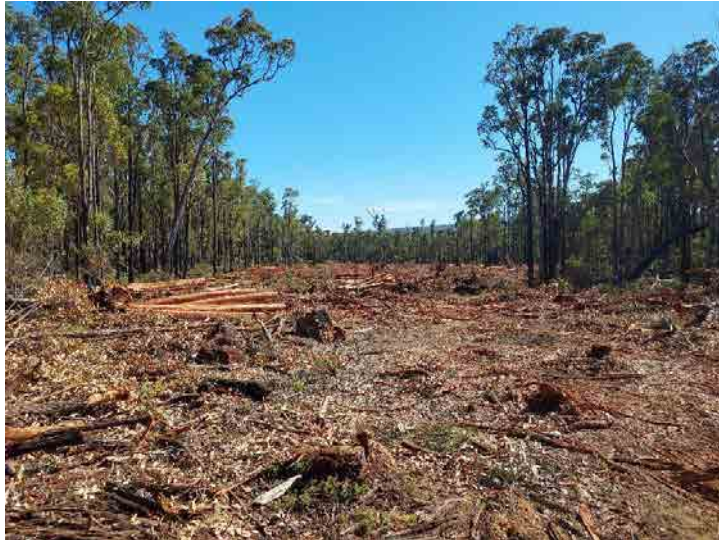
Condition number(s)	Task and Purpose	PNC Issues	Notes	Photo taken
5	Wittwer 11 (L4206, L4207, L4202, L4203, L4210, L4211) <ul style="list-style-type: none"> • Mining has occurred till 27 oct. • Check exploration drill holes at northern end of pit – all points are within black cockatoo legacy survey area • Confirm area is within native veg disturbance footprint. • Check drainage control at bottom end of pit 	None Identified	<p>Harvesting at end of wittwer 11</p>

<p>Exploration Minimal disturbance observed</p>

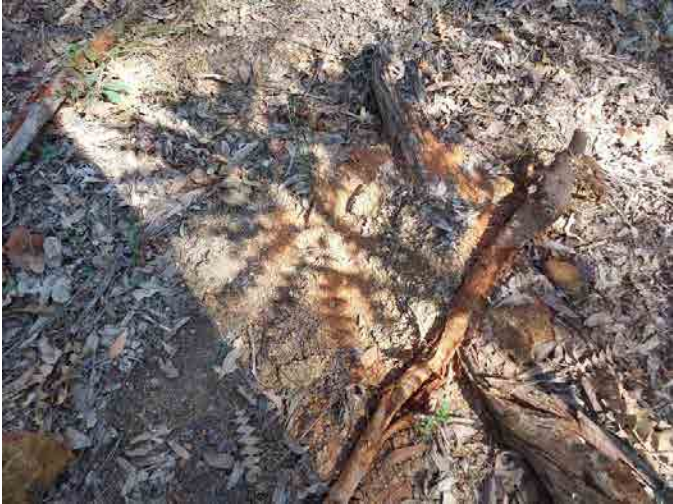
Condition number(s)	Task and Purpose	PNC Issues	Notes	Photo taken
			<p>No potentially significant trees Sighted in area. Example of filled in exp Drill hole.</p>

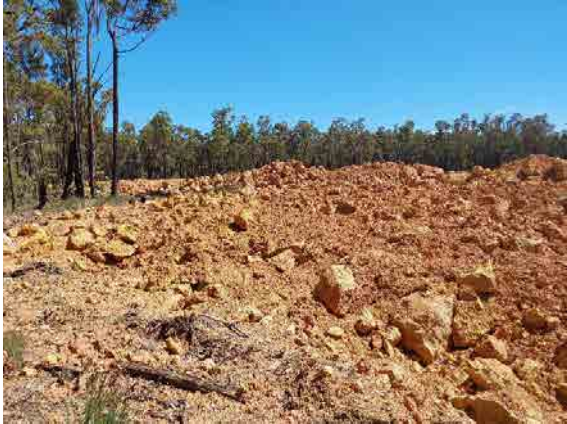
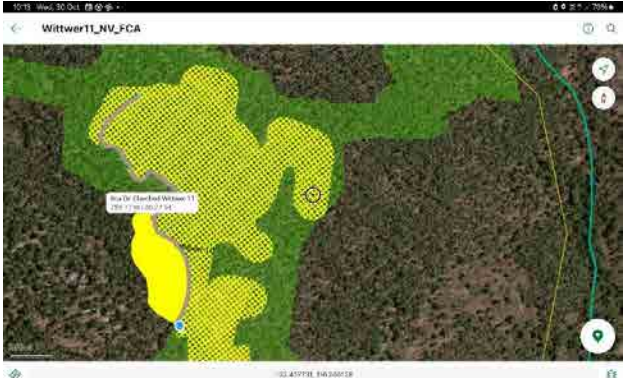
Condition number(s)	Task and Purpose	PNC Issues	Notes	Photo taken
			<div>Blasted area at pit boundary for watershed</div> <div>

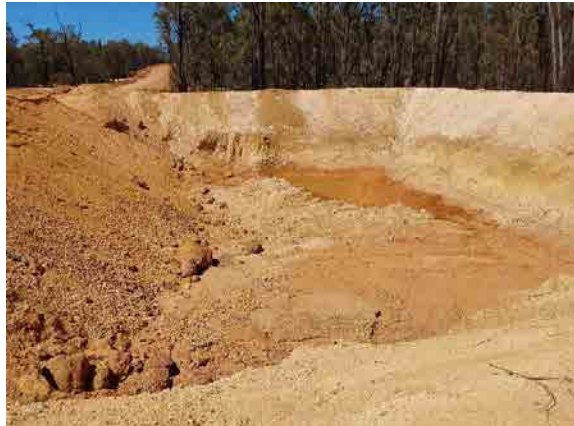
Condition number(s)	Task and Purpose	PNC Issues	Notes	Photo taken
			<p>Wittwer 11 mining area is all within the native vegetation disturbance boundary. Drainage control checked along path walked. No issues.</p> <p>Wittwer 11 road sump. 64. Minimal water</p>

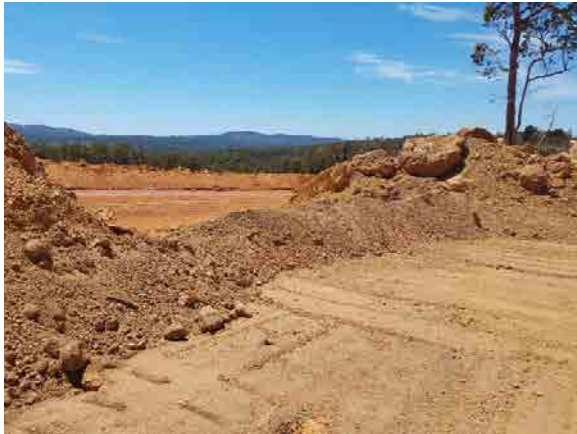
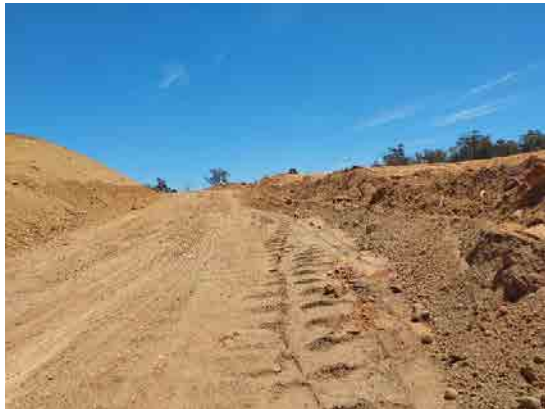
Condition number(s)	Task and Purpose	PNC Issues	Notes	Photo taken
			<p>Bund present around front of pit .</p> <div>

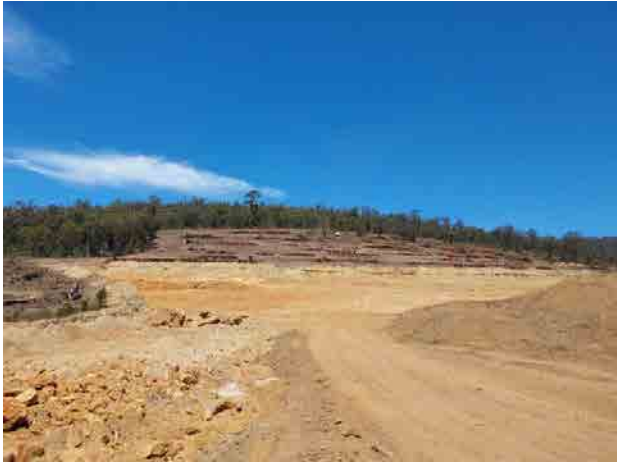
Condition number(s)	Task and Purpose	PNC Issues	Notes	Photo taken
			<p>Drainage protection spot towards front of pit is being constructed.Dozer and scraper in pit doing works.</p>

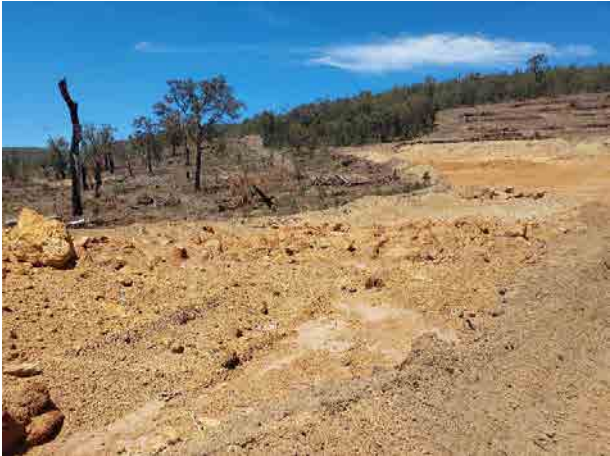
Condition number(s)	Task and Purpose	PNC Issues	Notes	Photo taken
			<p>Watershot is present at eastern front end of pit.</p>

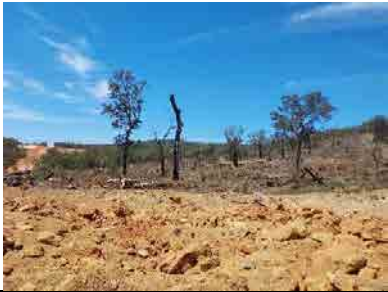
<p>Drainage protection slots on east side of it past sump have not been constructed yet. Photo below is looking east at front north end of pit.</p>

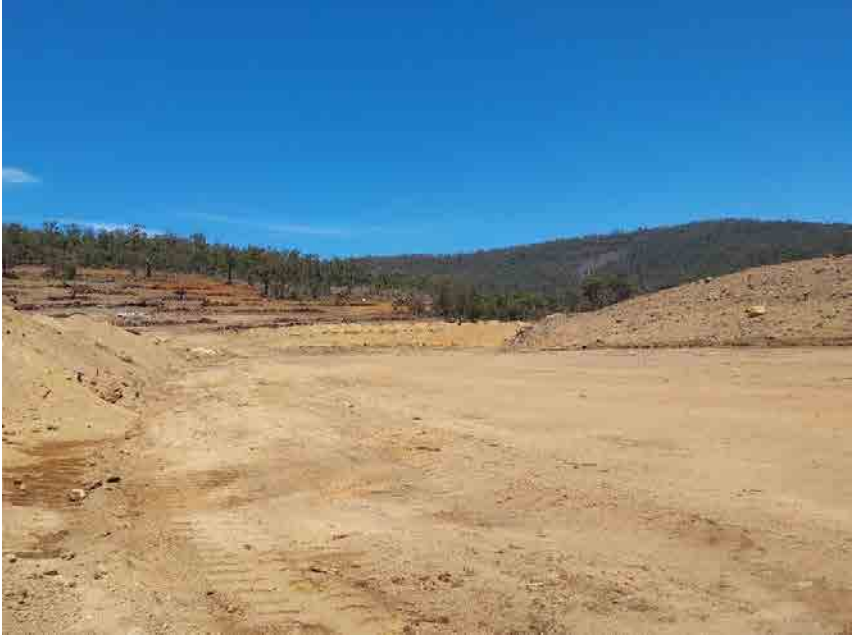
Condition number(s)	Task and Purpose	PNC Issues	Notes	Photo taken
			<div>North west side of stockpile. Drainage Protection Slot extends along length of</div> <div>

</div> <div>stockpile area.</div>

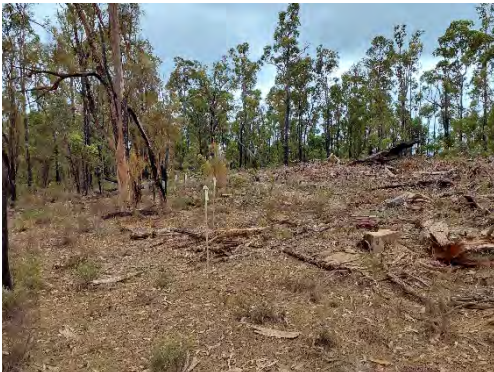
Condition number(s)	Task and Purpose	PNC Issues	Notes	Photo taken
5	Wittwer 8 (K4212, K4216, L4213, L4209) <ul style="list-style-type: none"> • Mining has occurred till 7/11 • Confirm mined areas are within the native veg disturbance footprint. • Check sump drainage capacity 	None Identified	Approved clearing boundary walked.

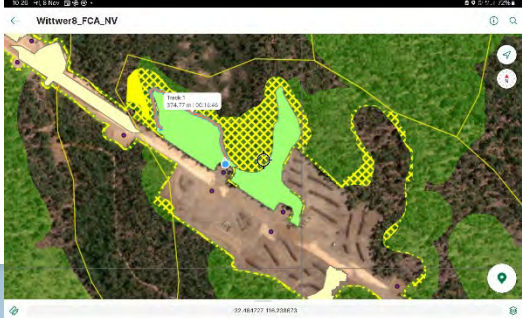
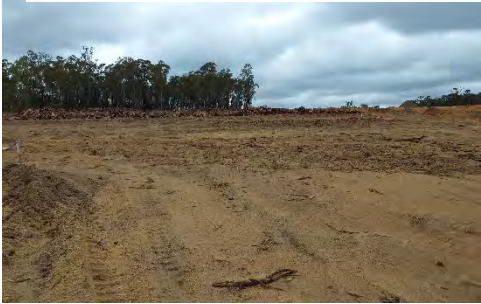
Condition number(s)	Task and Purpose	PNC Issues	Notes	Photo taken
			<p>Majority of pit has been cleared with wood in windrows</p> <p>Path walked. Approved clearing flagging and cleared areas within the native vegetation disturbance boundary</p>

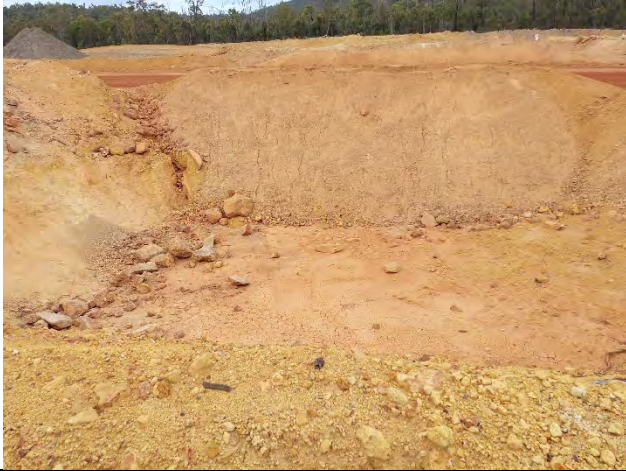
Condition number(s)	Task and Purpose	PNC Issues	Notes	Photo taken
			<p>Sump wittwer 8 haul road.</p> <p>North eastern side of wittwer 8. Blasting has occurred.</p>

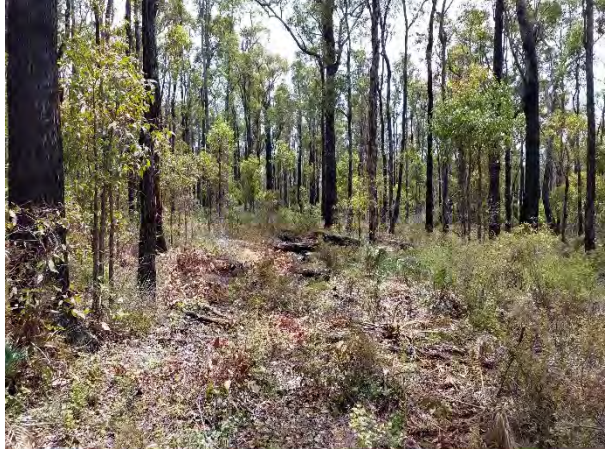
11 drill holes viewed. All fill in. No potentially significant trees Sighted.

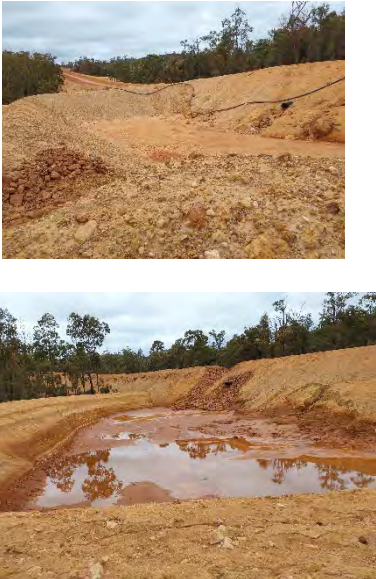
Condition number(s)	Task and Purpose	PNC Issues	Notes	Photo taken
4(d)	Turbidity monitor SE12 (K4212) <ul style="list-style-type: none"> Last event recorded 16/10 – data trend indicating false event Note - this monitor is located ~60 m south of the point for turbidity monitor. Monitor can be reached by travelling east from the sumps east of Iannetta 1 and following the cable from the turbidity monitor solar panels and case. 	None Identified	<p>Sumps along wittwer road near turbidity monitor</p>

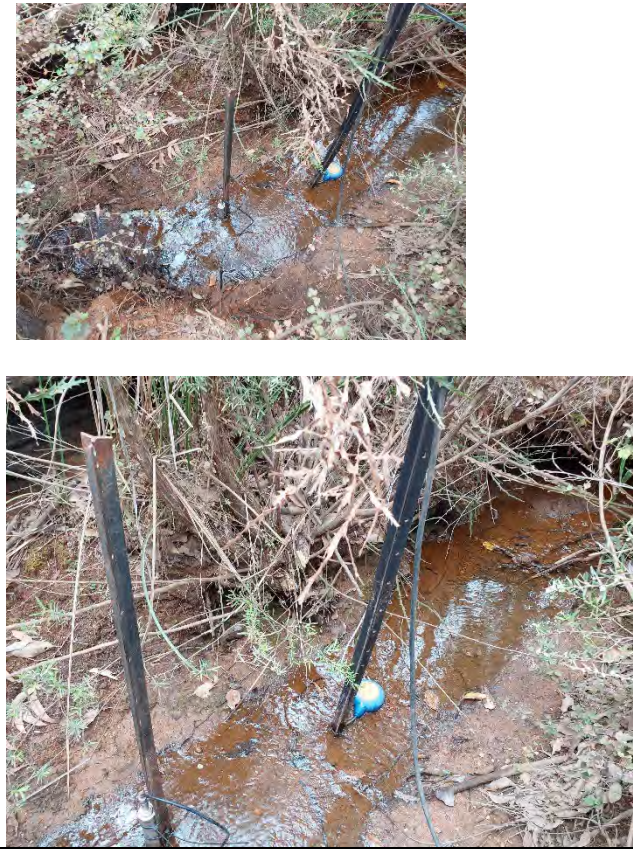
Condition number(s)	Task and Purpose	PNC Issues	Notes	Photo taken
			<div>Minimal water in stream but is clear and running</div> <div>

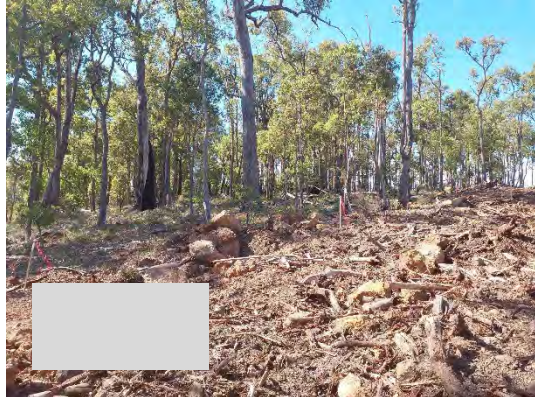
Condition number(s)	Task and Purpose	PNC Issues	Notes	Photo taken
5	Stone 3 (J4117) <ul style="list-style-type: none"> Confirm GDP (Purple area) is within native vegetation disturbance area Carting has occurred on 12th and 13th of November Check sump drainage capacity 	None identified	<p>GDP area is within native vegetation disturbance boundary.</p>

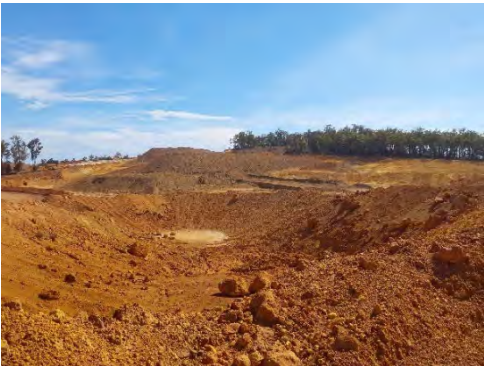
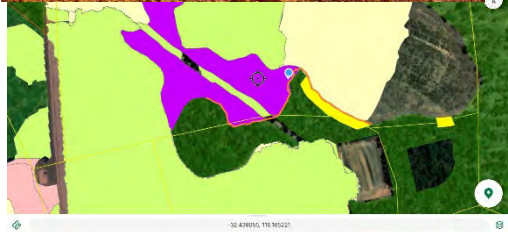
Condition number(s)	Task and Purpose	PNC Issues	Notes	Photo taken
			<p>Southern sump (sump no 11) of the circled sumps inspected. Sump is in a good condition and has full capacity. Freeboard > 10m.</p>

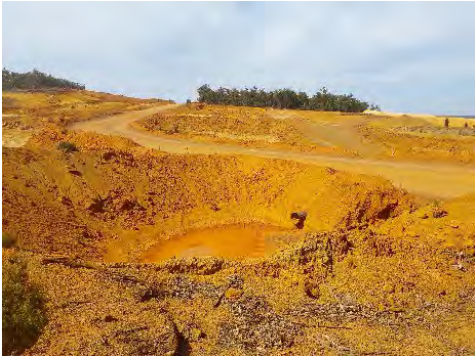
Condition number(s)	Task and Purpose	PNC Issues	Notes	Photo taken
			<p>Northern sump of the circled sumps does not exist in the marked location. The next sump (sump no 12) on the same side of the Stone road inspected instead. Sump is in a good condition (small erosion inside the sump) and has fill capacity. Freeboard approx. 5m.</p>

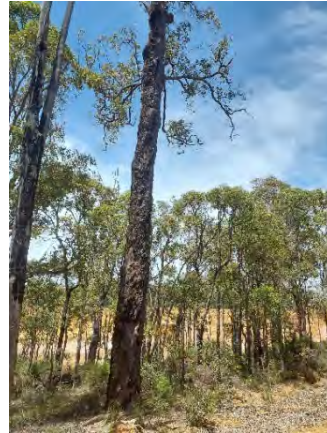
Condition number(s)	Task and Purpose	PNC Issues	Notes	Photo taken
5(d)	Davey 2 (K4201) <ul style="list-style-type: none"> Check for presence of Black Cockatoo tree #713 (Marri) Check mined areas area within native vegetation disturbance boundary 	None Identified	<p>Black Cockatoo tree inspected. Inspected Marri tree is within the 10m buffer zone (due to the Tablet's GPS inaccuracy).</p>

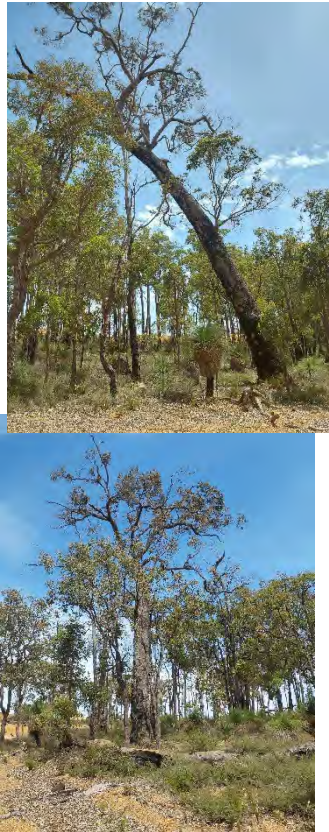
Condition number(s)	Task and Purpose	PNC Issues	Notes	Photo taken
			<p>There's another large Marri tree approx. 35 m east.</p>

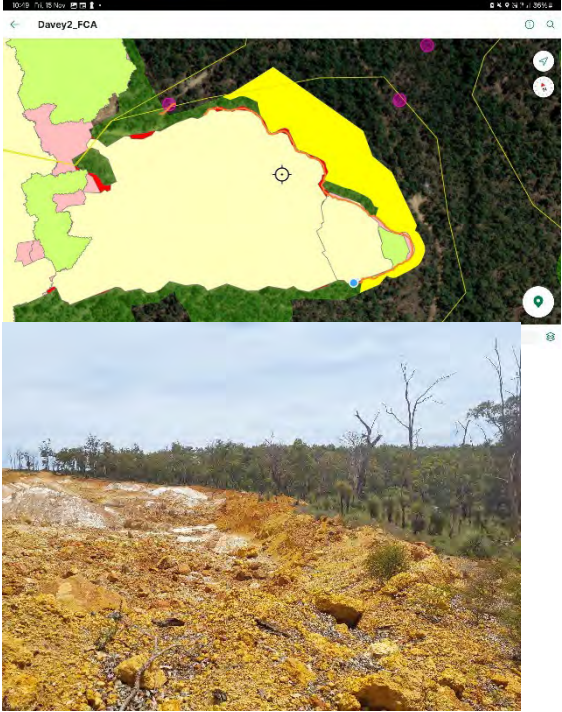
Condition number(s)	Task and Purpose	PNC Issues	Notes	Photo taken
			<p>Pit boundary walked near the native vegetation disturbance boundary area.</p> <p>Mined area is within the native vegetation disturbance boundary.</p>

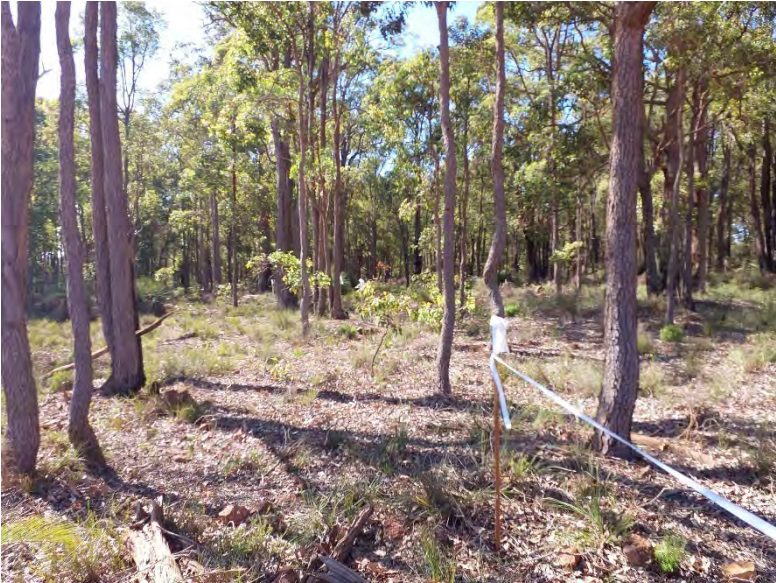
Condition number(s)	Task and Purpose	PNC Issues	Notes	Photo taken
5	Cocivera 3 (G4213, G4217, F4212) <ul style="list-style-type: none"> Pit has not been visited yet Check new GDP is within the native vegetation disturbance boundary Check for presence of Black Cockatoo tree on island in middle of pit. (1106, Marri) Check for presence of Black Cockatoo tree 6708 (Marri, 2015, possible nest) 	None Identified	<p>Approved clearing boundary walked. Area is within the native vegetation disturbance boundary. Gps accuracy 2.5 to 2.8m</p>

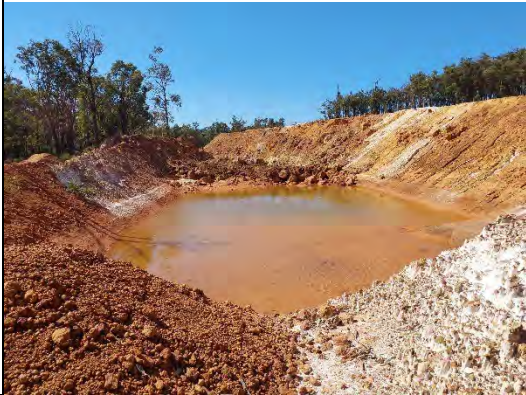
<p>Drainage controls opportunistically checked sumps on cocivera road</p>

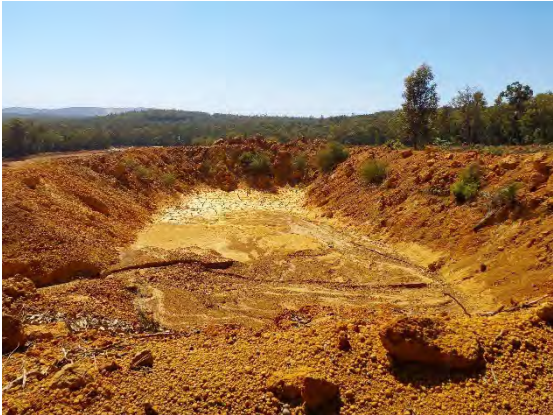
Condition number(s)	Task and Purpose	PNC Issues	Notes	Photo taken
			<div>Sump at entrance to cocivera 4</div> <div>

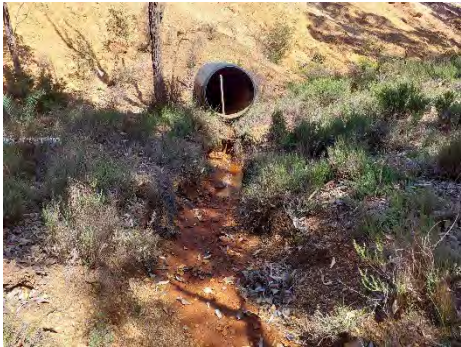
</div> <div>Culvert discharging water into forest.</div> <div>

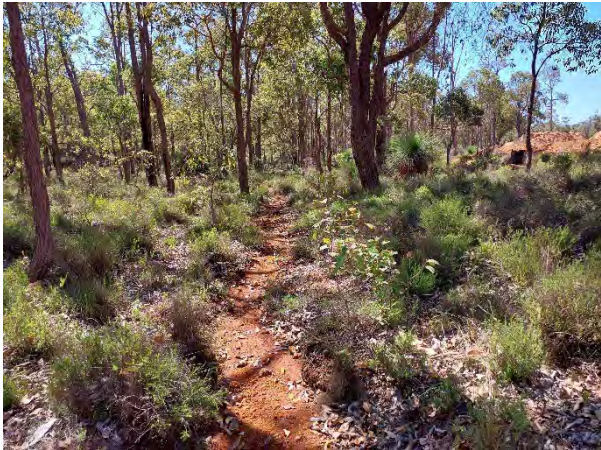
</div> <div> Tannins on water surfaces </div> <div>

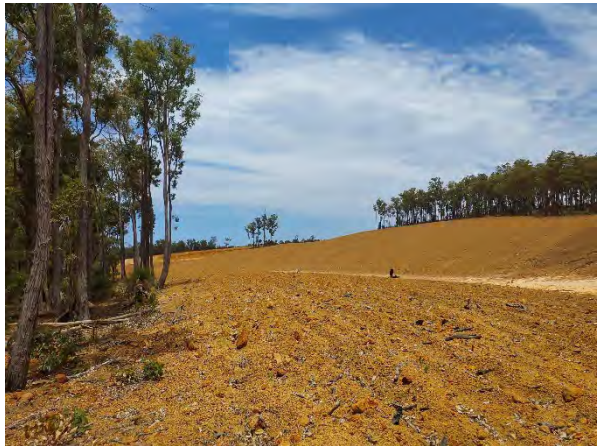
Condition number(s)	Task and Purpose	PNC Issues	Notes	Photo taken
			<p>Cocivera 3 black cockatoo Island</p>

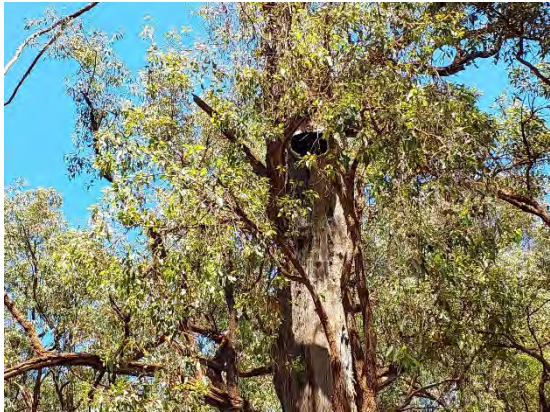
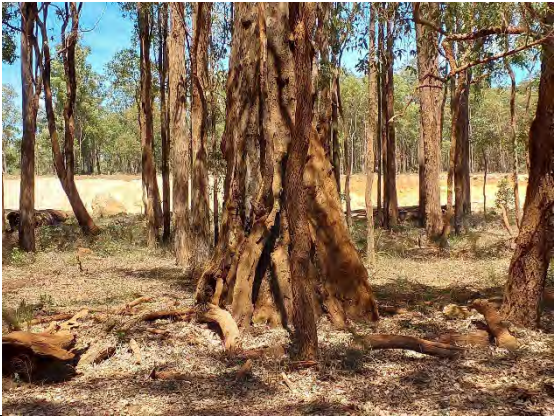
5	<p>Roberts 7 (G4222, G4221)</p> <ul style="list-style-type: none"> • Check pit is within native vegetation disturbance boundary at northern side of pit • Check exploration drill holes- is within legacy black cockatoo survey area • Check exploration drill holes at southern end of pit are within exploration disturbance footprint. 	None identified	<p>Dh 1 appears to be <10 from a jarrah tree with a hollow that may have hollow dimensions meeting nest tree classification.</p>

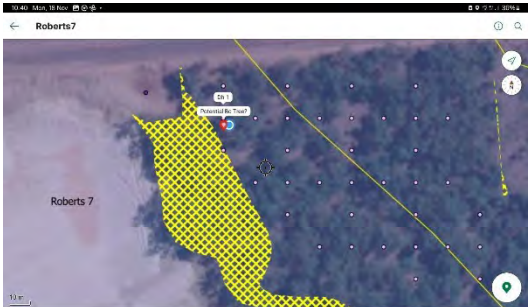
</div> <div> for potential bc tree </div> <div> Dh2 also appears to be within 10m of bc tree. </div>

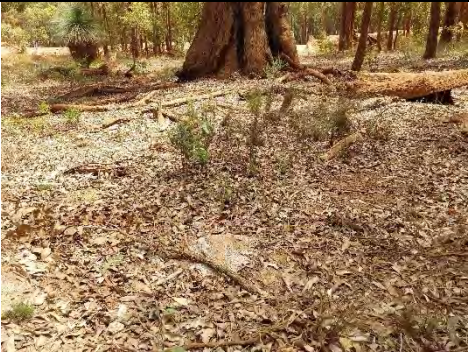
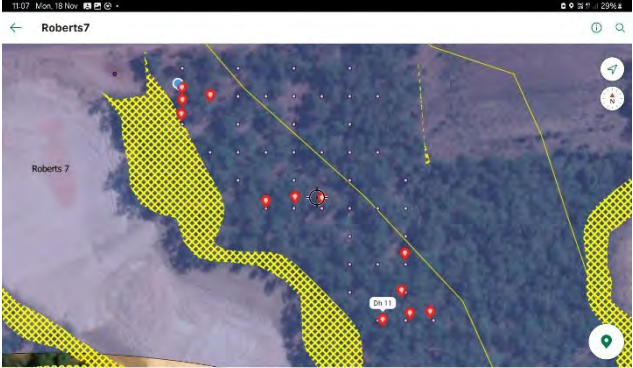
<p>11 dh viewed all within exp dist footprint. Disturbance observed to be minimal.</p>

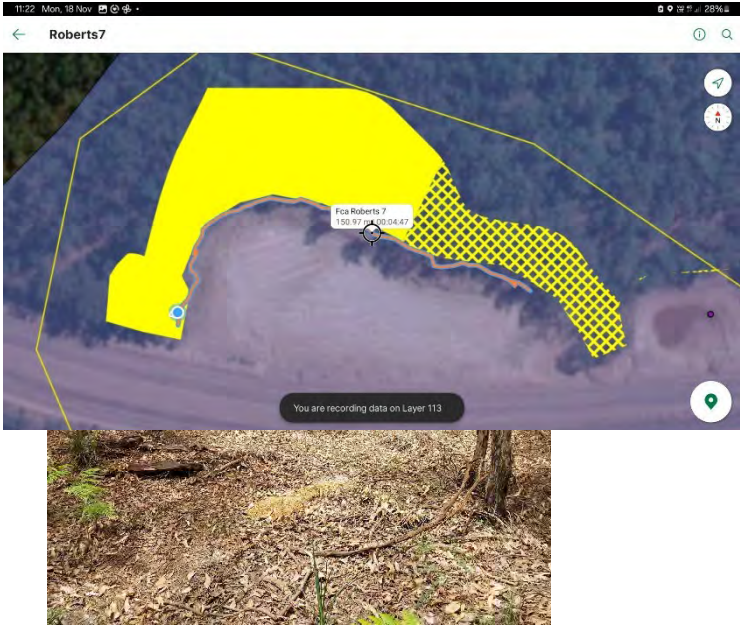
<p>The screenshot shows a mobile map application interface. At the top, the status bar displays '11:22 Mon, 18 Nov' and '28%'. Below the status bar, the title bar reads 'Roberts7'. The main map area shows a satellite view with a yellow highlighted polygon and a yellow checkered area. A label 'Fica Roberts 7' with coordinates '150.97 10.04.47' is visible. A notification at the bottom says 'You are recording data on Layer 113'. Below the map, there is a photo of a dirt pit in a wooded area.</p> </div>	
			<div> <p>Pit has been ripped. No accessible from haul road so assumed mining has finished.</p> </div>

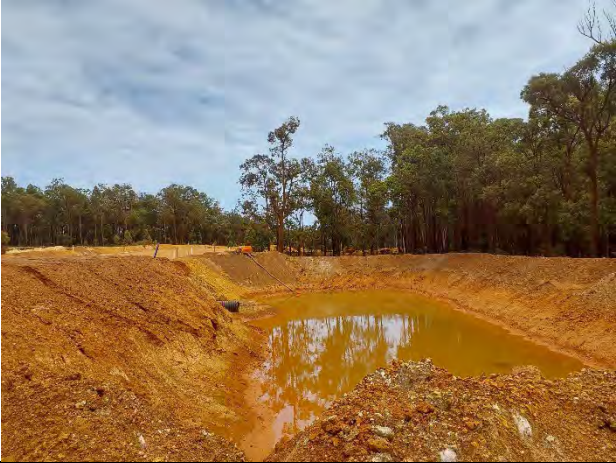
Condition number(s)	Task and Purpose	PNC Issues	Notes	Photo taken
			<p>Roberts road sump</p>

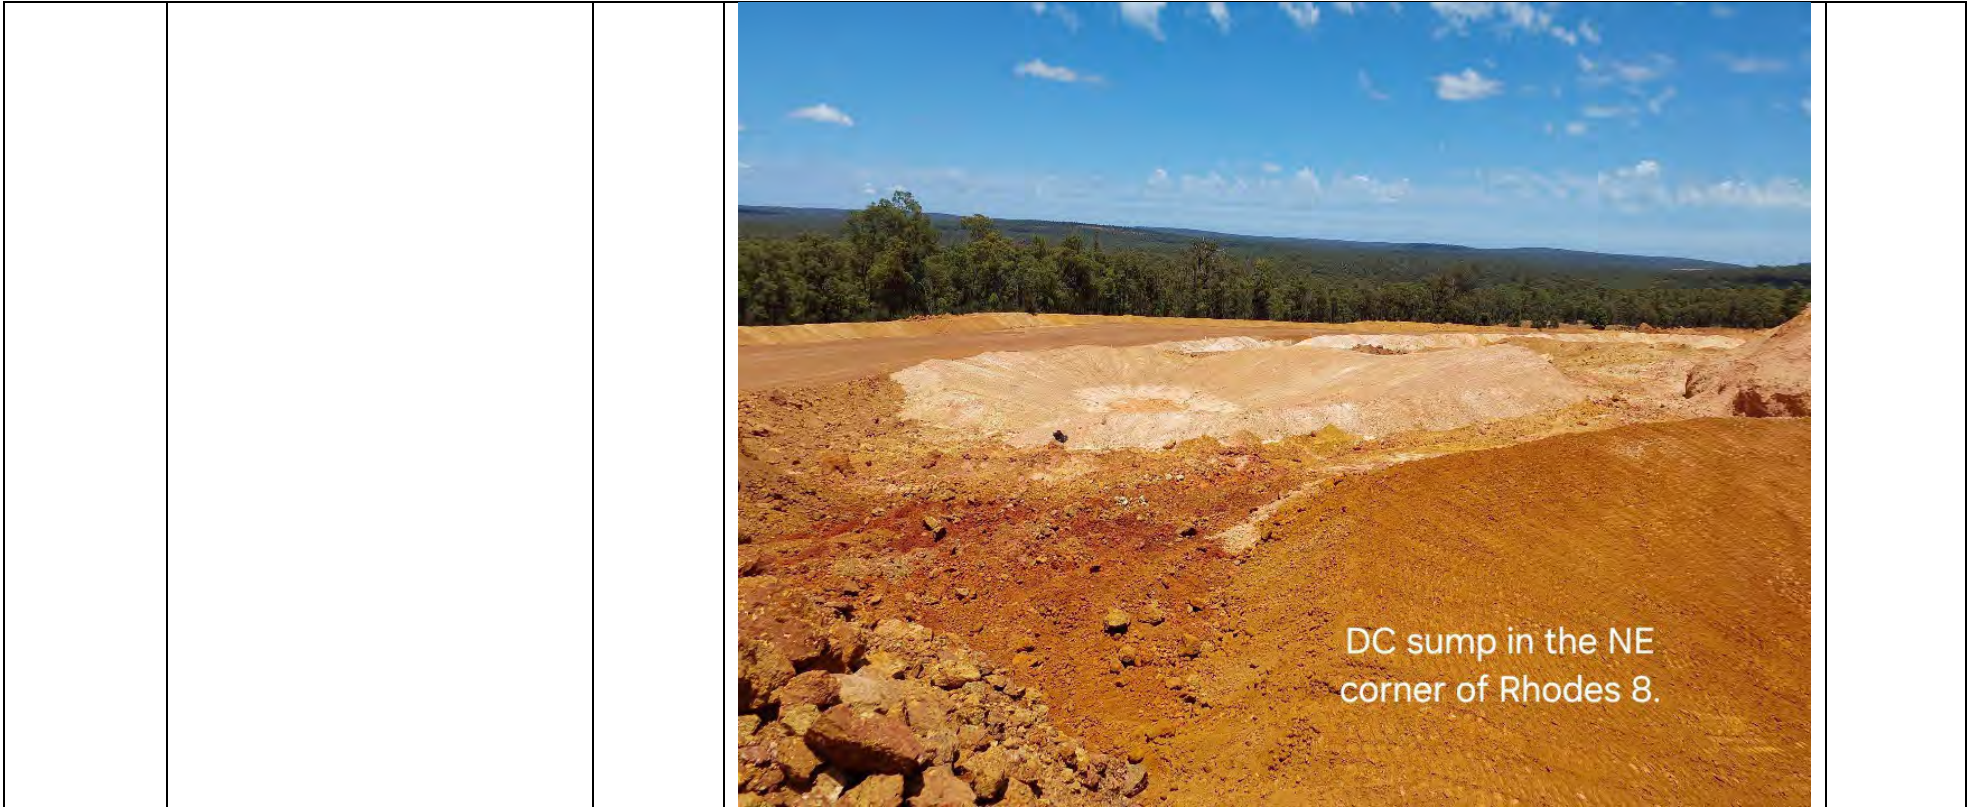
<p>Sump in rehabilitated northern section of Rhodes 8.</p>

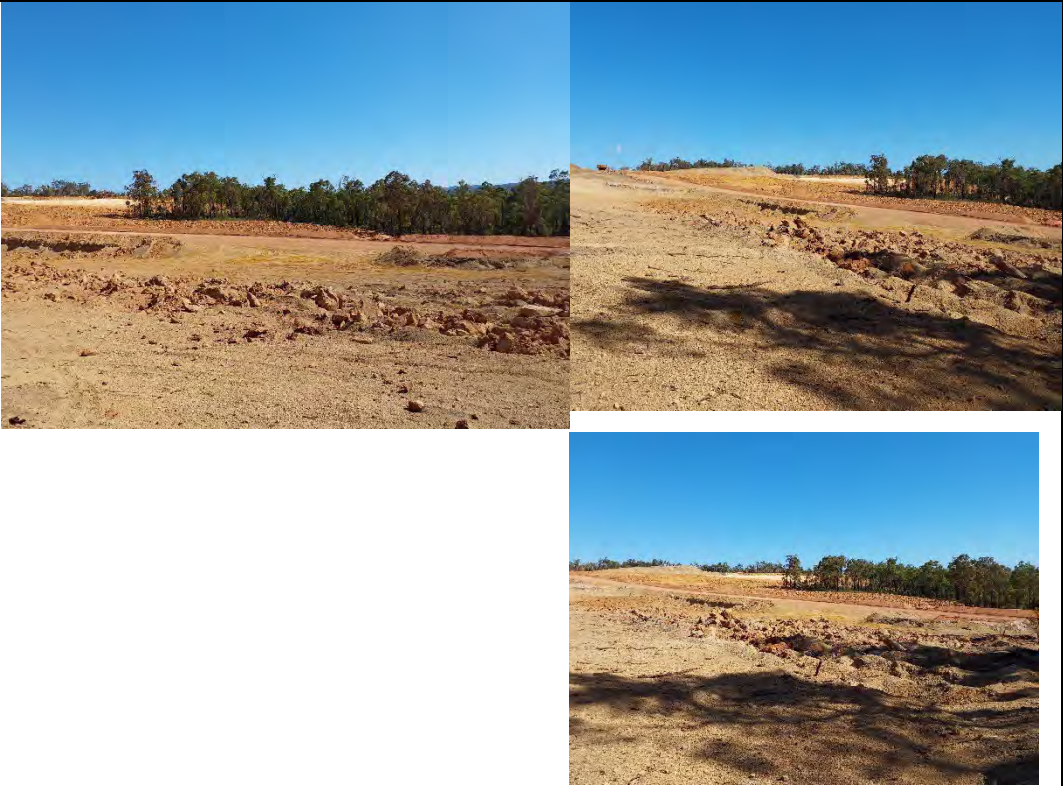
Condition number(s)	Task and Purpose	PNC Issues	Notes	Photo taken
5	Wittwer 4 (K4207, K4211) <ul style="list-style-type: none"> Check DC as per DCMP plans (saved in google drive) DCMP states DPSs are installed and maintained until mining development commences. DPSs are located at the base of the pit. Each DPS will be installed as early as possible in the clearing process to provide drainage protection 	None Identified	Machinery current moving timber. 3 drainage protection slots visible Watershots visible in the pit

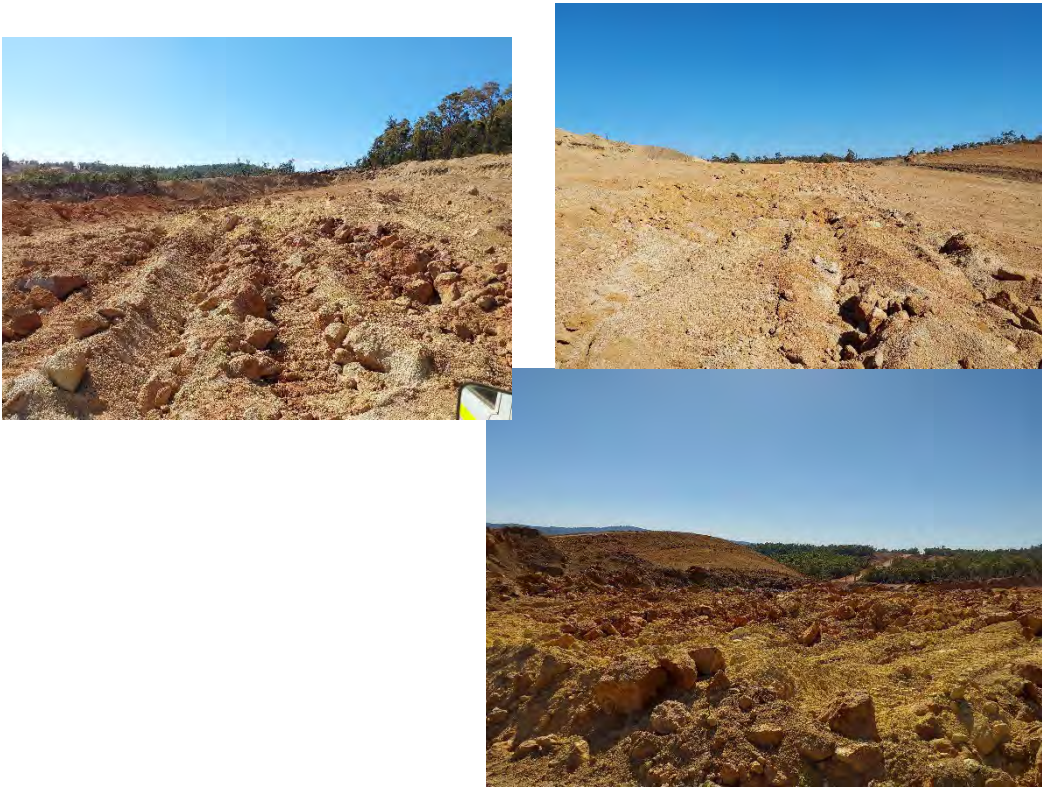
5	Downes 14 (K4225, K4226, K4302 K4301) <ul style="list-style-type: none"> Check DC as per DCMP plans (saved in google drive) DCMP states DPSs are installed and maintained until mining development 	None Identified	Machinery clearing area. Evidence of woody windrows Area not cleared yet. Recheck DPS at another date

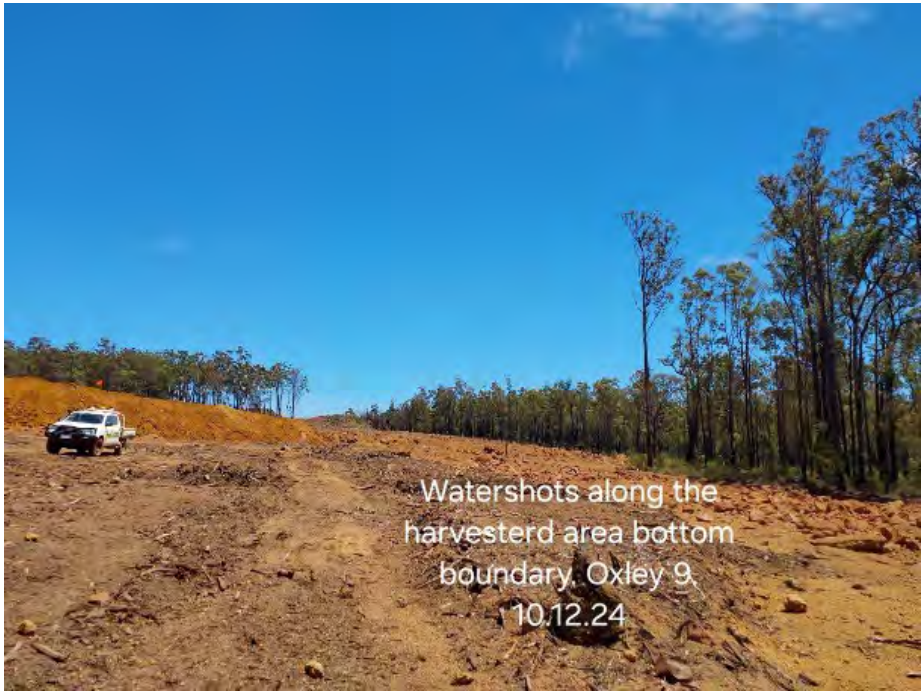
Condition number(s)	Task and Purpose	PNC Issues	Notes	Photo taken
5	Oxley 9 (G5525) <ul style="list-style-type: none"> Check drainage control of harvested area. Check distance of Black Cockatoo tree #2108 (Marri) from harvested area and bore and clearing buffer. 	None Identified	<p>The recently harvested area in Oxley 9 has been water shot blasted at the low point ends for drainage control.</p>
