Document type
Compliance Assessment Report (CAR)

Alcoa of Australia Limited – WA Operations

2024 – 2028 Mining and Management Program - Compliance Assessment Report 2025

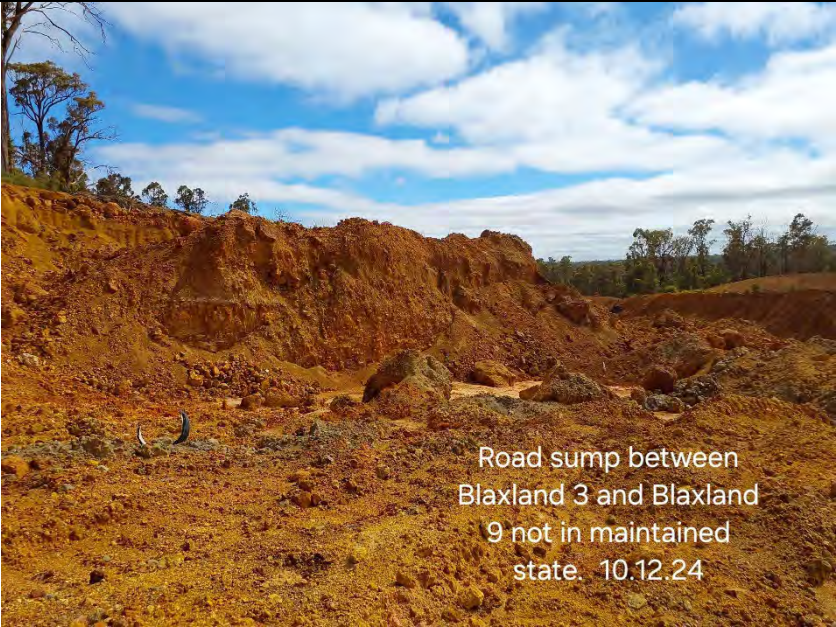
<div> Road sump between Blaxland 3 and Blaxland 9 not in maintained state. 10.12.24 </div> </div>

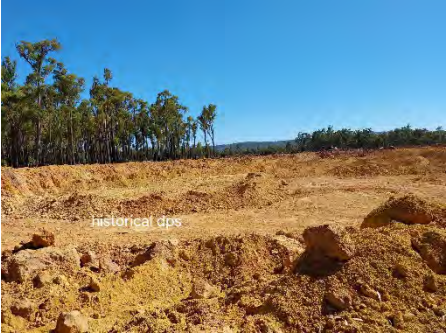
Condition number(s)	Task and Purpose	PNC Issues	Notes	Photo taken
			<p>Snipper present in harvesting area end of pit.</p>

<p>Clearing within approved clearing pegs.</p>

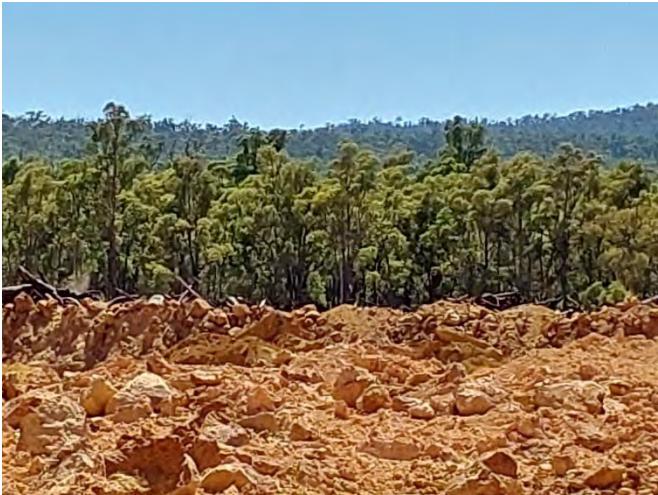
Condition number(s)	Task and Purpose	PNC Issues	Notes	Photo taken
			<p>Snipper present on eastern side of pit past historical drainage protection slot.</p>

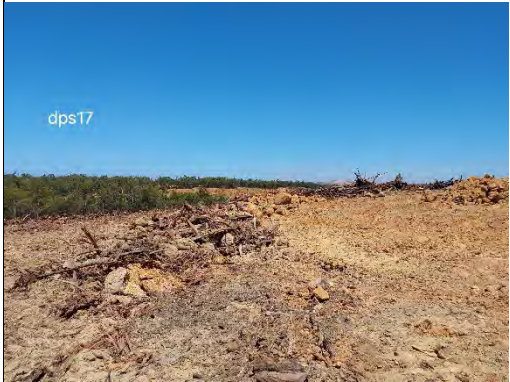
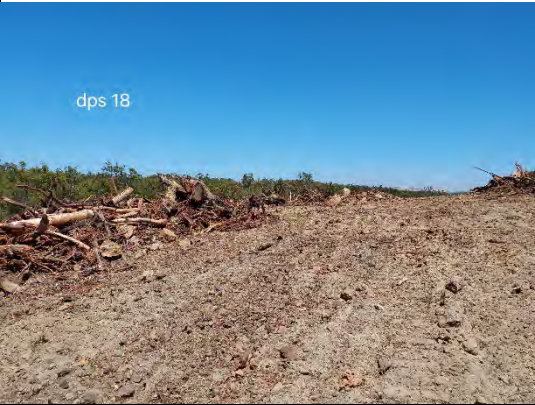
Condition number(s)	Task and Purpose	PNC Issues	Notes	Photo taken
5	Downes 14 (K4225, K4226, K4302 K4301) <ul style="list-style-type: none"> Check DC as per DCMP plans (saved in google drive) DCMP states DPSs are installed and maintained until mining development commences. DPSs are located at the base of the pit. Each DPS will be installed as early as possible in the clearing process to provide drainage protection 	None Identified	<p>Drainage protection slot locations viewed as pictured below. No drainage protection slot in place yet. Wood is in windrows and presence of slight Bund at bottom of pit. Drainage protection slot 17, 18 and 15 pictured from eastern side of dps locations looking west.</p>

Condition number(s)	Task and Purpose	PNC Issues	Notes	Photo taken
			<div> <div>bottom end of harvested area</div> <div>dps 15</div> </div>

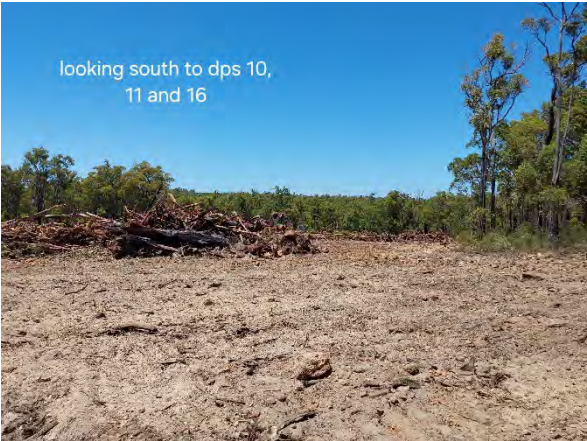
Condition number(s)	Task and Purpose	PNC Issues	Notes	Photo taken
			<div> <div>looking south to dps 10, 11 and 16</div>

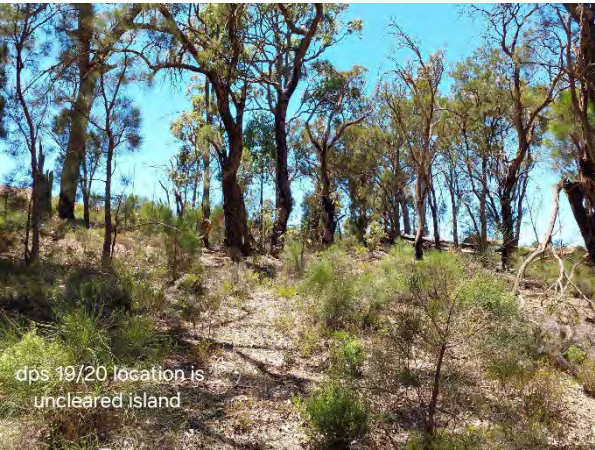
<p>dps 19/20 location is uncleared island</p>

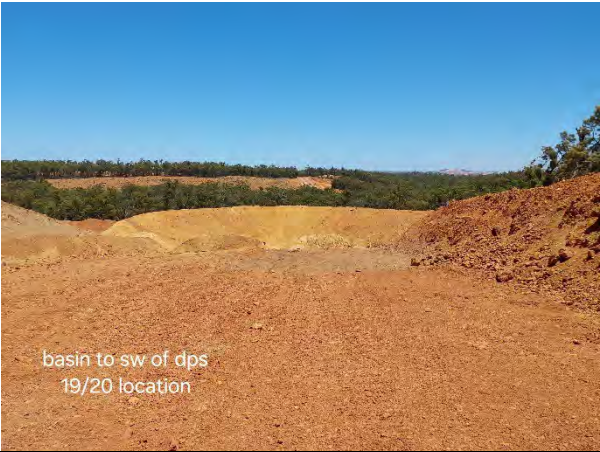
<p>basin to sw of dps 19/20 location</p>

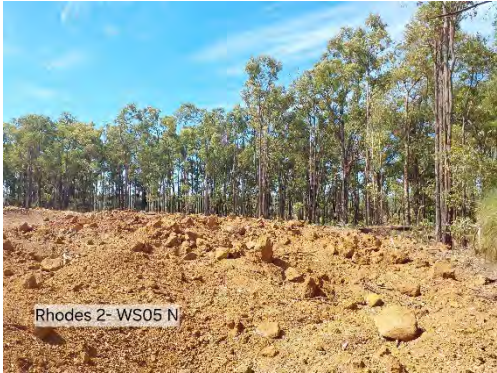
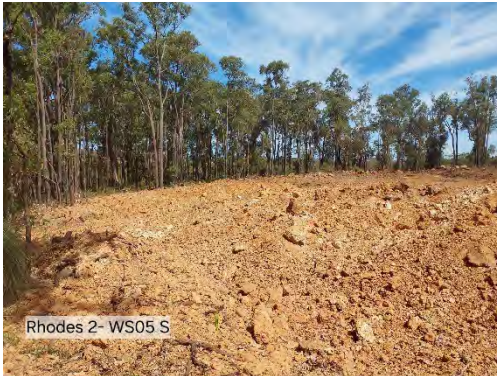
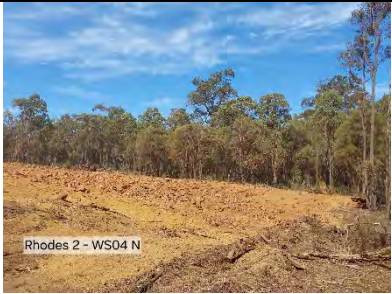
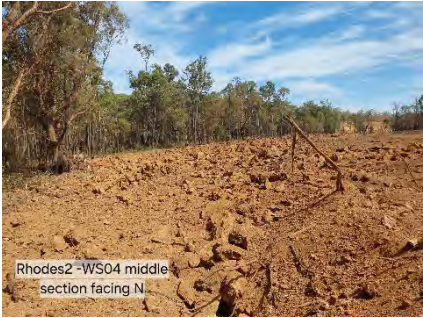
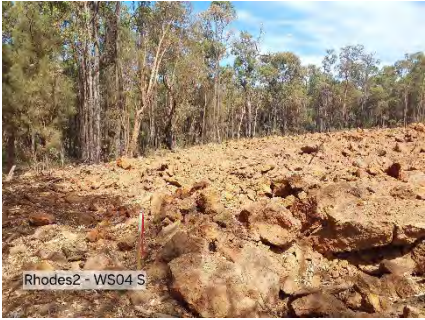
Condition number(s)	Task and Purpose	PNC Issues	Notes	Photo taken
5	Rhodes 2 (G4308, G4304) <ul style="list-style-type: none"> Check DC as per DCMP plans (saved in google drive) DCMP states DPSs are installed and maintained until mining development commences. DPSs are located at the base of the pit. Each DPS will be installed as early as possible in the clearing process to provide drainage protection. 	None identified	<p>Drainage Protection Slots inspected; watershots are in place for both WS04 and WS05. Please refer the photos below.</p>

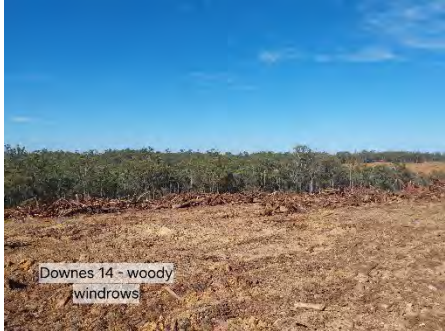
<p>Downes 14 - S side</p>   <p>Downes 14- W side</p>   <p>Downes 14- SE corner</p>	
--	--	--	---	--

Condition number(s)	Task and Purpose	PNC Issues	Notes	Photo taken
5	Downes 14 (K4225, K4226, K4302 K4301) <ul style="list-style-type: none"> Check DC as per DCMP plans (saved in google drive) DCMP states DPSs are installed and maintained until mining development commences. DPSs are located at the base of the pit. Each DPS will be installed as early as possible in the clearing process to provide drainage protection 	None Identified	Drainage Protection Slots areas inspected; woody windrows are in place.

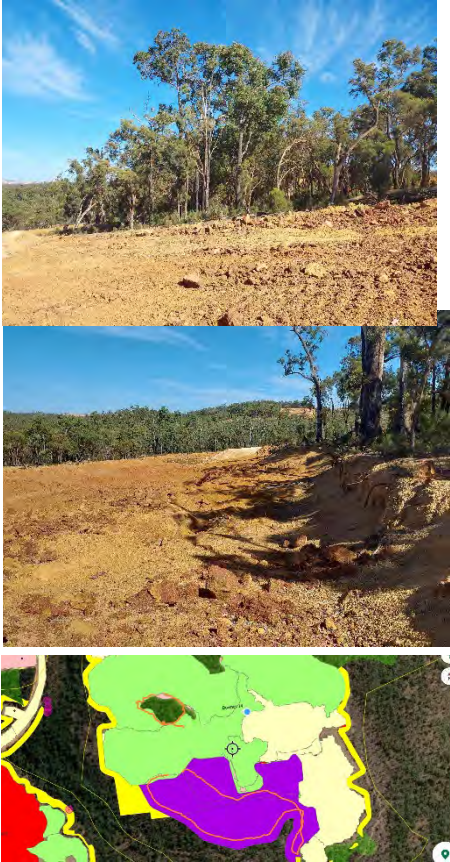
Condition number(s)	Task and Purpose	PNC Issues	Notes	Photo taken
			<p>Small Drainage Protection Slot in the northern part of the pit is uncleared forest with uneven surface on the southwestern side (> closest to the indicated location of the DPS in the DCMP).</p>

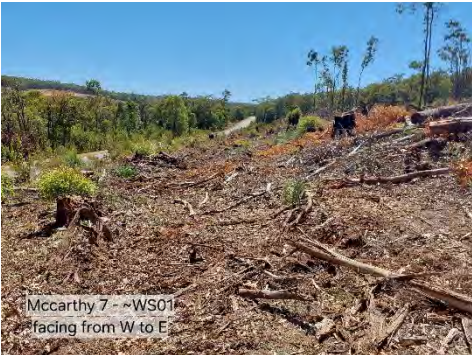
<p>McCarthy 7 - ~WS01 facing from W to E</p>

Condition number(s)	Task and Purpose	PNC Issues	Notes	Photo taken
5	<p>Mccarthy 7 (F4302, F4303)</p> <ul style="list-style-type: none"> • Check DC as per DCMP plans (saved in google drive) • DCMP states DPSs are installed and maintained until mining development commences. DPSs are located at the base of the pit. • Each DPS will be installed as early as possible in the clearing process to provide drainage protection. • GDP area is shown in blue 	None Identified	<p>Area has not been cleared yet. Hence, no Drainage Protection Slots in place.. Soft surface with large amount of biogenic matter to increase surface water infiltration.</p>

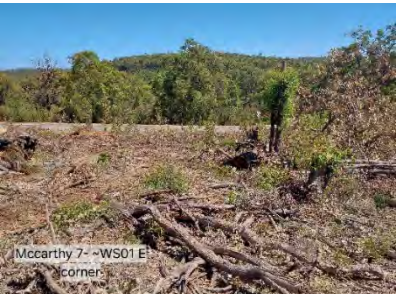
<p>McCarthy 7 - ~WS01 E corner</p>

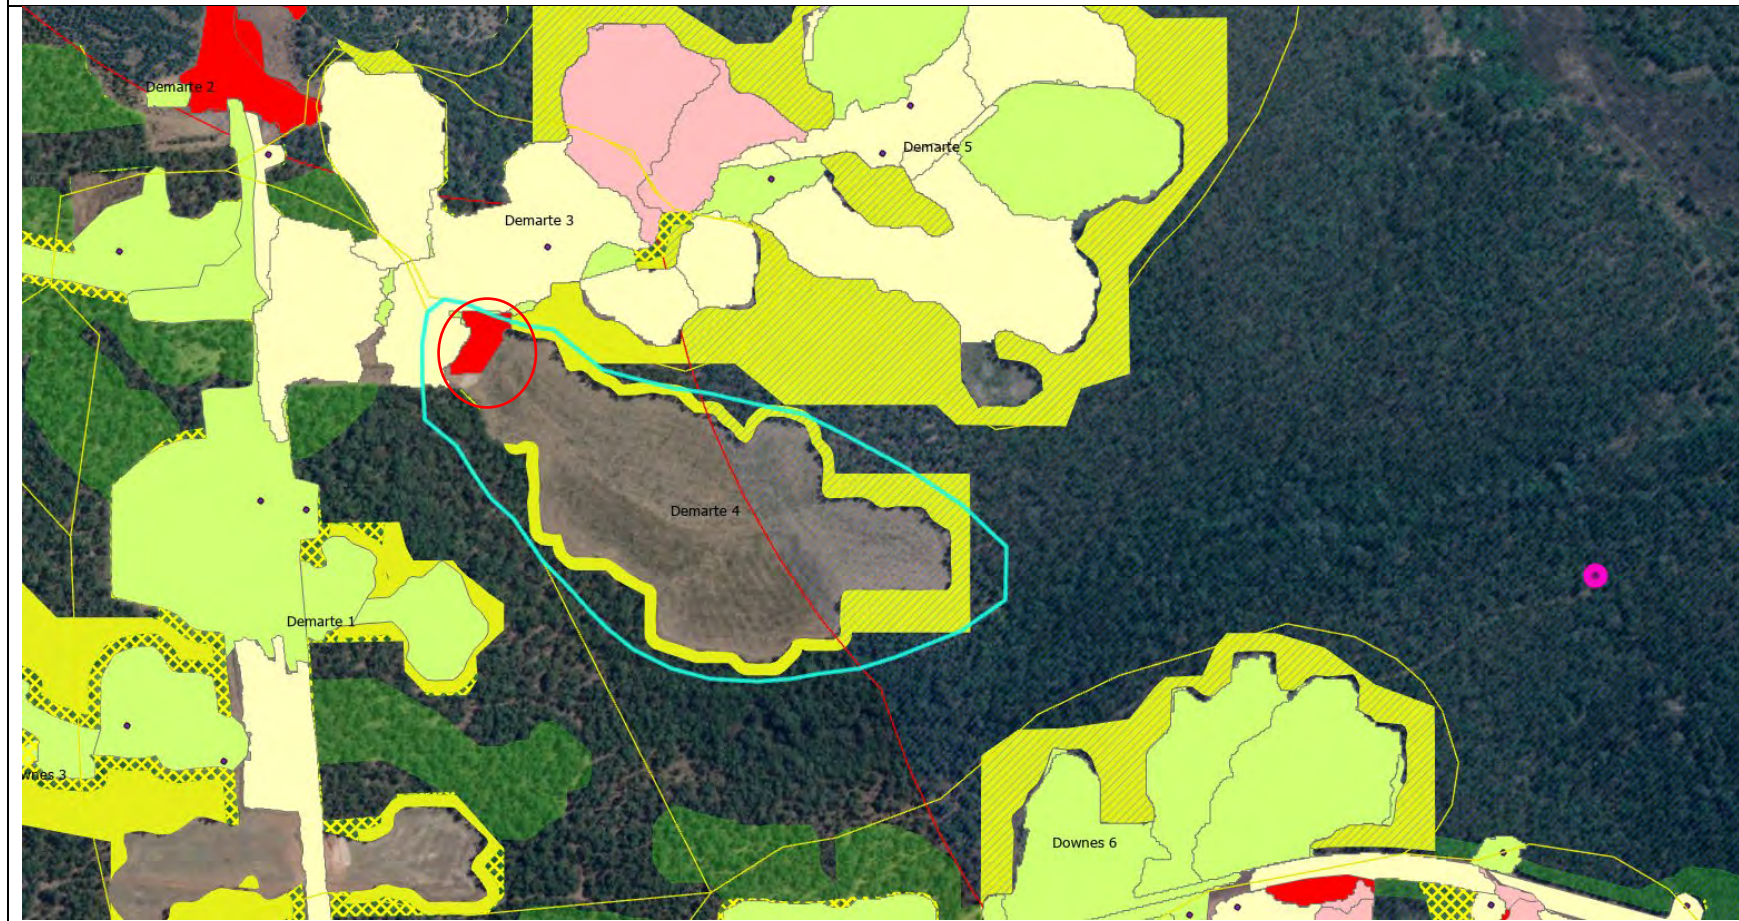
Demarte 4 DC

5	Demarte 4 (H4215, H4219, H4214) <ul style="list-style-type: none"> Pit has not been visited yet Pit is within top 1km buffer. 	<i>None Identified</i>	Drainage control at bottom end of pit is sufficient for the runoff potential from the pit.

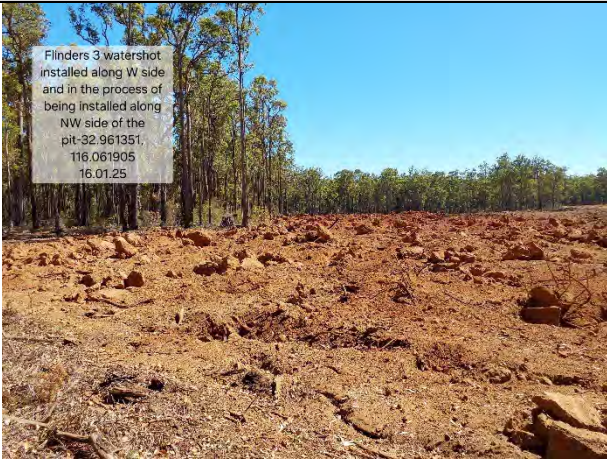
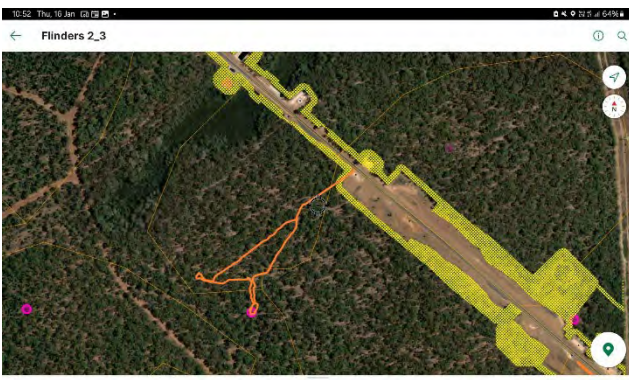
Condition number(s)	Task and Purpose	PNC Issues	Notes	Photo taken
			<p>Flinders 3 watershed installed along W side and in the process of being installed along NW side of the pit-32.961351, 116.061905 16.01.25</p>

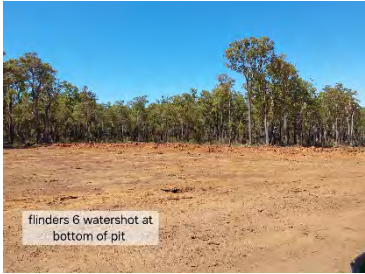
<div>flinders 6 watershot at bottom of pit</div> </div> <div>

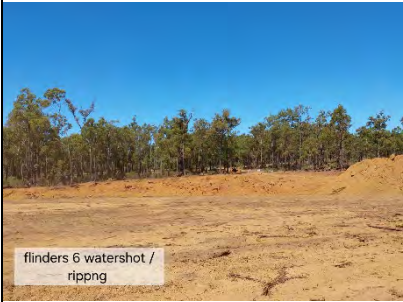
<div>flinders 6 watershot / rippng</div> </div>

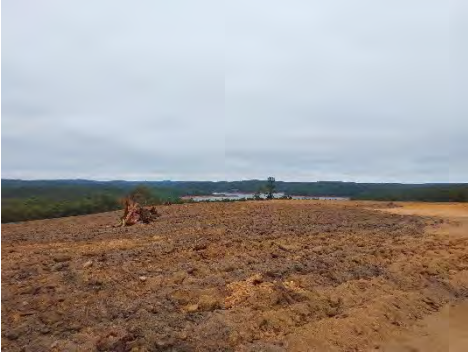
<p>- Evidence of ripping at stone 12 for drainage control.</p>

Condition number(s)	Task and Purpose	PNC Issues	Notes	Photo taken
			<div>- No mining activities occurring</div> <div>

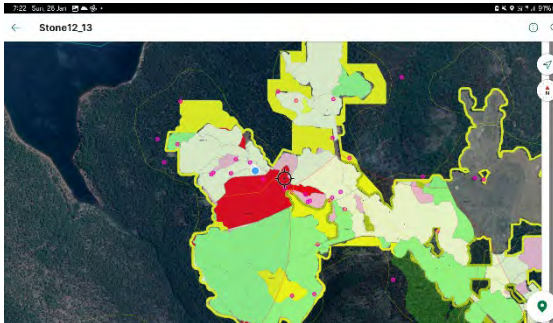
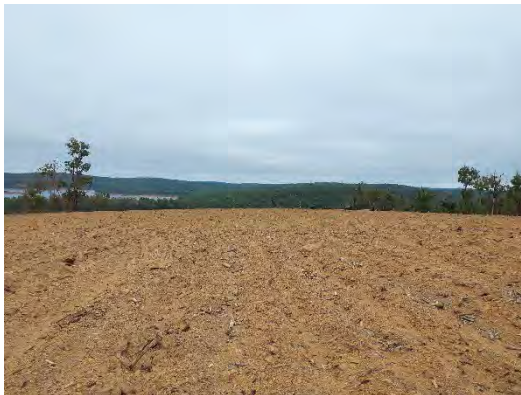
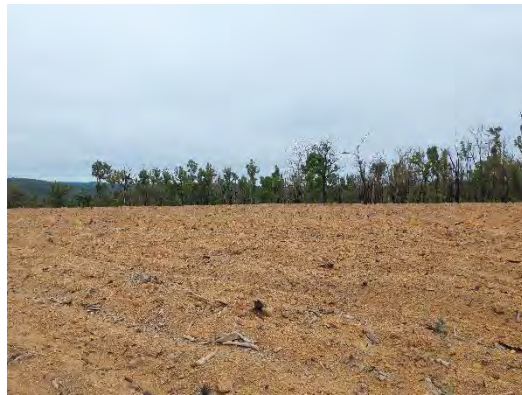
Condition number(s)	Task and Purpose	PNC Issues	Notes	Photo taken
5	Stone 13 (H4102) <ul style="list-style-type: none"> Check drainage control at bottom of pit and in <25% dc area on north-eastern side of pit. Check drainage control in <50% dc area of pit. Confirm no mining activities are occurring (pit is in top 1km buffer) Erosion out of pit on northern side and western boundary noted during last inspection. 	None identified

<p>Looking toward northeastern side of pit where erosion was last evident</p>

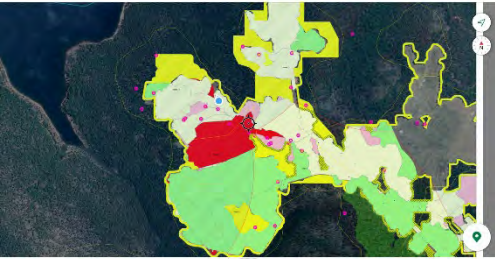
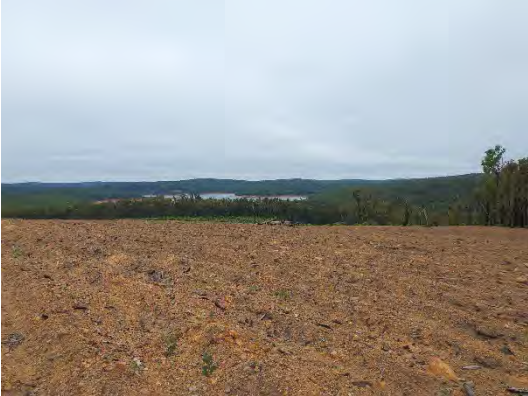
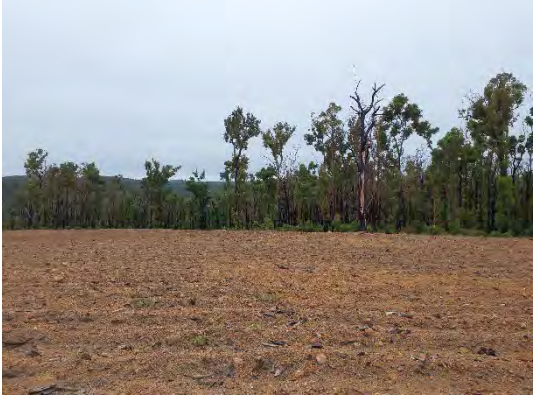
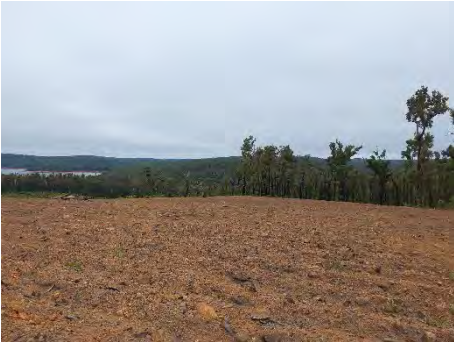
</div> <p>No evidence of further erosion out of pit, with drainage controls installed to manage runoff from the pit.</p>	<div>

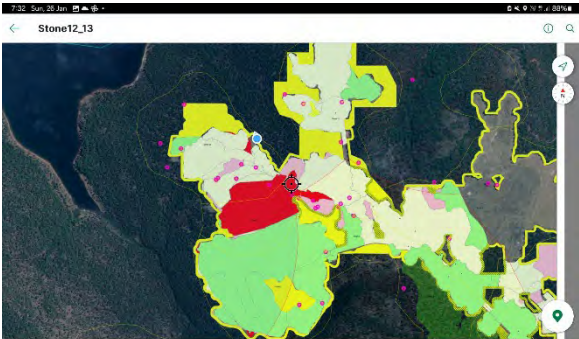
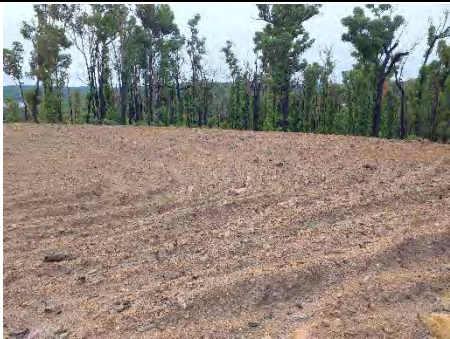
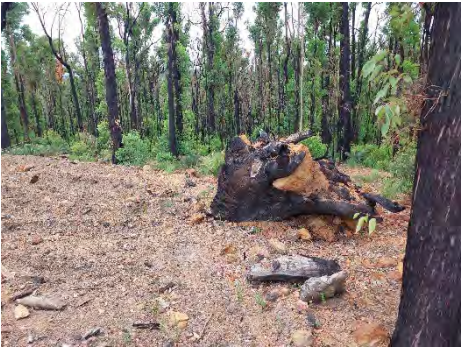
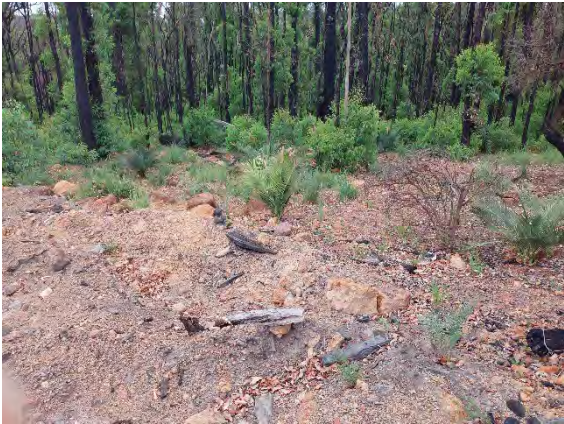
</div> <p>No mining activities occurring</p>

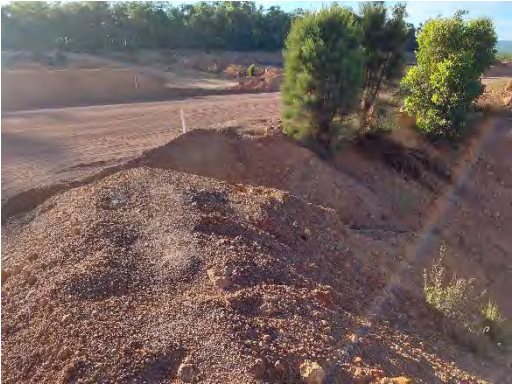
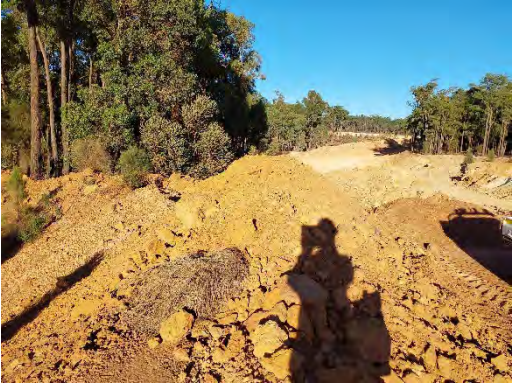
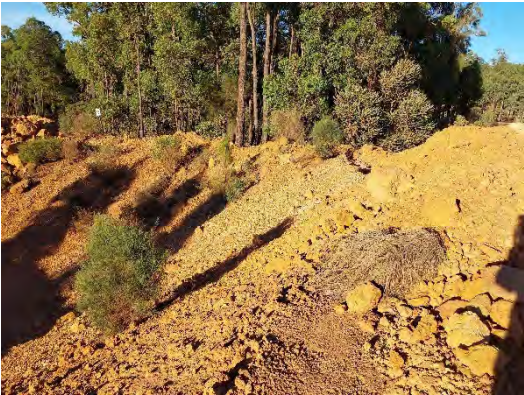
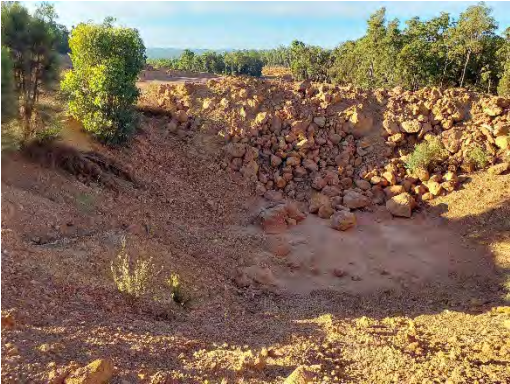
Condition number(s)	Task and Purpose	PNC Issues	Notes	Photo taken
5	Blacklock 10 (J4227, J4303) <ul style="list-style-type: none"> Harvesting has occurred in preceding week. Check harvested area is within native veg disturbance footprint. Check drainage capacity at sump 	None Identified	Sump adequate upon entry into Blacklock 10 haul road

</div> <p>2 other sumps either side of road entering blacklock 10 sufficient</p>

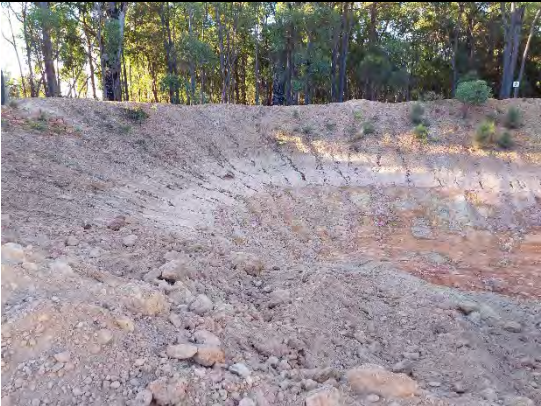
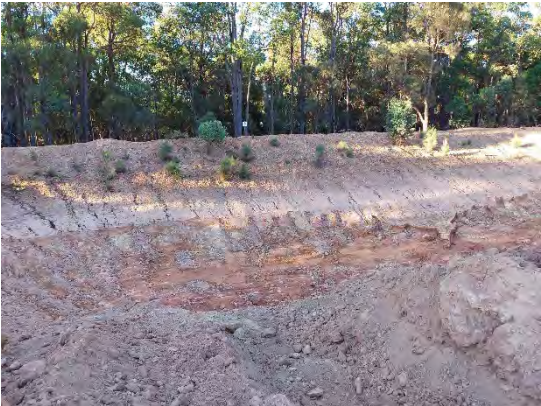
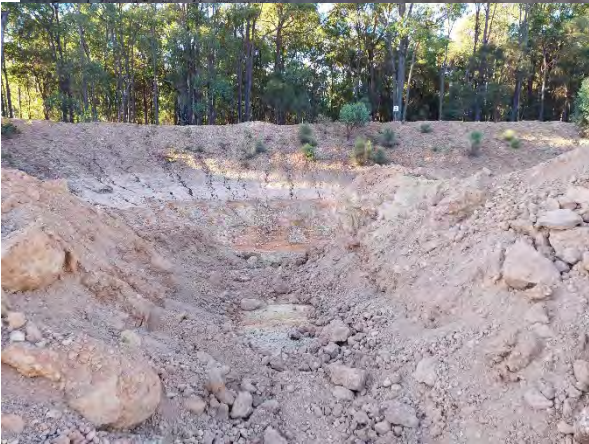
Condition number(s)	Task and Purpose	PNC Issues	Notes	Photo taken
			<div>     </div> <p>Checked 3 harvested areas. Walked the boundary (white flag) where clearing ends. Western side, clearing has occurred. All disturbance is within native vegetation disturbance boundary. Southern side walked boundary (white flag) where clearing stops within native vegetation disturbance boundary. Eastern side. Could not walk as area has not been cleared.</p>	<div>     </div>

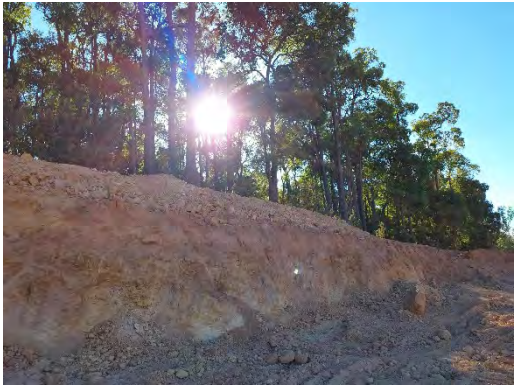
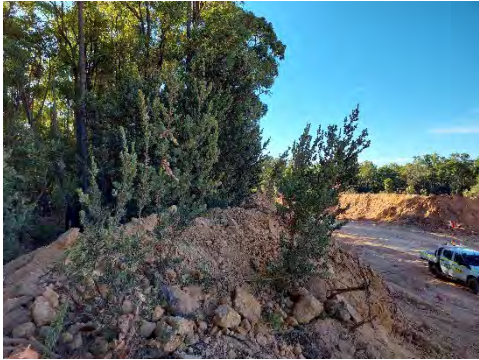
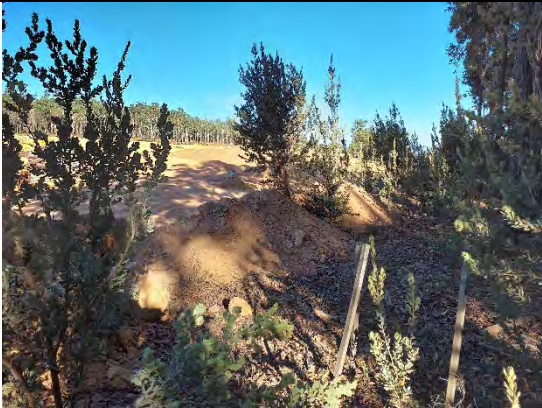
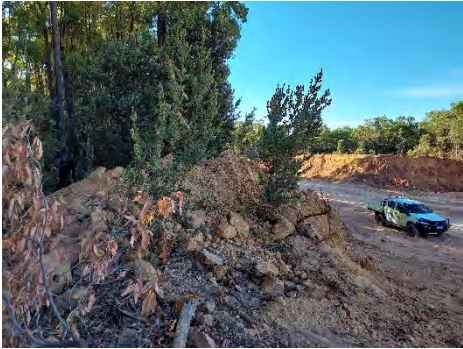
Condition number(s)	Task and Purpose	PNC Issues	Notes	Photo taken
			<div>Eastern side of the pit, Not cleared</div> <div>         </div>

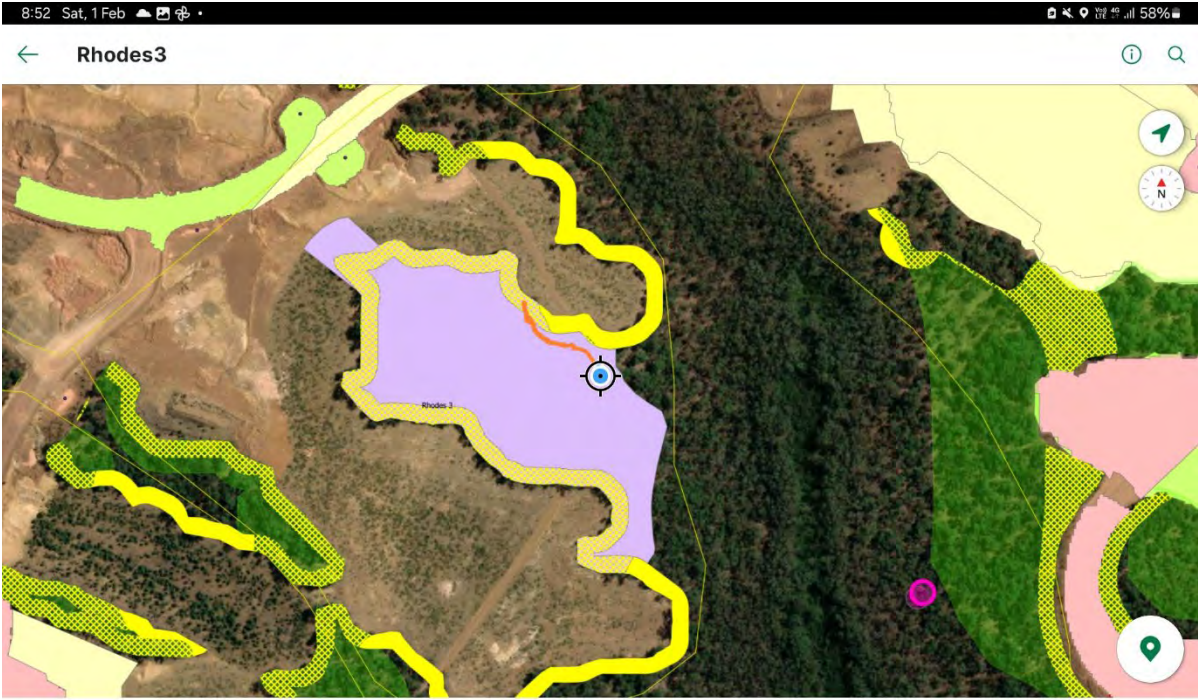
Rhodes 3 (G4303, G4304) <ul style="list-style-type: none"> Check cleared area is within 	<i>None Identified</i>	Clearing not undertaken outside white flags and within the native vegetation disturbance boundary.

Condition number(s)	Task and Purpose	PNC Issues	Notes	Photo taken
	<p>Native vegetation disturbance boundary areas. Clearing has been undertaken in the preceding week.</p> <ul style="list-style-type: none"> Check clearing on eastern side is within NV disturbance footprint. NV disturbance footprint is exactly in line with GDP boundary on eastern side.

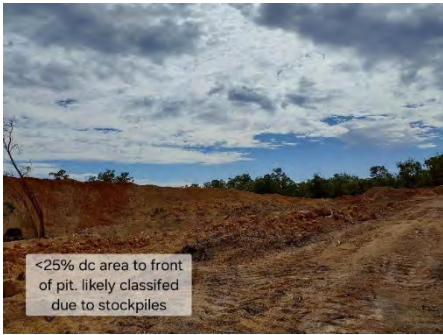
Condition number(s)	Task and Purpose	PNC Issues	Notes	Photo taken
5	Manning 10 (F4209, F4210, F4214) <ul style="list-style-type: none"> Stripping has occurred in weeks previous, check within the native vegetation disturbance footprint. Check drainage control with >25% capacity in areas 	None Identified	<p><25% drainage capacity area at northern end of pit is stockpiles.</p>

Condition number(s)	Task and Purpose	PNC Issues	Notes	Photo taken
			Stripping confirmed to be within native vegetation disturbance footprint. Boundaries of stripped areas walked.

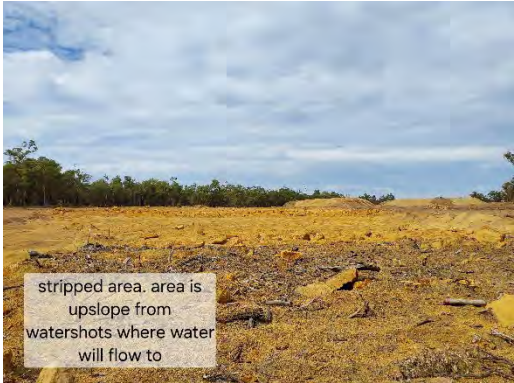
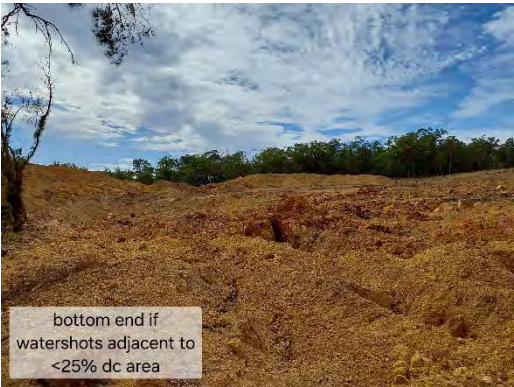
Condition number(s)	Task and Purpose	PNC Issues	Notes	Photo taken
			<p>Stripped area 1 on northern side of pit</p>

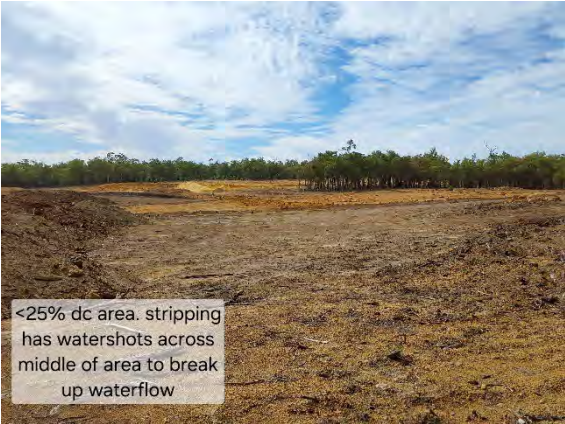
<p><25% dc area. stripping has watershots across middle of area to break up waterflow</p>

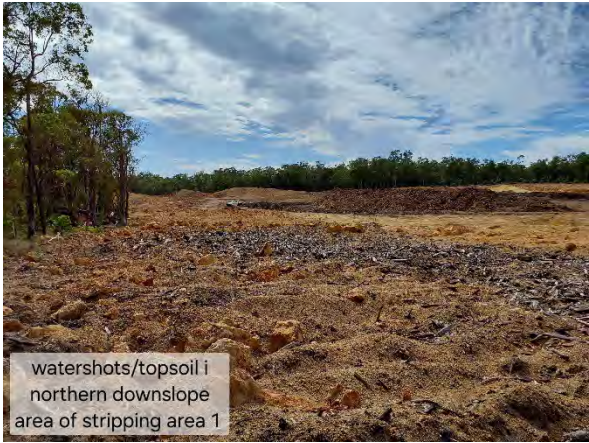
<p>watershots/topsoil i northern downslope area of stripping area 1</p>

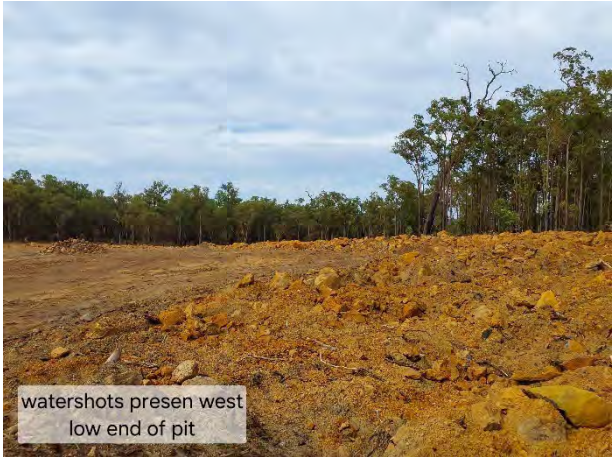
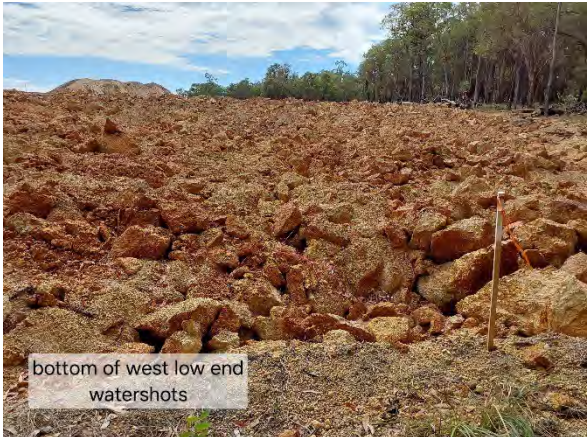
Condition number(s)	Task and Purpose	PNC Issues	Notes	Photo taken
			<p>Western Low end of stripped area 1.</p>

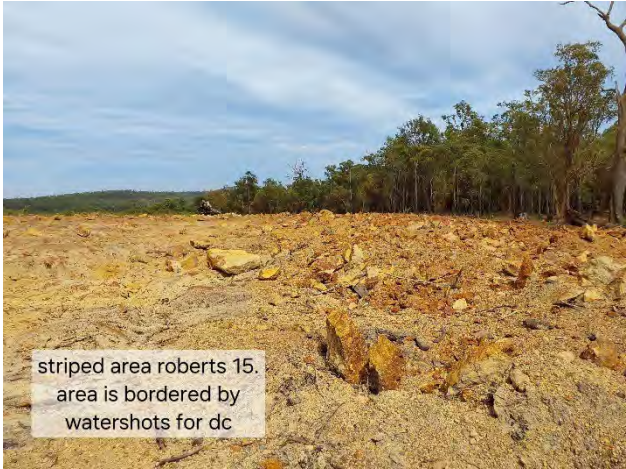
Condition number(s)	Task and Purpose	PNC Issues	Notes	Photo taken
			<p>Opportunistically viewed stripping in Roberts 15, Drainage controls are in place.</p>

<p>striped area roberts 15. area is bordered by watershots for dc</p> <p>Stripped area east side Manning 10</p>

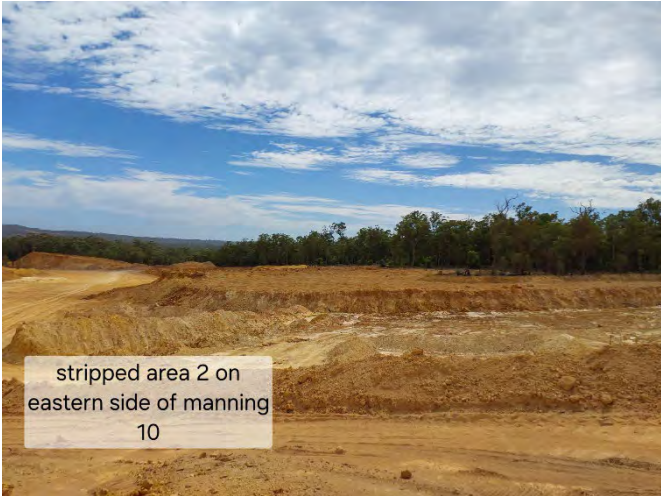
<p>stripped area 2 on eastern side of manning 10</p>

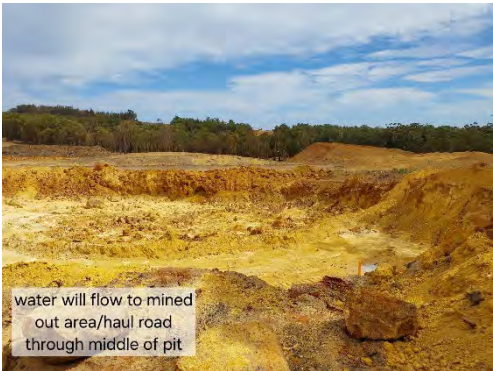
<p>water will flow to mined out area/haul road through middle of pit</p>

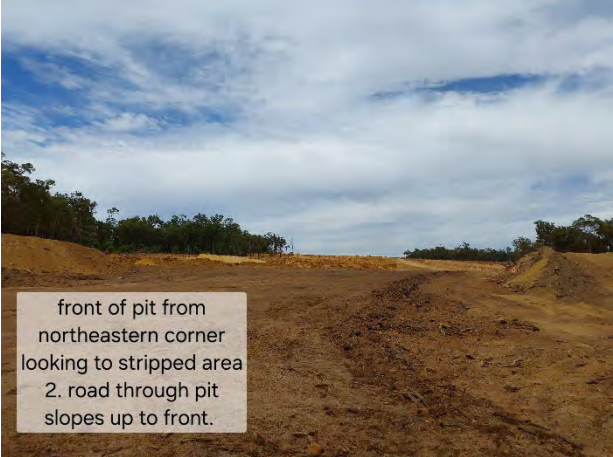
<p>front of pit from northeastern corner looking to stripped area 2. road through pit slopes up to front.</p>

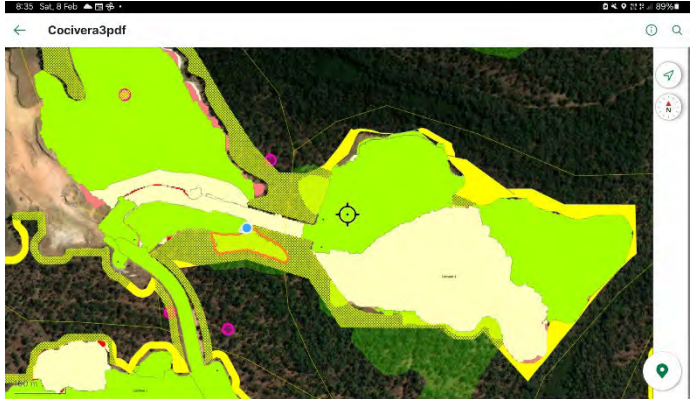
Condition number(s)	Task and Purpose	PNC Issues	Notes	Photo taken
5	Cocivera 3 (G4217, G4213, F4216, G4209) <ul style="list-style-type: none"> Snipping works complete in previous week, check within the Native Vegetation disturbance area 	None Identified	<p>Walked cleared area. Area confirmed to be in native vegetation disturbance footprint.</p>

<p>Clearing observed to be within approved clearing pegged areas. Topsoil still present and cleared vegetation placed in windrows on contour.</p>

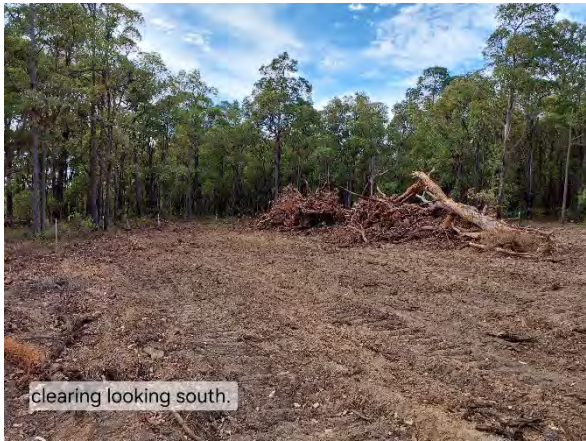
<p>clearing looking south.</p>

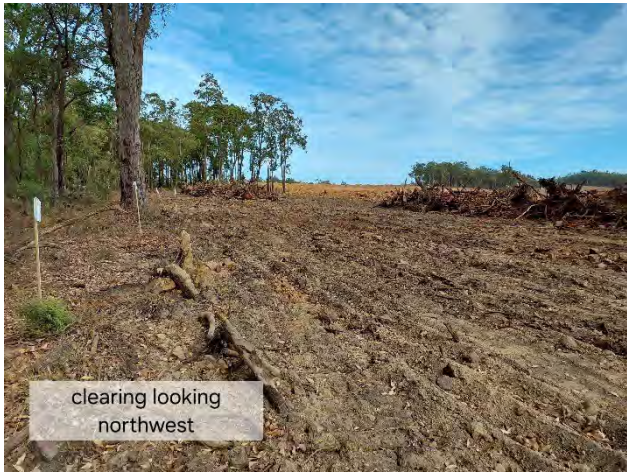
<p>clearing looking northwest</p>

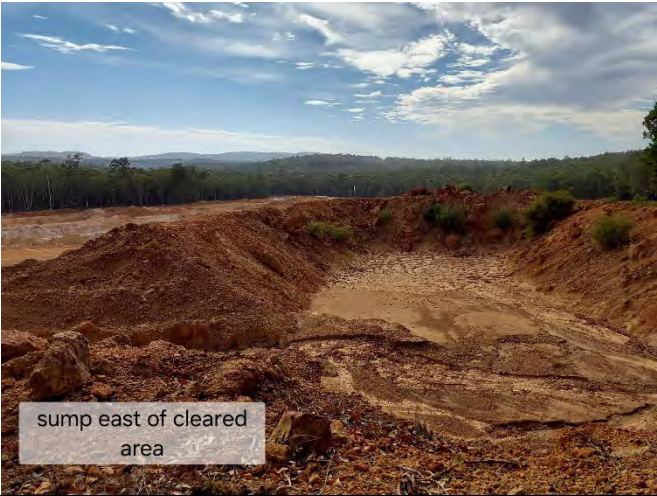
<p>sump east of cleared area</p>

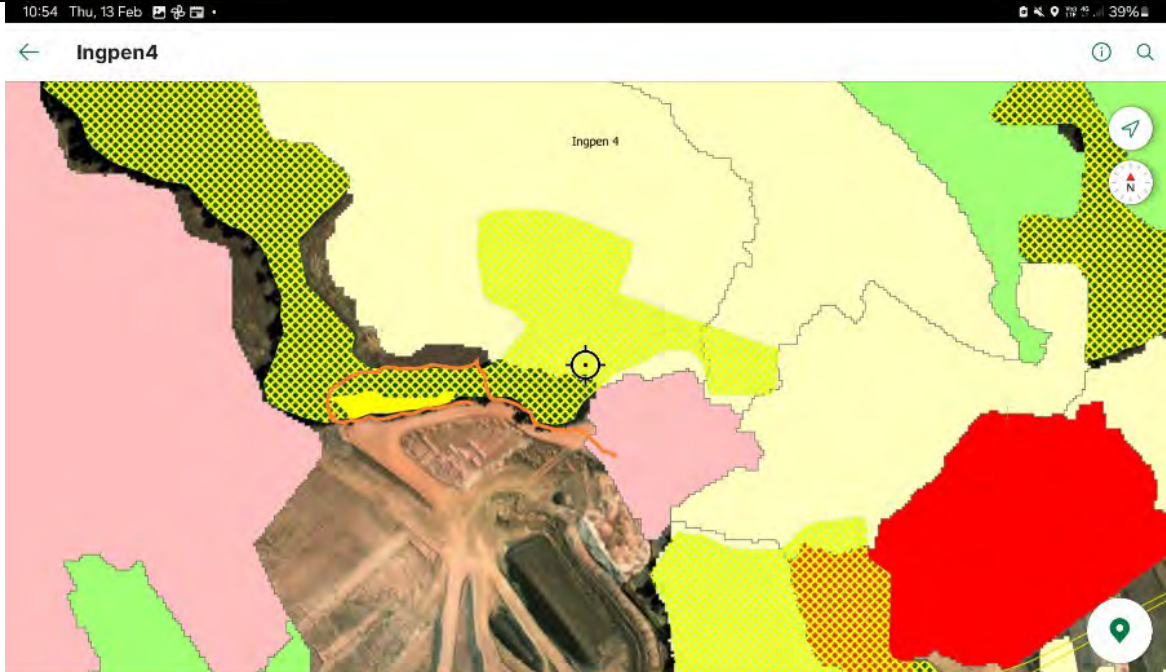
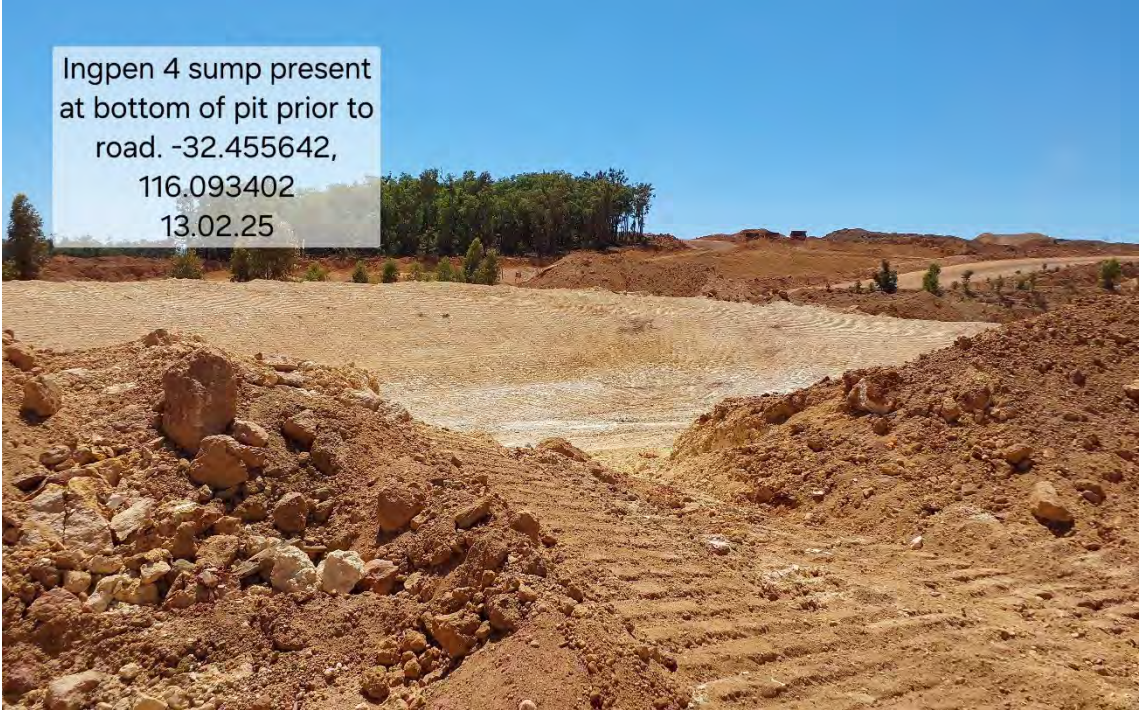
Condition number(s)	Task and Purpose	PNC Issues	Notes	Photo taken
5	Ingpen 4 (G4205, G4209, G4210) <ul style="list-style-type: none"> Drainage works occurring in preceding week. Check drainage capacity at bottom of <50% drainage capacity area Check drainage capacity at <25% areas Check mined areas do not enter fca relinquished area 	None Identified	<p>Drainage work have included installation of sumps to collect runoff from site and some exposed areas have been ripped.</p> <p>Unable to access area with drainage capacity >50% due to an exclusion zone around the area.</p>

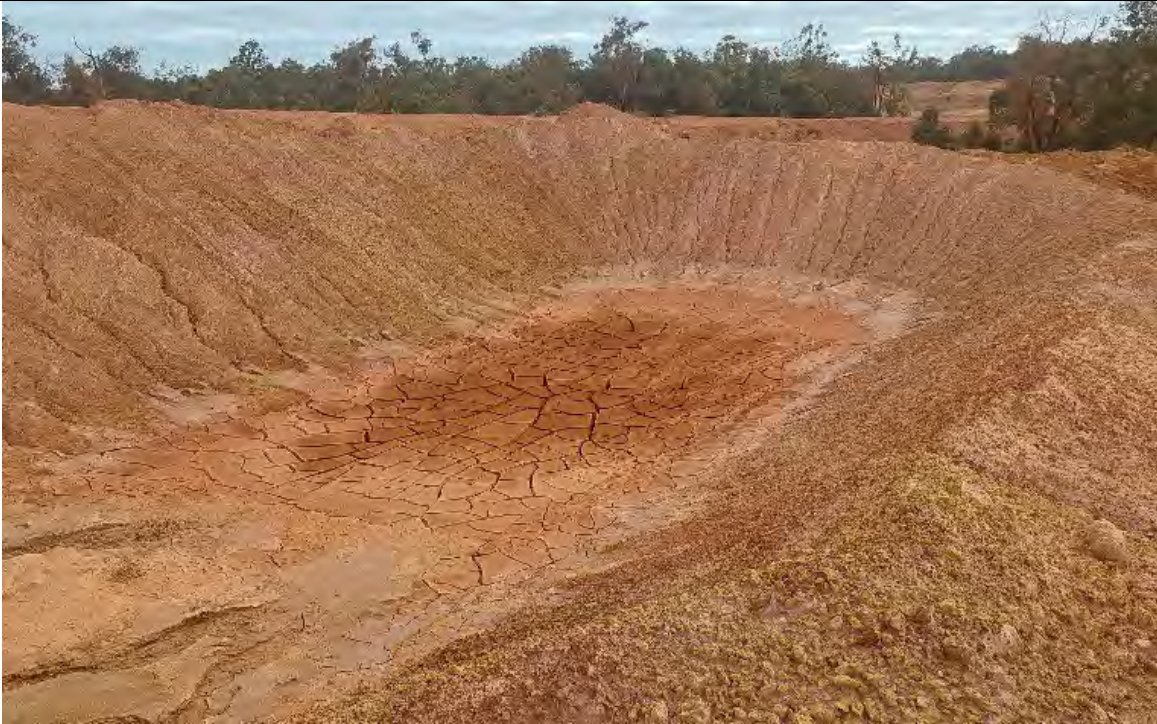
Condition number(s)	Task and Purpose	PNC Issues	Notes	Photo taken
			  <p>Sumps in the pit and collecting runoff from the road are in good condition.</p>

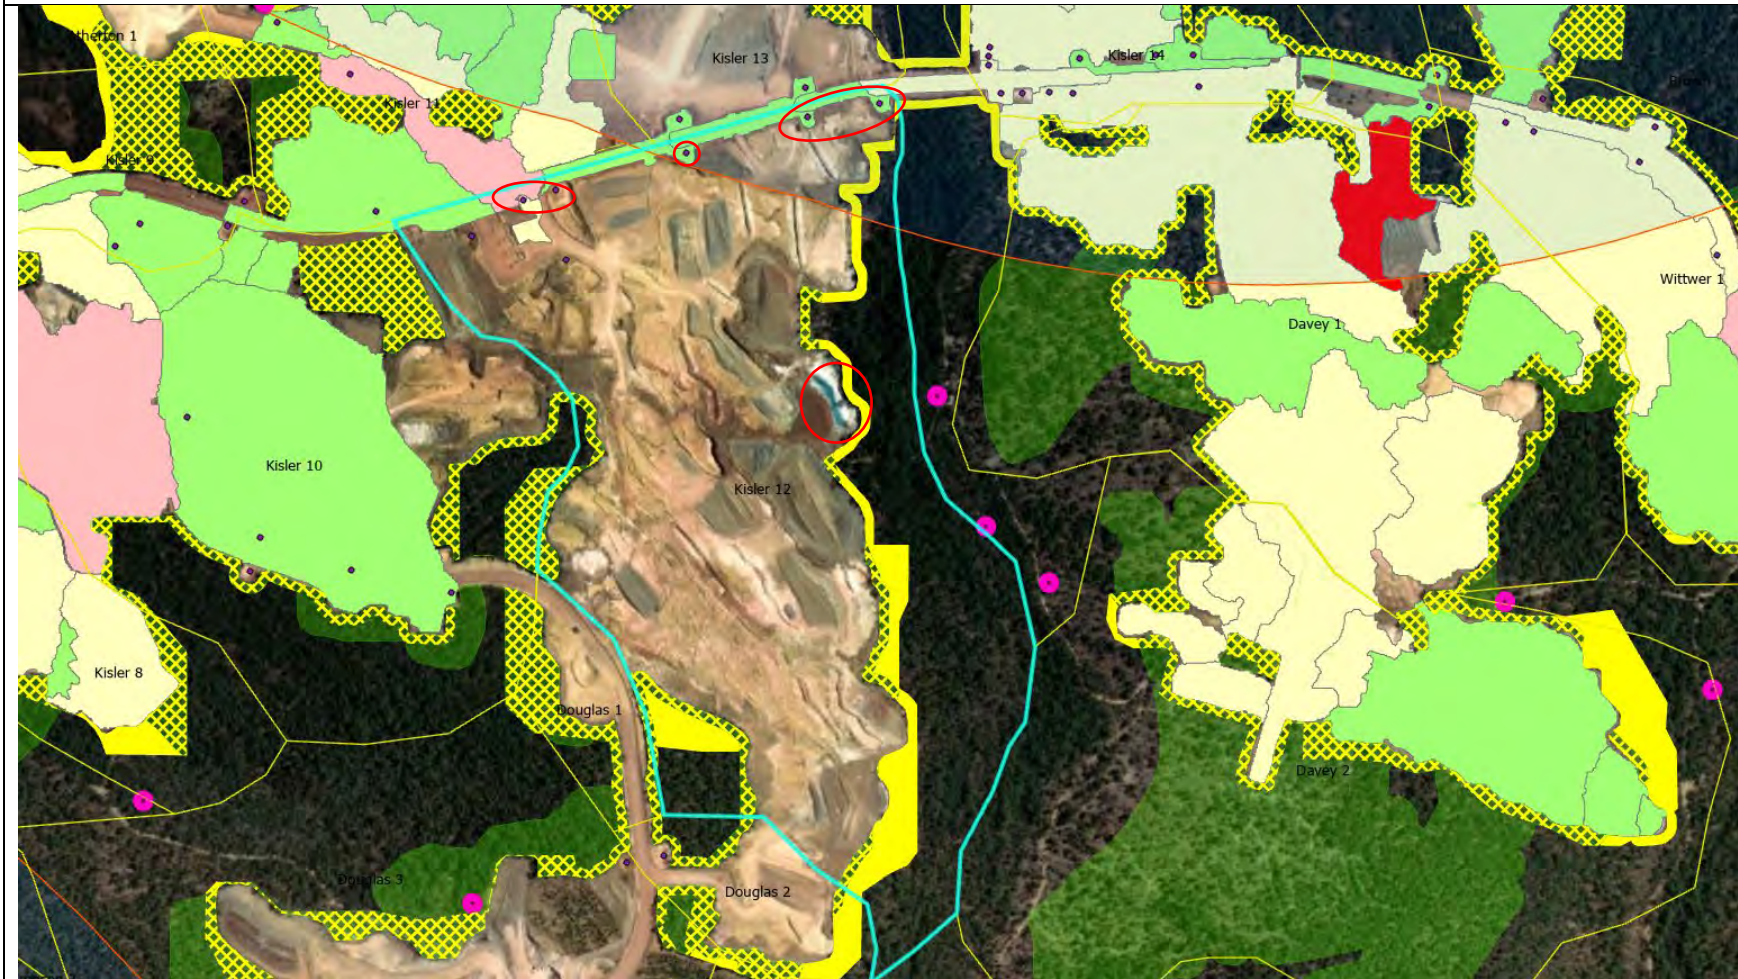
Kisler 12 – sumps circled and water present on imagery

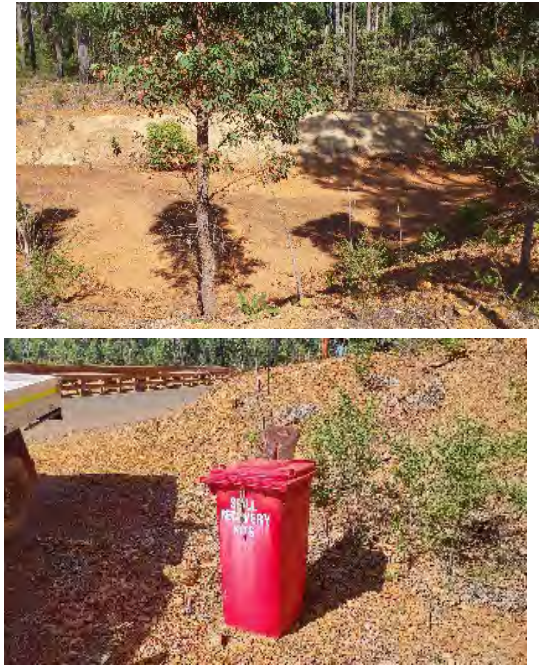
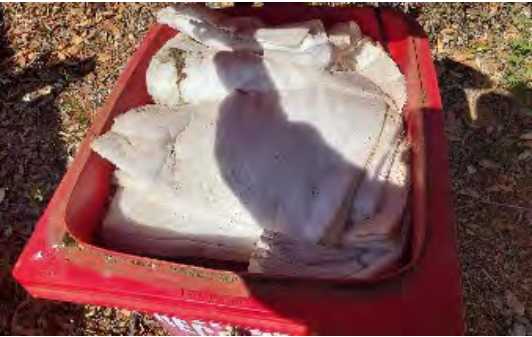
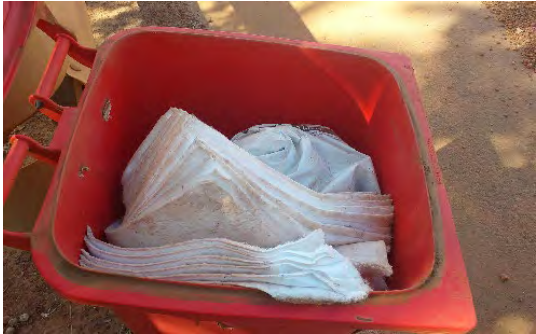
Condition number(s)	Task and Purpose	PNC Issues	Notes	Photo taken
4(b)	Check Sampson Dam crossing area (E5320, E5323, E5324) <ul style="list-style-type: none"> Check capacity and condition of sumps Check Turbidity monitor SM46 	None Identified	<p>Fully stocked spill kits present on either side of the crossing at Sampson dam causeway. Sump on southern side has full capacity and is in good condition. Sump on Northern side has the inlet blocked from the road, requires clean out.</p> <p>Turbidity monitor SM46 observed, stream is dry with loose debris on the stream floor.</p>
