Document type
Compliance Assessment Report (CAR)

Alcoa of Australia Limited – WA Operations

2024 – 2028 Mining and Management Program - Compliance Assessment Report 2025

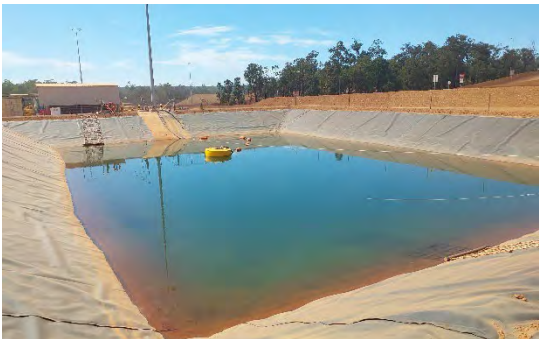
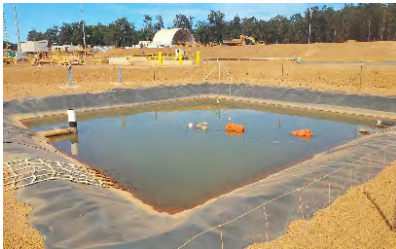
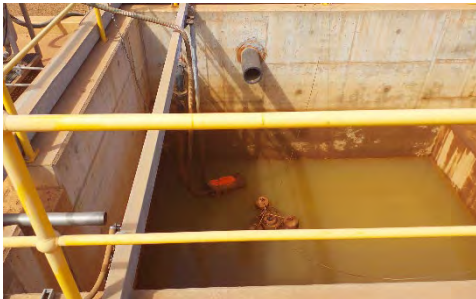
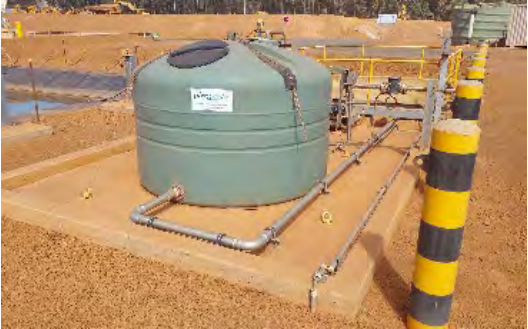
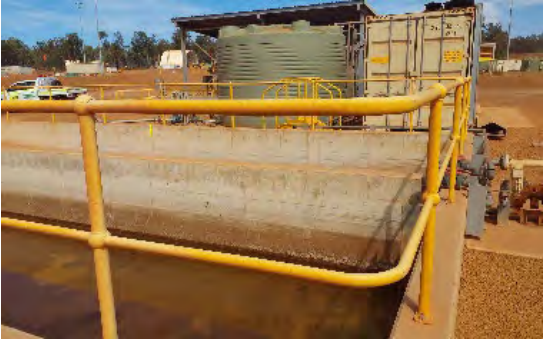
Condition number(s)	Task and Purpose	PNC Issues	Notes	Photo taken
4(b)	Larego oily water pond and DAF holding sumps and Stormwater management facilities (F5520, F5524) <ul style="list-style-type: none"> • Check capacity of stormwater and wastewater facilities • Checks for loss of containment or spills evident around the site. 	None Identified	<p>DAF system inspected, sumps have capacity and lining is in good condition with no rips or tears observed.</p> <p>Tanks and facilities are on concrete bunded areas to contain spills to the site.</p> <p>Fauna egress mats are present in all sumps.</p>

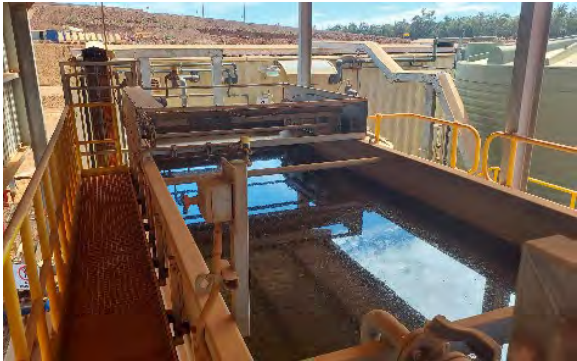
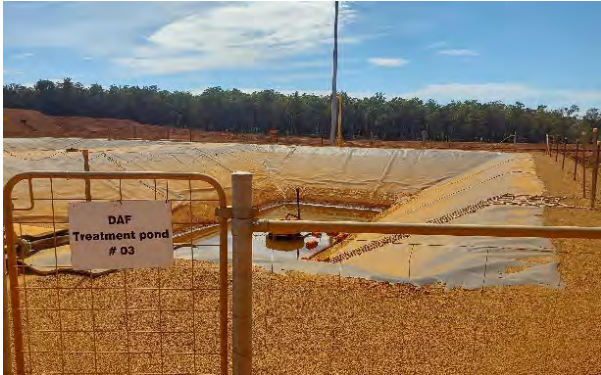
4(b)	Arundle dangerous goods and waste	None Identified	Sumps on the southern side of the road all have adequate capacity, with only AP1 having water present in the pond.

Condition number(s)	Task and Purpose	PNC Issues	Notes	Photo taken
	area/ stormwater ponds <ul style="list-style-type: none"> • Check capacity of stormwater and wastewater facilities • Checks for loss of containment or spills evident around the site. • Inspect dangerous goods and containment of chemicals 		<p>Empty IBC on an empty pallet bund and generator within a bund at the area.</p> <p>At the Arundle site noted caustic chemical contained within bunds, some spilt sodium hydroxide present in the bunds.</p> <p>Adequate capacity within ponds sighted at the site.</p>

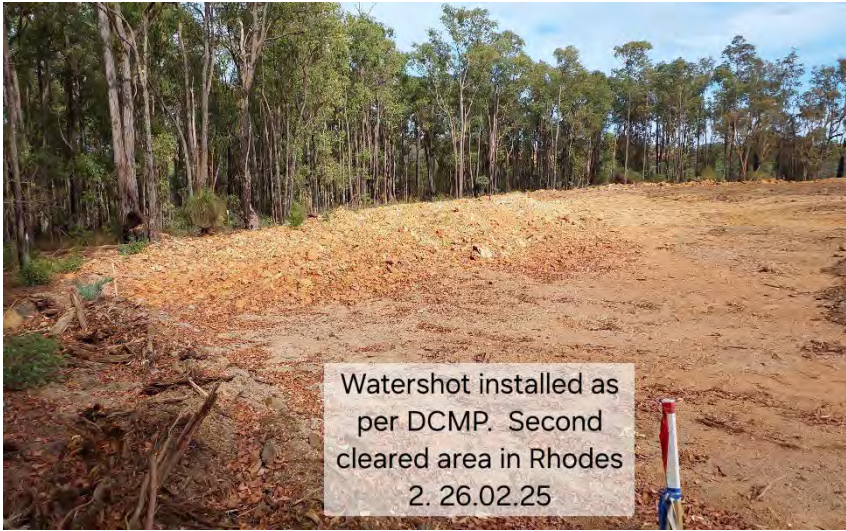
Condition number(s)	Task and Purpose	PNC Issues	Notes	Photo taken
5	<p>Rhodes 2 (G4308, G4304)</p> <ul style="list-style-type: none"> Check DC as per DCMP plans (saved in google drive) DCMP states DPSs are installed and maintained until mining development commences. DPSs are located at the base of the pit. Each DPS will be installed as early as possible in the clearing process to provide drainage protection. 	None identified	<p>Watershot blasted Drainage Controls are in place along the base of cleared section as per DCMP. No concerns noted. See below photos.</p>

<p>Watershot DC at western boundray of cleared Rhodes 2. 26.02.25</p> <p>Watershot DC at western end of Rhodes 2. 26.02.25</p>

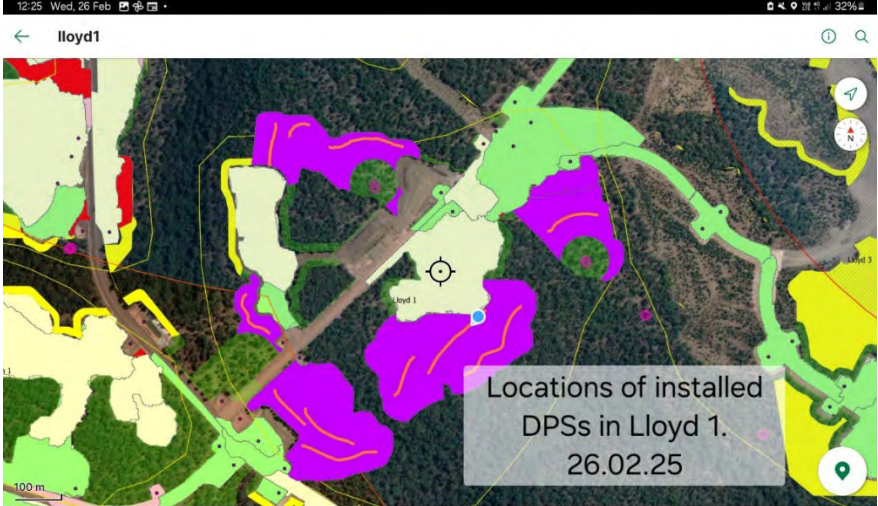
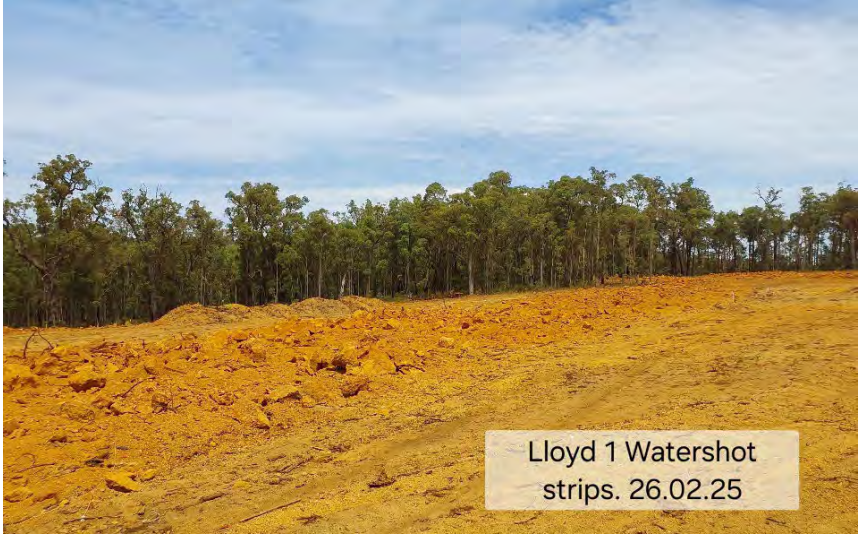
Condition number(s)	Task and Purpose	PNC Issues	Notes	Photo taken
5	<p>Lloyd 1 (G4207, G4208, G4212, G4211)</p> <ul style="list-style-type: none"> Check DC as per DCMP plans (saved in google drive) DCMP states DPSs are installed and maintained until mining development commences. DPSs are located at the base of the pit. Each DPS will be installed as early as possible in the clearing process to provide drainage protection. GDP area is shown in purple Check area circle in red, was not able to be checked last week Focus on checking DCMPs in circled areas if possible (unable to 	None Identified	<p>Drainage Protection Slots installed in the recently cleared areas. No concerns noted.</p>

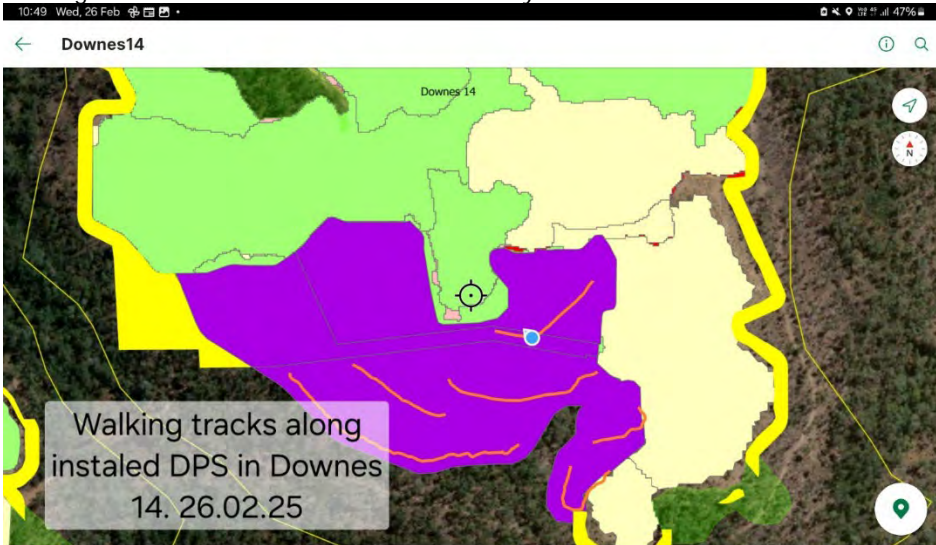
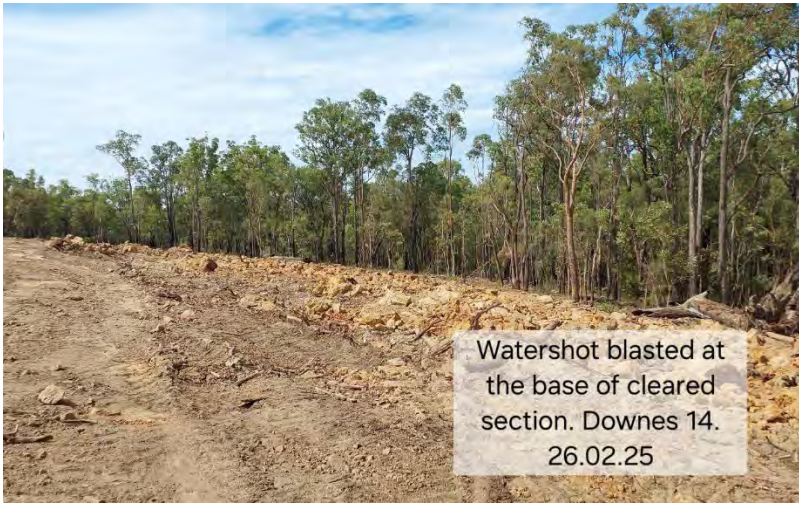
Condition number(s)	Task and Purpose	PNC Issues	Notes	Photo taken
5	<p>Downes 14 (K4225, K4226, K4302, K4301)</p> <ul style="list-style-type: none"> Check DC as per DCMP plans (saved in google drive) DCMP states DPSs are installed and maintained until mining development commences. DPSs are located at the base of the pit. Each DPS will be installed as early as possible in the clearing process to provide drainage protection. 		<p>Drainage Protection Slots installed in the recently cleared areas. No concerns noted.</p>

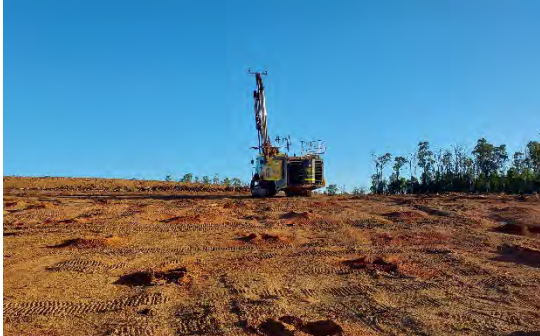
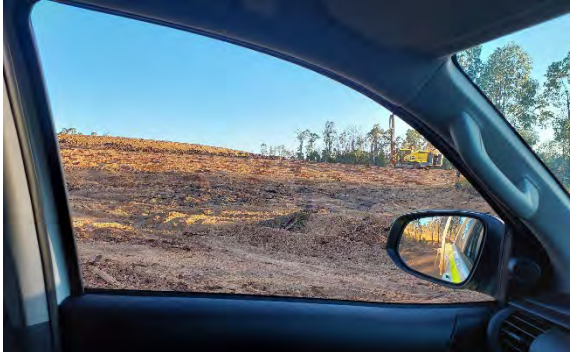
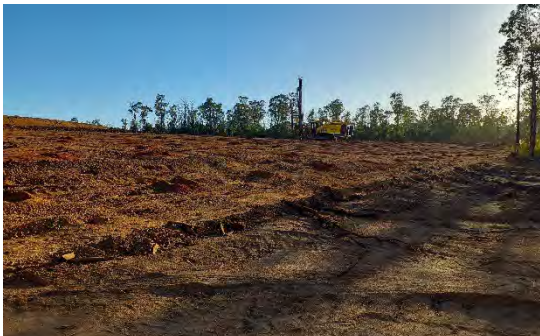
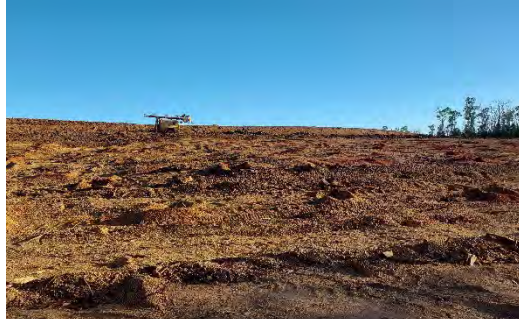
Condition number(s)	Task and Purpose	PNC Issues	Notes	Photo taken
4(d)	Flinders 9 (F5514, F5513, F5509, F5510) <ul style="list-style-type: none"> Recent stripping and DPS work has occurred in the pit. Check drainage controls for the new clearing areas 	None Identified	<p>No access to the Northern side with scrapers and dozers in area stockpiling</p> <p>Wind and woody wind rows evident southern side for drainage controls.</p> <p>Southern side drill holes present. Workers present in area about to move the drill rig and make a road through area.</p> <div>

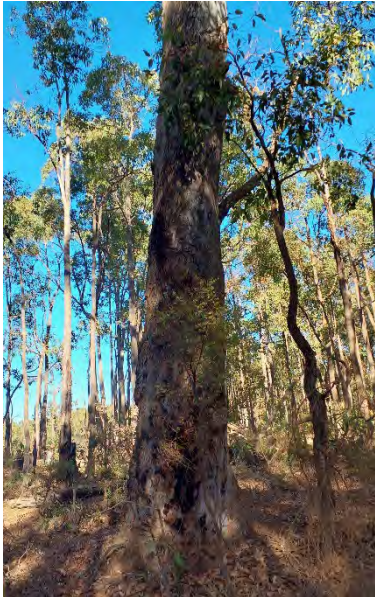
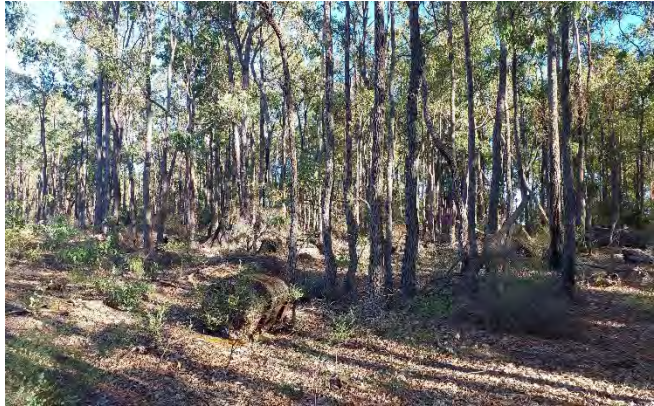
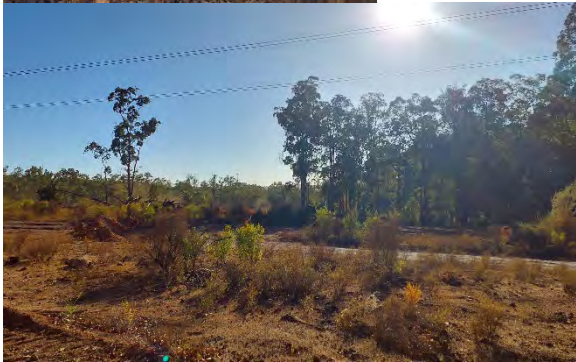
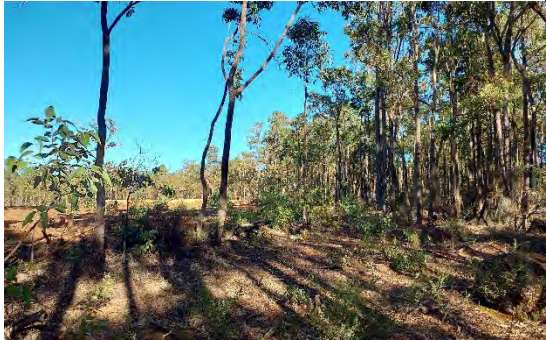
Condition number(s)	Task and Purpose	PNC Issues	Notes	Photo taken
4(d), 5(d)	Flinders 1 (F5520, F5519, F5524, F5523) <ul style="list-style-type: none"> Check GDP 301 disturbance area Check Black Cockatoo tree 2634 is not within disturbance area 	None Identified	<p>Black cockatoo not within disturbance area.</p> <p>Mining operations occurring north of Flinders 1 in Flinders 2</p> <p>Haul road being installed between Flinders 1 and 2.</p> <p>Windrows and boulders in place</p> <div>

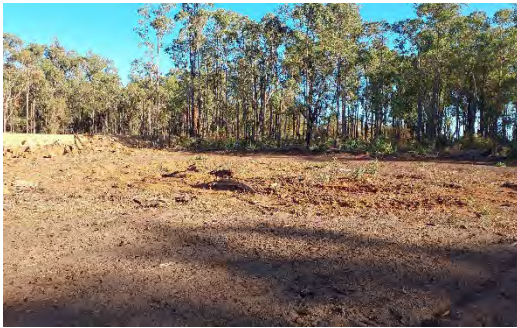
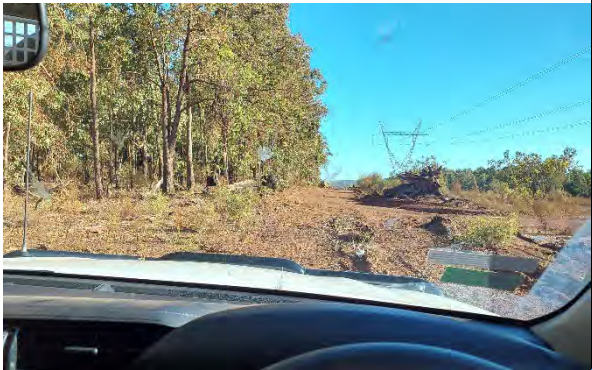
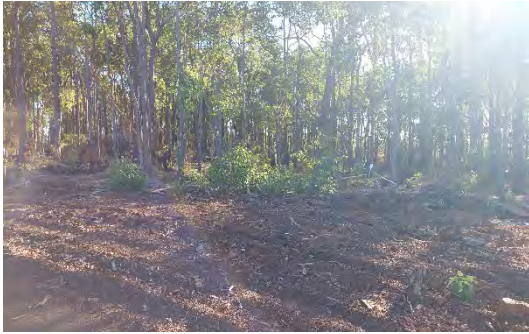
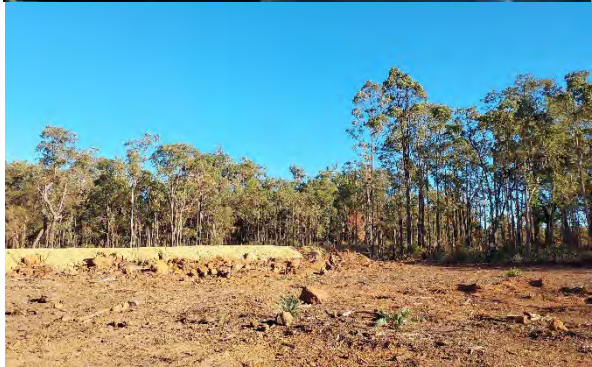
4(d)	Central 3 (F5503, F5427) <ul style="list-style-type: none"> Check recent clearing and DPS works that have occurred in the pit last week. Drainage capacity and sumps to be check for condition and capacity 		<p>Woody windrows and watershots present in area for drainage control.</p> <p>Checked sumps. All in good condition and sufficient capacity</p>

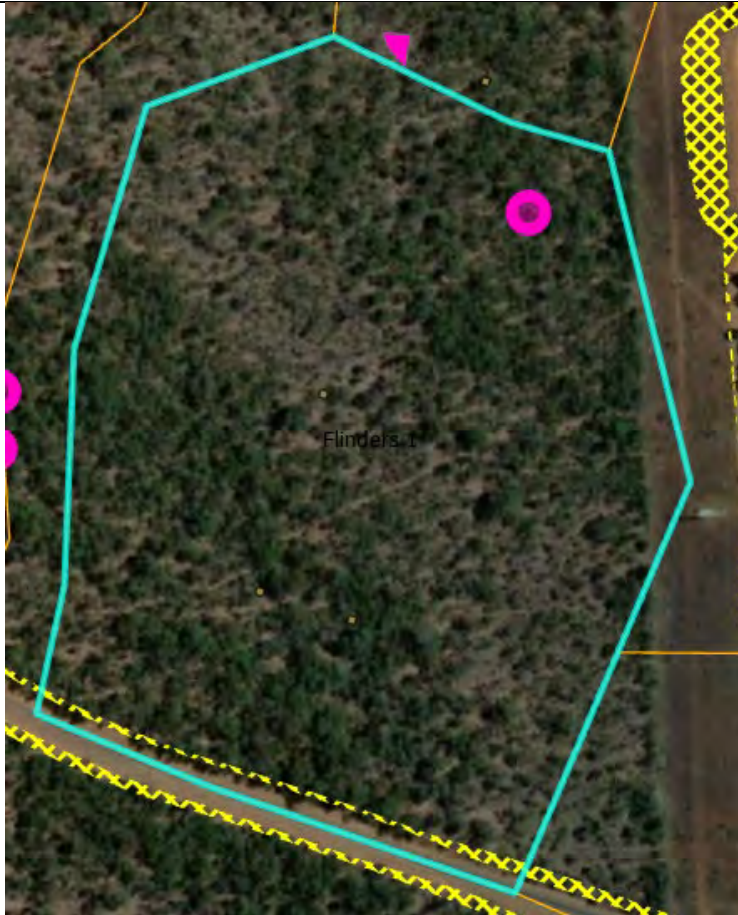
Flinders 1 – check GDP area and disturbance distance to BC tree 2634 (marri)

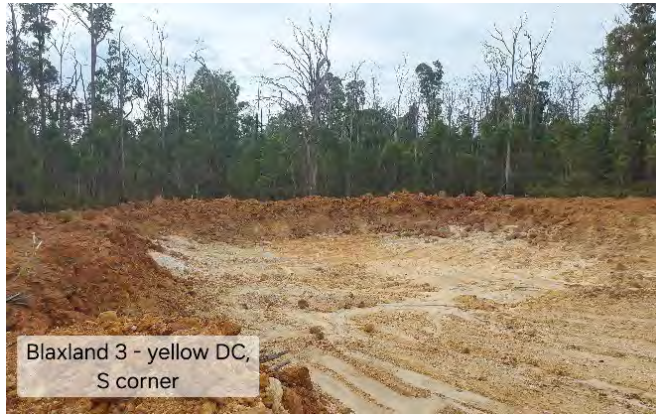
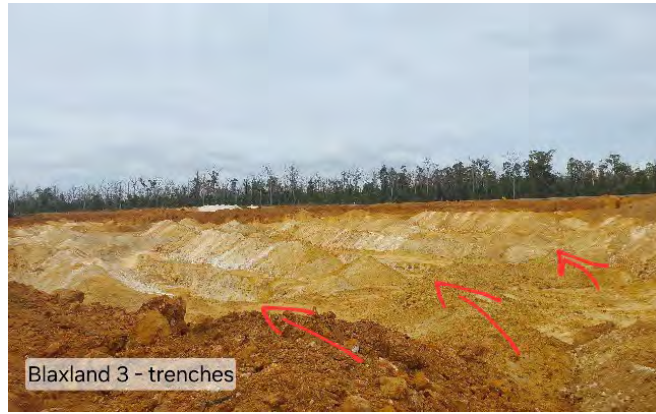
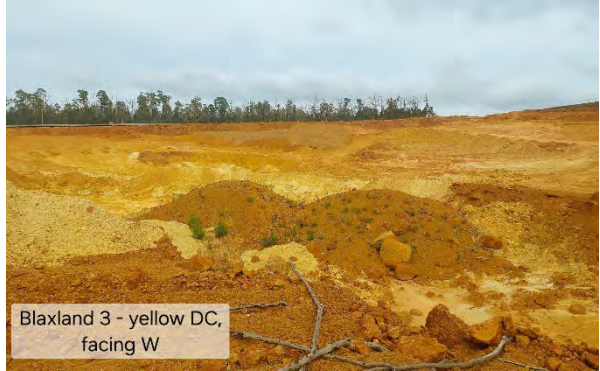
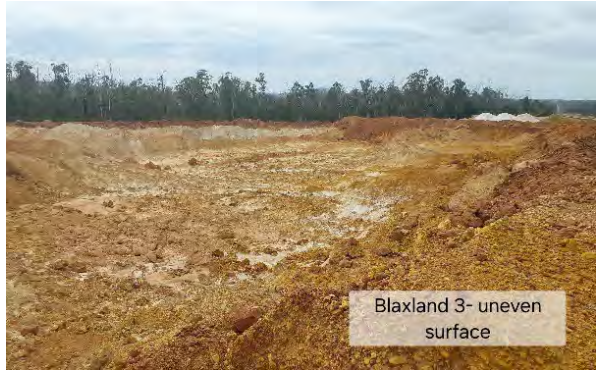
Condition number(s)	Task and Purpose	PNC Issues	Notes	Photo taken
4(d)	Blaxland 3 (F5506, F5505, F5501) <ul style="list-style-type: none"> Check drainage control in <25% drainage capacity area and at bottom of pit. Check the condition and capacity of the pit 	None Identified	<p>Southern end of the pit inspected.</p> <p>Drainage controls measures are sufficient: trenches, uneven surface and pit walls at the forest boundary. No drainage control risks noted.</p>

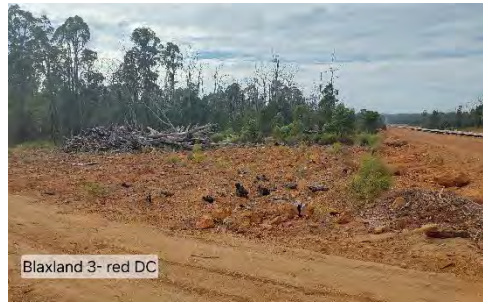
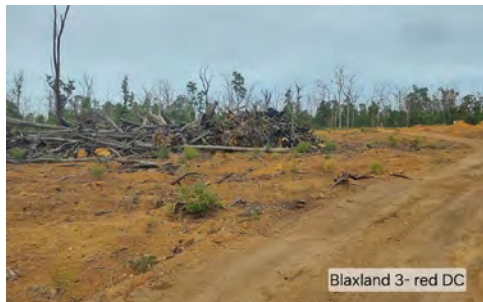
Condition number(s)	Task and Purpose	PNC Issues	Notes	Photo taken
			<p>Drainage Capacity area <25% inspected. Area is ripped and has an old woody windrow.</p>

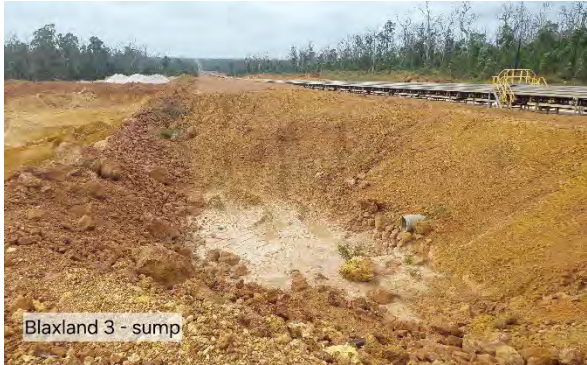
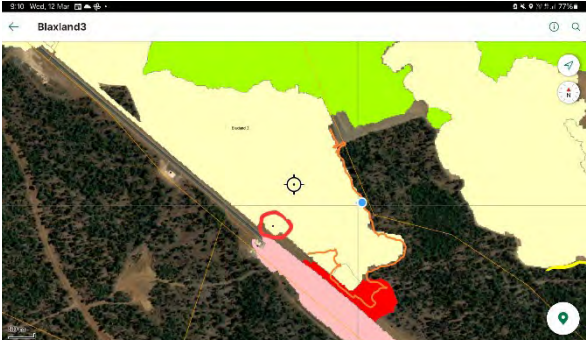
Condition number(s)	Task and Purpose	PNC Issues	Notes	Photo taken
			<p>Sump inspected. Sump is in a good condition and has its full capacity remaining. Inspected sump circled with red in the screenshot below.</p>

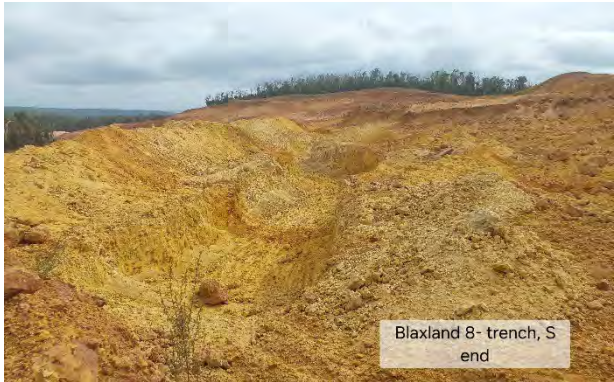
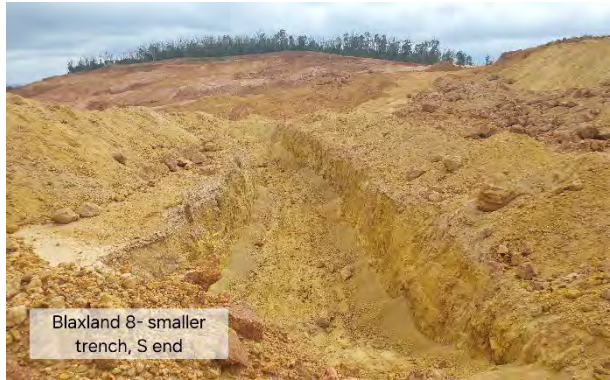
4(d)	Blaxland 8 (F5501, F5425) <ul style="list-style-type: none"> Check drainage control in the area with 25 –50% capacity, recent works have occurred in the pit 	None Identified	<p>Southern end of the pit (yellow DC) has two trenches. Both trenches are followed by a bund containing runoff.</p>

<p>Water would report to the southern part of Blaxland 6, where is a double trench near the forest boundary. Drainage control measures in the southern end of Blaxland 8 are sufficient.</p>

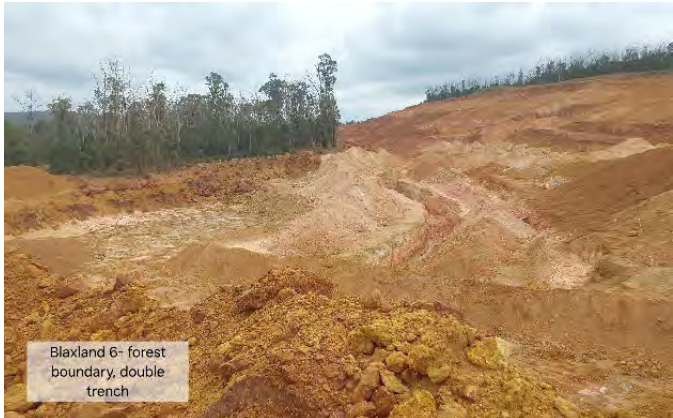
<p>Blaxland 6- forest boundary, double trench</p> <p>Northwestern forest edge has sharp pit walls, approx. 2-5m freeboard.</p>

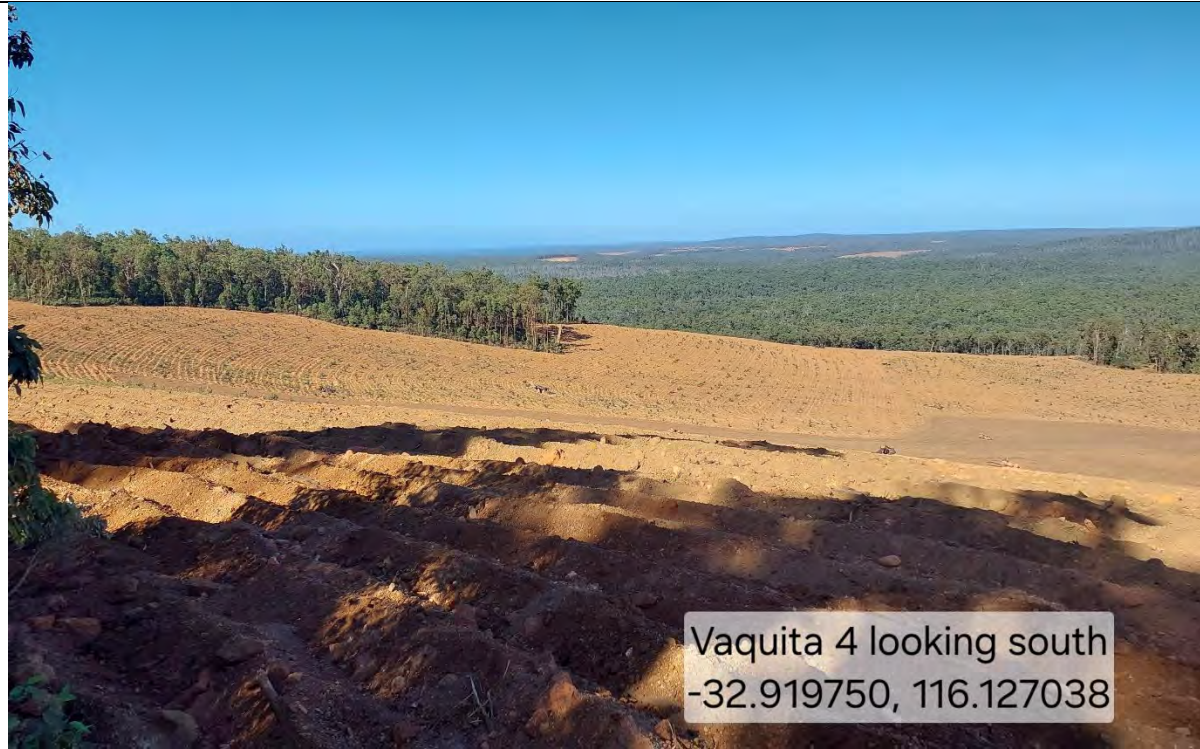
Vaquita 4 looking south
-32.919750, 116.127038

4(d)	Vaquita 4 (H5409) <ul style="list-style-type: none"> Check drainage capacity for the pit, with majority of the pit <50% 	None Identified	<p>Pit has been rehabilitated. Drainage at bottom end of pit is captured by basin.</p>

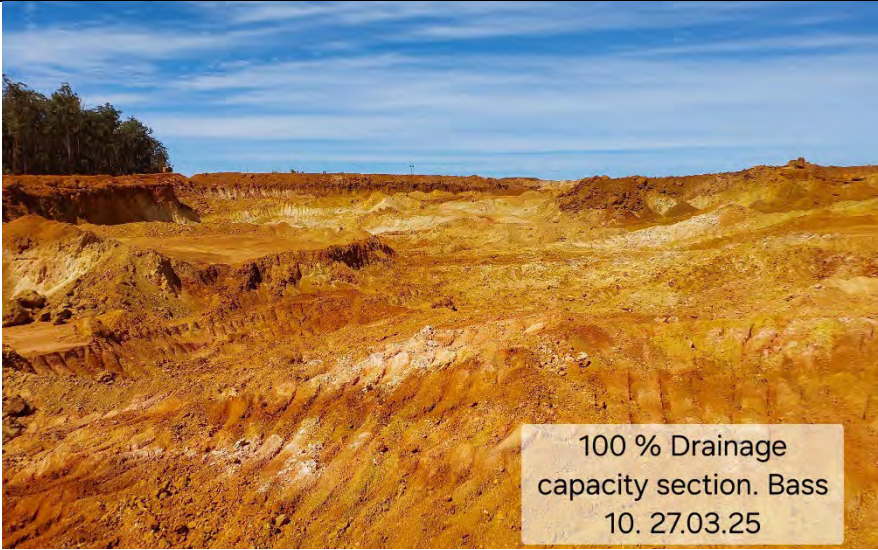
<p>General view of Bass 10 50% drainage capacity risk area. 27.03.25</p>

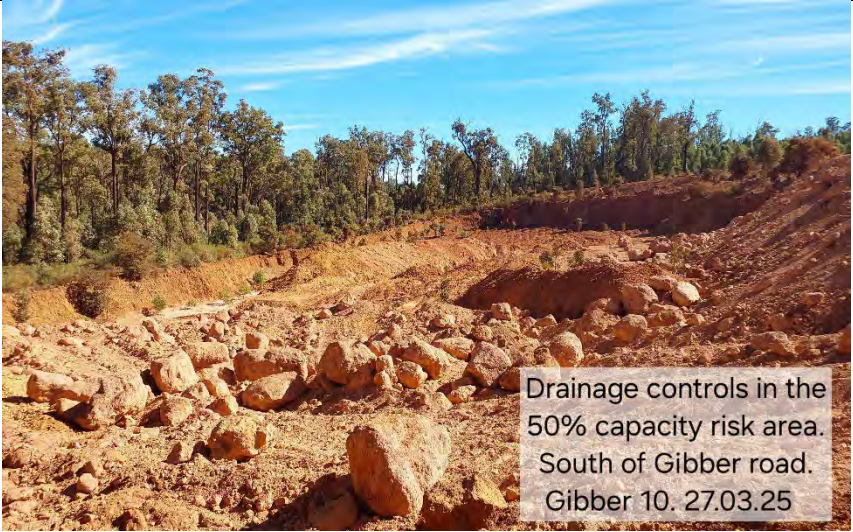
<p>Drainage controls in the 50% capacity risk area. South of Gibber road. Gibber 10. 27.03.25</p>

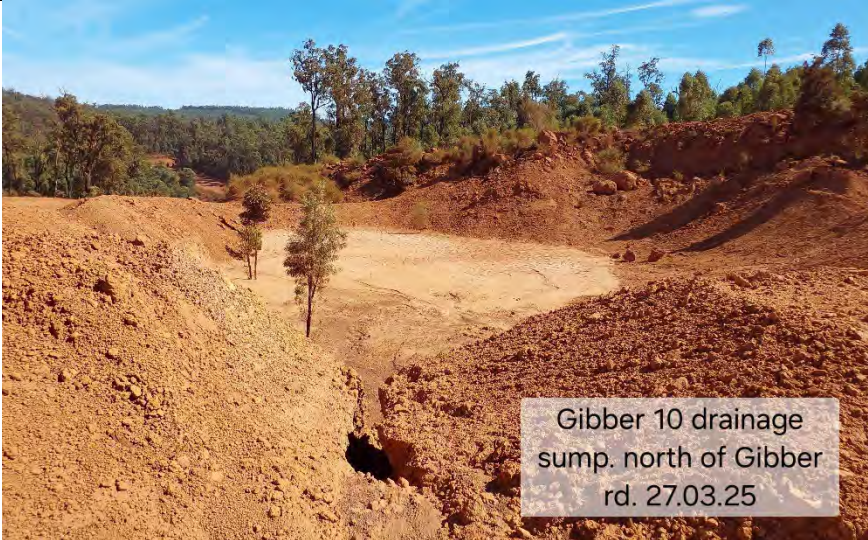
<p>Gibber 10 drainage sump. north of Gibber rd. 27.03.25</p>

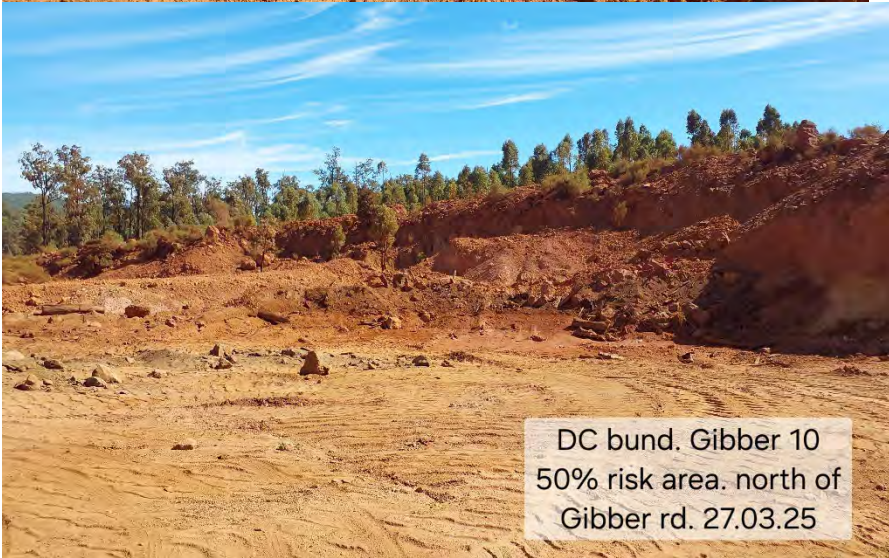
<p>DC bund. Gibber 10 50% risk area. north of Gibber rd. 27.03.25</p>

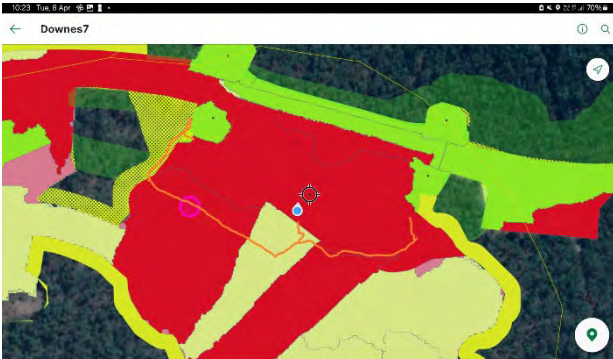
Condition number(s)	Task and Purpose	PNC Issues	Notes	Photo taken
5	Downes 7 (H4220, H4224) <ul style="list-style-type: none"> Check drainage controls within areas of <25% drainage capacity on the norther part of the pit (southern part has been rehabbed) The pit is within the 1km top water level of the serpentine dam. Mapped BC tree (1337) in the pit has been previously cleared 	None Identified	<p>Most of the DC <25% area has been rehabilitated. Drainage control measures are in place from the haul road (Downes).</p>

<p>Rehabilitated area is followed flat area, bunds, slight stripping and more bunds before reaching the haul road.</p>

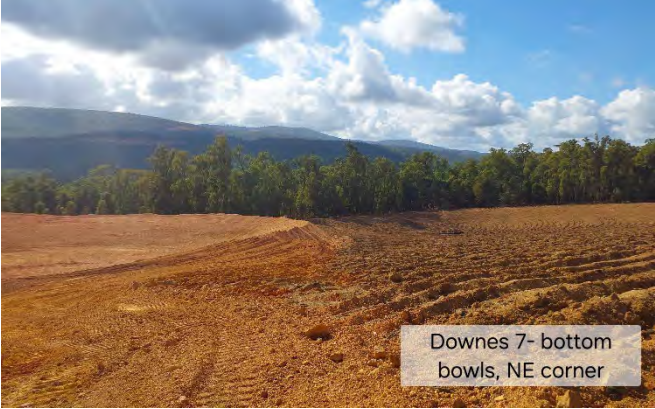
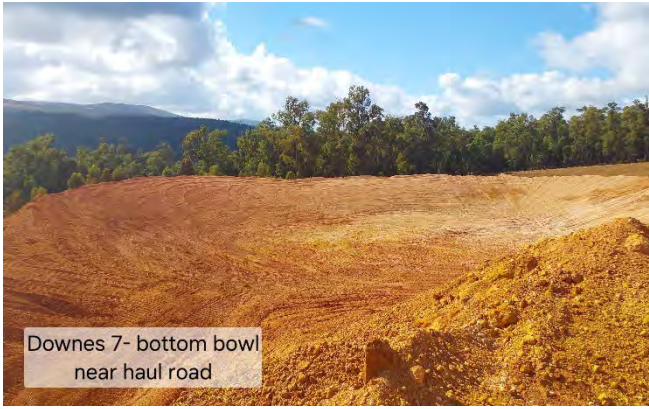
Condition number(s)	Task and Purpose	PNC Issues	Notes	Photo taken
			<p>Northeastern corner has double bottom bowls; one large near the haul road, and smaller one in the rehabilitated area.</p>

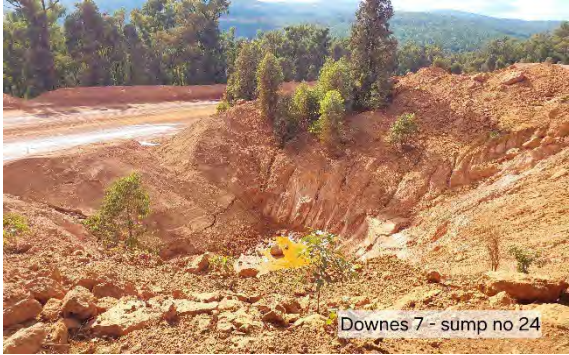
Condition number(s)	Task and Purpose	PNC Issues	Notes	Photo taken
			<p>Check sump no 24 inspected. Sump has some erosion on the walls, but full capacity remaining.</p>

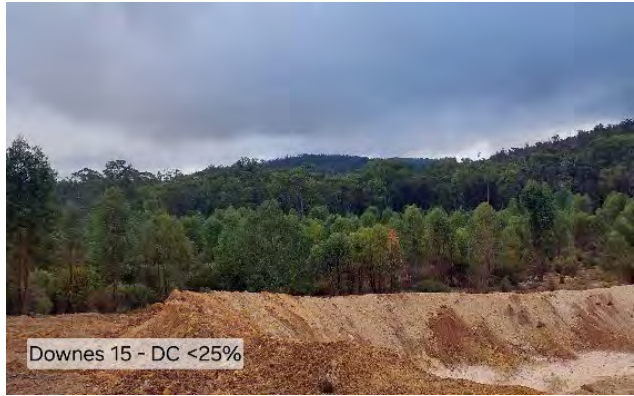
<p>Downes 15 - DC <25%</p>

<p>Downes 7 - sump no 24</p>	
5	<p>Downes 15 (K4221)</p> <ul style="list-style-type: none"> Check drainage controls within areas of <25% drainage capacity on the norther part of the pit. Check BC tree 2869 has not been disturbed. (BC trees 4647 and 5713 have already been checked). 	None Identified	<p><25% Drainage Capacity area has been rehabilitated.</p>

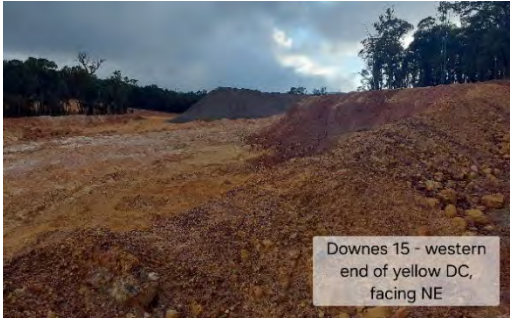
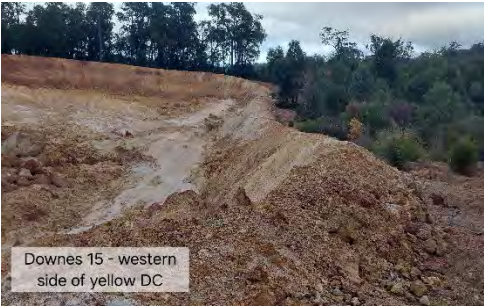
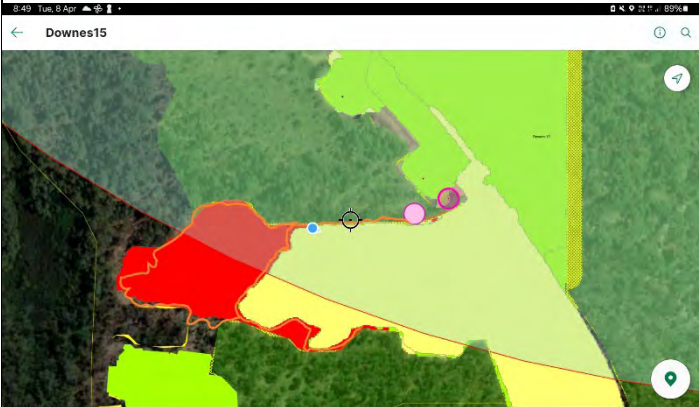
Condition number(s)	Task and Purpose	PNC Issues	Notes	Photo taken
			<p>Downes 15- western end of DC <25%</p> <p>Small DC <25% area south of yellow Drainage Control is flat area between pit and forest boundary.</p> <p>Downes 15- small <25% DC, S of yellow DC</p>

Condition number(s)	Task and Purpose	PNC Issues	Notes	Photo taken
			<p>Opportunistically, yellow DC area inspected. Pit boundary walked; pit has high and sharp pit walls. No drainage risks noted. Stockpile next to the haul road.</p>

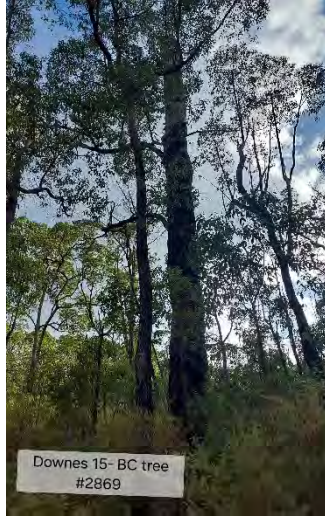
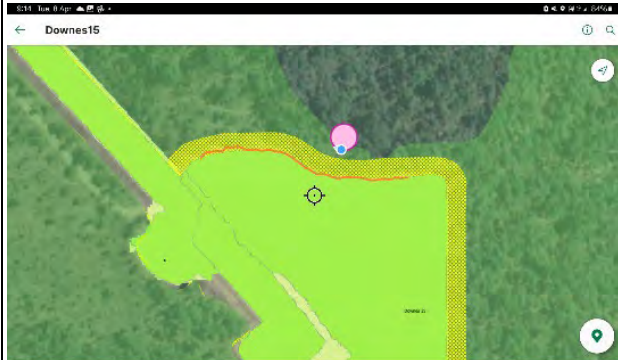
Condition number(s)	Task and Purpose	PNC Issues	Notes	Photo taken
			<p>Pit boundary near supposedly Black Cockatoo tree #2869 walked and tracked. Tree remains undisturbed.</p>

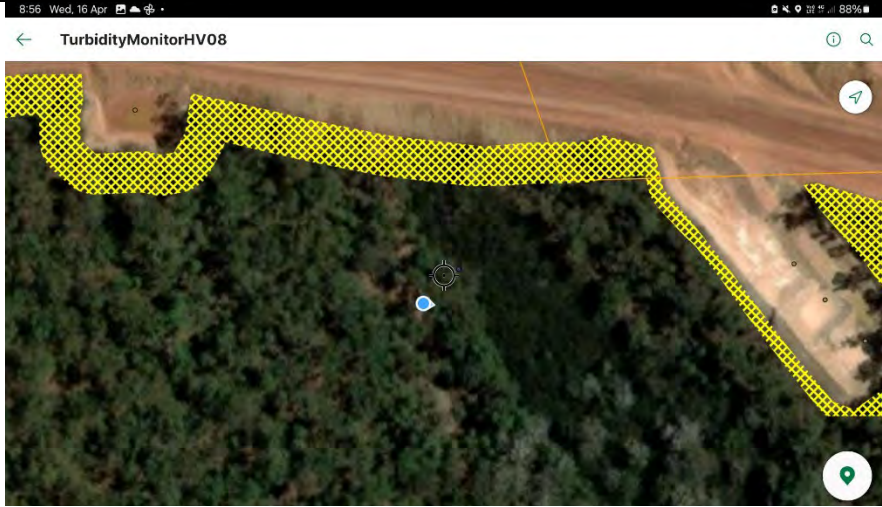
4(d)	Turbidity Monitor HV08 (G5509) <ul style="list-style-type: none"> Check that turbidity monitors are in place and no observed disturbance or sediment/ debris has built up around the sensor. <i>Travel north on LV bypass road, turn right and follow track to bottom. Turn left</i>		<p>Clear water flowing through the stream, no observed sediment in the water.</p> <p>Could not access NTU readings, box is locked.</p>

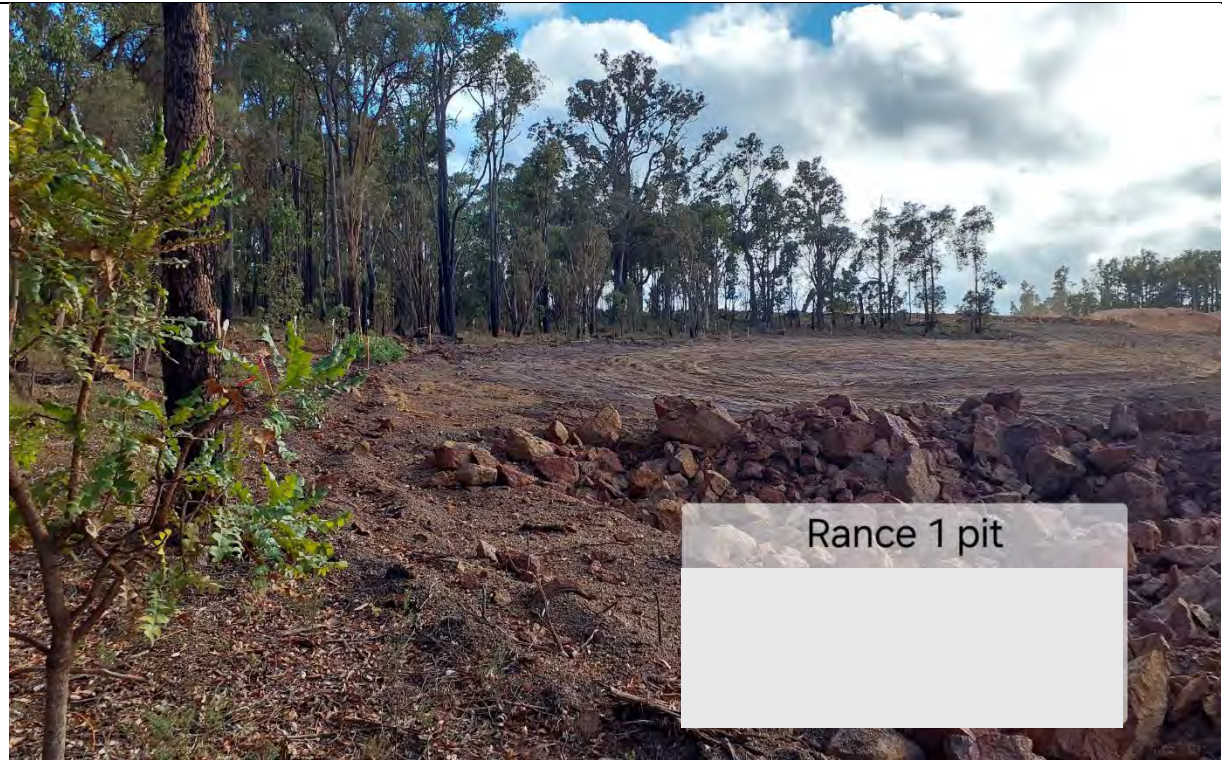
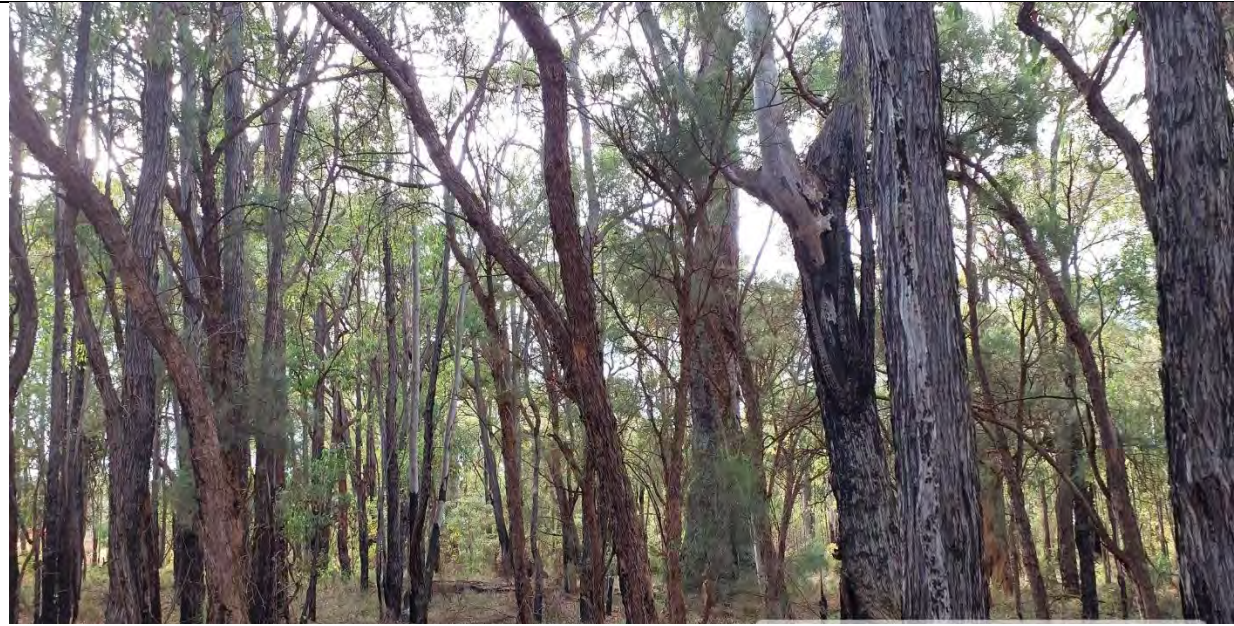
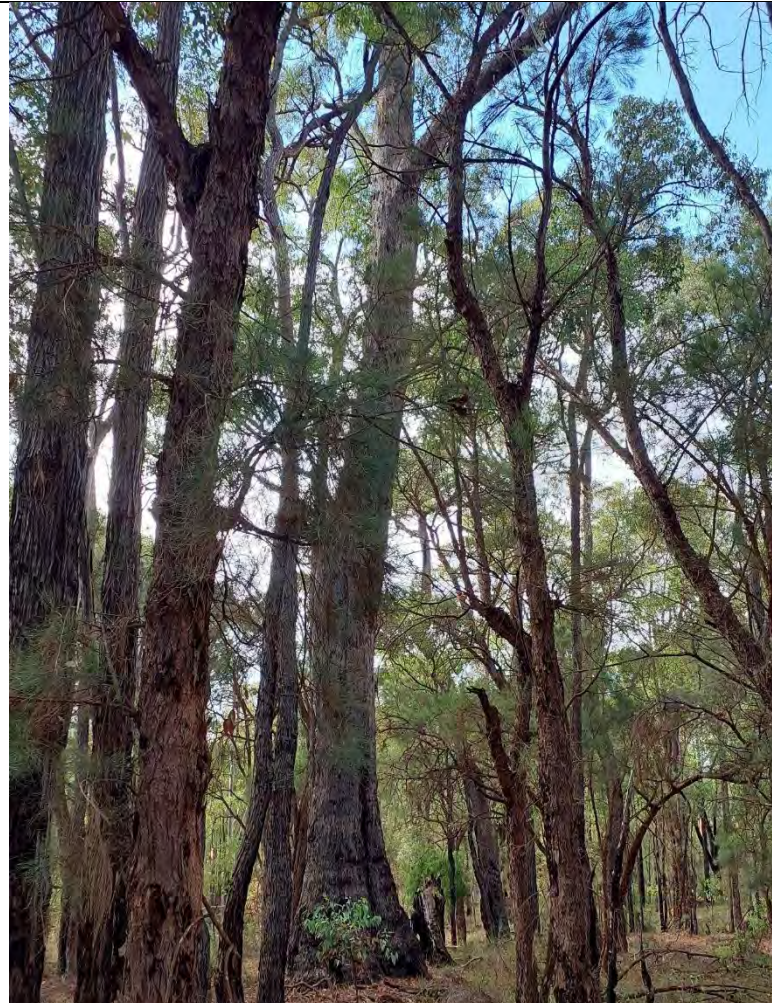
Condition number(s)	Task and Purpose	PNC Issues	Notes	Photo taken
5	Rance 1 (J4120, J4124, K4117, K4121) <ul style="list-style-type: none"> Recent stripping has occurred in the pit, check that it is within the FCA and NV areas Opportunistically check Significant/ Black cockatoo tree 5520 (Jarrah) has not been disturbed. 	<i>None identified</i>	<p>Recent snipping and scraping has occurred within the native vegetation disturbance boundary.</p> <p>Watershots installed at bottom end of developed area for drainage control.</p> <p>Black Cockatoo tree 5520 is undisturbed.</p>

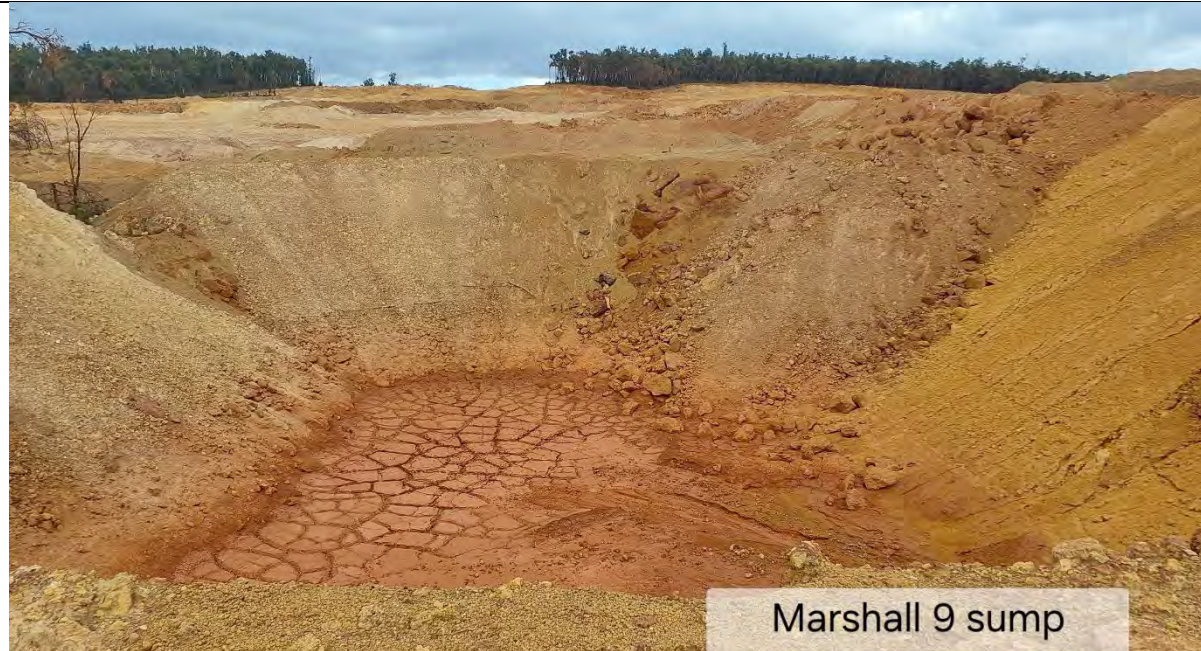
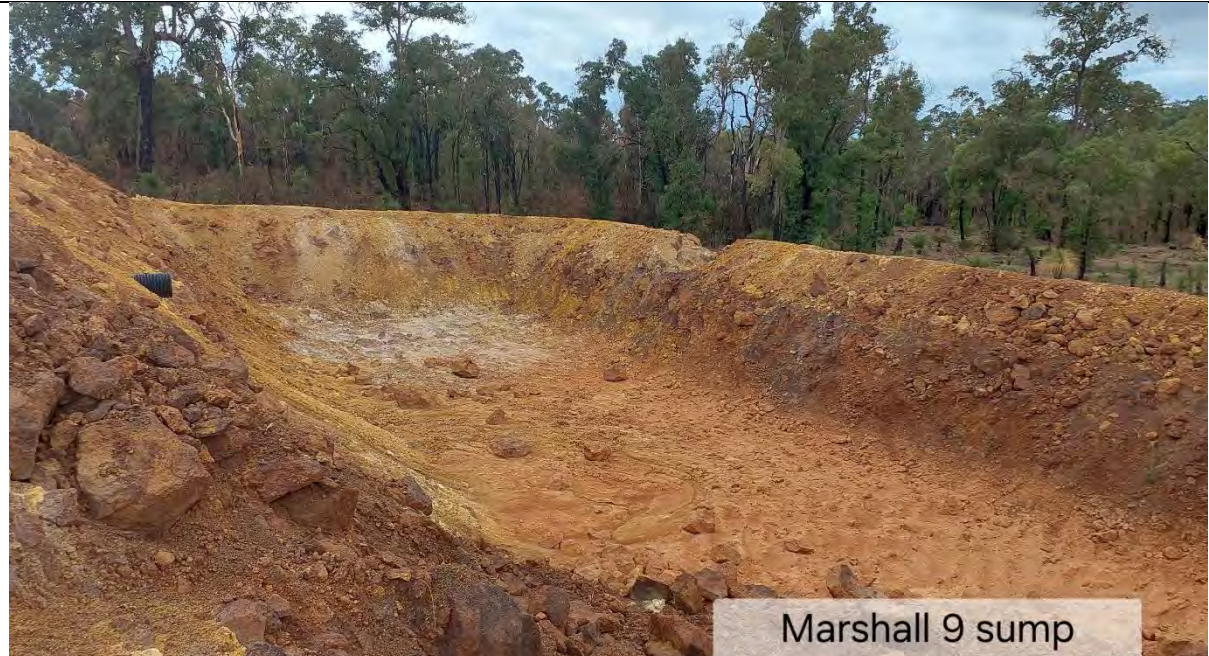
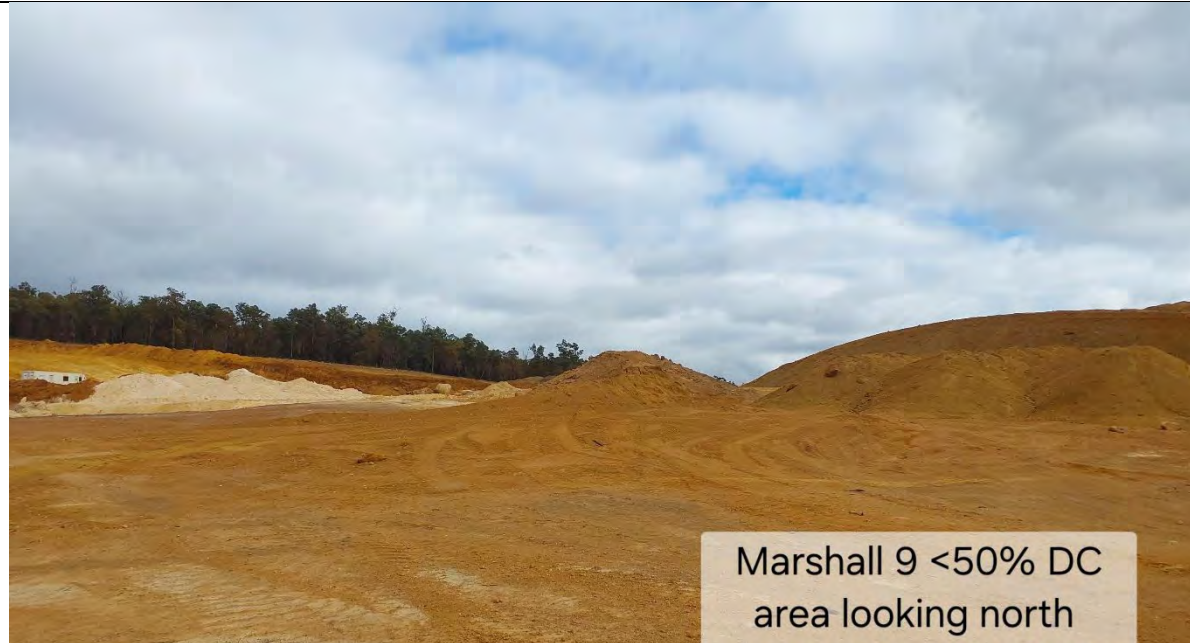
Marshall 9 sump

Condition number(s)	Task and Purpose	PNC Issues	Notes	Photo taken
5	Marshall 9 (G4117) <ul style="list-style-type: none"> Recent drainage works have occurred in the pit, check the condition and capacity of the sumps within the pit. Check areas of 50% drainage capacity for controls preventing runoff into eh surrounding forest. Pit is beside the Serpentine Pipehead catchment area. 	<i>None identified</i>	<p>Sumps in good condition with full capacity.</p> <p><50% DC area north of Marshall 9 road is used as stockpile. Lower end of pit drains towards haul road.</p> <p><50% DC area south of Marshall 9 road is used as stockpile with some mining activity. Lower end of pit drains towards Sump.</p> <p>No drainage issues</p>
