Document type
Compliance Assessment Report (CAR)

Alcoa of Australia Limited – WA Operations

2024 – 2028 Mining and Management Program - Compliance Assessment Report 2025

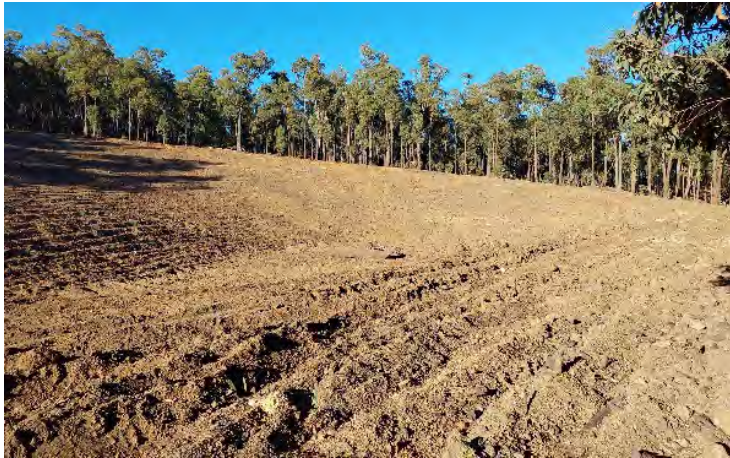
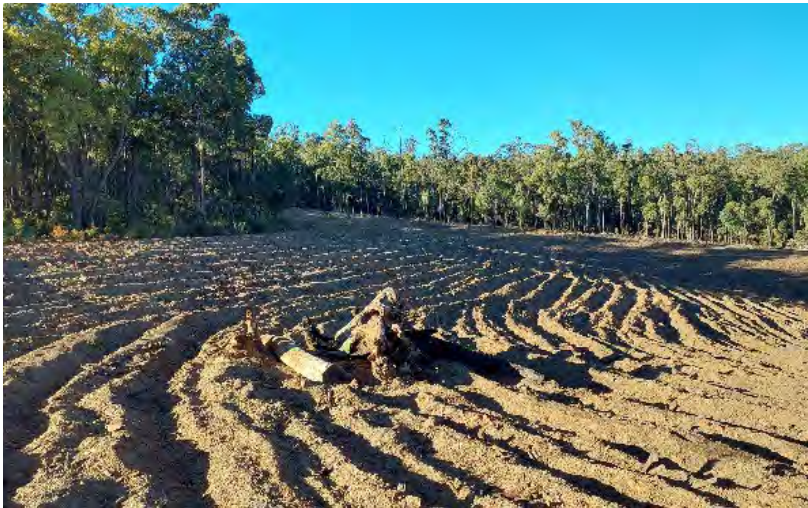
Condition number(s)	Task and Purpose	PNC Issues	Notes	Photo taken
4(d)	Blacklock 11 (J4226) <ul style="list-style-type: none"> Check drainage controls in area mapped as 50% drainage capacity area Area is within top 1km of the Serpentine water level 	None Identified	<p>Pit has been ripped in preparation for rehab.</p> <p>On the low side of the pit was no observed runoff into the forest areas beside the pit.</p> <p>No drainage issues.</p>

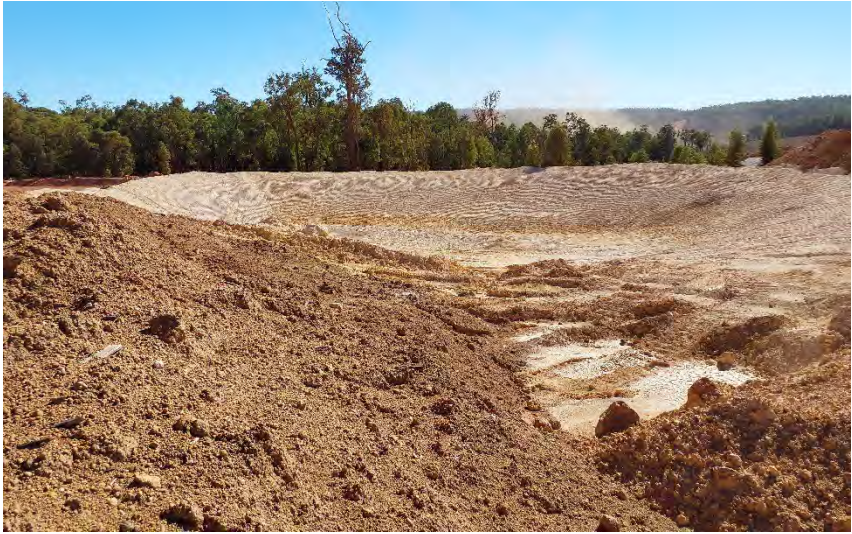
Condition number(s)	Task and Purpose	PNC Issues	Notes	Photo taken
4(d)	Ingpen 4 (G4205) <ul style="list-style-type: none"> Check drainage controls in area mapped as 25% drainage capacity. Check the condition and capacity of the sumps within the pit\ 	None Identified	<p>Sumps and trenches present in the pit to divert and contain runoff within the pit.</p> <p>Stockpiles in the pit are within bunds or above sumps to contain any runoff from them.</p>

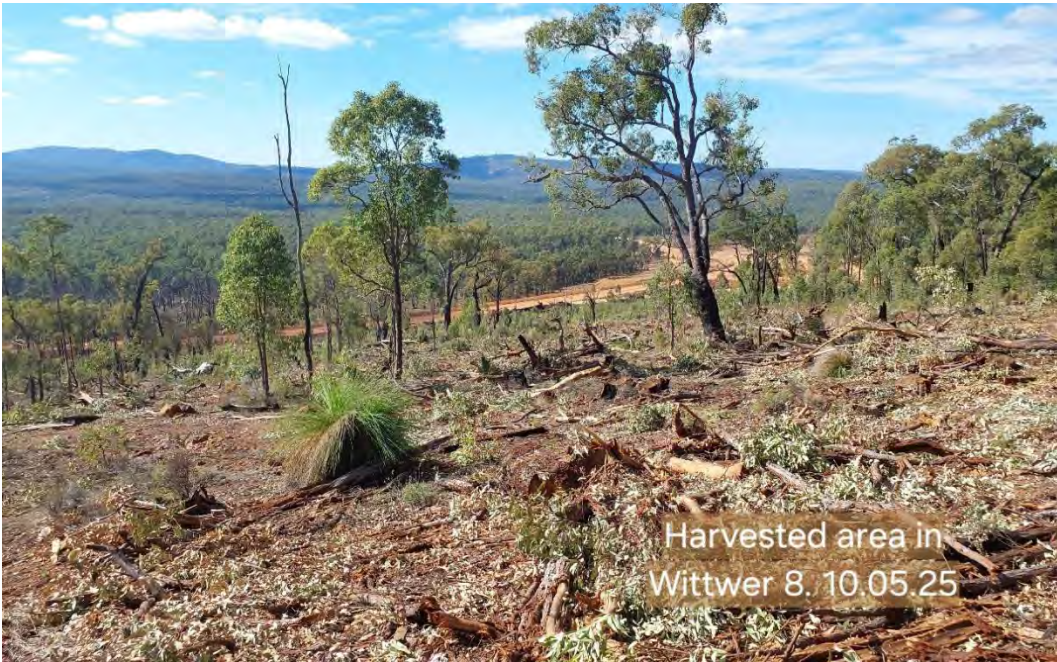
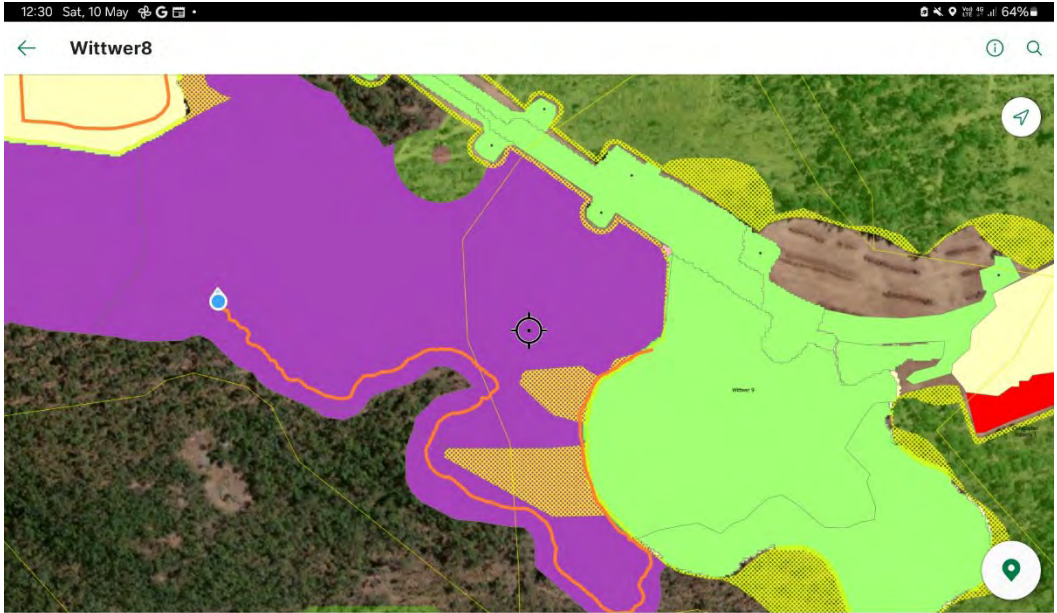
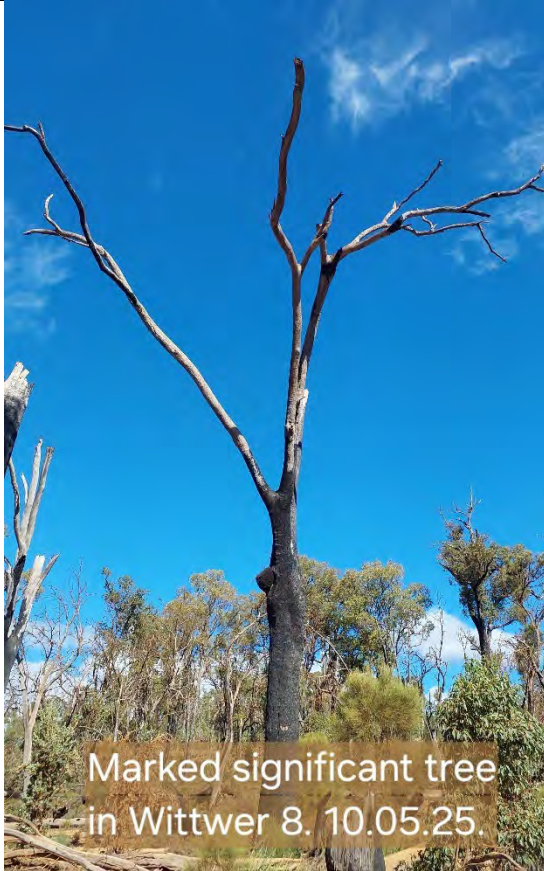
Condition number(s)	Task and Purpose	PNC Issues	Notes	Photo taken
5	Wittwer 8 (L4213, K4216) <ul style="list-style-type: none"> Recent clearing and harvesting has occurred in the pit, check that all disturbance works are within the NV disturbance boundary Check that mining activities have not disturbed within the buffer zone for significant tree ID 953. 	None identified	<p>Harvested area boundary checked by walking. Checked area disturbance boundary stayed within the approved native vegetation disturbance boundary.</p> <p>No disturbance around the significant tree checked. The tree is already burned.</p>

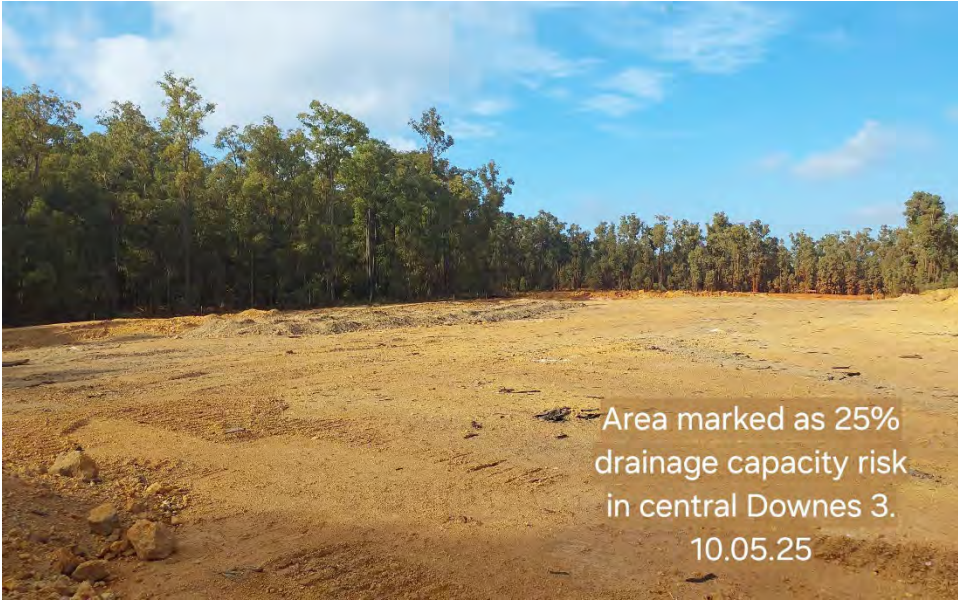
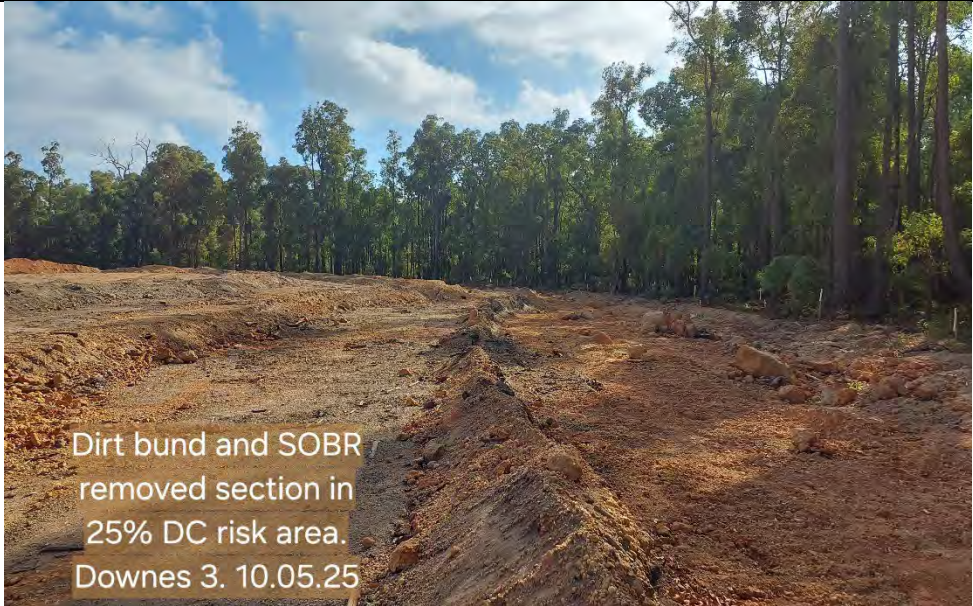
Condition number(s)	Task and Purpose	PNC Issues	Notes	Photo taken
4(d)	<p>Downes 3 (H4217, H42118, H4222)</p> <ul style="list-style-type: none"> • Check drainage controls within the pit, most of the pit is mapped as less than 25% drainage capacity. • Check the condition and capacity of the sumps within the pit. 	None identified	<p>The area with 25% drainage capacity risk in the central part of the pit has smooth surface with a bund to contain runoff to the pit</p> <p>The eastern boundary edge next to the forest has been prepared for mining stage and adequate drainage control.</p>

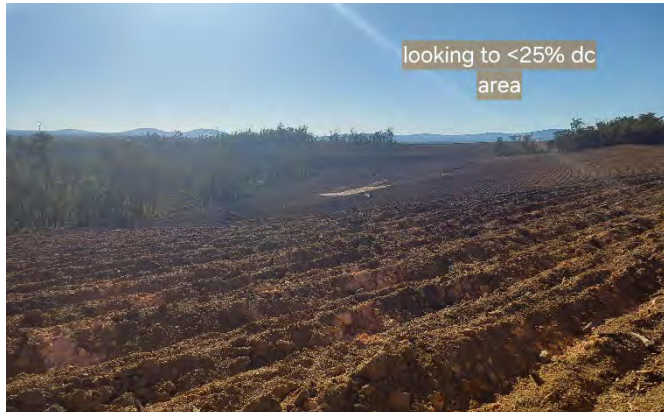
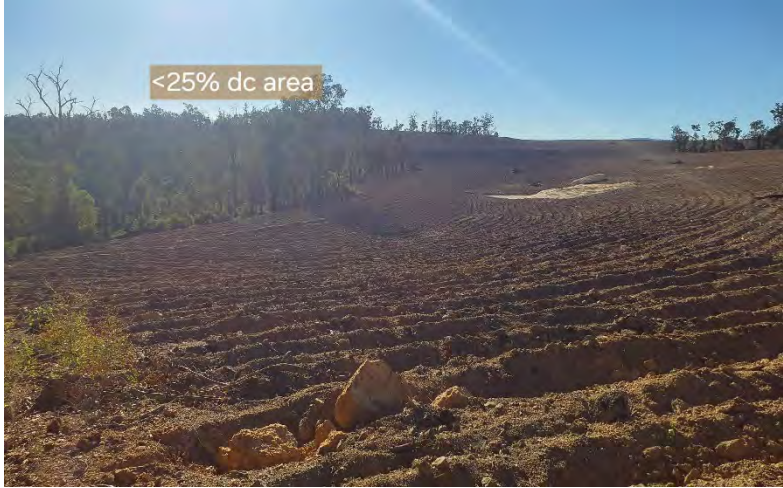
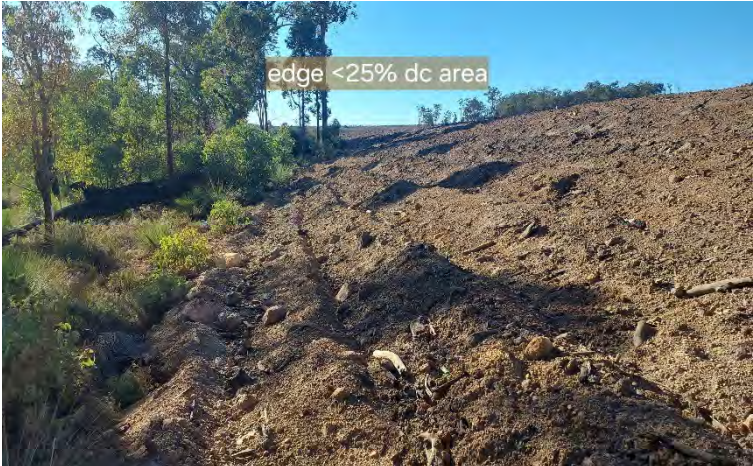
Condition number(s)	Task and Purpose	PNC Issues	Notes	Photo taken
4(d), 5	Rance 8 (J4114) <ul style="list-style-type: none"> Check drainage controls along the northern edge of the pit between Rance 6 (bit of overlap). Check that suitable drainage controls area in place to prevent runoff entering the forest. Pit is on the edge of the top water level 1km buffer for the Serpentine dam. 	None Identified	<p>Drainage controls checked at low end of pit. New rehab in place and contour bowl in place at low edge. Low runoff risk from the pit.</p> <p>No runoff out of pit Sighted but rehab is quite new.</p>

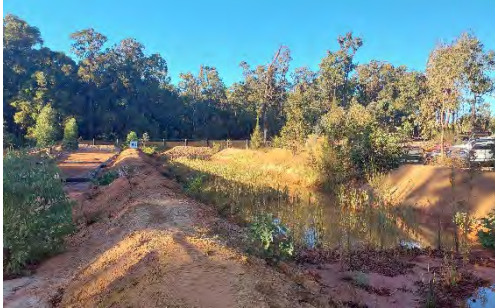
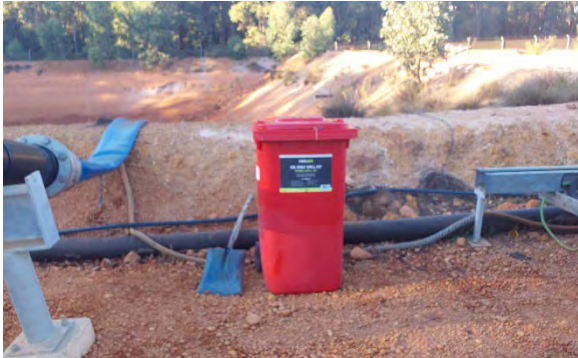
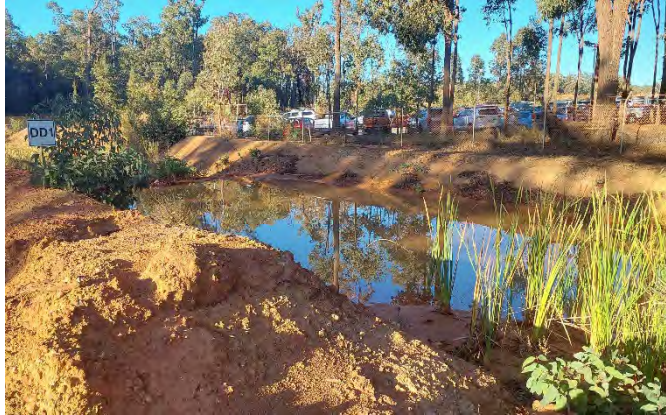
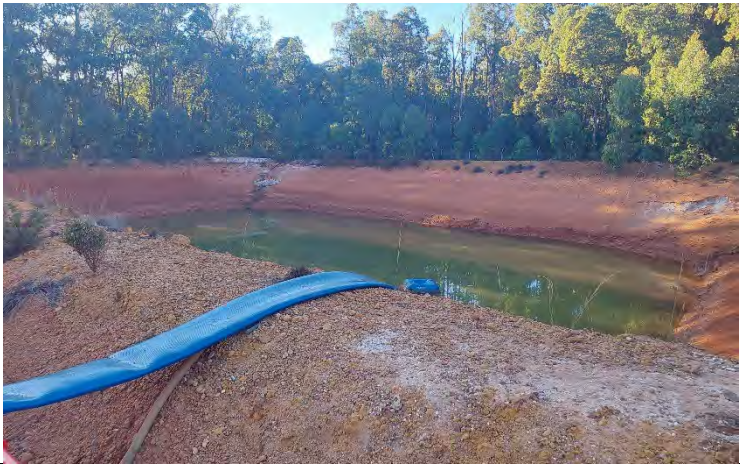
Condition number(s)	Task and Purpose	PNC Issues	Notes	Photo taken
4(d)	Dimasi Sump (G4228) <ul style="list-style-type: none"> Check the sump capacity and condition of the sump inlets and overflows. Ensure the banks are stable and not collapsing into the sump, with further rainfall expected in the next few weeks/ months. 	None Identified	<p>Sumps at <10% capacity. Walls fine. Oil spill kit in place</p>

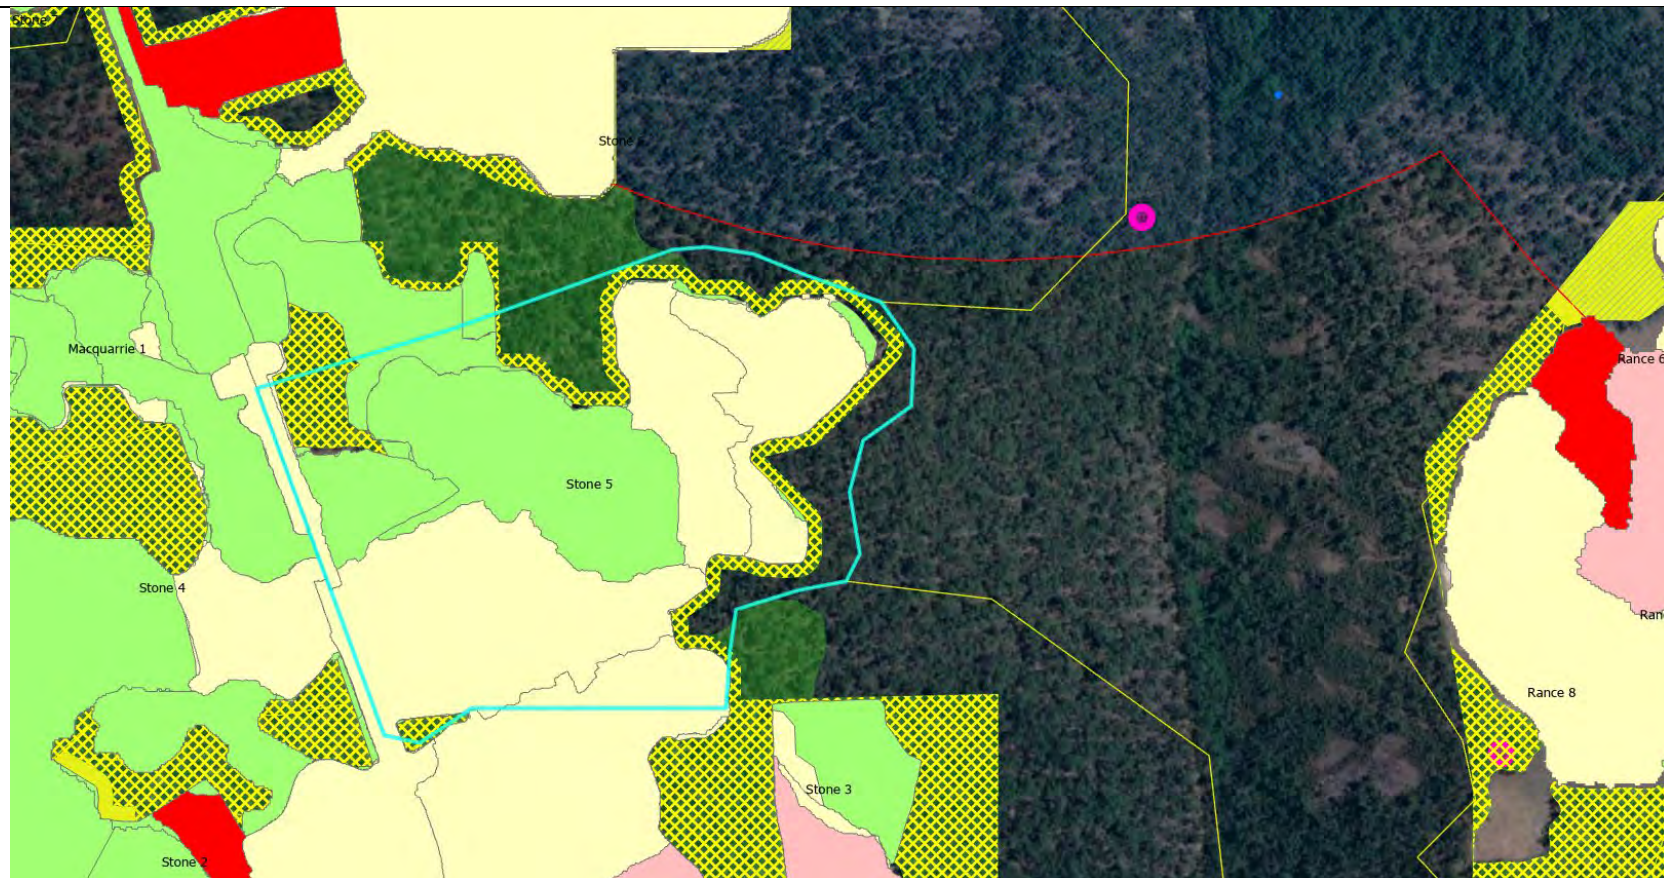
5	Stone 5 (J4113, H4116) <ul style="list-style-type: none"> Check drainage control at pit boundary. Pit is on the edge of the top water level 1km buffer for the Serpentine dam 	None identified	Low end of pit drainage control checked. Presence of 2 trench system followed by basin towards low end of pit. Walls at least 1 m high.

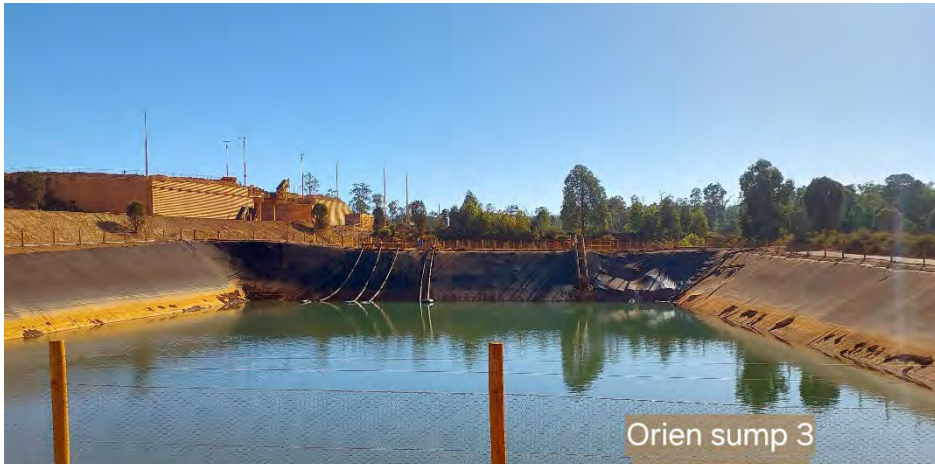
Condition number(s)	Task and Purpose	PNC Issues	Notes	Photo taken
4(b)	<p>Inspect Orion Wastewater treatment facilities and storage sumps (F5214)</p> <ul style="list-style-type: none"> Orion Sump 3 must be maintained and operated with a minimum freeboard of 50% of the sump capacity Orion Sump 3 HDPE liner must be maintained to prevent water loss via infiltration; and Orion Sumps 1 and 2 must be maintained and operated with a minimum freeboard of 30% of each sump capacity. 	None identified	Sumps are all in good condition with capacity

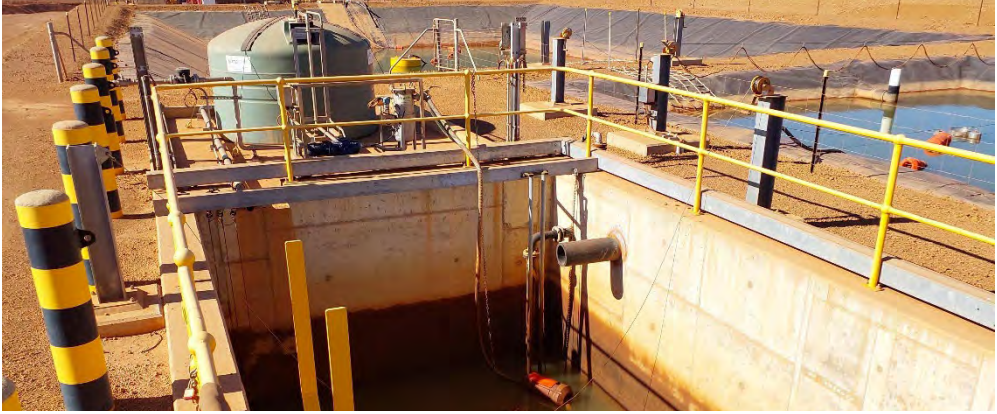
<p>Larego DAF -32.968815, 116.077634</p>
--	--	--	--	---

4(b)	<p>Inspect Larego oily water pond and DAF holding sump/s (F5520)</p> <ul style="list-style-type: none"> A DAF treatment facility and, associated pre and post treatment sumps and drying beds will be installed. Collected wastewater from the Larego Site will be treated to the currently authorised water quality parameters as in L6465/1989/10 Oily wastewater will be captured in separate sumps, which contain a sediment trap and a hydrocarbon trap. These sumps will also have the capability for mounting a belt skimmer allowing removal of free surface hydrocarbons 	None identified	DAF is in good condition. Oil water separator has capacity. DAF ponds have capacity.

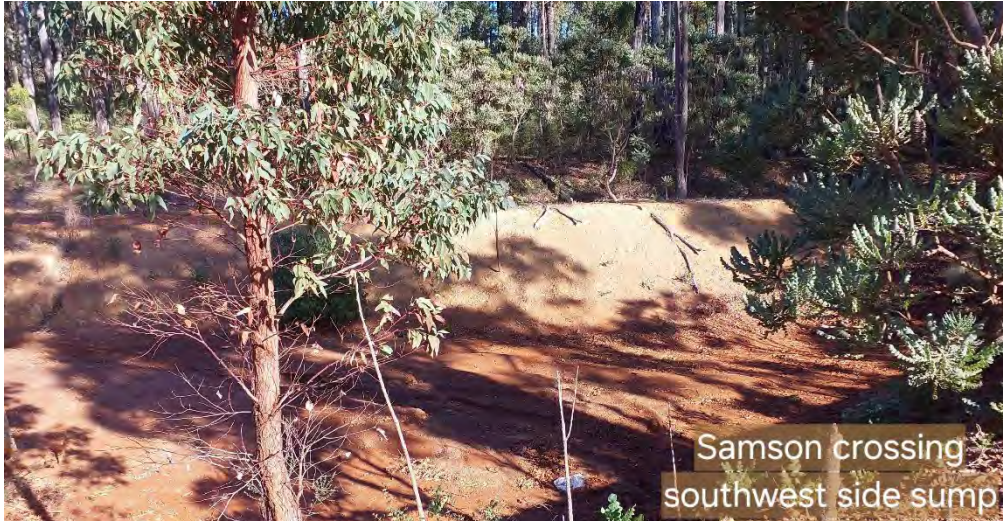
4(b)	<p>Inspect Samson Dam crossing area (E5323, E5320)</p> <ul style="list-style-type: none"> Check condition and capacity of the sumps containing runoff from the haul road leading to the Samson dam crossing. 	None identified	<p>Sumps at each end of Samson crossing have capacity. Northeast sump has some standing water.</p>

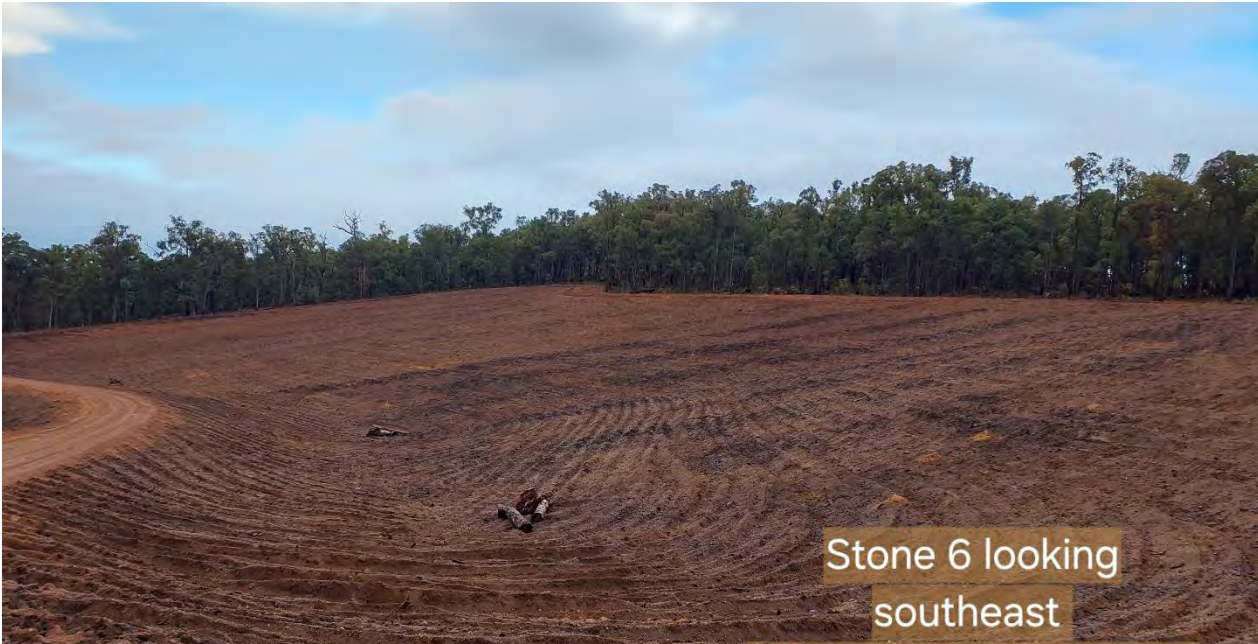
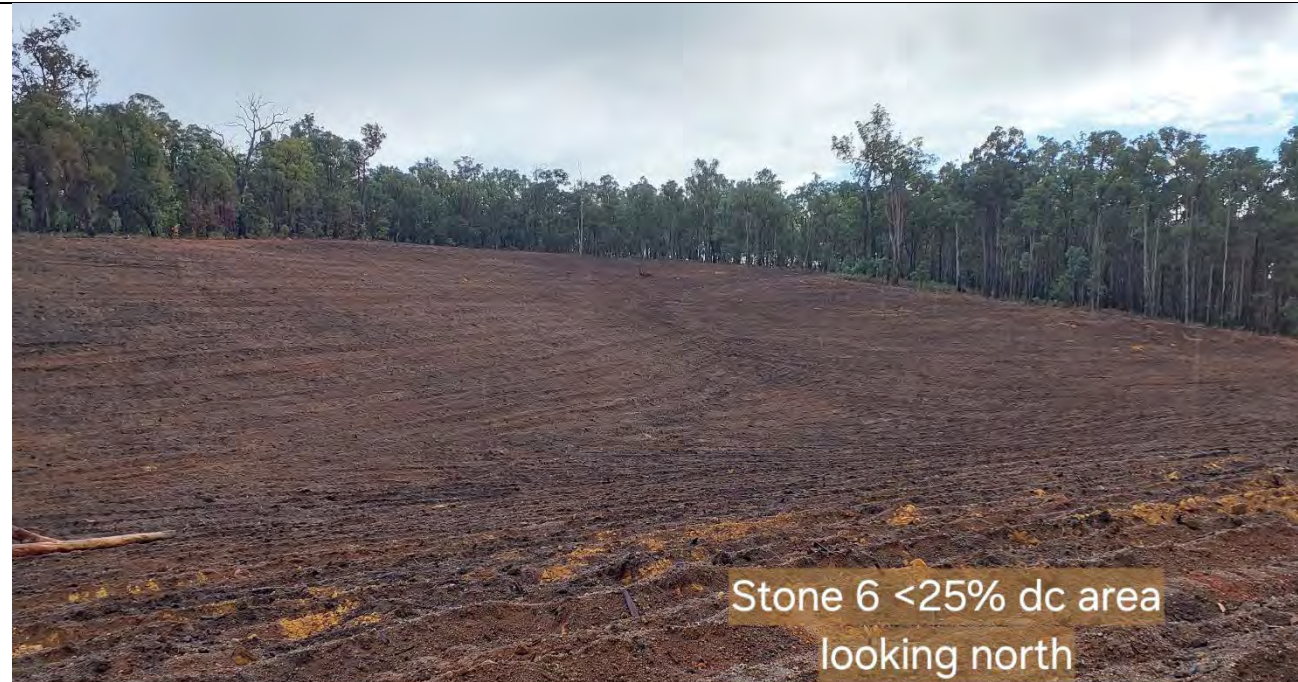
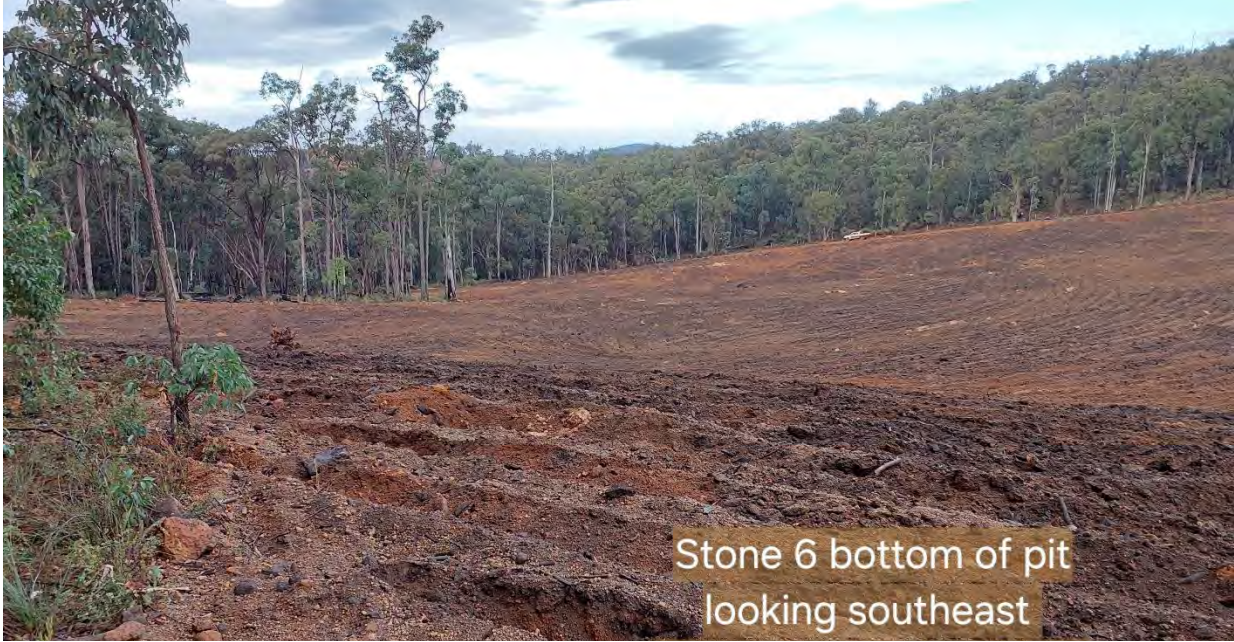
Condition number(s)	Task and Purpose	PNC Issues	Notes	Photo taken
4(d), 5	Stone 6 (H4108, J4105, H4112, J4109) <ul style="list-style-type: none"> Check the drainage controls within the pit, most of the pit is mapped as less than 50% drainage capacity Over half the pit is within the RPZ. 	None identified	<p>Pit has been landscaped and ripped.</p> <p>Bottom end of pit has been contoured and has basins to contain runoff.</p>

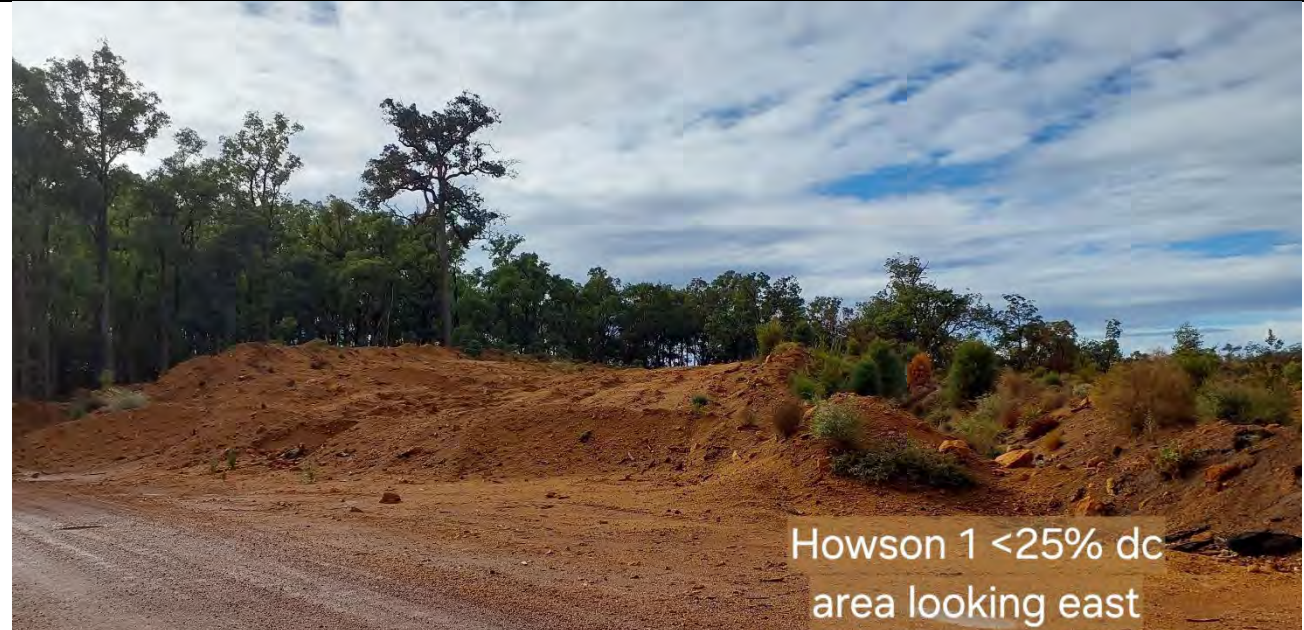
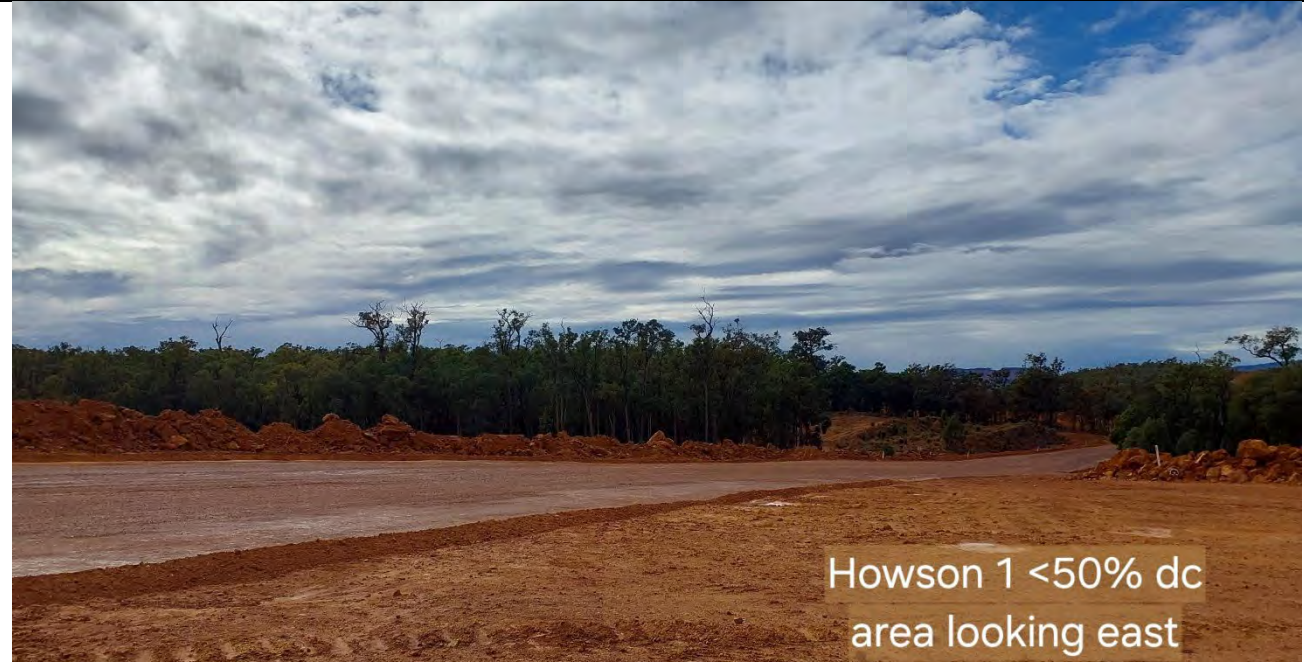
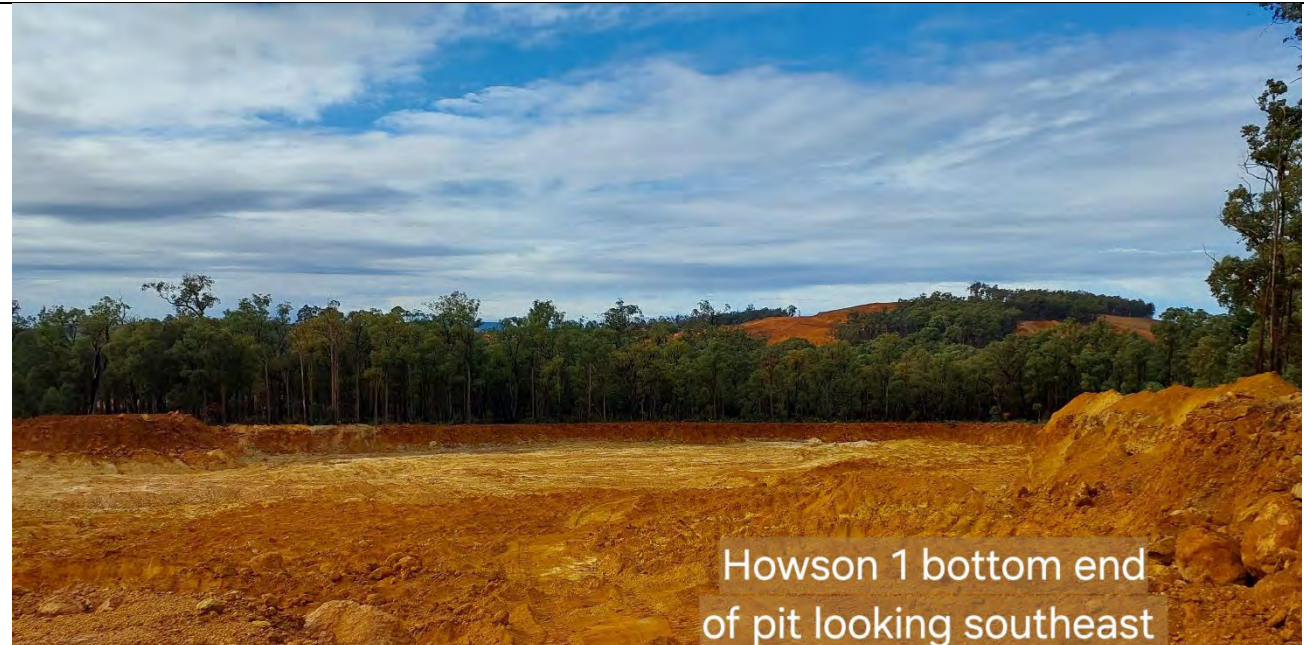
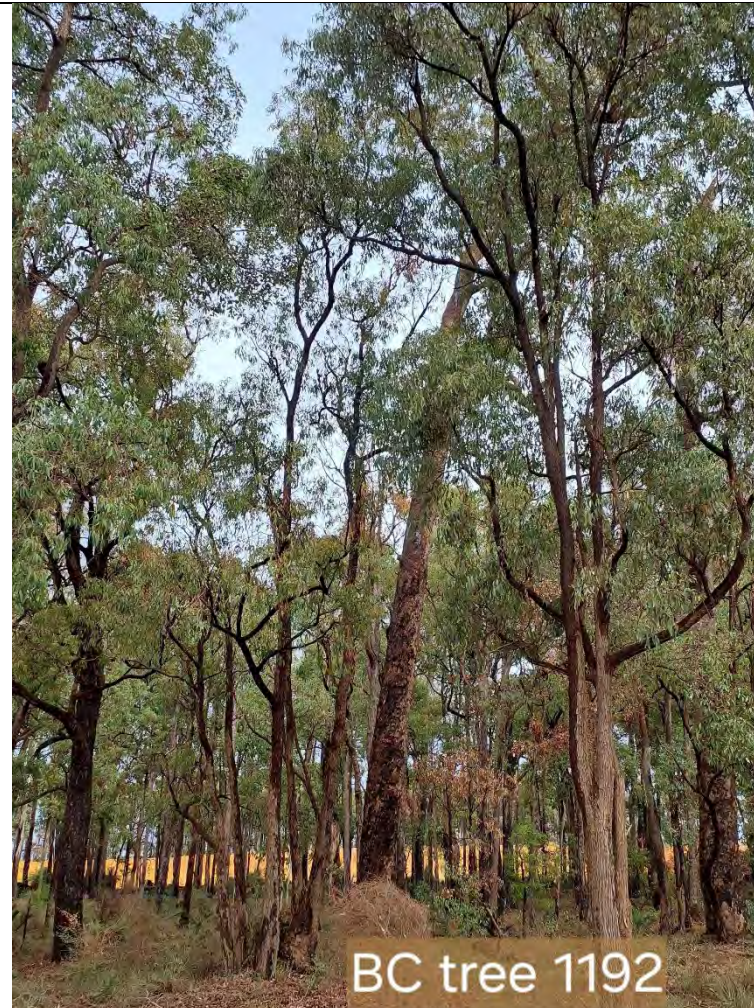
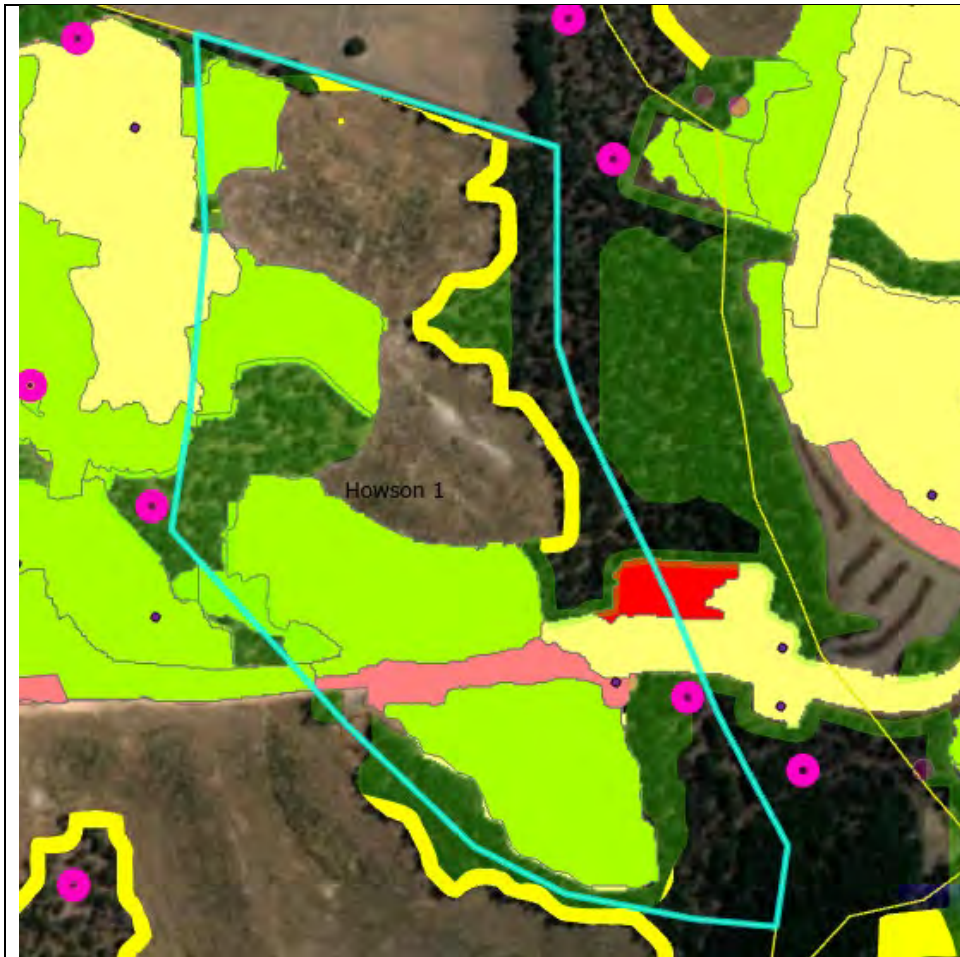
Howson 1- DC, BC tree 1192

Condition number(s)	Task and Purpose	PNC Issues	Notes	Photo taken
4(d), 5	Howson 1 (F4204) <ul style="list-style-type: none"> Check drainage controls within the pit, in areas where the area is mapped as less than 25 and 50% drainage capacity in the southern part of the pit Check Black Cockatoo tree 1192 (marri) has not been disturbed 	<i>None identified</i>	<p>Northern end of pit has been rehabbed.</p> <p>Southern end of pit has been mined. Drainage controls in place at bottom end of pit.</p> <p>Black Cockatoo tree 1192 is undisturbed.</p>

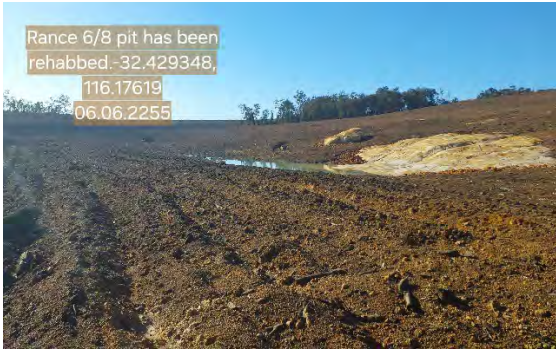
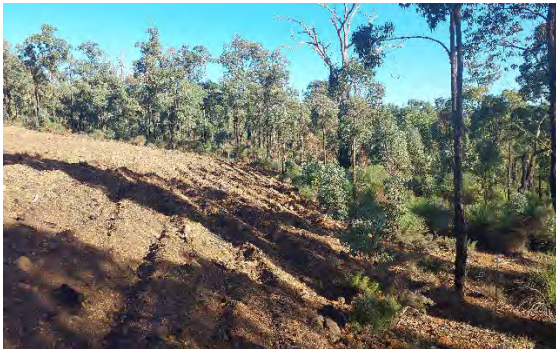
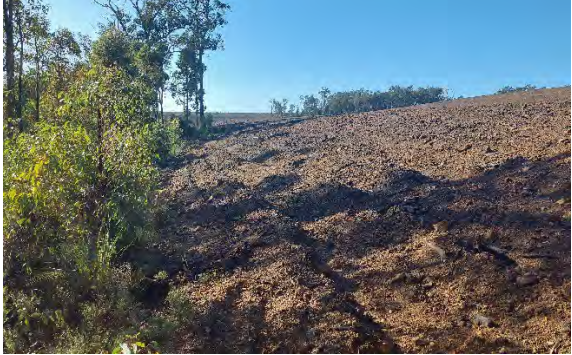
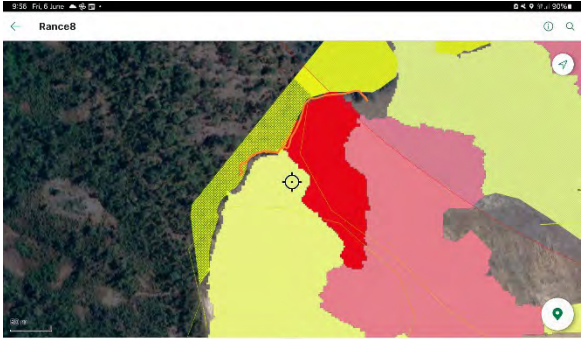
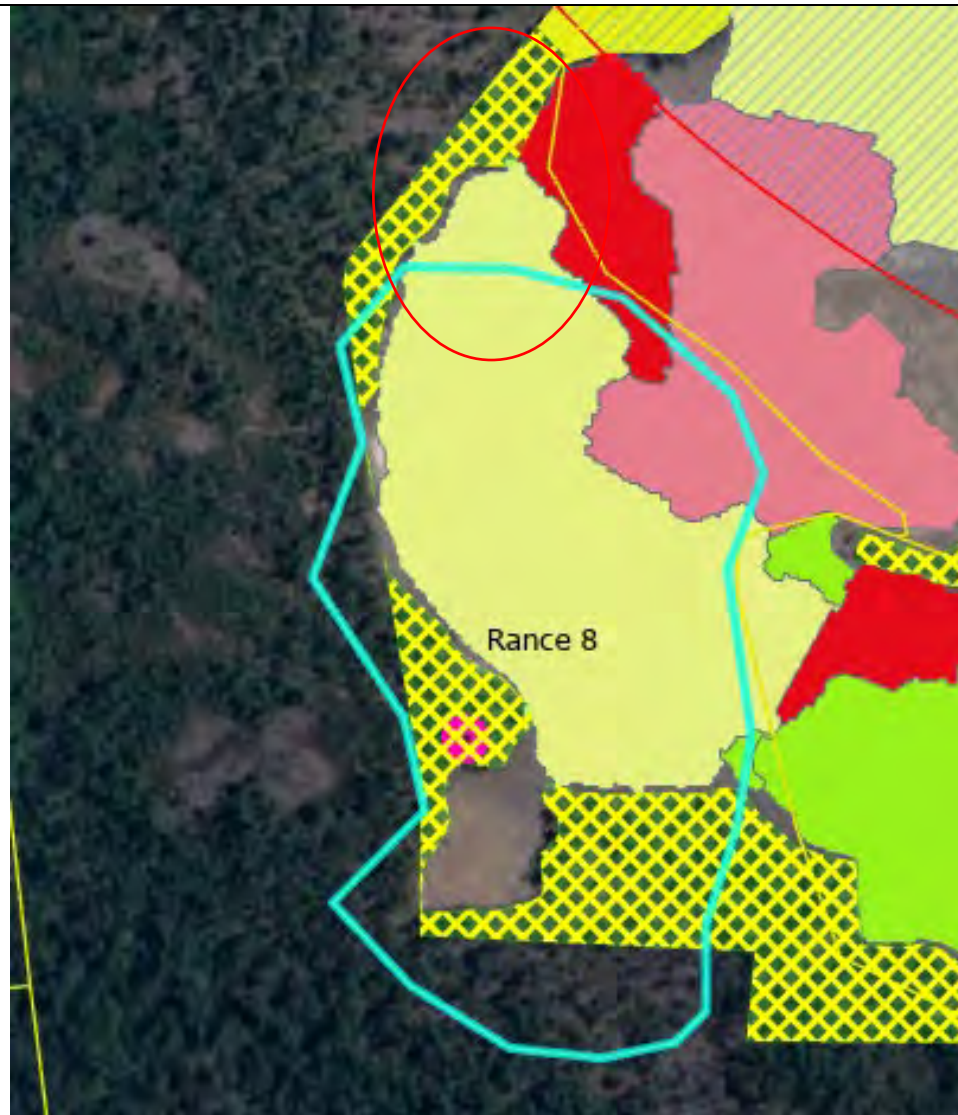
Rance 8 – DC

Condition number(s)	Task and Purpose	PNC Issues	Notes	Photo taken
5	Rance 8 (J4114) <ul style="list-style-type: none"> Check the drainage controls within the pit, most of the pit is mapped as less than 50% drainage capacity. Last visit on 16/05/2025, identified that a steep area in the pit would benefit from an inspection following rainfall. Check area mapped as 25% drainage capacity for suitable drainage controls. 	None Identified	<p>There is no observed sediment runoff from the pit following the recent rainfall.</p> <p>Bowl in the pit is containing runoff from the pit.</p> <p>Inspected lower side of the 25% drainage capacity area, no drainage issues noted.</p>

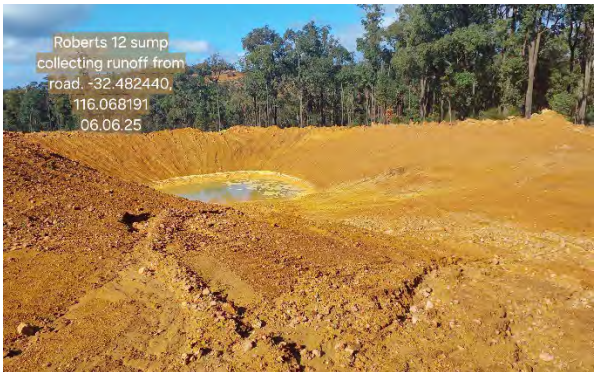
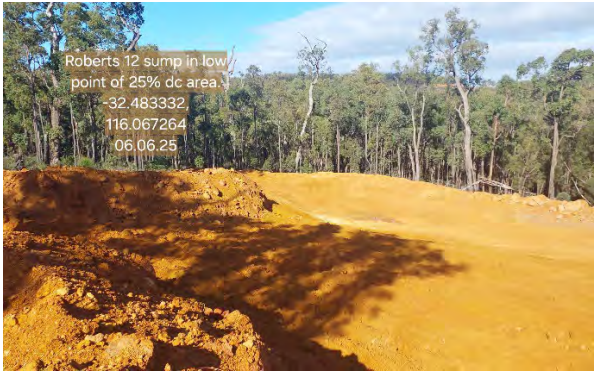
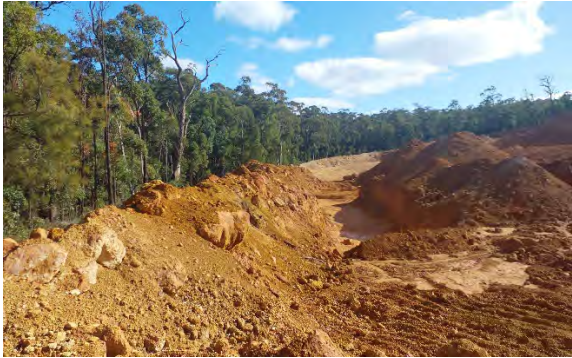
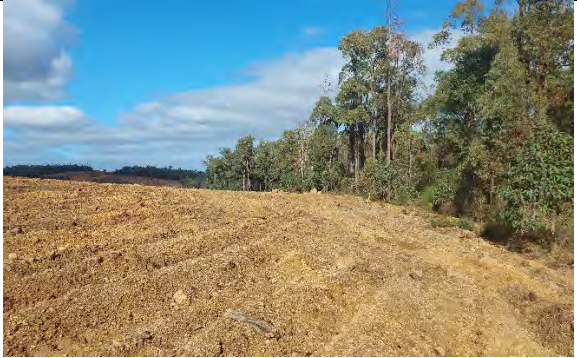
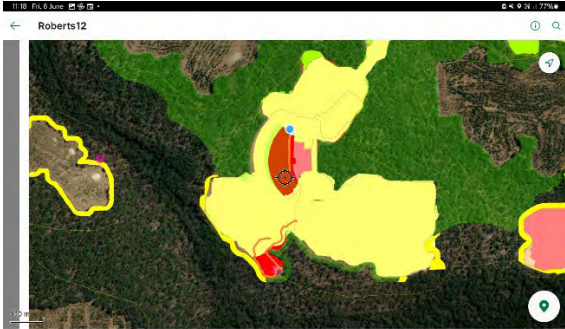
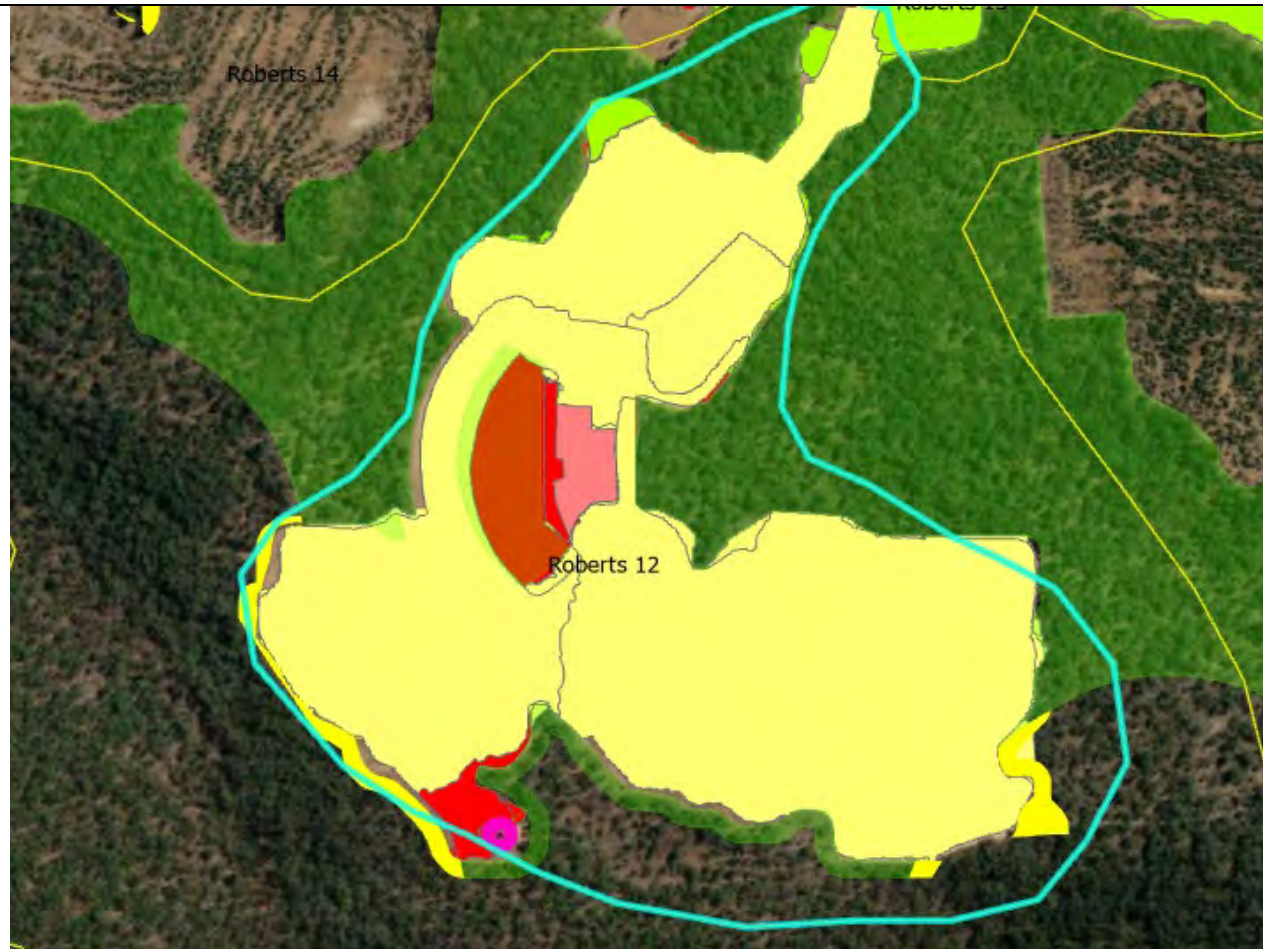
Roberts 12 - DC

Condition number(s)	Task and Purpose	PNC Issues	Notes	Photo taken
4(d)	Roberts 12 (F4223, F4227) <ul style="list-style-type: none"> Check drainage controls within the pit, in areas where the area is mapped as less than 25% and 50% drainage capacity in the southern part of the pit 	None identified	<p>Low area mapped as 25% drainage capacity has a sufficiently sized sumps to contain any runoff from the area.</p> <p>Trenches and other sumps also present in low area throughout the pit.</p> <p>No observed runoff from the pit going into the forest.</p> <p>Mapped Black Cockatoo tree still present with more than 10m buffer in place. No tag on tree only marked by a 'H'.</p> <p>Northern area mapped as 25% drainage capacity has not been cleared, area beside mapped as 50% has been ripped.</p>
