# WQMS Data Review

## Huntly Bauxite Mine

JULY 2026

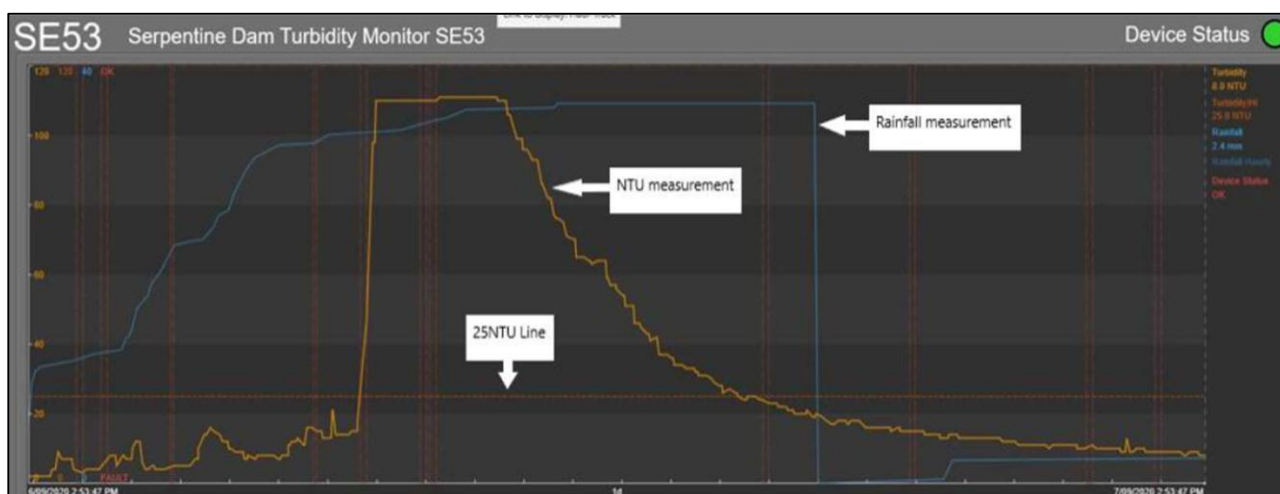
Figure 1 Typical 'true' exceedance event

These events are caused by an actual increase in stream turbidity. Per Alcoa's "Turbidity Event Classification Guidelines" true exceedance events typically exhibit:

- A sharp, sudden incline in turbidity levels.
- A return to baseline turbidity levels in a pattern resembling a normal (Gaussian) distribution.

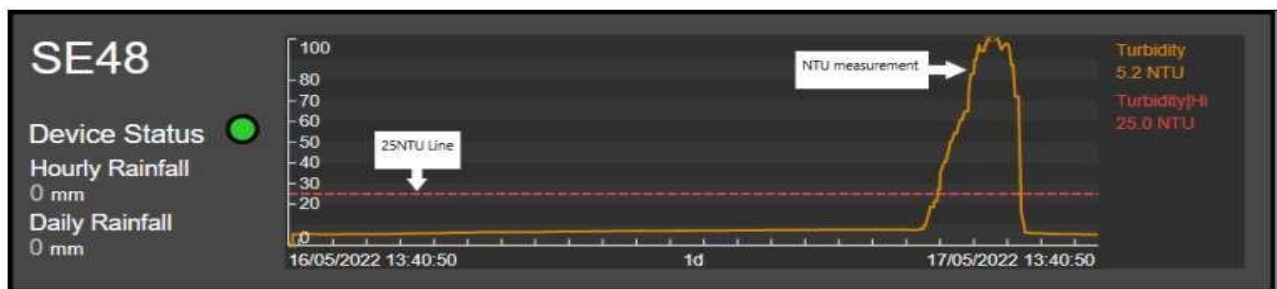
Figure 2 Typical 'False' Exceedance event

These events are caused by factors unrelated to actual turbidity increase, such as:

- Organic debris (e.g., leaves, sticks, algae) obstructing the sensor
- Air bubbles or water turbulence near the sensor
- Fluctuating water levels intermittently covering and uncover the sensor lens.

False events typically exhibit sharp inclines and declines without the characteristic bell curve shape of true events.

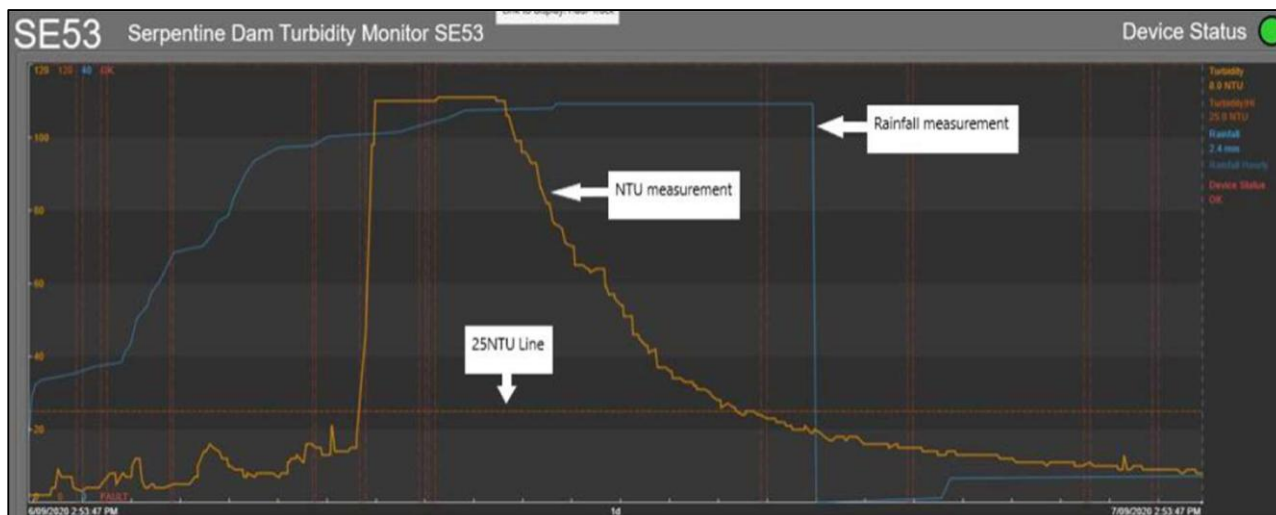
Figure 1 Typical 'True' exceedance event.

A sharp, sudden incline in turbidity levels.

A return to baseline turbidity levels in a pattern resembling a normal (Gaussian) distribution.

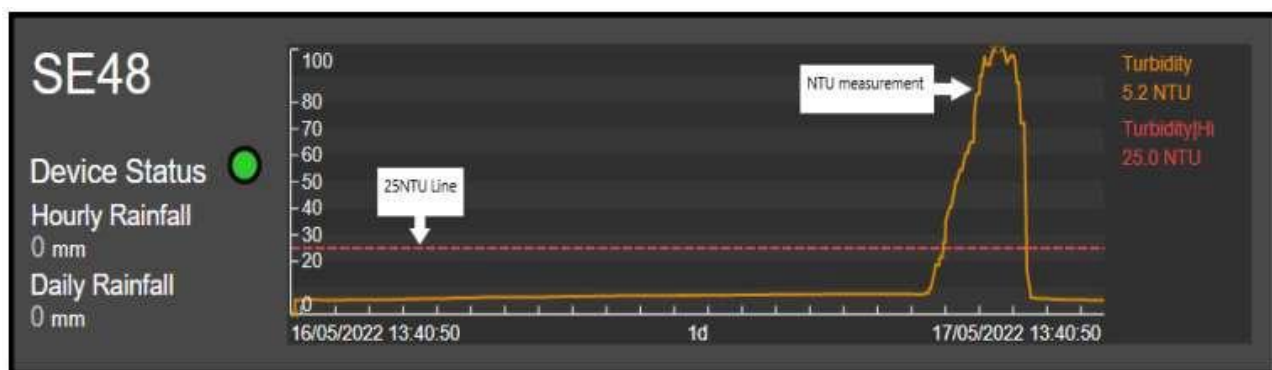
Figure 2 Typical 'false' exceedance event.

Fluctuating water levels intermittently covering and uncover the sensor lens.

False events typically exhibit sharp inclines and declines without the characteristic bell curve shape of true events
