# WQMS Data Review

## Huntly Bauxite Mine

JUNE 2026

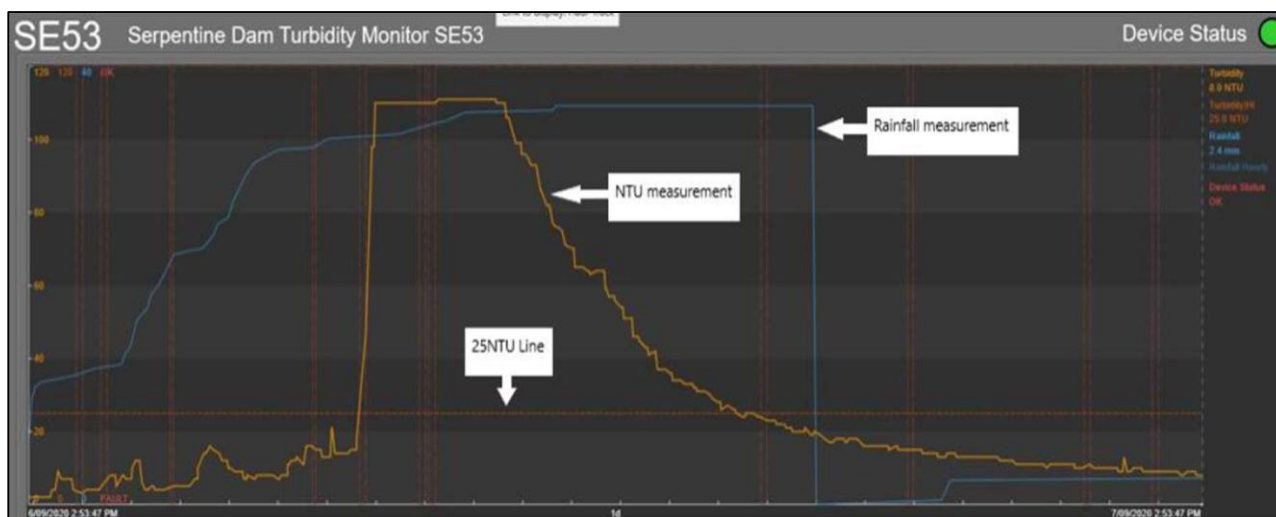
A sharp, sudden incline in turbidity levels.

A return to baseline turbidity levels in a pattern resembling a normal (Gaussian) distribution.

Figure 1 Typical 'True' exceedance event.

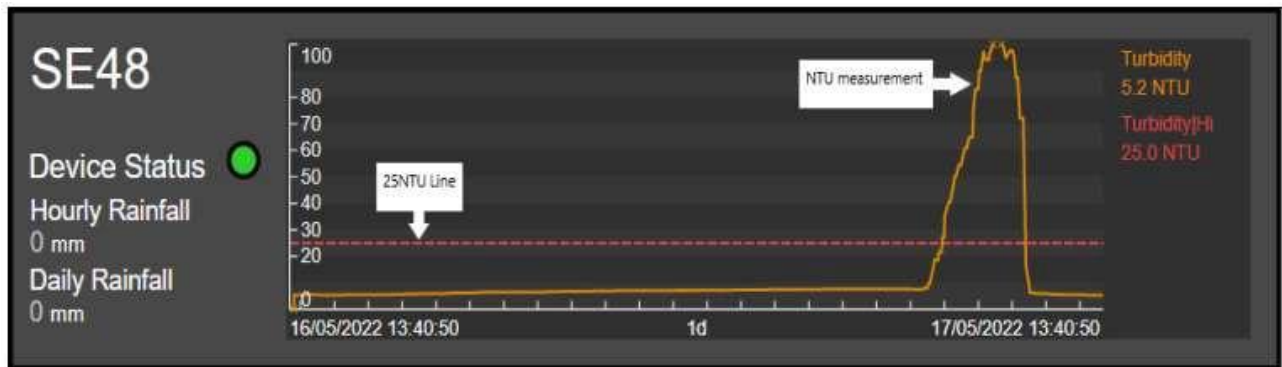
Fluctuating water levels intermittently covering and uncover the sensor lens.

False events typically exhibit sharp inclines and declines without the characteristic bell curve shape of true events

Figure 2 Typical 'false' exceedance event.
