Appendix 14 – Big Brook Crossing Supporting Documents

Big Brook Causeway Construction and Operational Plan Version 6 – FOURTH MMPLG SUBMISSION

The purpose of Version 6 Big Brook Causeway Construction and Operational Plan is to provide all the necessary information for the Mining and Management Program Liaison Group (MMPLG) to review the Big Brook Causeway engineering upgrades, provide comment and ultimately provide approval.

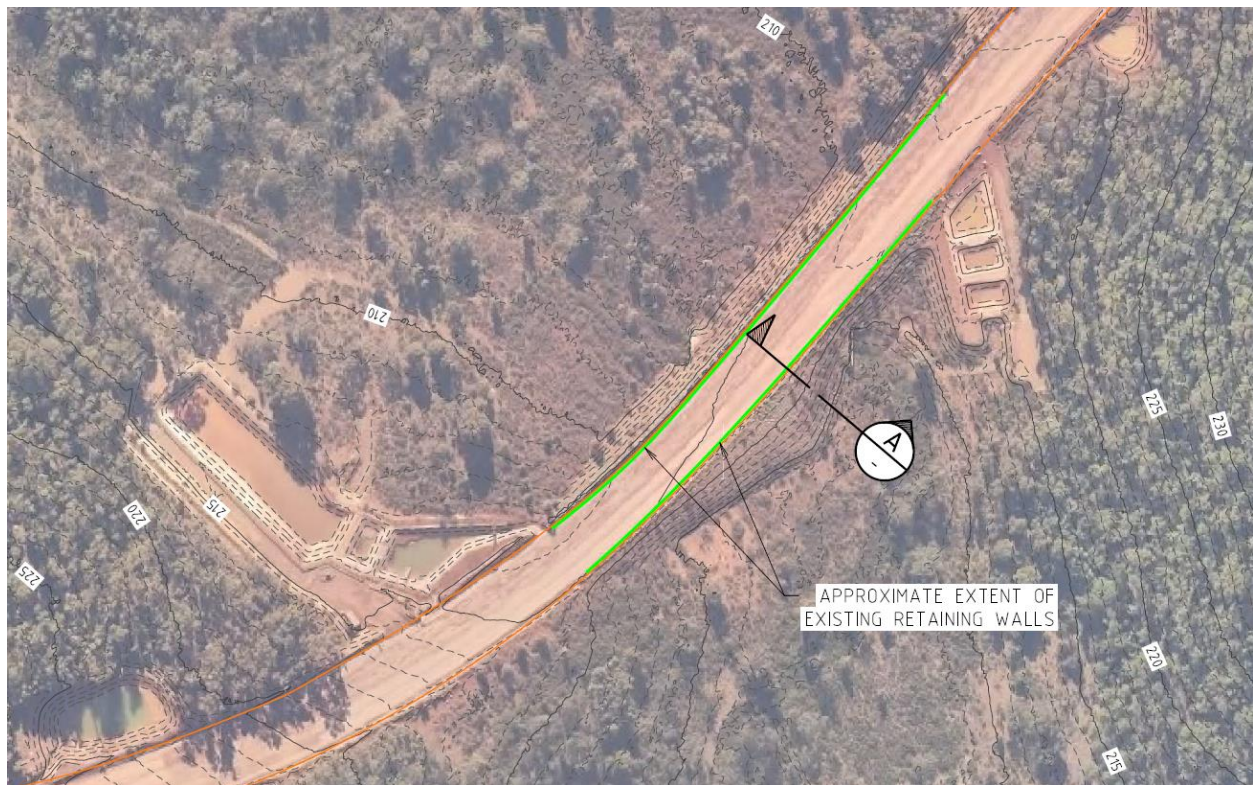
Figure 7 - Approximate extent of existing Causeway barrier

The existing barrier along the Big Brook Causeway is constructed of precast concrete L-panelling with rock fill providing support to the wall. The current barrier is constructed approximately 1.5m high along the roadway. Figure 7 shows the extent of this barrier and Figure 8 shows a typical cross section.

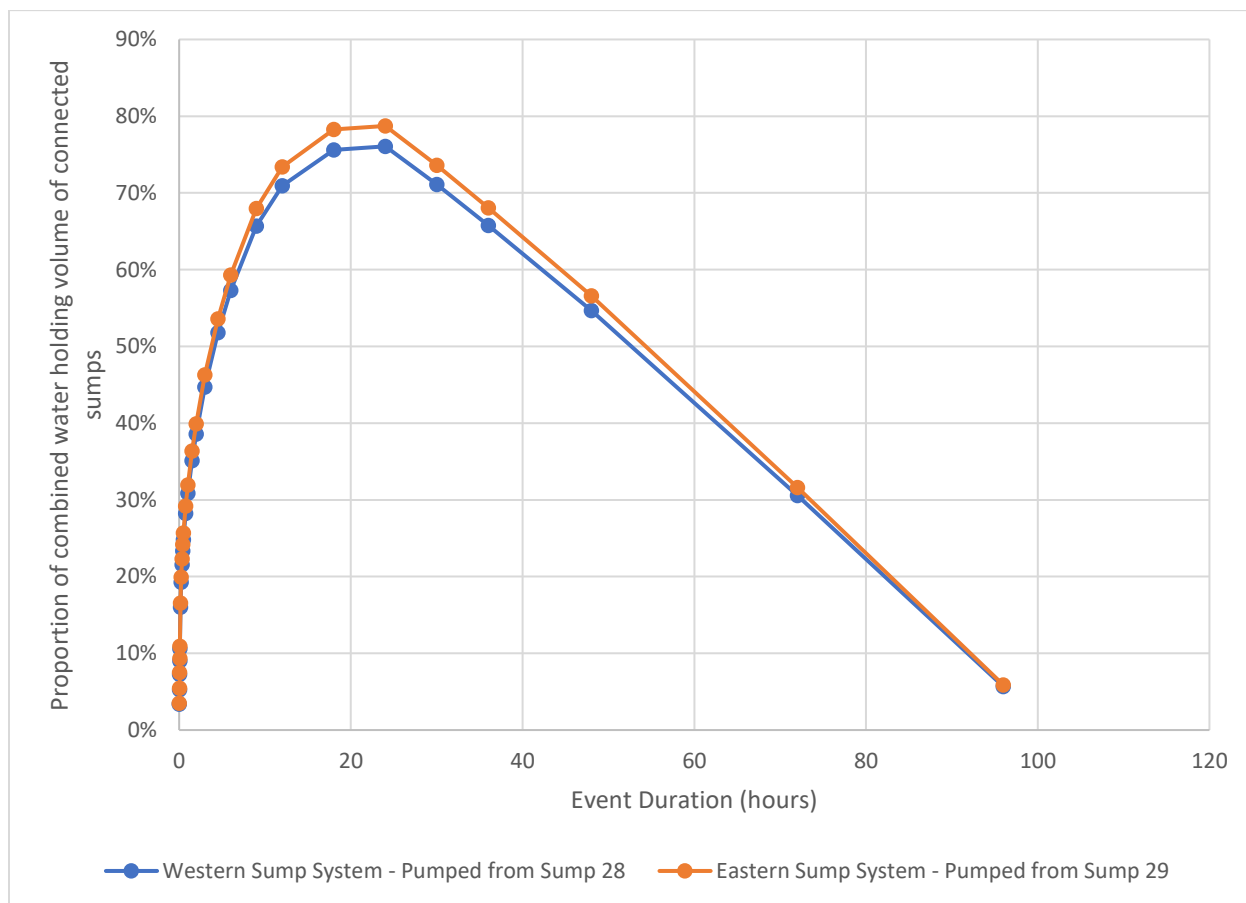
Figure 9 - Combined performance of upgraded sumps and pumping infrastructure - maximum sump volume reached during a 0.05% AEP storm event

Figure 9 presents the combined performance of the upgraded sumps and proposed pumping infrastructure during a 0.05% (2000 yr ARI) storm event. As presented, the combined upgraded sump capacity and pumping is expected to limit water volumes in the sumps to less than 80% of the sump capacity. This indicates that the upgraded sumps and pumping infrastructure will accommodate runoff from more than a 0.05% storm event of 7 days duration.

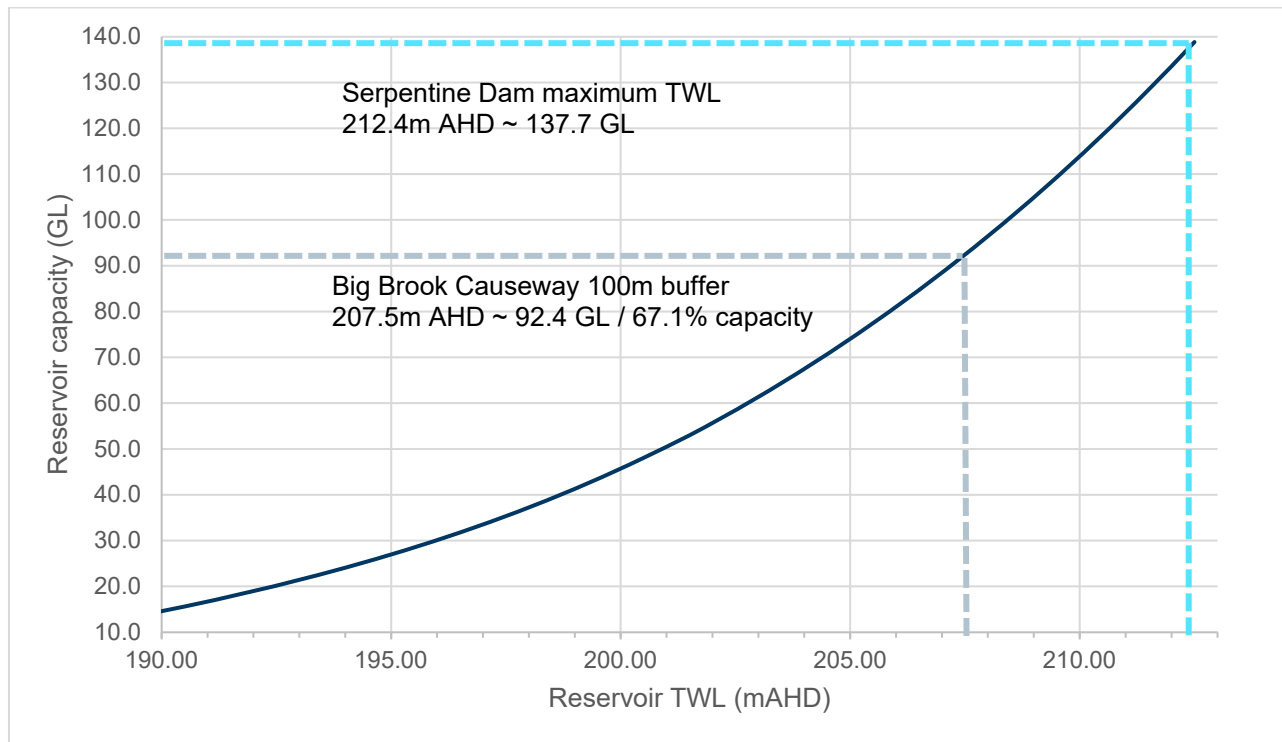
Figure 4 Serpentine Dam volume to water level curve

Serpentine Dam has a full supply capacity of 137.7 gigalitres (GL) at a TWL of 212.4 mAHD which is the dam crest level, with an estimated maximum headwater level of 213.9 mAHD at the Big Brook Causeway causeway. The Big Brook Causeway 100 m buffer is defined by the Water Corporation as being at an elevation of 207.5 mAHD, which represents a reservoir capacity of approximately 92.4 GL or 67.1% of full capacity (see Figure 3, Figure 4).

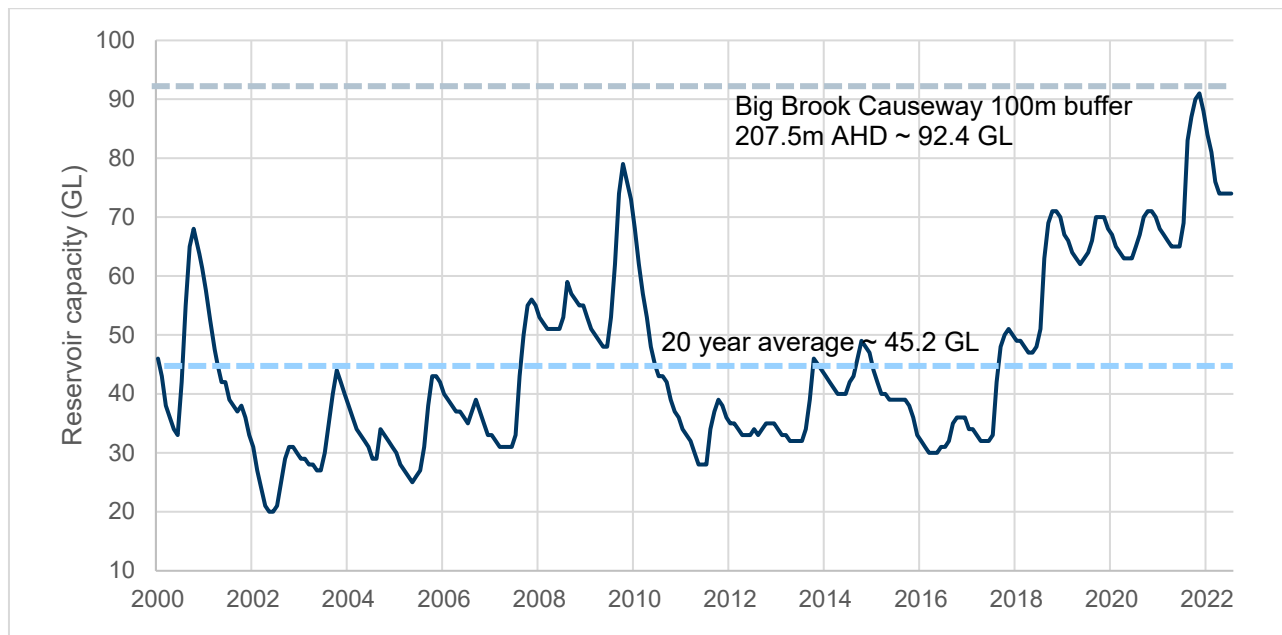
Figure 5 Serpentine Dam volume history 2000-2022⁶

The Serpentine Dam capacity has been less than 80 GL, averaging about 45 GL, from 2000 to 2020 (Figure 5). A combination of high inflows and water banking from 2016 onwards has resulted in the reservoir capacity progressively rising. In August 2021, Water Corporation issued a cease operation order to Alcoa due to rising reservoir water levels. The temporary cessation of causeway operations had significant impacts to the Huntly Mine in terms of cost and complexity and to the Kwinana and Pinjarra Alumina Refineries in terms of ore grade.

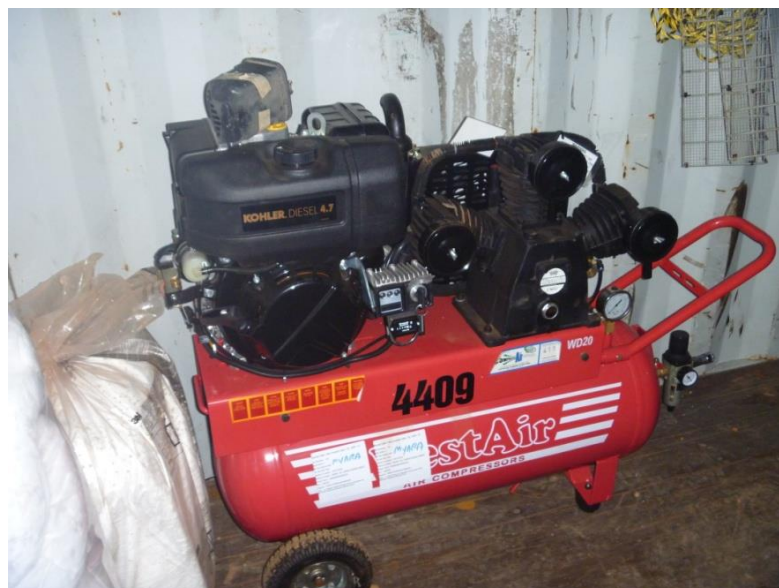
Figure 1. Compressor

21. CONDUCT a pre-start on the compressor diesel engine before operating.
22. START the compressor diesel engine.

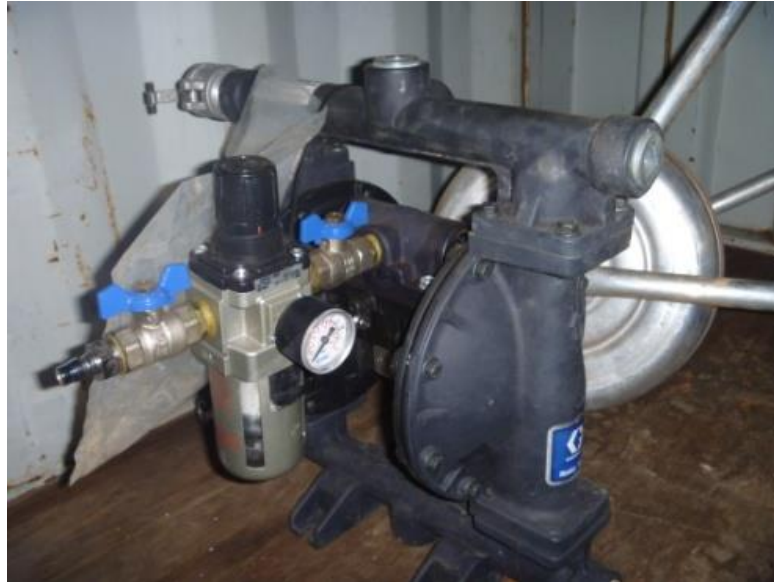
Figure 2. Water Pump

23. REMOVE the oil skimmer from the shipping container and locate it at the work area.
24. REMOVE the air powered water pump (Figure 2) from the shipping container and locate it at the work area.

25. CHECK that the hose and coupling are in good condition then connect the vacuum pipe to the intake port on the pump.
26. CHECK that the hose and coupling are in good condition then connect the delivery pipe to the discharge port on the pump.
27. SECURE the delivery end of the discharge pipe into the top of the IBC outside the shipping container.
28. CONNECT the air supply line between the compressor and the pump.
29. CHECK that the airline is in good condition and all airline connections are in good working order before use to avoid the uncontrolled release of stored energy.
30. CONNECT the draw pipe to the skimmer.
31. DEPLOY the skimmer into the contaminated dam on the upstream side of the marine bunding (Figure 3).
32. PRIME the water pump using water from the bucket using water from the fire truck or water from the 20L water container located in the shipping container.

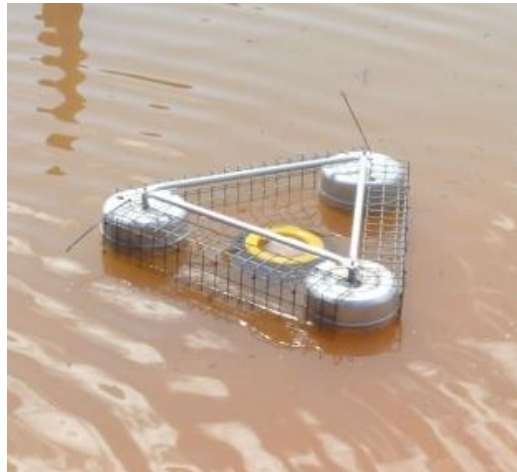
Figure 3. Skimmer deployed in sump

33. TURN the pump on, slowly at first to ensure the draw pipe remains primed.
34. CHECK for contaminants leaking onto the ground from connections.
35. MONITOR the level of contaminant in the IBC and bring another IBC out of the shipping container if required.
